# Investigation Results of Smoke Coming out from Electric Motors in the Cesium Absorption Tower Temporary Storage Facility at Fukushima Daiichi Nuclear Power Station

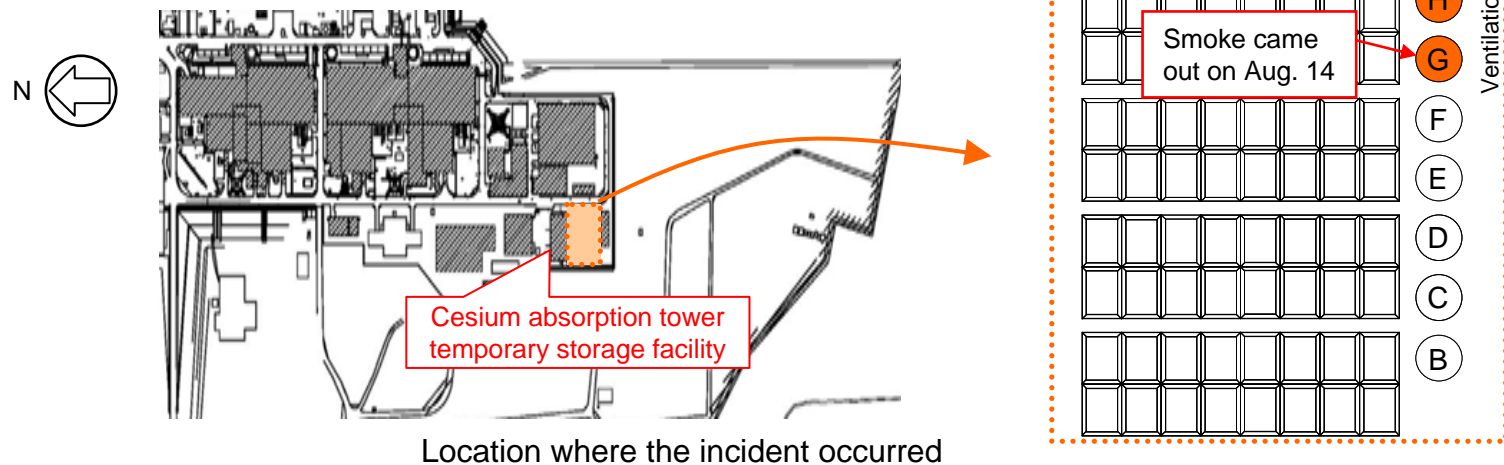
Location where the incident occurred

On August 14 and October 2, 2012, smoke came out from the electric motor of the absorption tower ventilation pump at the outdoor cesium absorption tower temporary storage facility located in the south of the central environment facility.
