Water Leakage Found Near Units 5-6 Low Radioactivity Density Accumulated

Water Tank at Fukushima Daiichi Nuclear Power Station

Date and Time the leakage was found
December 25, 2012 at around 11:04 AM

Location
Units 5-6 low radioactivity density accumulated water tank area

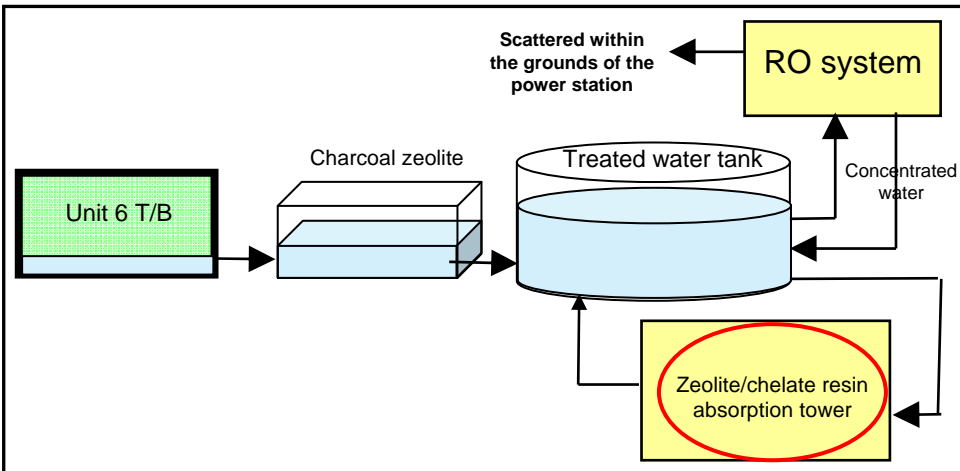
Location where water leakage occurred

Outline
A TEPCO employee found water leakage from the sampling pipe outlet near Units 5-6 low radioactivity density accumulated water tank (located outside). Though the leaked water has been absorbed into the ground (gravel) and affected 1m x 1m area, it has not flowed outside since there is no drainage in the surrounding area. The amount of leaked water is estimated to be approx. 10L (max.).
