# Fukushima Nuclear Accident Analysis Report

## ( Interim Report ) -Summary-

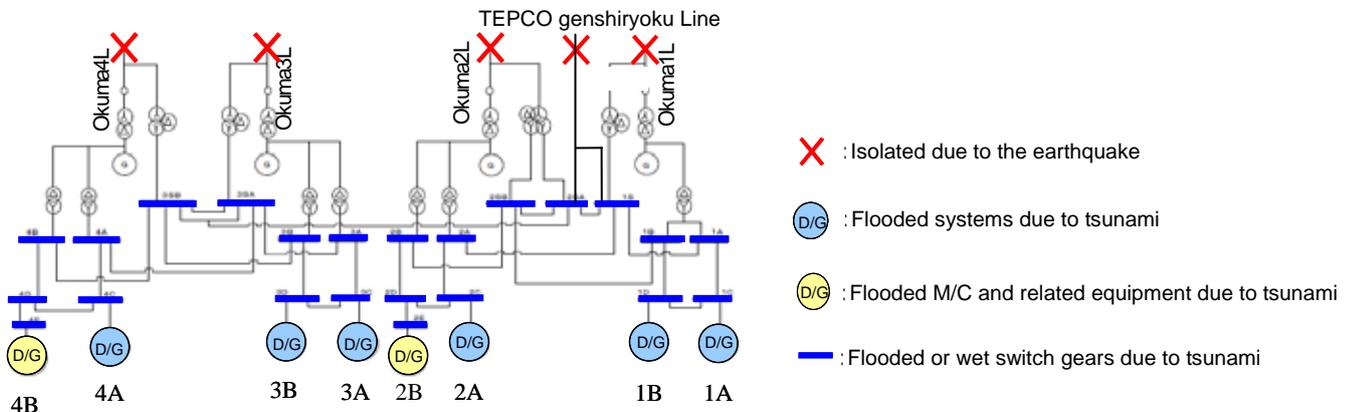
Single line diagram of Units 1 to 4, Fukushima Daiichi

- All AC power sources for Units 1 to 6, except for one EDG for Unit 6 lost their functions because of the tsunami and it resulted in all motor-driven pumps and motor-driven valves being inoperable. Numerous switchgears became wet or flooded and became unusable. It turned out that there were almost no operable switchgears to connect to in order to activate the equipment even though external electricity sources (e.g. power supply cars) could be prepared.
- Units 1, 2 and 4 lost their DC power sources resulting in the monitoring instruments being out of use.
- Seawater facilities necessary for heat removal from reactors and various equipments were also wet or flooded. This resulted in inoperability of large pumps and other equipments that required cooling of motors.

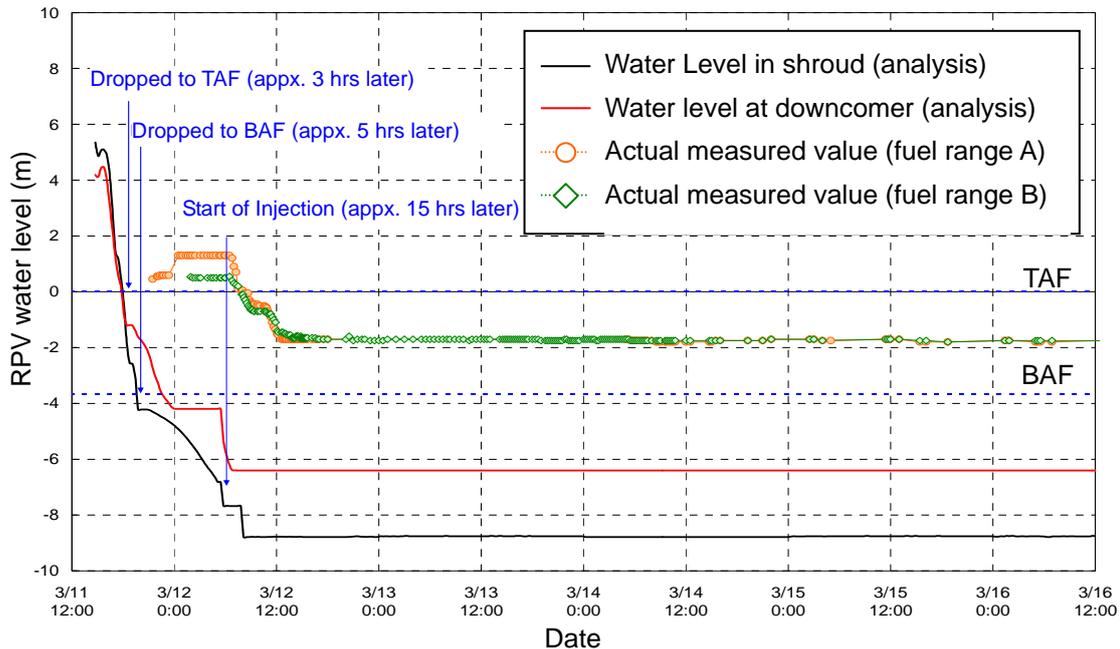
Example of an analysis result of RPV water level at Fukushima Daiichi Unit 1

- The reactor water level started to decrease after the reactor core isolation cooling system stopped. Prior to the depressurization by safety relief valves, a fire engine's pump was started and the low pressure water injection was ready to be operated. However, the safety relief valve could not immediately be opened during the reactor depressurizing operation. Hence the low pressure water

injection did not start quickly. This caused further deterioration of the cooling function and the amount of water in the reactor sharply decreased following the pressure decrease, which led to the core damage. (A similar event sequence of events is considered to have occurred at Unit 3.)

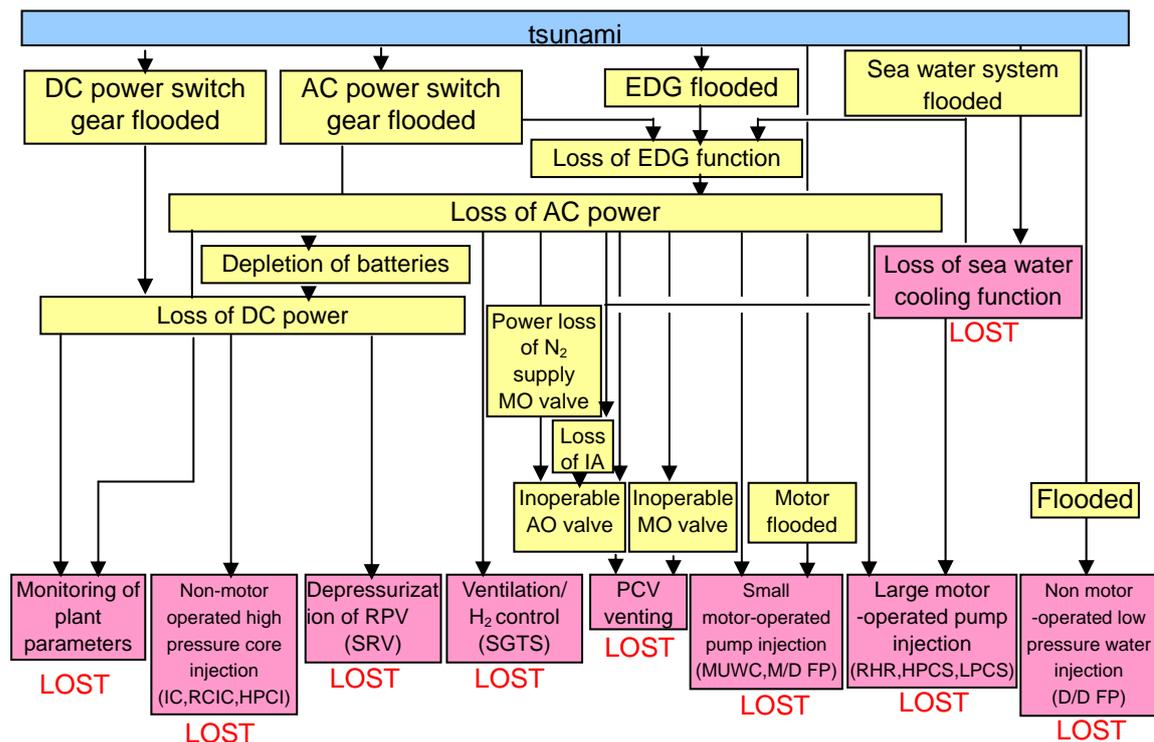
Causes Leading to the Loss of Critical Functions to Prevent Core Damage and Mitigate Effects

Based on the accident progress at Fukushima, the correlation of primary factors resulting in the loss of vital functions is shown in the following figure. "Simultaneous power loss of AC and DC power for an extended period of time" and "residual heat removal function of the emergency sea water system for an extended period of time" are two of the primary factors that caused a simultaneous loss of multi-safety function due to flooding by tsunami in this accident.
