Fukushima Nuclear Accidents Investigation Report

Attachment

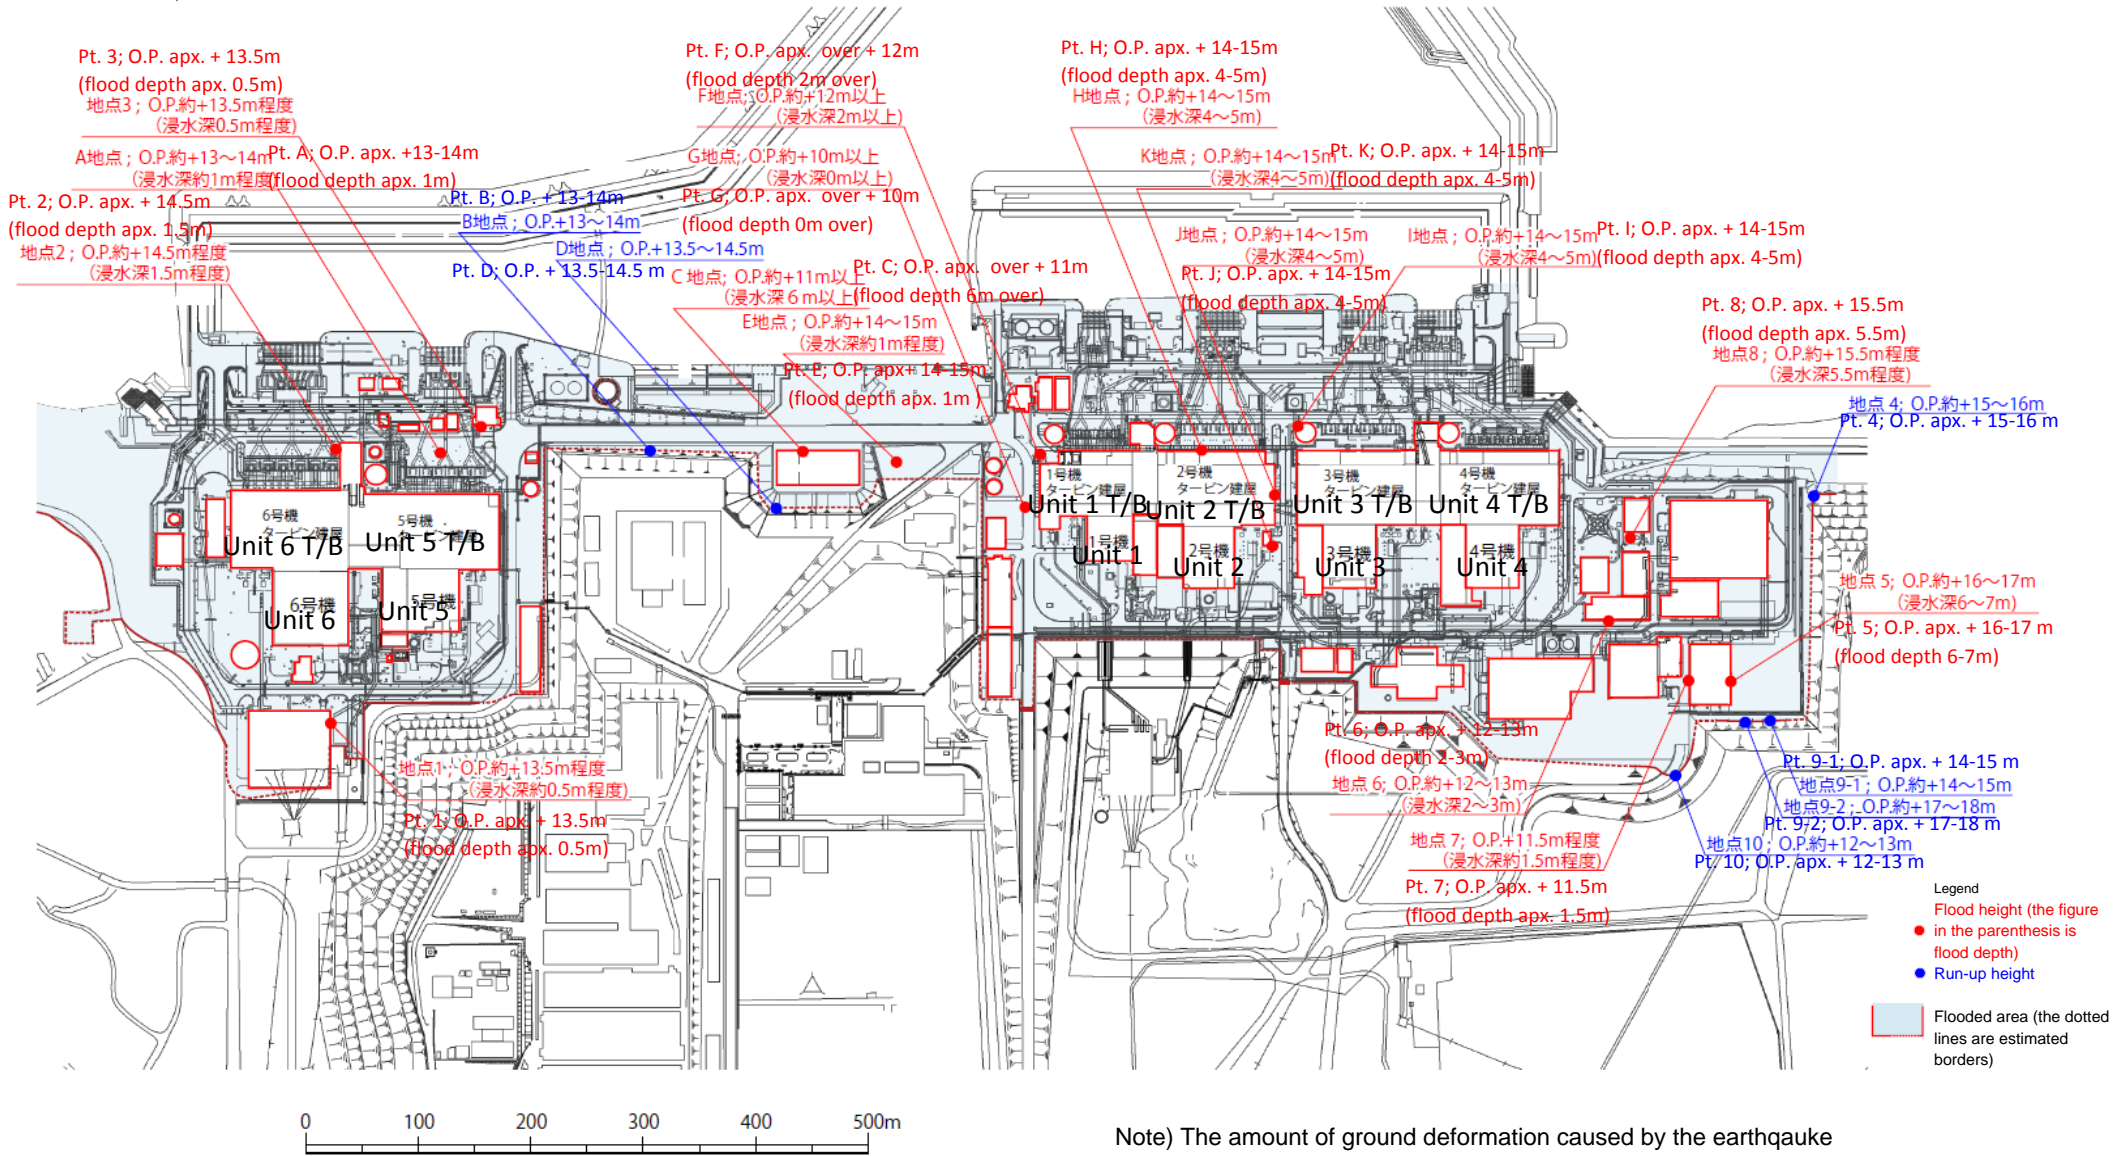
Tsunami investigation results at the Fukushima Daiichi Nuclear Power Station (Flood height, Flood depth and Flooded area)

Note) The amount of ground deformation caused by the earthquake is not reflected in the flood height and run-up height.

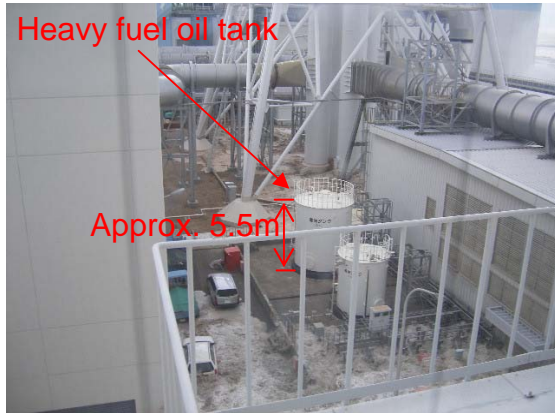
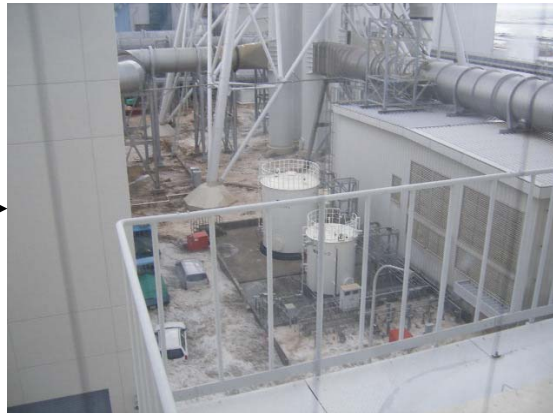
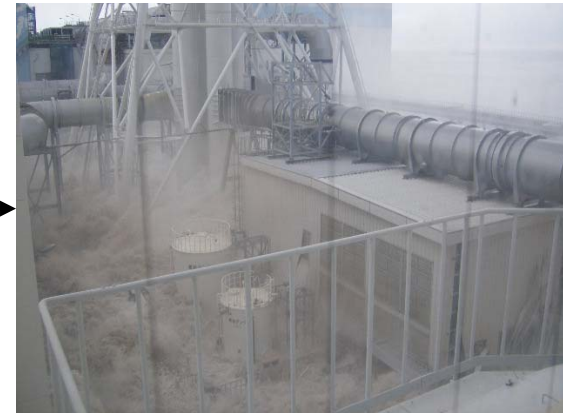
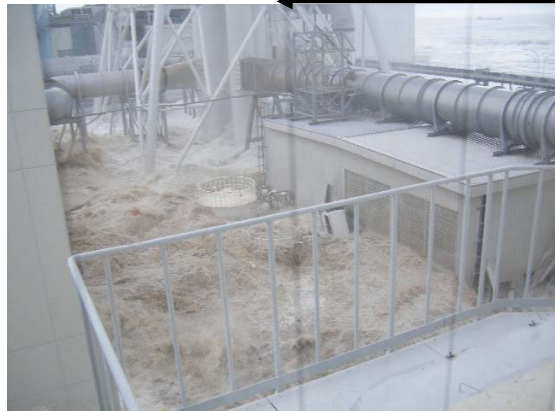
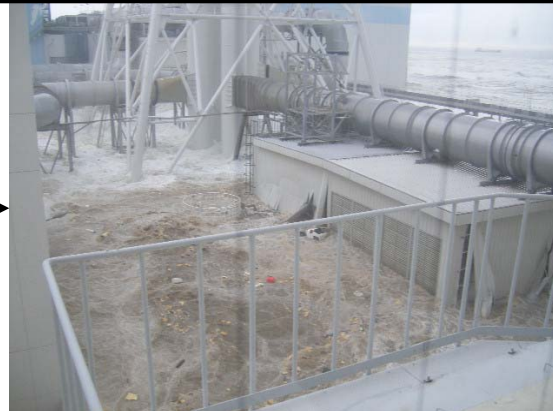
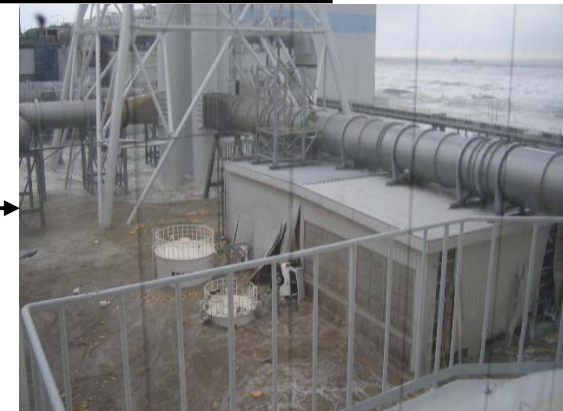
Outdoor flooding state at the Fukushima Daiichi Nuclear Power Station (March 11)

<Around the central radioactive waste treatment building at south-side of Unit 4: Ground level O.P. +10m, Heavy fuel oil tank height approximately 5.5m>

Right after flooding: 0 sec.

After 6 sec.

After 46 sec.

After 56 sec.

After 74 sec.

After 98 sec.

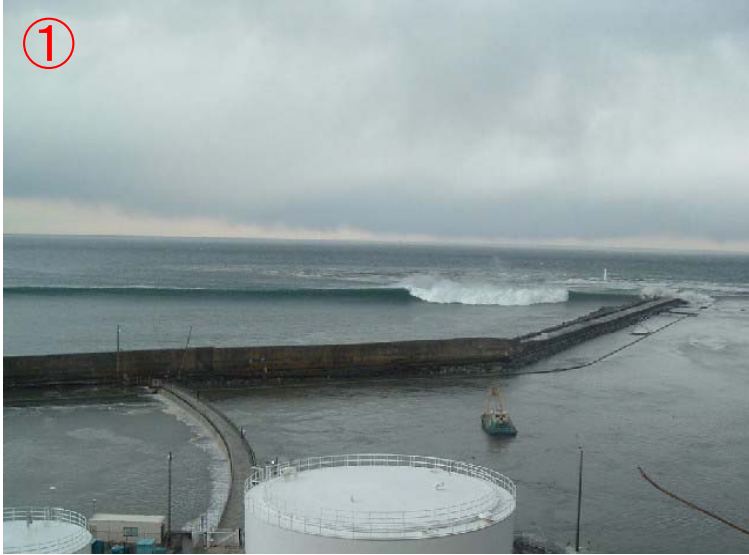
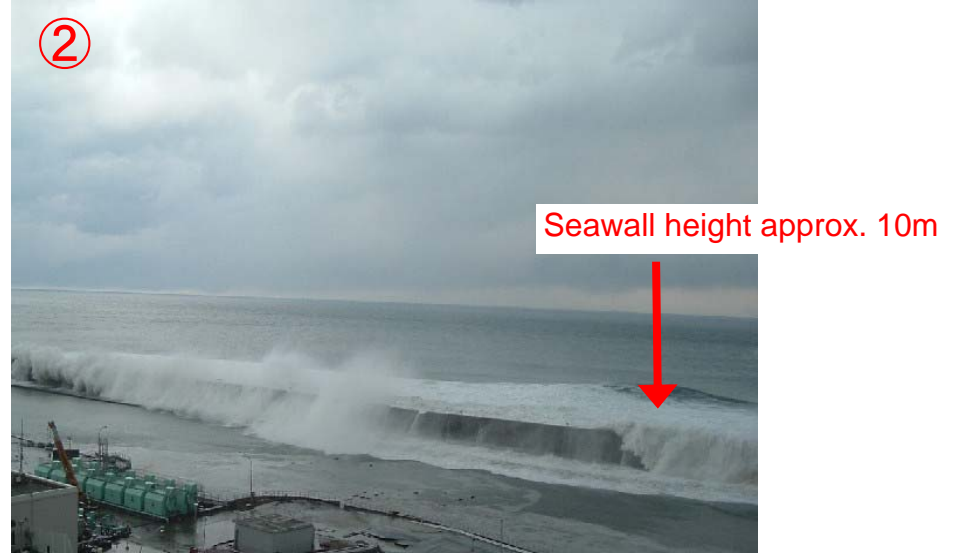
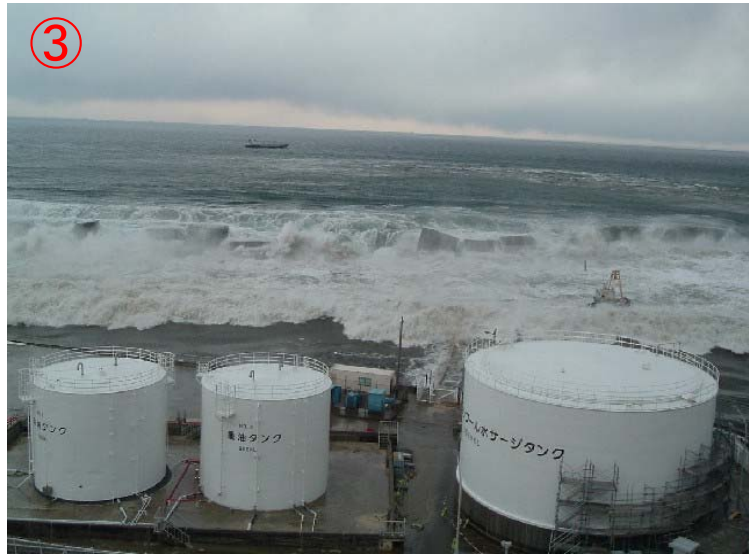
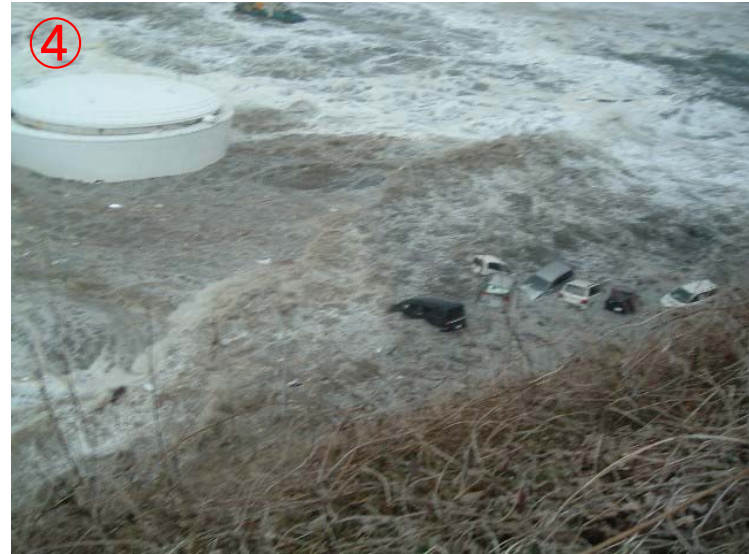
State of the tsunami that hit the Fukushima Daiichi Nuclear Power Station

<Ocean side of Fukushima Daiichi Nuclear Power Station Units 5 and 6 (east side of solid waste storage)>

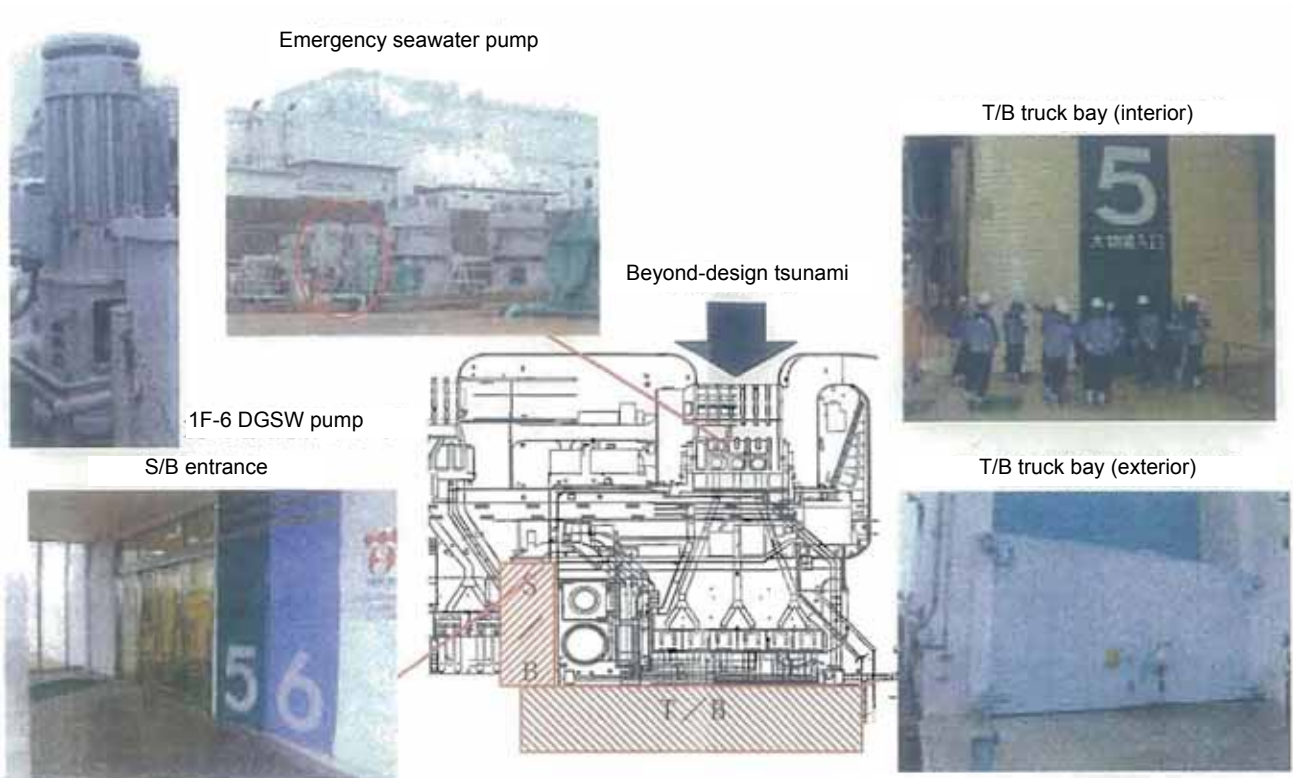
Fig. 3 Outdoor facilities that may be flooded due to beyond-design tsunamis (Fukushima Daiichi Unit 5)

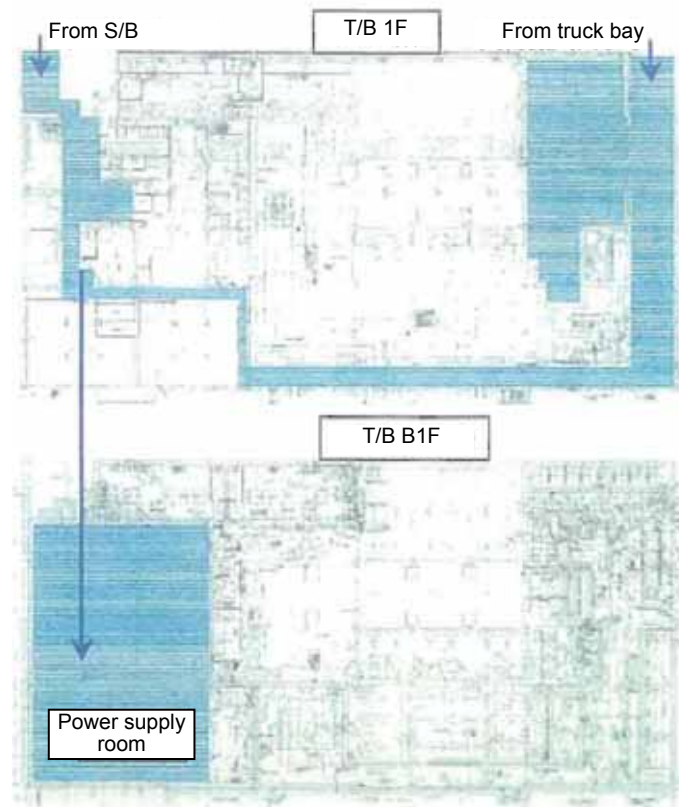
Fig. 5 Tsunami water ingress pathway (1F-5)

[Tsunami water level O.P. 14m] When it is postulated that water flows into the T/B truck bay or S/B entrance, it is verified that all T/B areas will be flooded and there is possible loss of function of power supply facilities (Fig. 5).

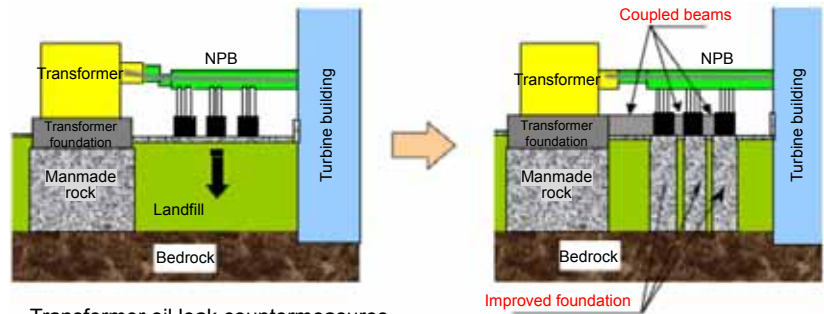
Transformer foundation subsidence countermeasures

- The Niigata-Chuetsu-Oki Earthquake caused the foundation around transformers and surrounding equipment to subside. The difference between the foundation structures of each piece of equipment caused uneven subsidence.
- In conjunction with this subsidence the secondary bushing terminal of the transformer came in contact with the non-segregated phase bus (NPB) duct. This caused an arc discharge that ignited insulation oil leaking from the transformer thereby resulting in a fire.
- Furthermore, insulation oil leak into the ground because the transformer oil fence was damaged by the earthquake.

→ As a countermeasure for uneven subsidence the ground beneath the NPB foundation was improved and the foundation was unified with that of the transformer. A rubber insulation sheet was also installed within the duct as a measure to enhance NPB duct insulation. And, an incombustible water shielding sheet (polychlorinated vinyl sheet) that conforms to displacement has been attached to the inside of the oil fence in order to prevent insulation oil from leaking into the soil in the event that the oil fence is damaged.

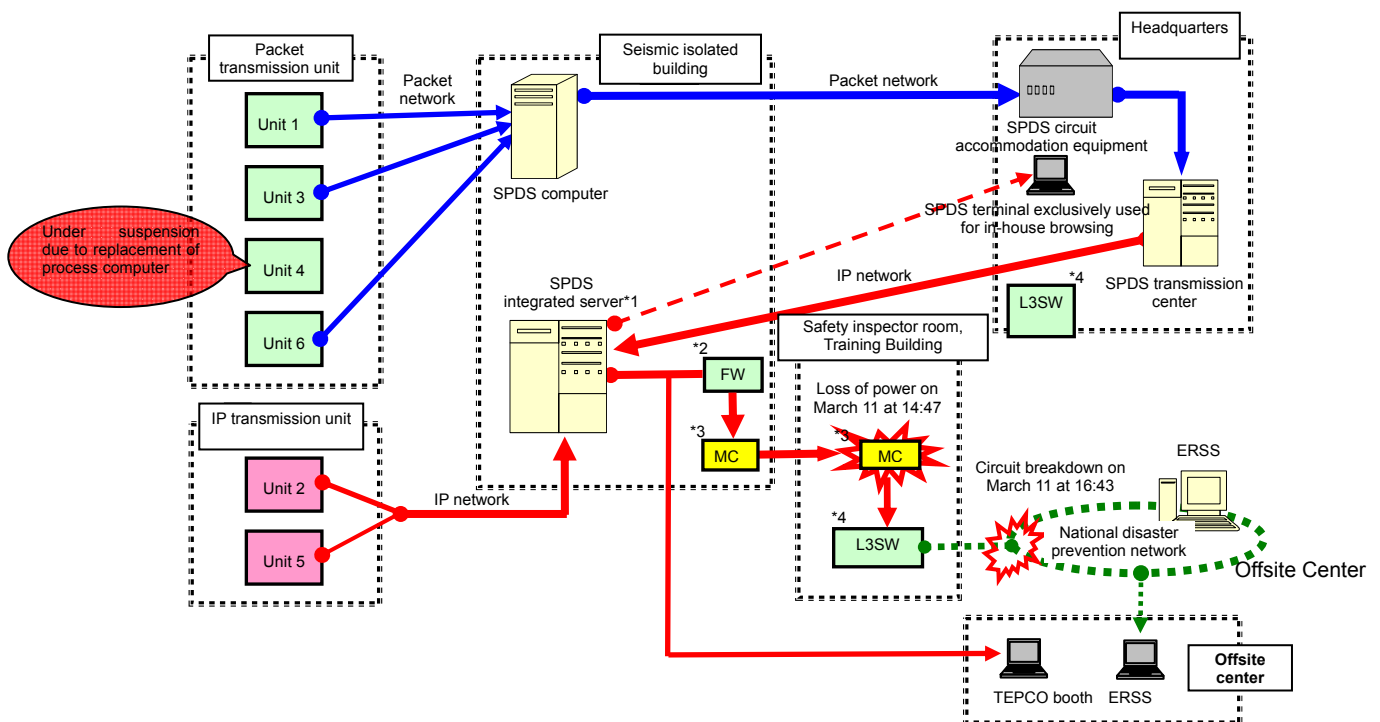
- At the Fukushima Daiichi NPS, transmission routes were altered in November 2010 to allow direct transmission from the power station, but only data from Unit 5 and Unit 2 could be directly sent leaving data from Unit 1, 3, 4, and 6 to be sent to headquarters via conventional facilities after which it was then sent back to the power station's server and then to the ERSS. A diagram is shown below.

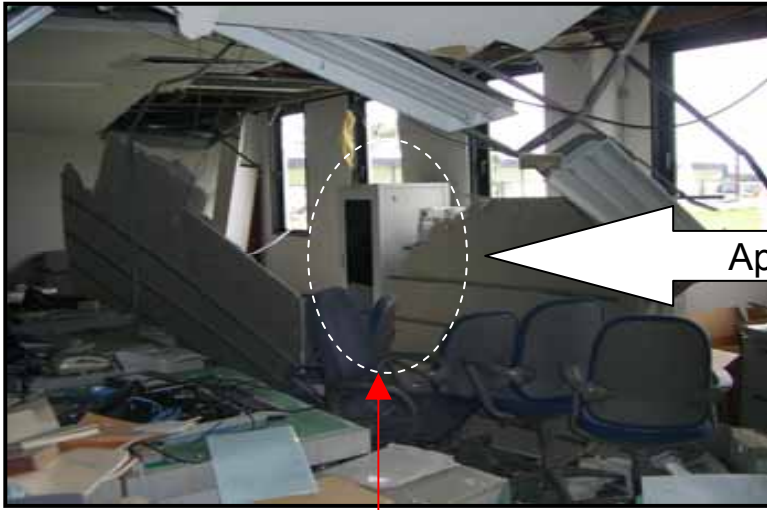
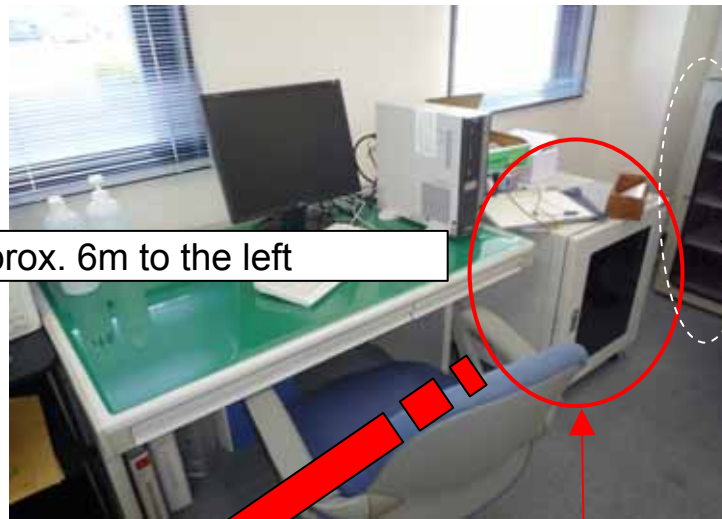
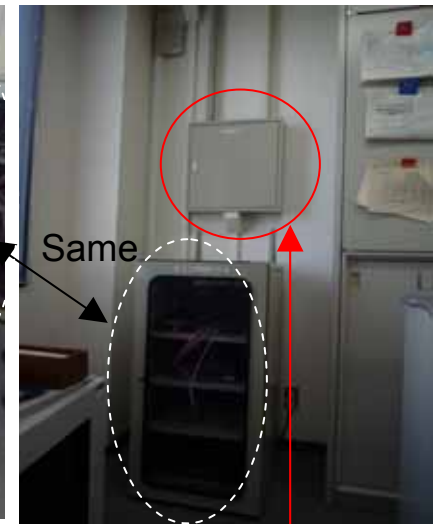
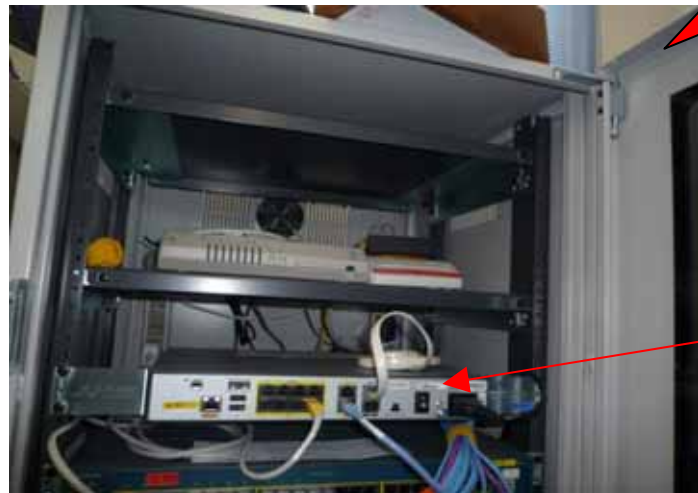
Supplement -1 Fukushima Daiichi NPS Safety Inspector Room SPDS-ERSS Equipment

⑤ Rack where L3SW and UPS were supposed to be installed

④ This device was mistaken for the L3SW because:

- There is an outlet behind the rack to which the device's power cable was connected.
- It was told before two outlets were available and coincidentally two outlets behind this device were also available.
- Power cable was mistakenly thought to be coupled since the power cable extended to the side of the rack where the UPS was housed (left).

③ Housing rack where the safety inspector mistakenly said the L3SW would be housed upon prior visit for installing work.
An L3SW battery (UPS) was going to be connected to the MC as a backup power source

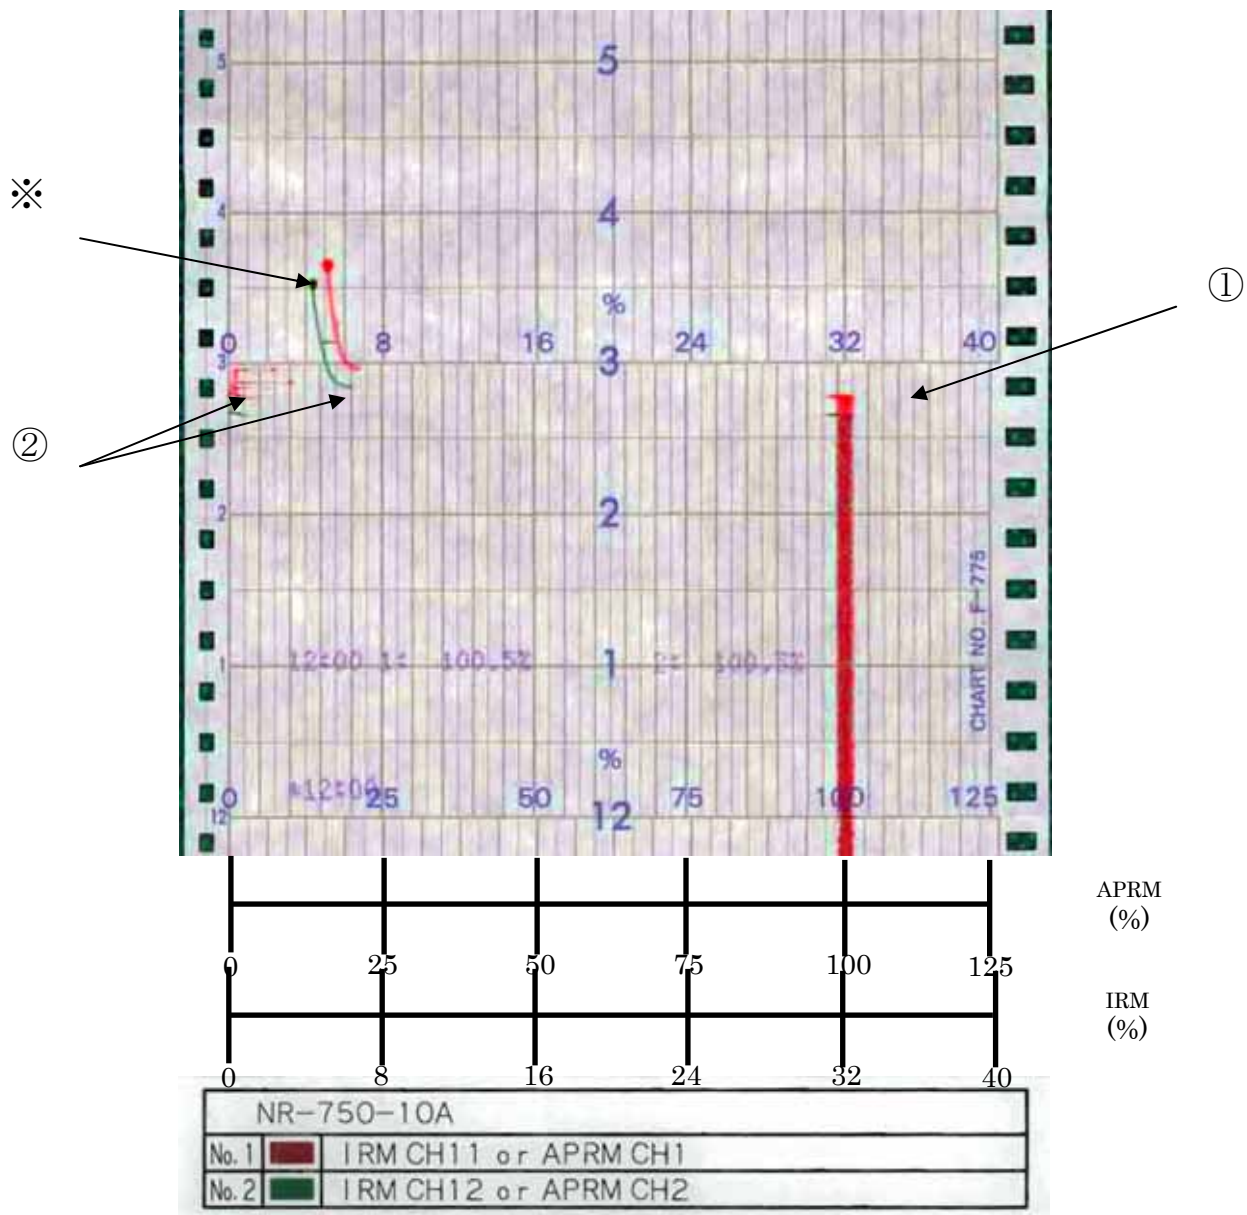
[Intermediate Range Monitor (IRM), Average Power Range Monitor (APRM)], m

- ① Scram triggered by Earthquake at 14:46 and fall in output due to scram.
- ② Below the range of Average Power Range Monitor (APRM) and changed to Intermediate Range Monitor (IRM)
- * It is assumed that the tsunami arrived at 15:30.
It is supposed that the record stopped due to the impact of the tsunami.

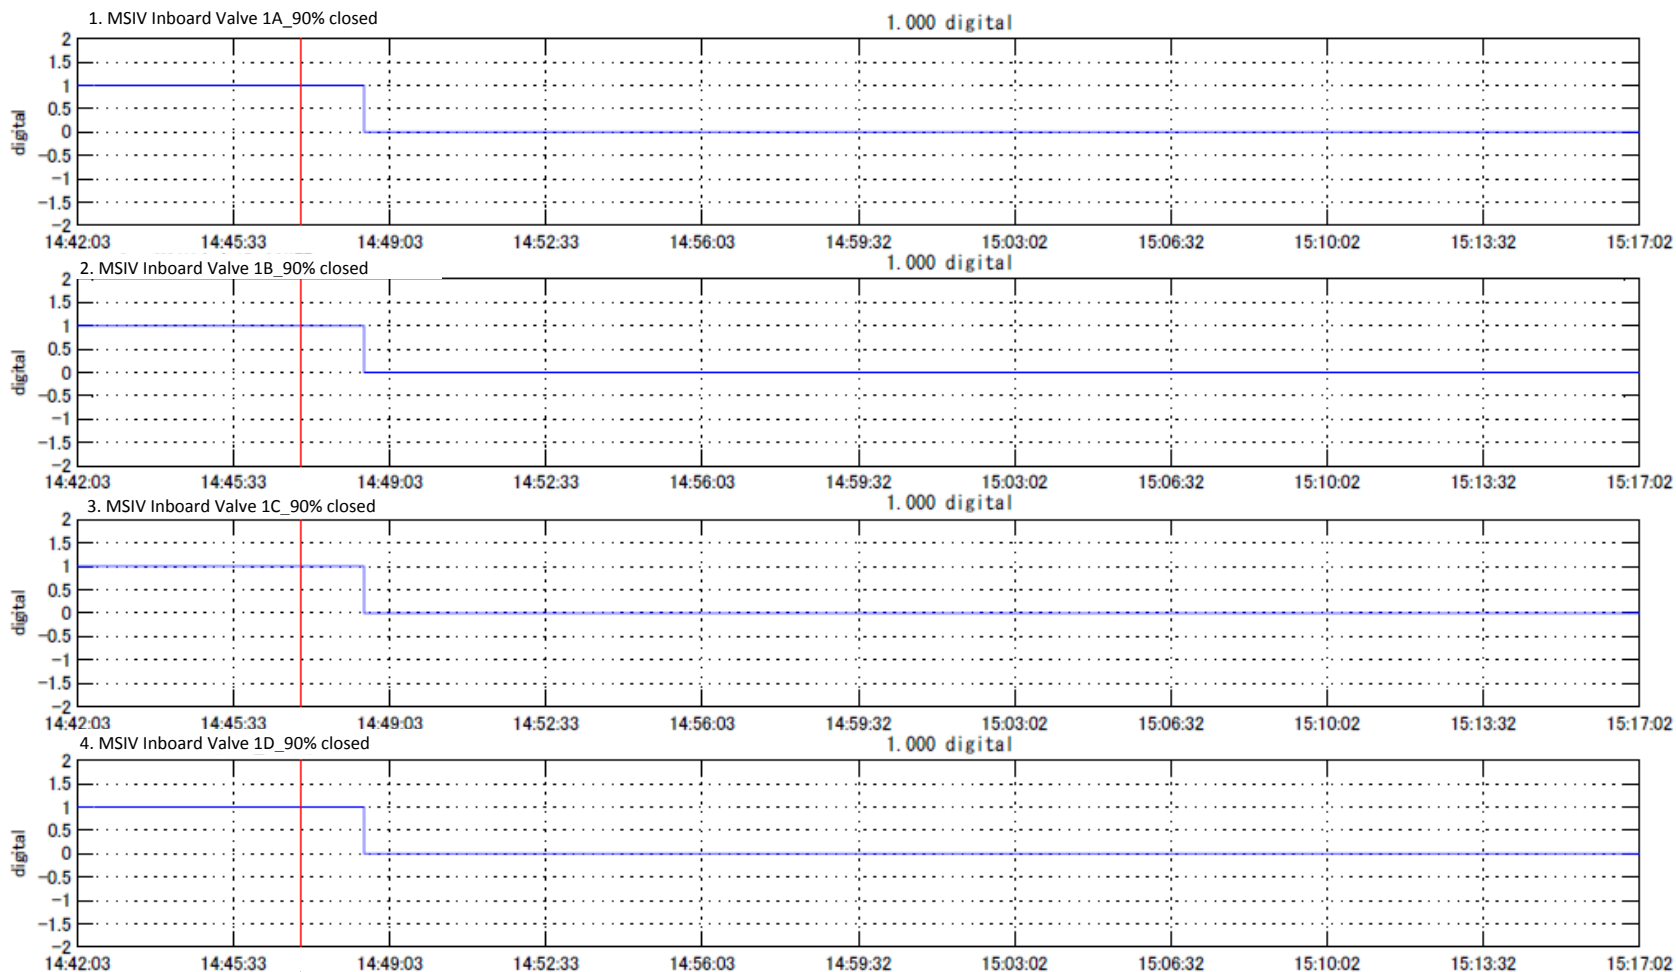
The main steam isolation valve (intboard) is closed.

Main steam isolation valve closed
Start of automatic recording by transient recorder in conjunction with vibration of the top of the reactor recirculation pump (A)

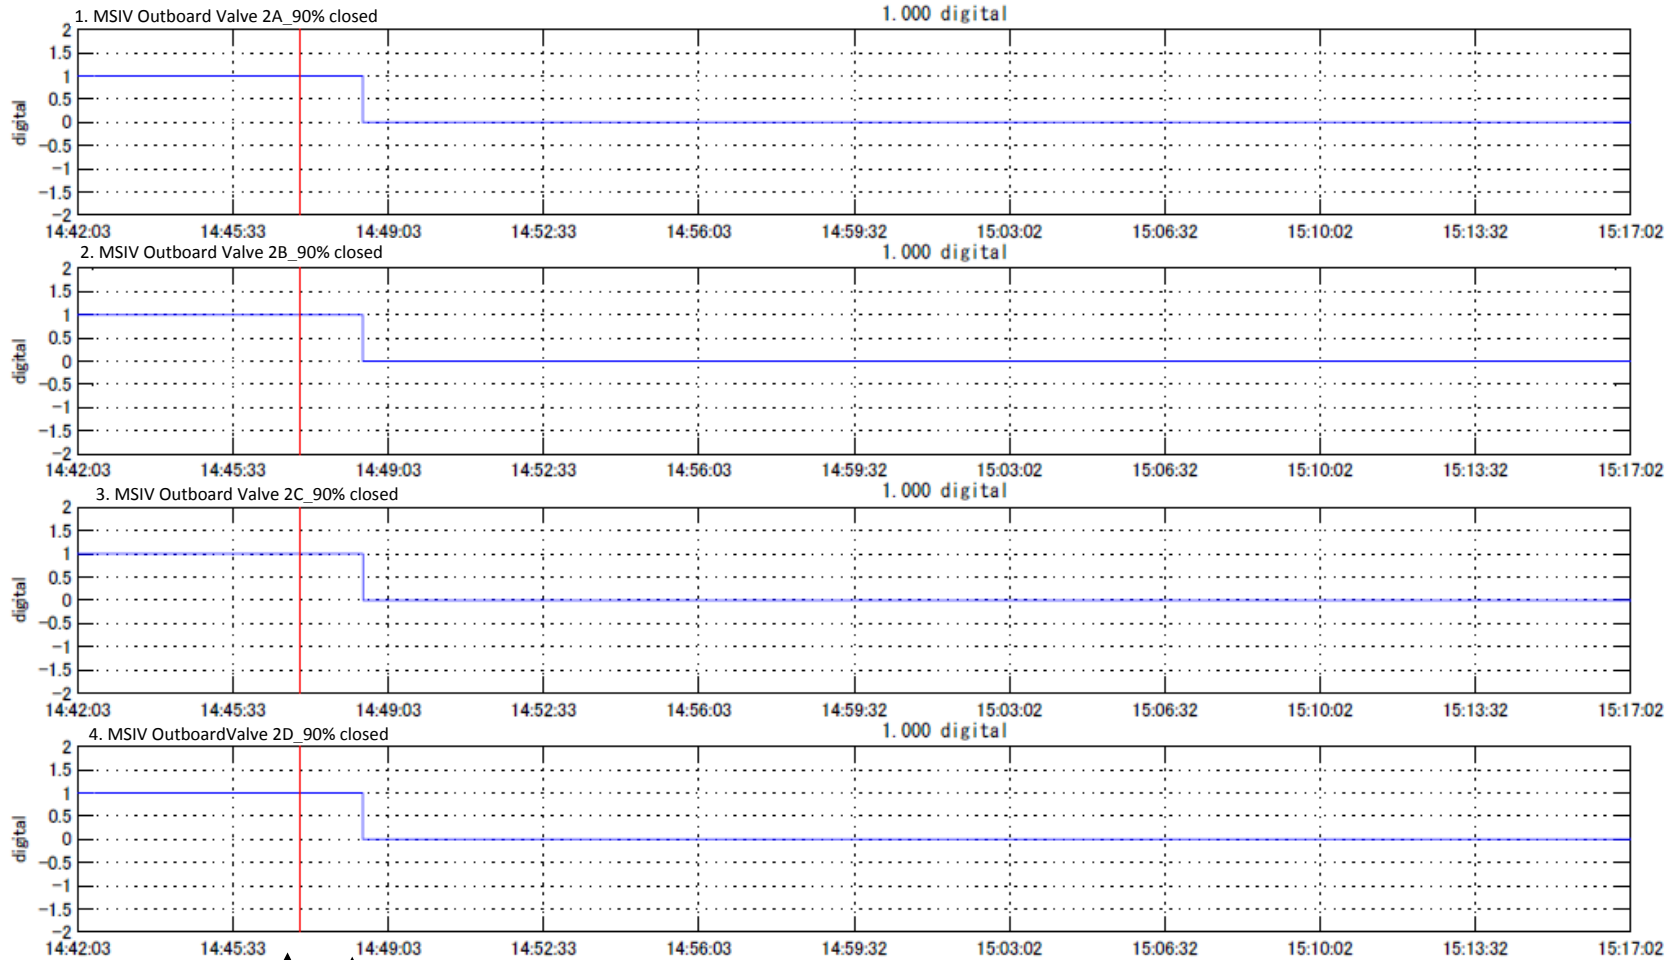
The main steam isolation valve (outboard) is closed.

Main steam isolation valve closed
Start of automatic recording by transient recorder in conjunction with vibration of the top of the reactor recirculation pump (A)

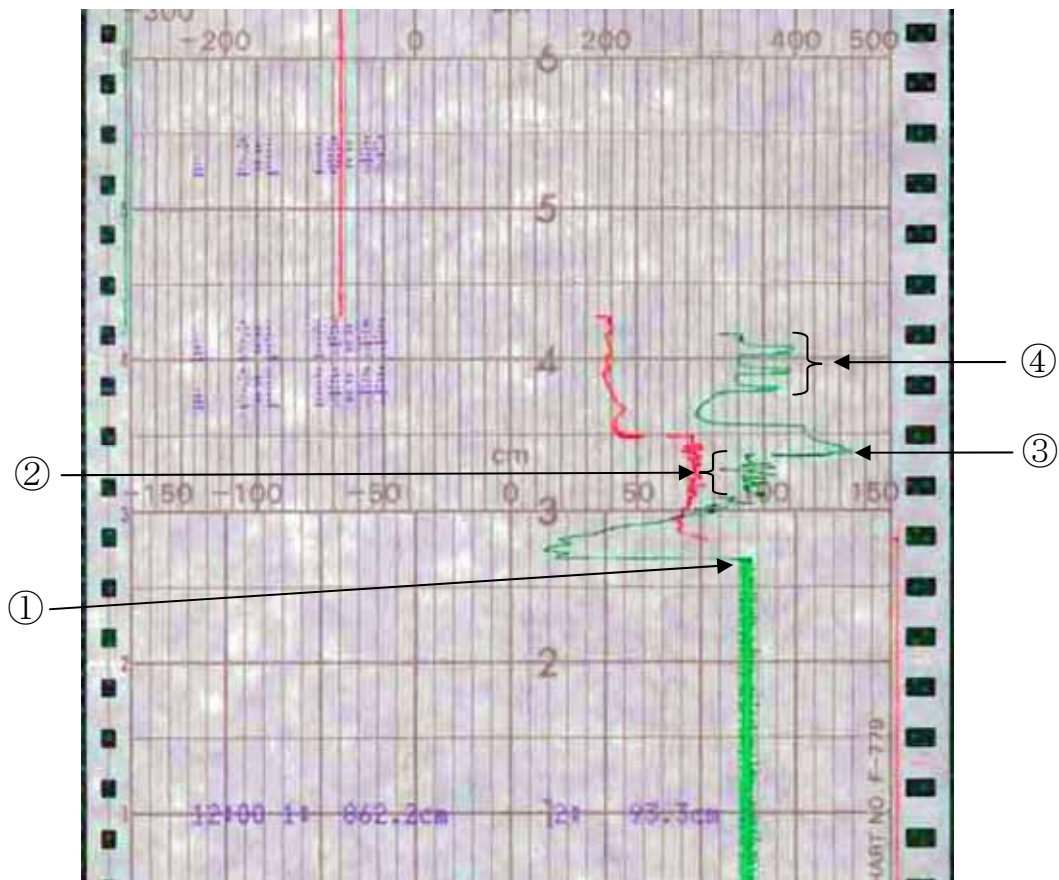
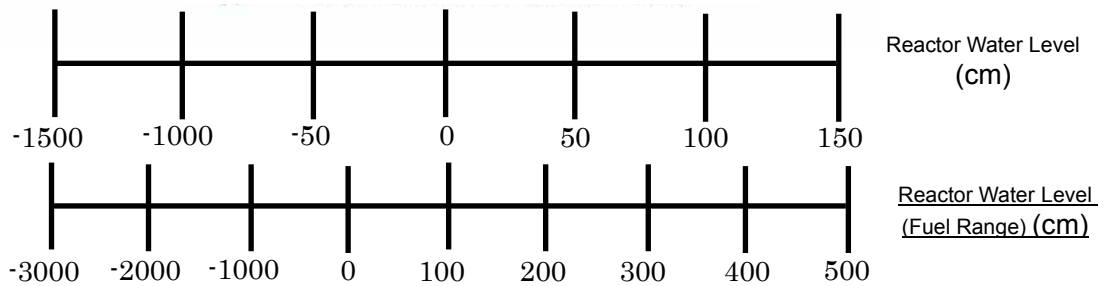
[Reactor Water Level]

- ① Scram triggered by earthquake at 14:46 (Chart fast forwarded: 60 times the speed, 1 hour = 1 minute)
- ② Loss of off-site power around this time, MSIV closed (Chart fast forwarding reset due to loss of power)
- ③ Automatic IC startup
- ④ Change in water level supposedly due to IC operations

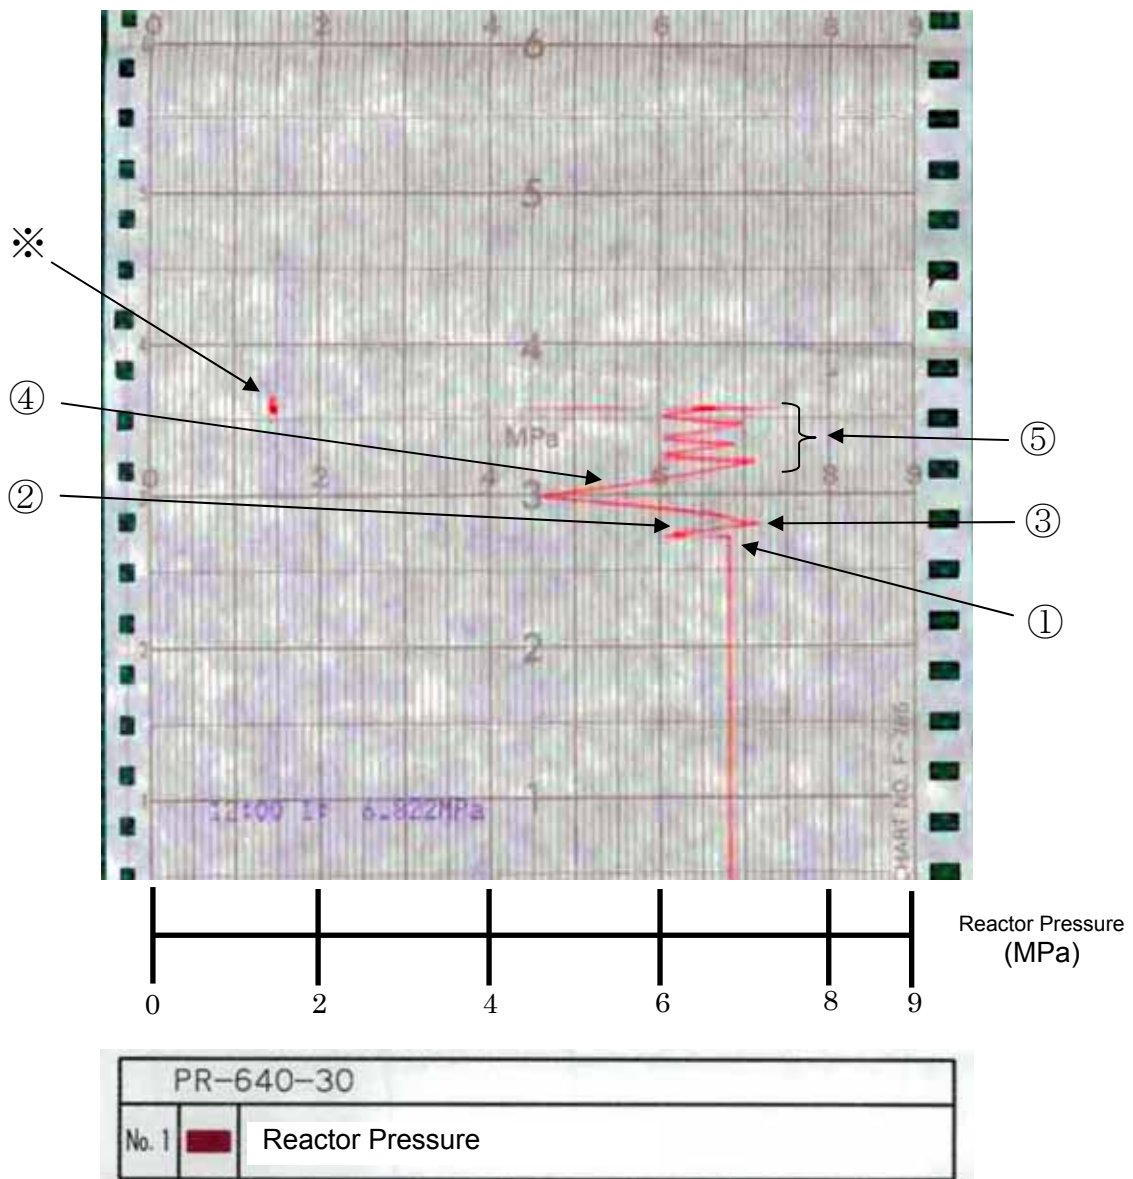
[Reactor Pressure]

- ① Scram triggered by earthquake at 14:46
- ② Rise in pressure due to the closing of MSIV
- ③ IC activation and consequent drop in pressure at 14:52
- ④ Rise in pressure due to IC shutdown
- ⑤ Change in pressure supposedly caused by IC

* It is supposed that the tsunami arrived shortly after 15:30. It is assumed that the record stopped due to the impact of the tsunami.

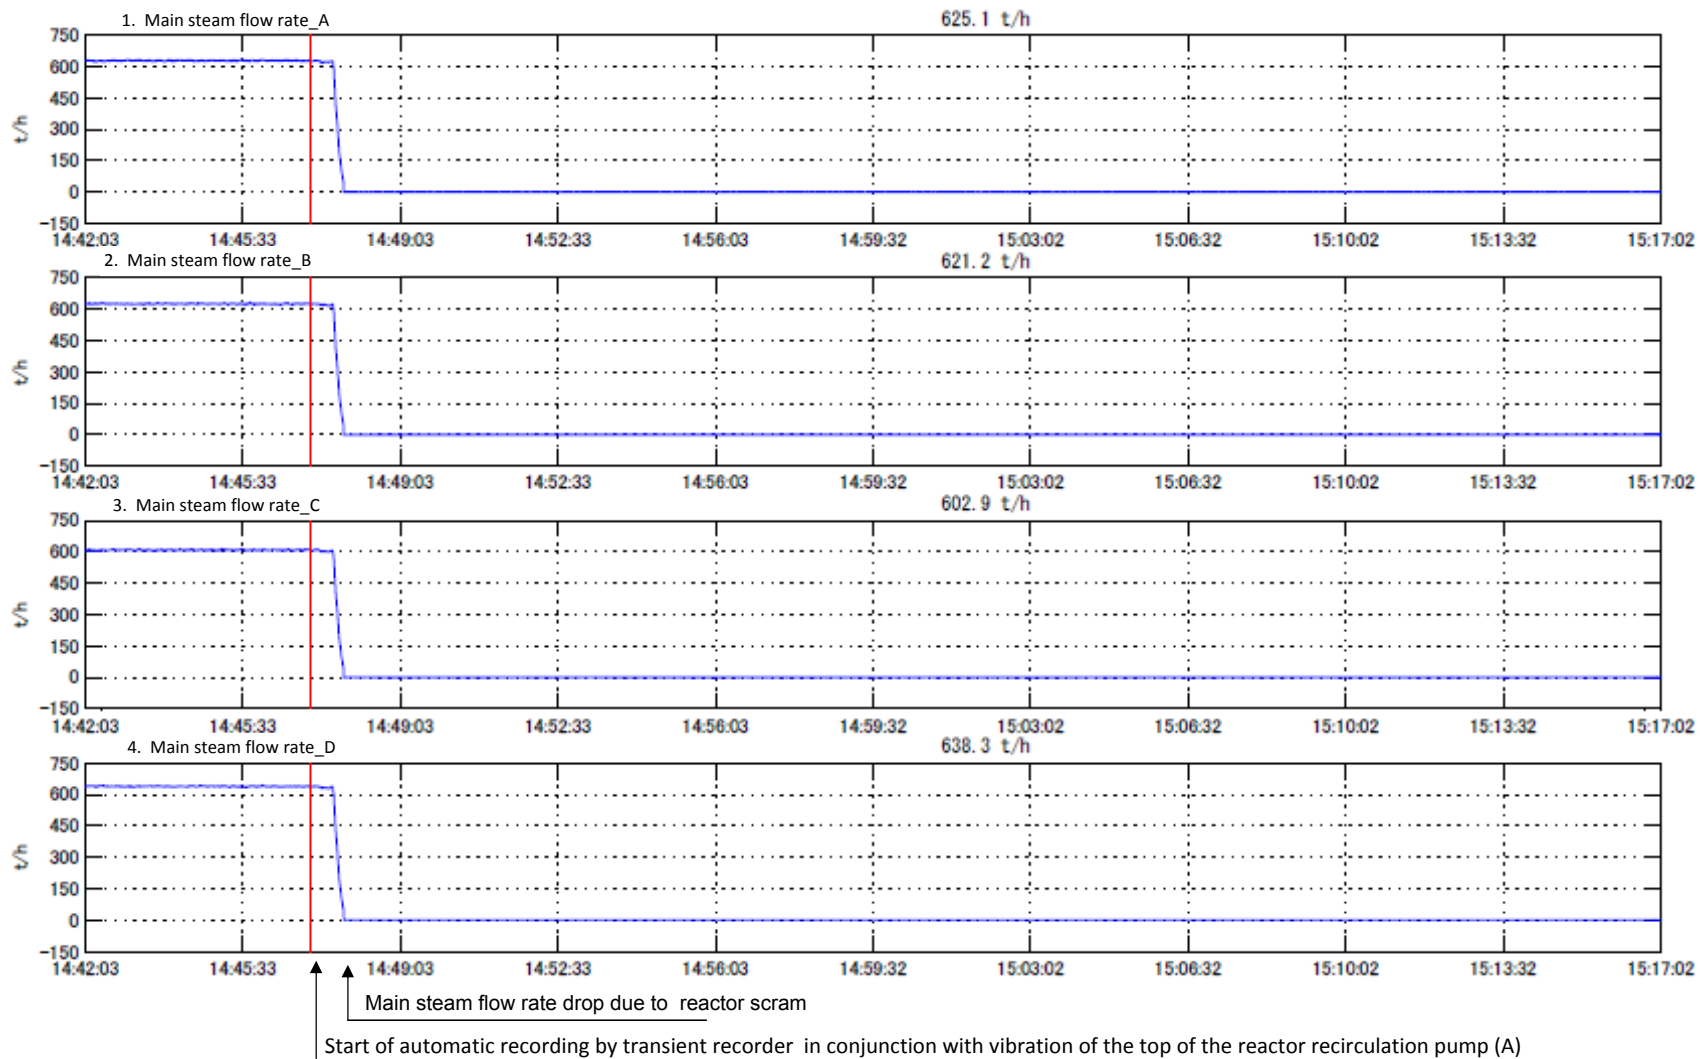
The main steam flow rate drops in tandem with reactor scram.

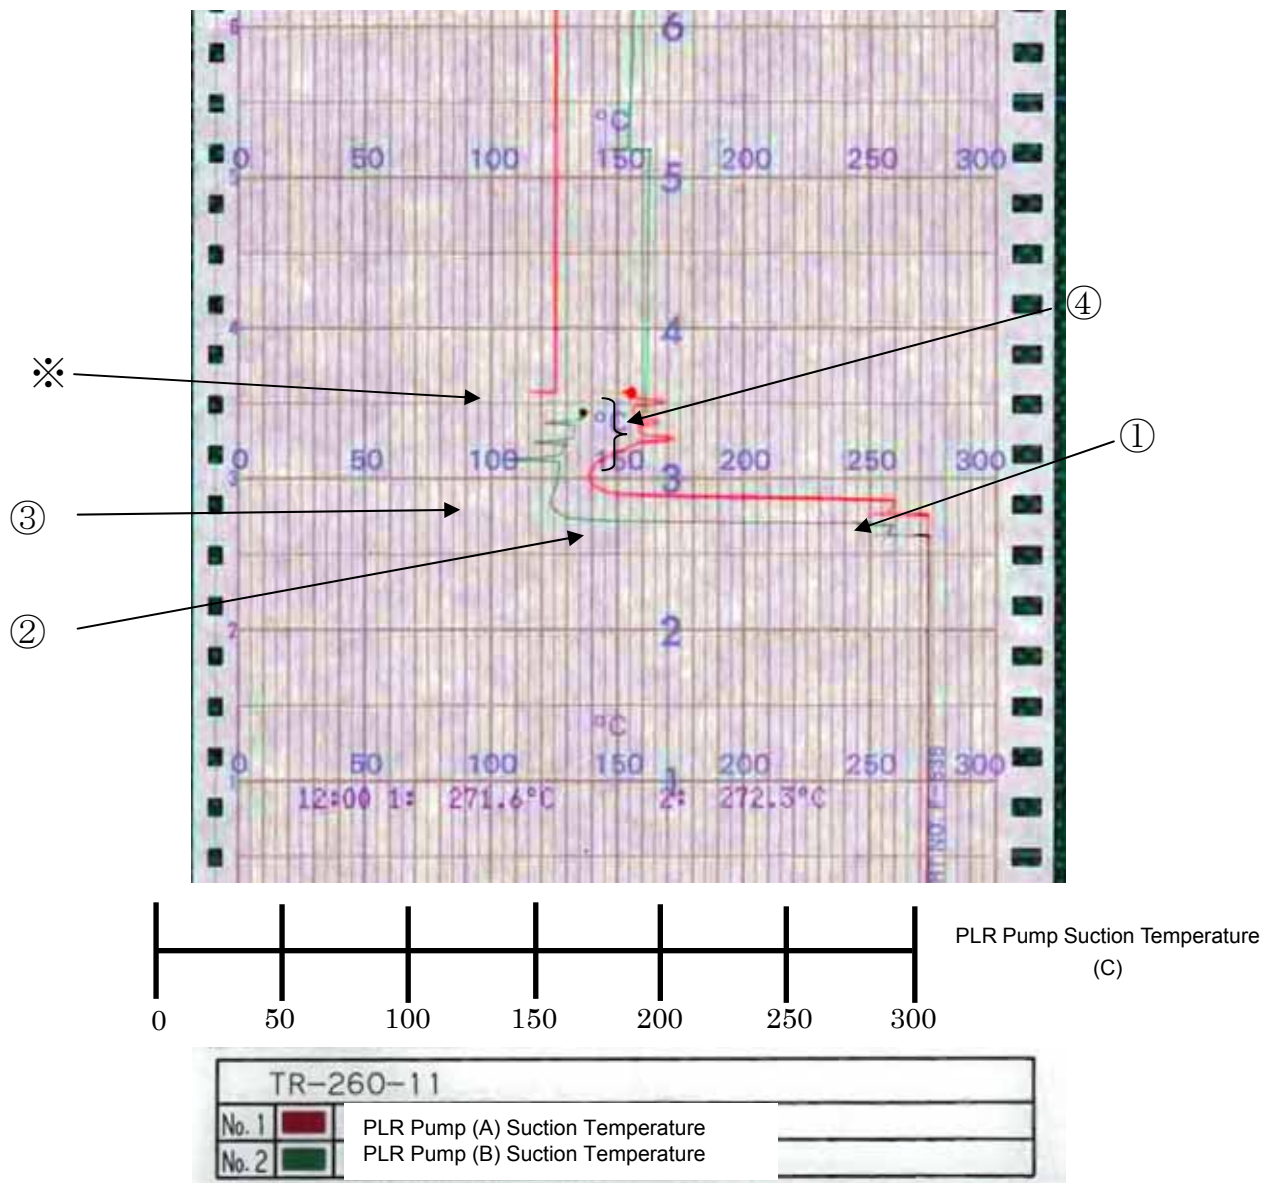
[Primary Loop Recirculation (PLR) Pump Suction Temperature]

- ① Scram Triggered by Earthquake at 14:46
- ② Drop in output due to scram, decrease in pressure due to IC activation, decrease in temperature because of low temperature water injection.
- ③ Shutdown of automatically activated IC
- ④ Change resulting from pressure control with IC (A) (PLR pump (B) suction temperature dropped dramatically due to cooled water from IC operation flowing directly into the PLR loop (B) suction. The cooled water flowed toward PLR Loop (A) on the opposite side of PLR loop (B) while slowly being warmed, and PLR pump (A) temperature gently dropped slightly after)

* Loss of power for recorders shortly after 15:30 due to arrival of tsunami, resulting in the recorder to stop temporarily. It is assumed that it restarted afterwards.
