Fukushima Nuclear Accidents Investigation Report

Attachment

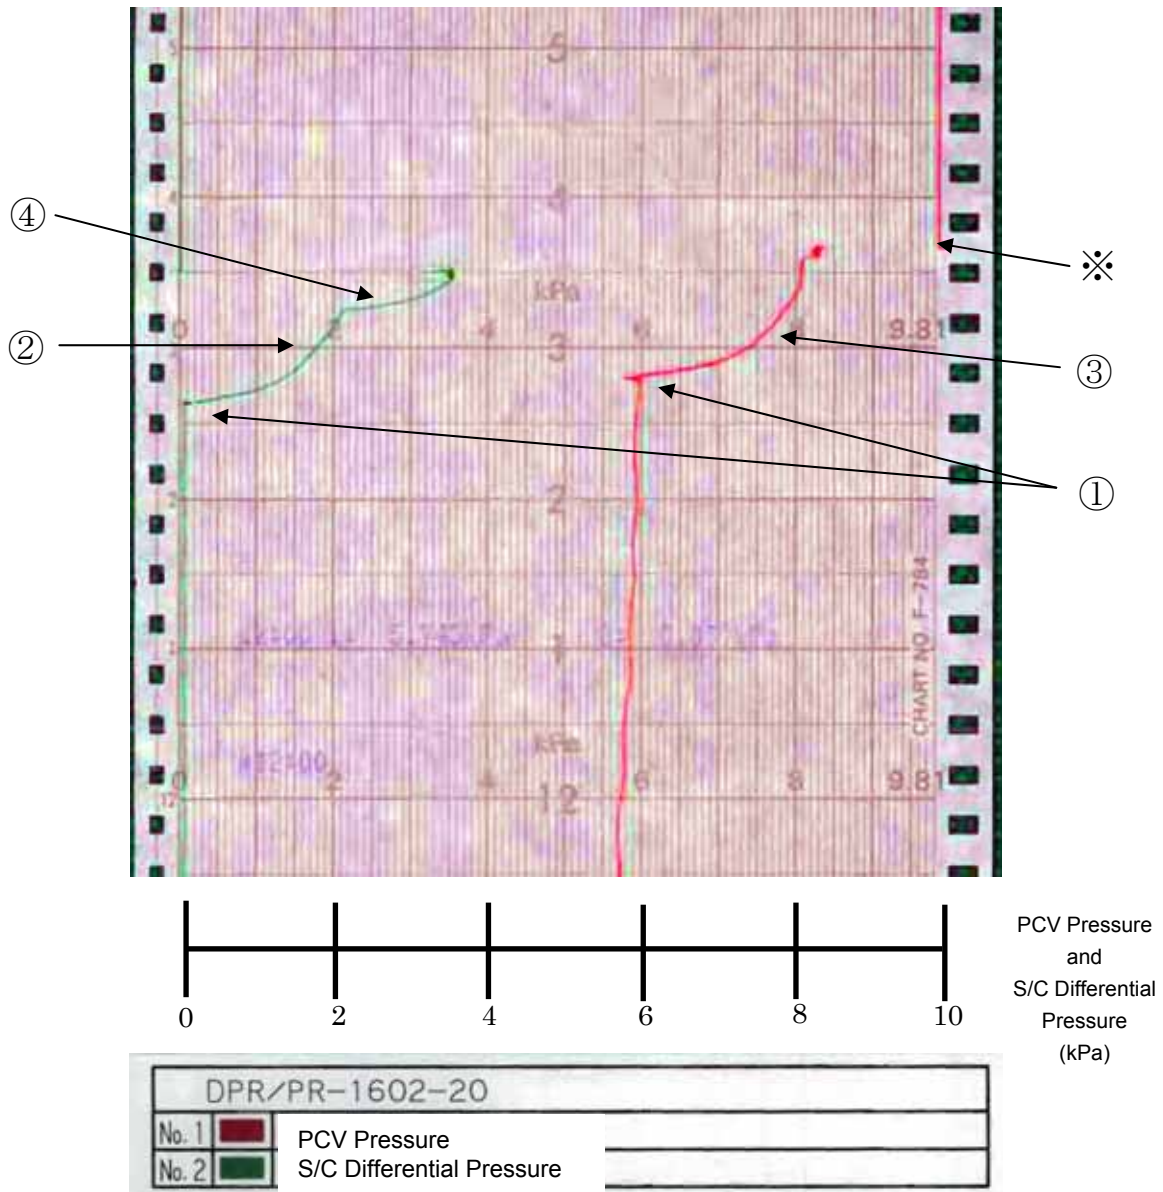
[Primary Containment Vessel (PCV) Pressure, Suppression Chamber (S/C) Differential Pressure]

- ① Scram triggered by earthquake at 14:46
 - ② Rise in S/C Differential Pressure following rise in PCV pressure
 - ③ Rise in PCV pressure due to PCV air conditioning shutdown
 - ④ Decrease in S/C pressure following S/C cooling
 (indicates further increase in differential pressure)= inflection point
- * It is supposed that the tsunami arrived shortly after 15:30. It is assumed that the chart no longer gives an accurate reading due to the impact of the tsunami.

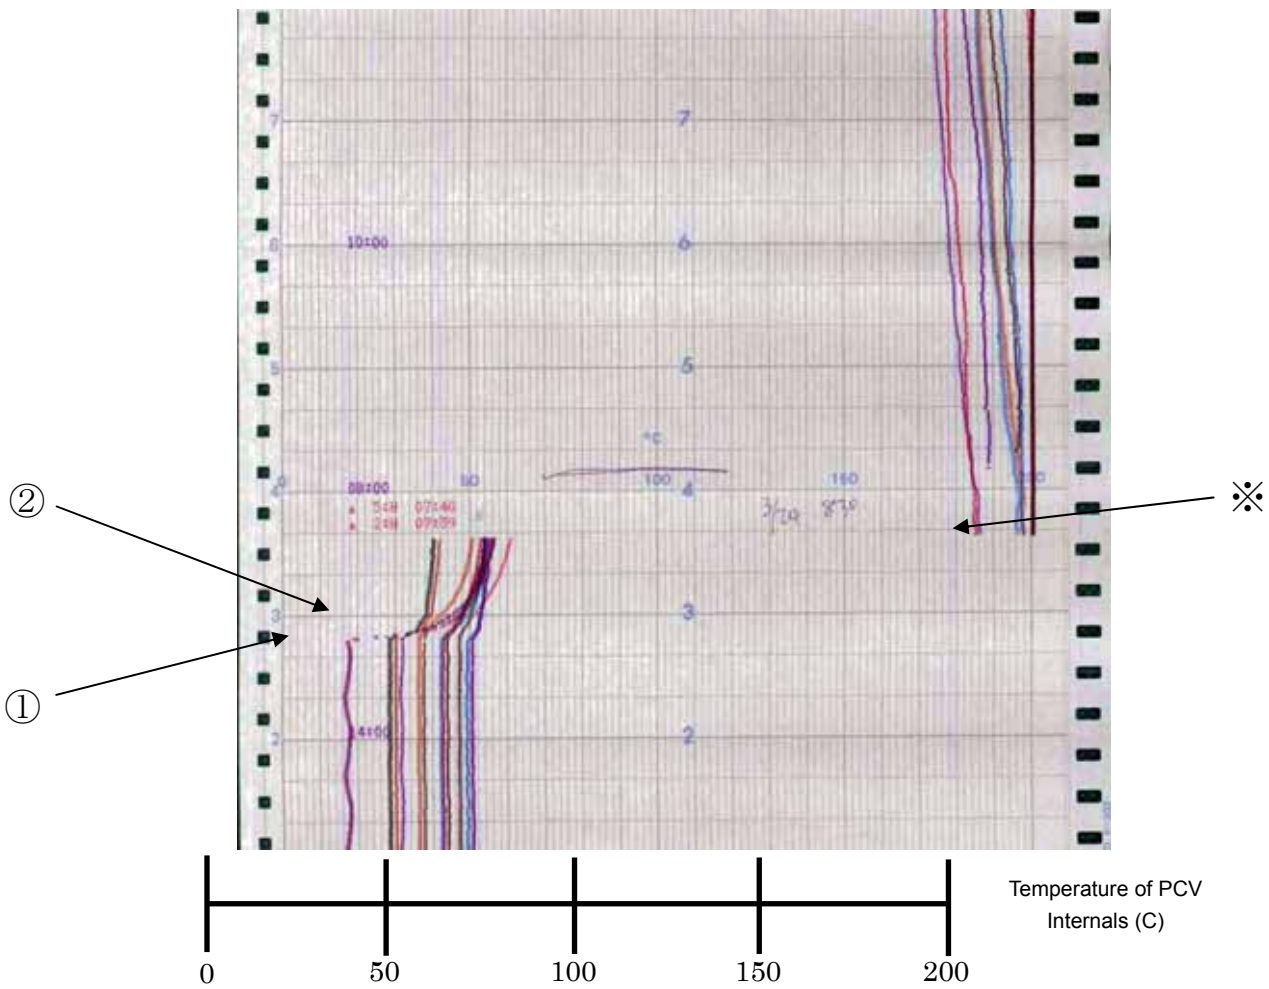
[Temperature of Primary Containment Vessel (PCV) Internals]

- ① Scram triggered due to Earthquake at 14:46
- ② Rise in PCV Temperature following shutdown of PCV air conditioning due to loss of power.(Significant rise in pressure caused by piping ruptures was not found.)
- * Loss of power for recorders shortly after 15:30 due to tsunami resulted in temporary halt in recording. Recording restarted on March 24 following restoration of power for recorders.

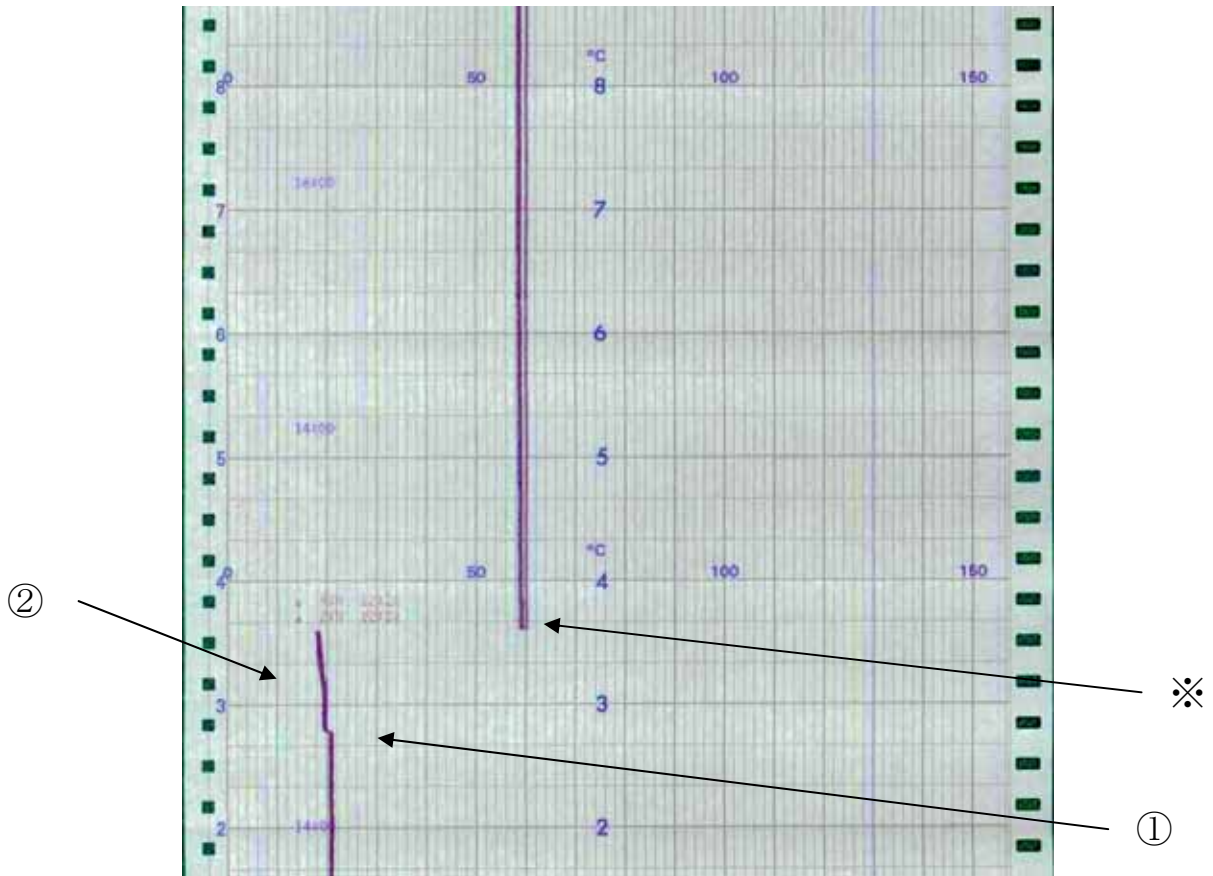
[Suppression Pool Water Temperature]

*It is assumed that the tsunami arrived shortly after 15:30. It is also assumed that correct recordings were not made due to the impact of the tsunami.

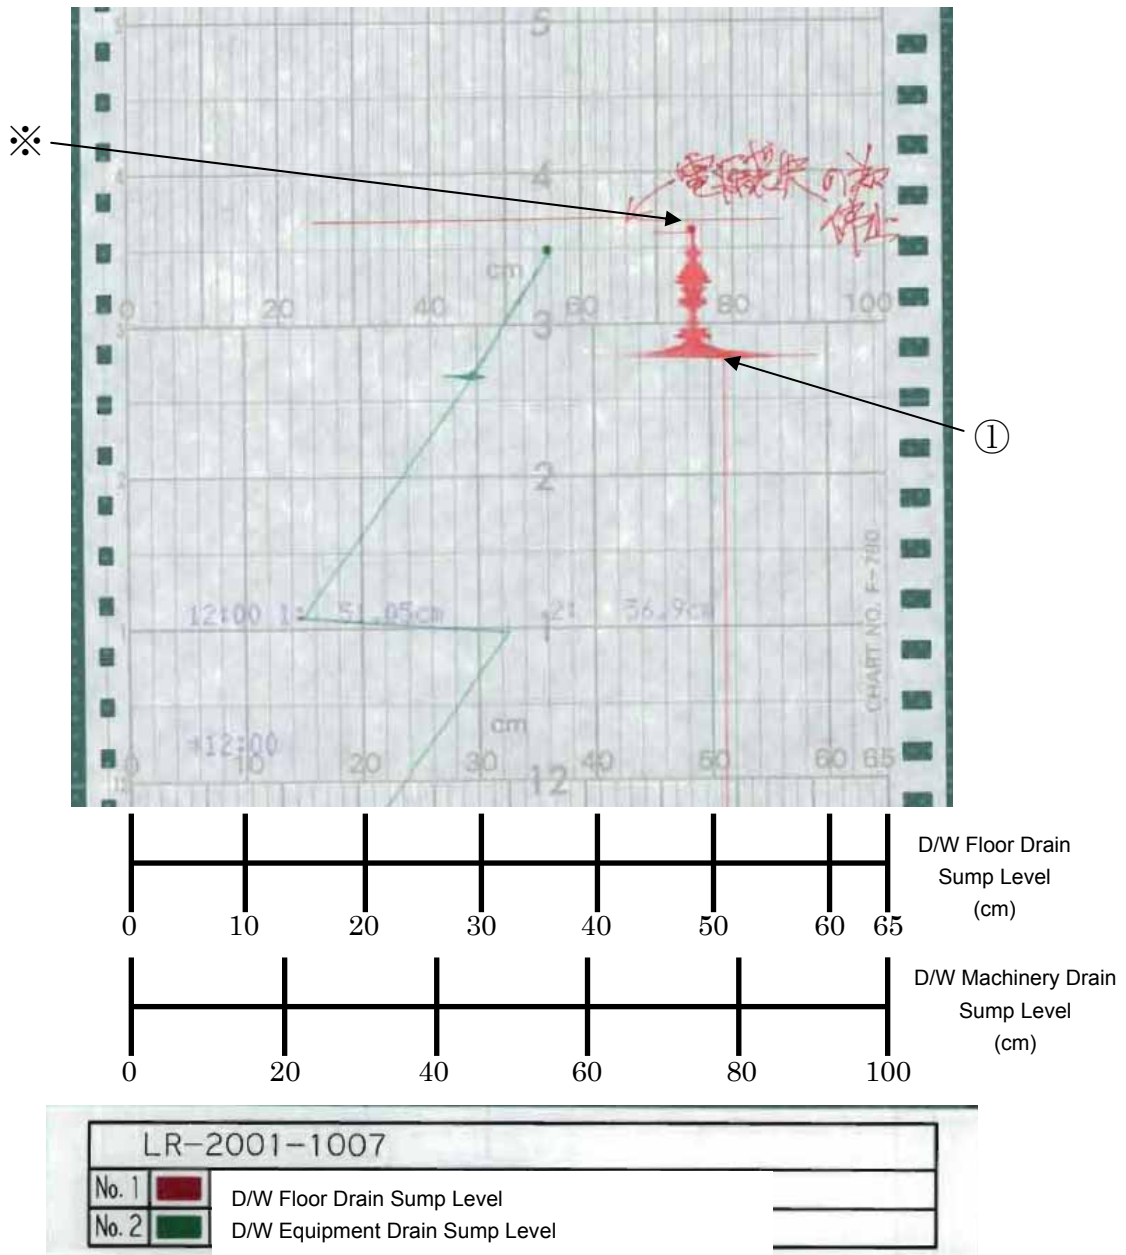
[Dry Well (D/W) Floor Drain Sump Water Level]

① Scram triggered by earthquake at 14:46

※ It is supposed that the tsunami arrived shortly after 15:30. It is assumed that the record stopped due to the impact of the tsunami.

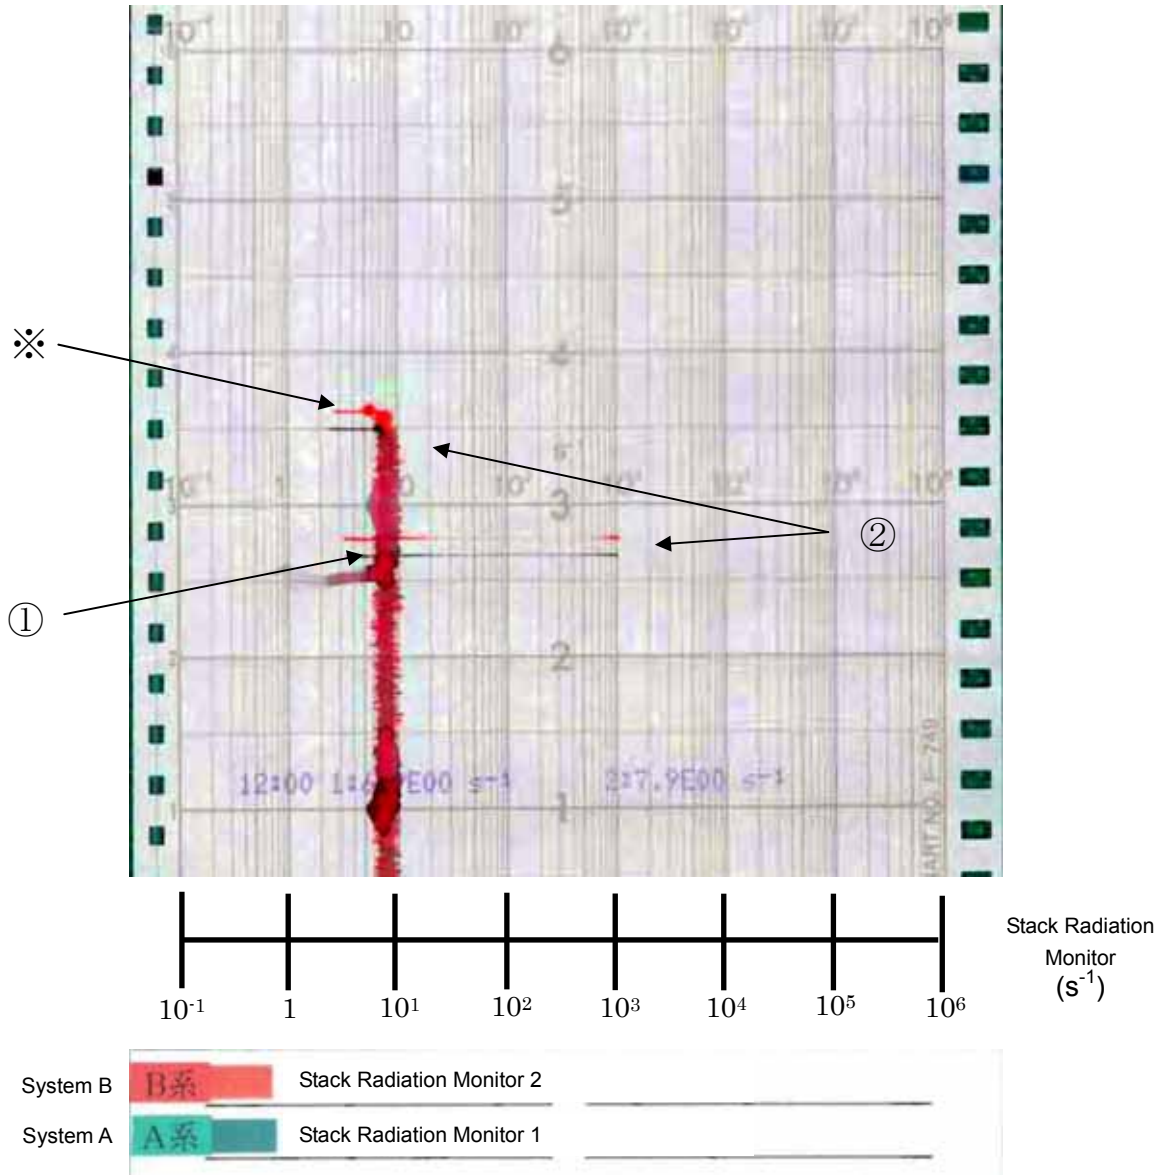
[Stack Radiation Monitor]
 (Stack Radiation Monitor is shared by Units 1 & 2)

① Scram triggered by earthquake at 14:46

② Signal thought to be noise

*It is supposed that the tsunami arrived shortly after 15:30. It is assumed that the record stopped due to the impact of the tsunami.

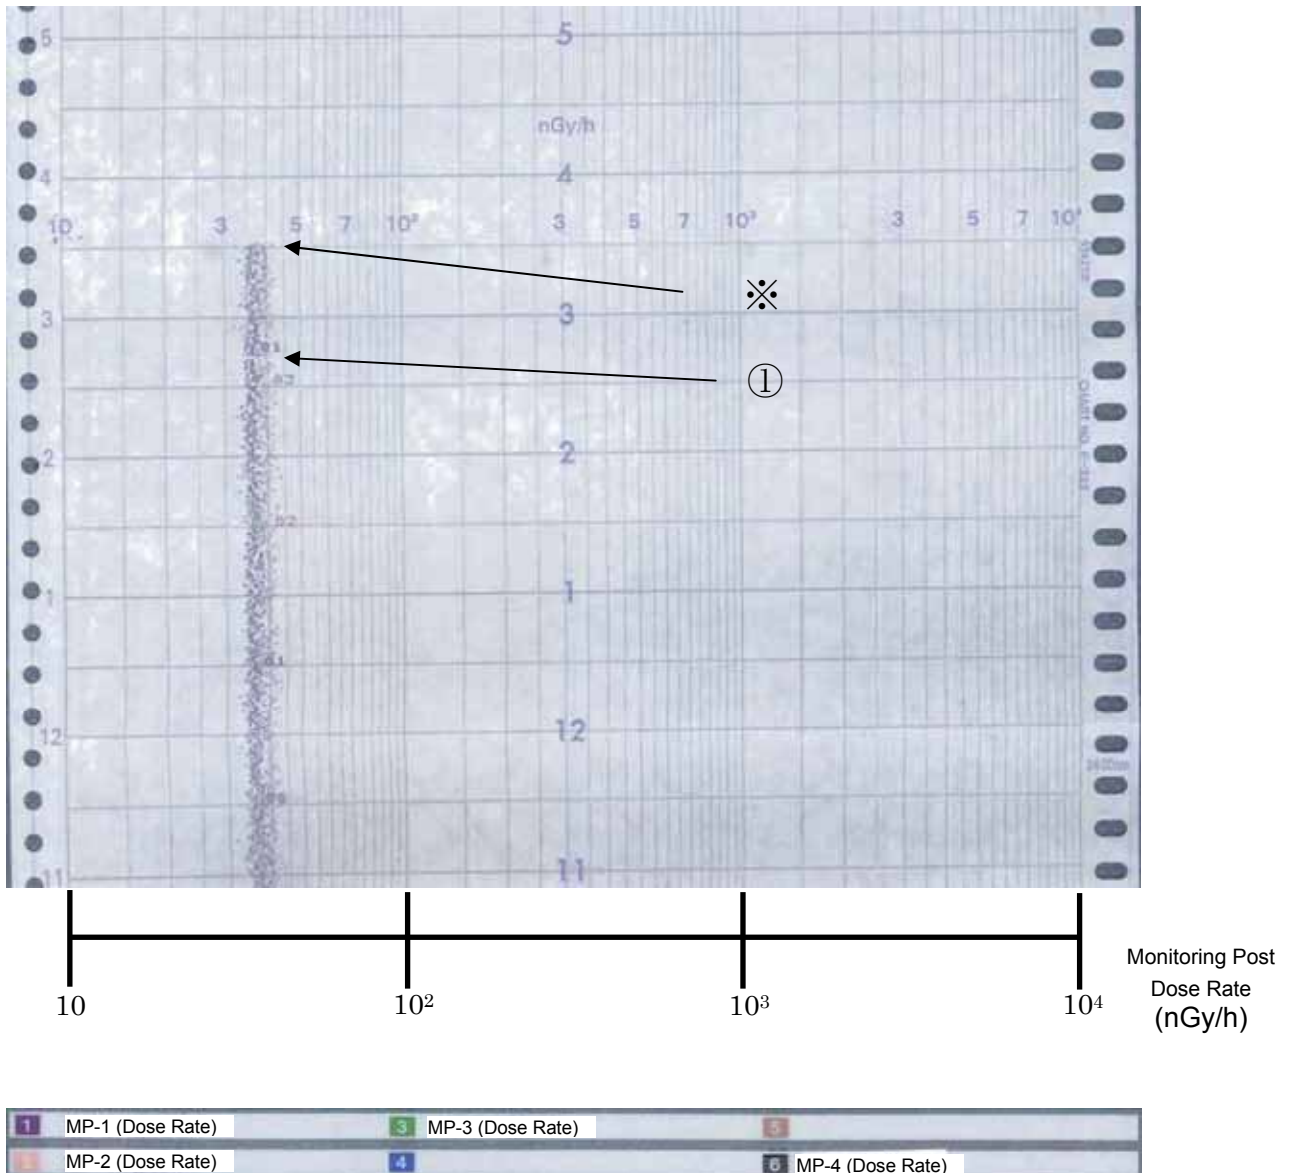
[Monitoring Post 1~4 (Low Radiation Levels)]

① Scram triggered by earthquake at 14:46

*It is supposed that the tsunami arrived shortly after 15:30. It is assumed that the record stopped due to the impact of the tsunami.

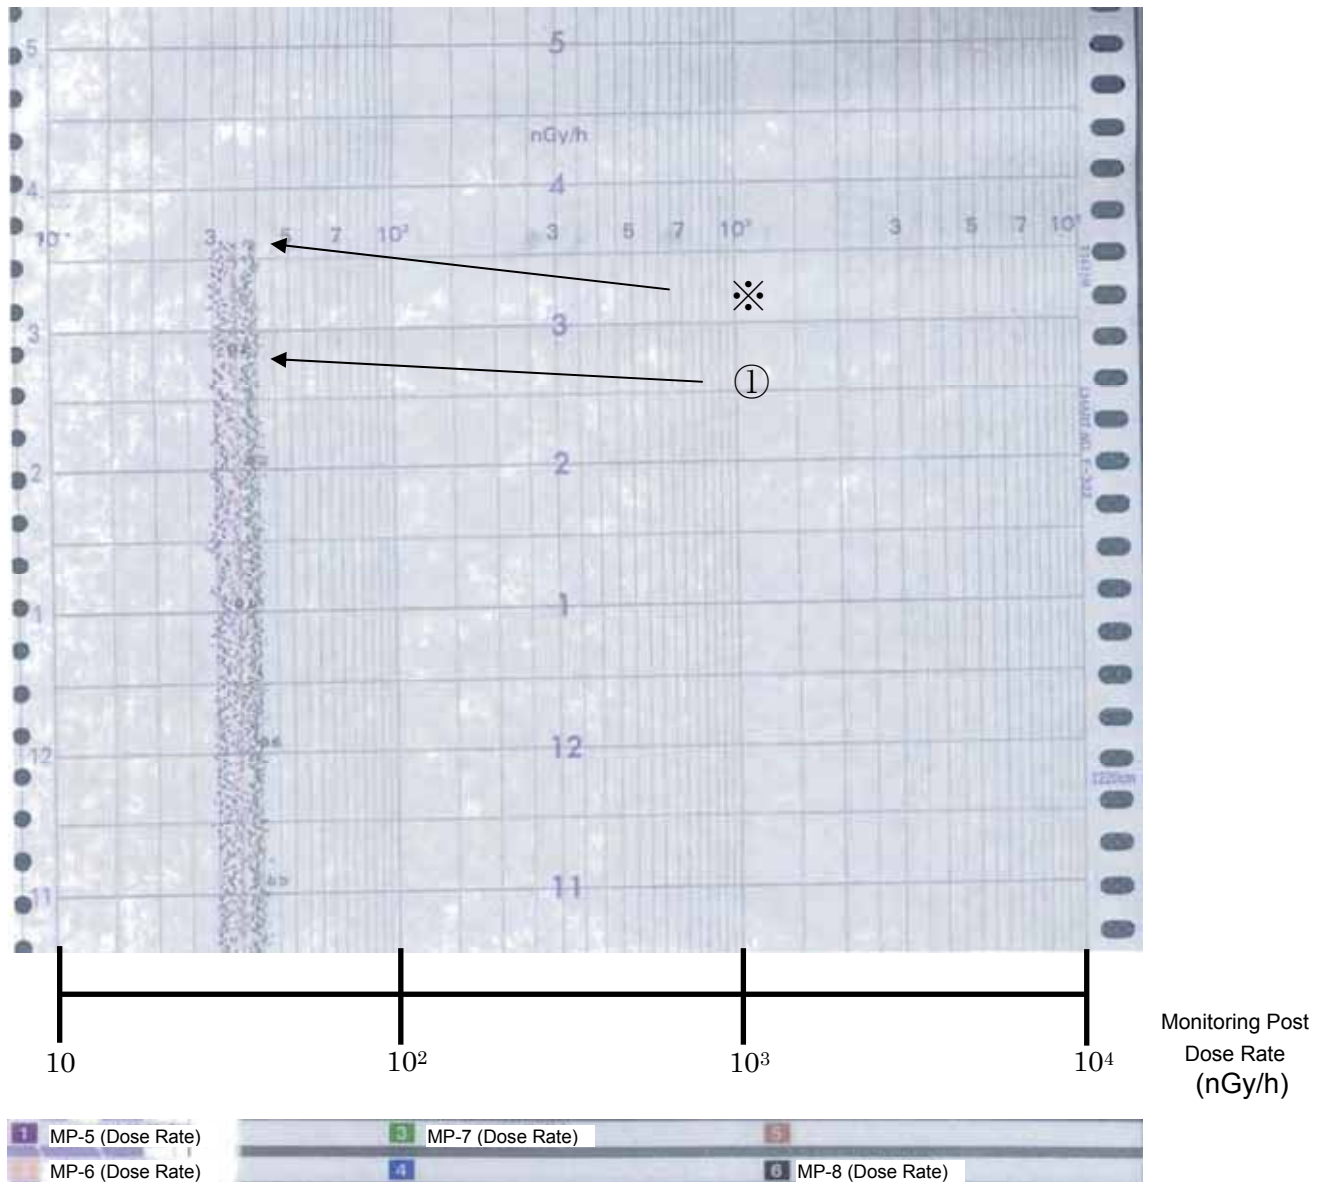
[Monitoring Post 5~8 (Low Radiation Levels)]

① Scram triggered by earthquake at 14:46

*It is supposed that the tsunami arrived shortly after 15:30. It is assumed that the record stopped due to the impact of the tsunami.

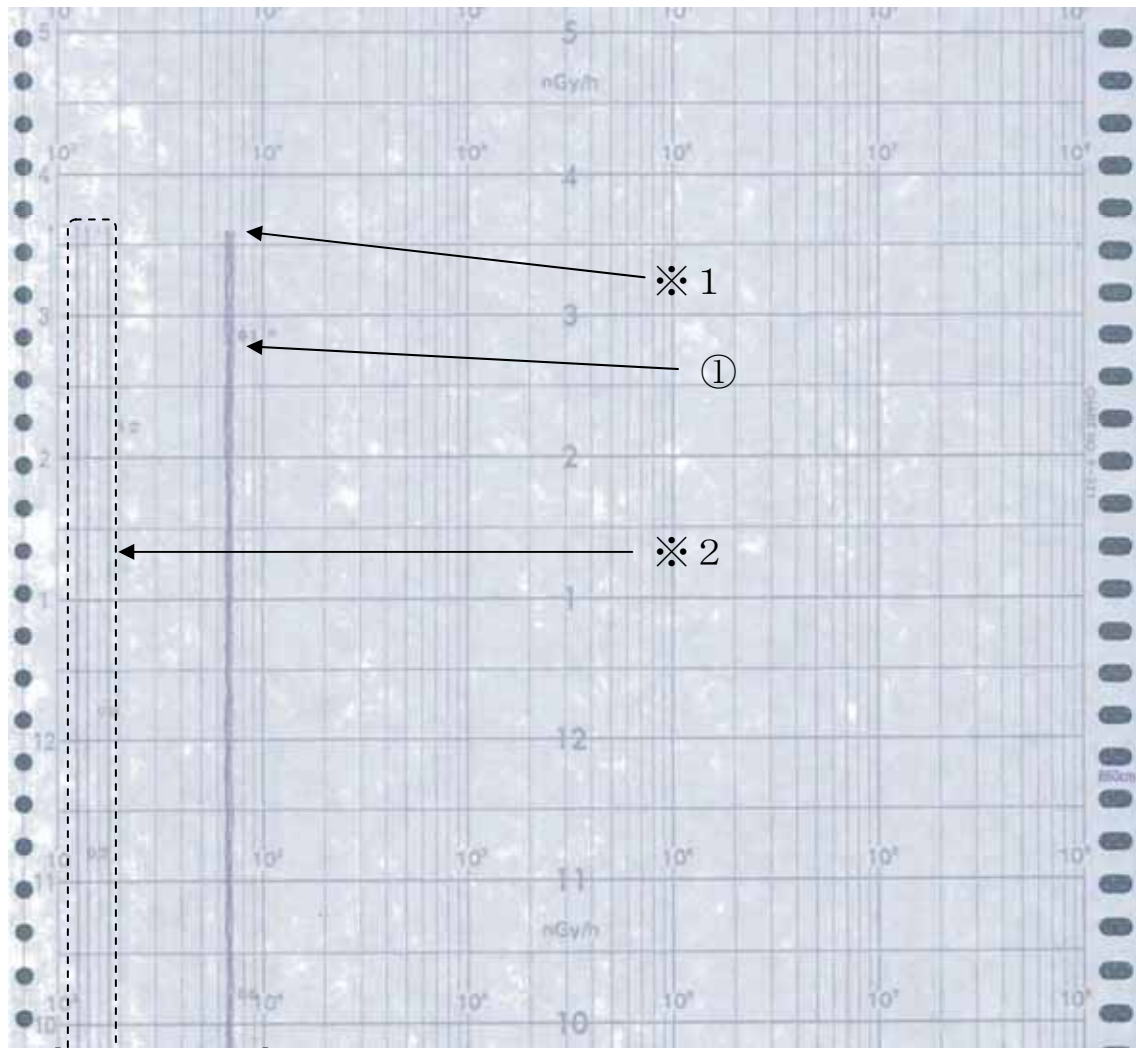
[Monitoring Post 1~4 (High Radiation Levels)]

- ① Scram triggered by earthquake at 14:46
- ※1 It is supposed that the tsunami arrived shortly after 15:30. It is assumed that the record stopped due to the impact of the tsunami.
- ※2 This recorder can record two ranges (Low Range: $10 \sim 10^6$ nGy/h, High Range: $10^3 \sim 10^8$ nGy/h). Indication of the range here means that Low Range is being recorded. (For High Range, records are plotted on the right side of the chart.)

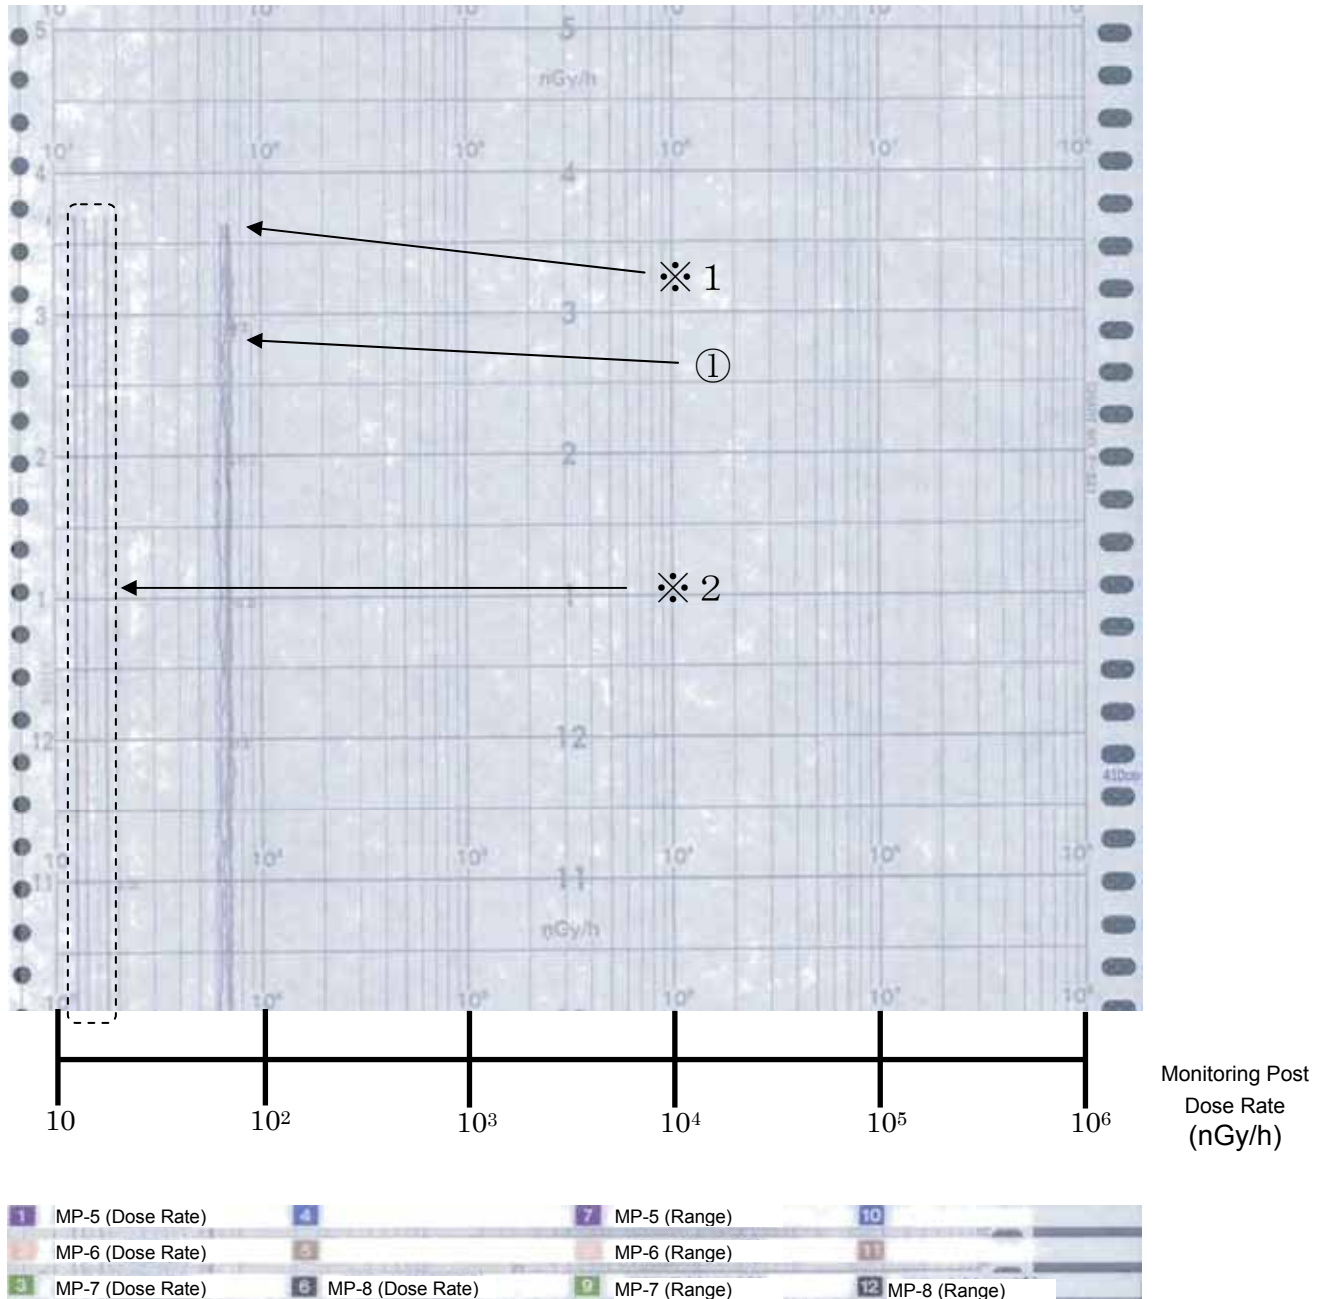
[Monitoring Post 5~8 (High Radiation Levels)]

- ① Scram triggered by earthquake at 14:46
- ※1 It is supposed that the tsunami arrived shortly after 15:30. It is assumed that the record stopped due to the impact of the tsunami.
- ※2 This recorder can record two ranges (Low Range: $10 \sim 10^6$ nGy/h, High Range: $10^3 \sim 10^8$ nGy/h). Indication of the Range here means that Low Range is being recorded. (For High Range, records are plotted on the right side of the chart.)

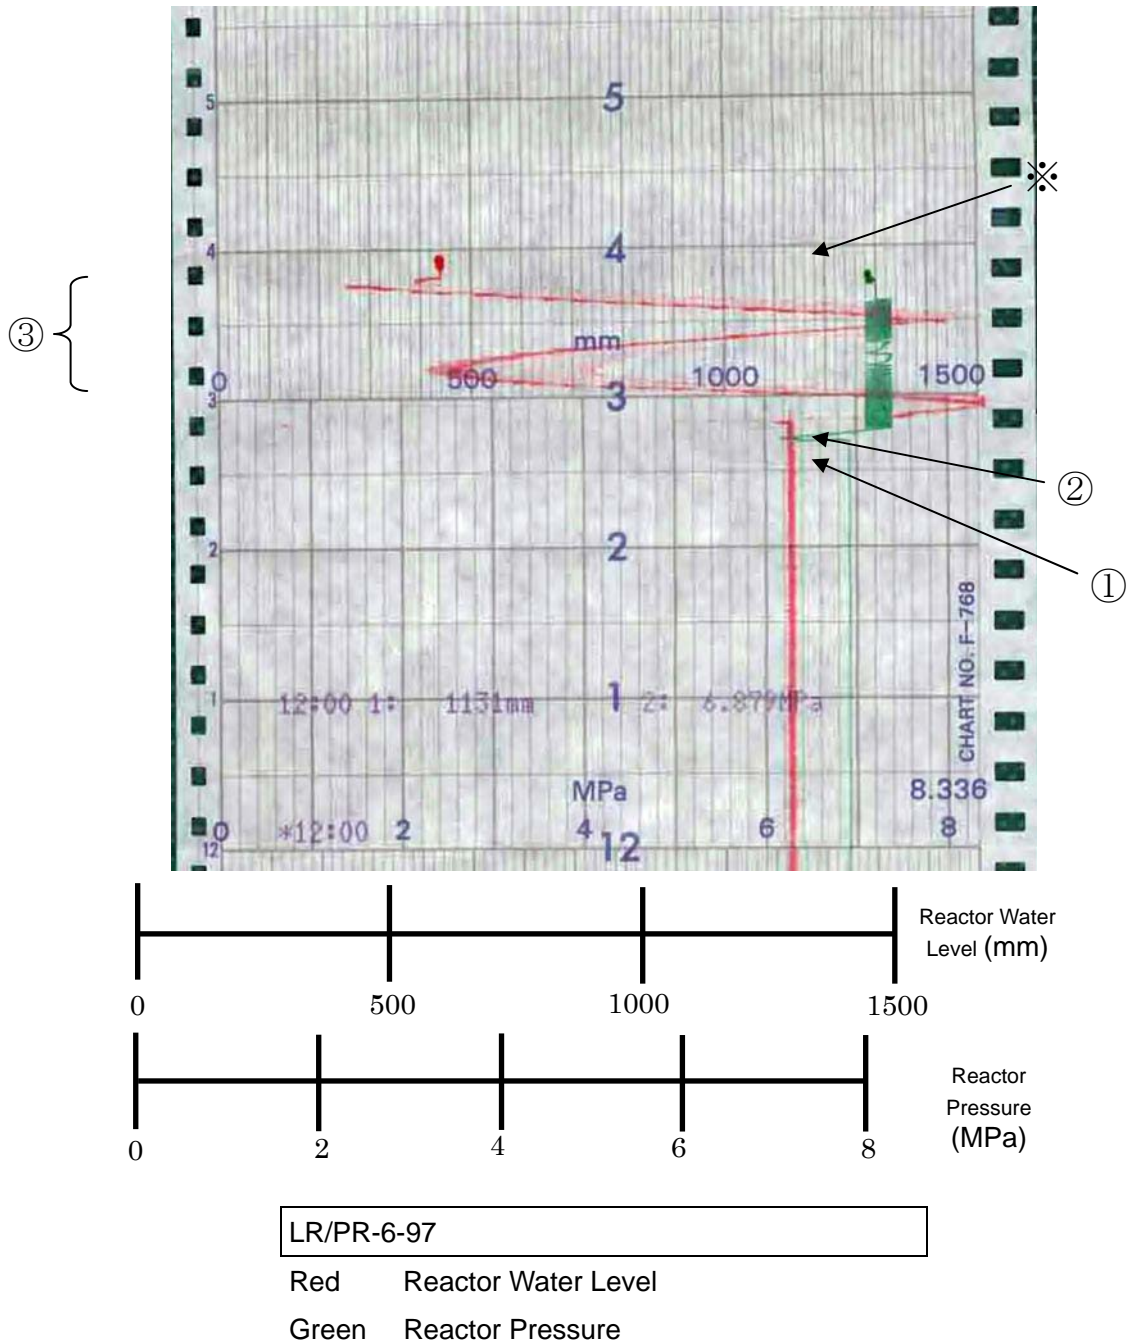
[Reactor Water Level, Reactor Pressure]

- ① Scram triggered by earthquake at 14:47
- ② Rise in pressure due to closing of MSIV, and pressure control due to the opening and closing of SRV that followed
- ③ Adjustment of water level due to RCIC startup and shutdown

*It is supposed that the tsunami arrived shortly after 15:30. It is assumed that the record stopped due to the impact of the tsunami.

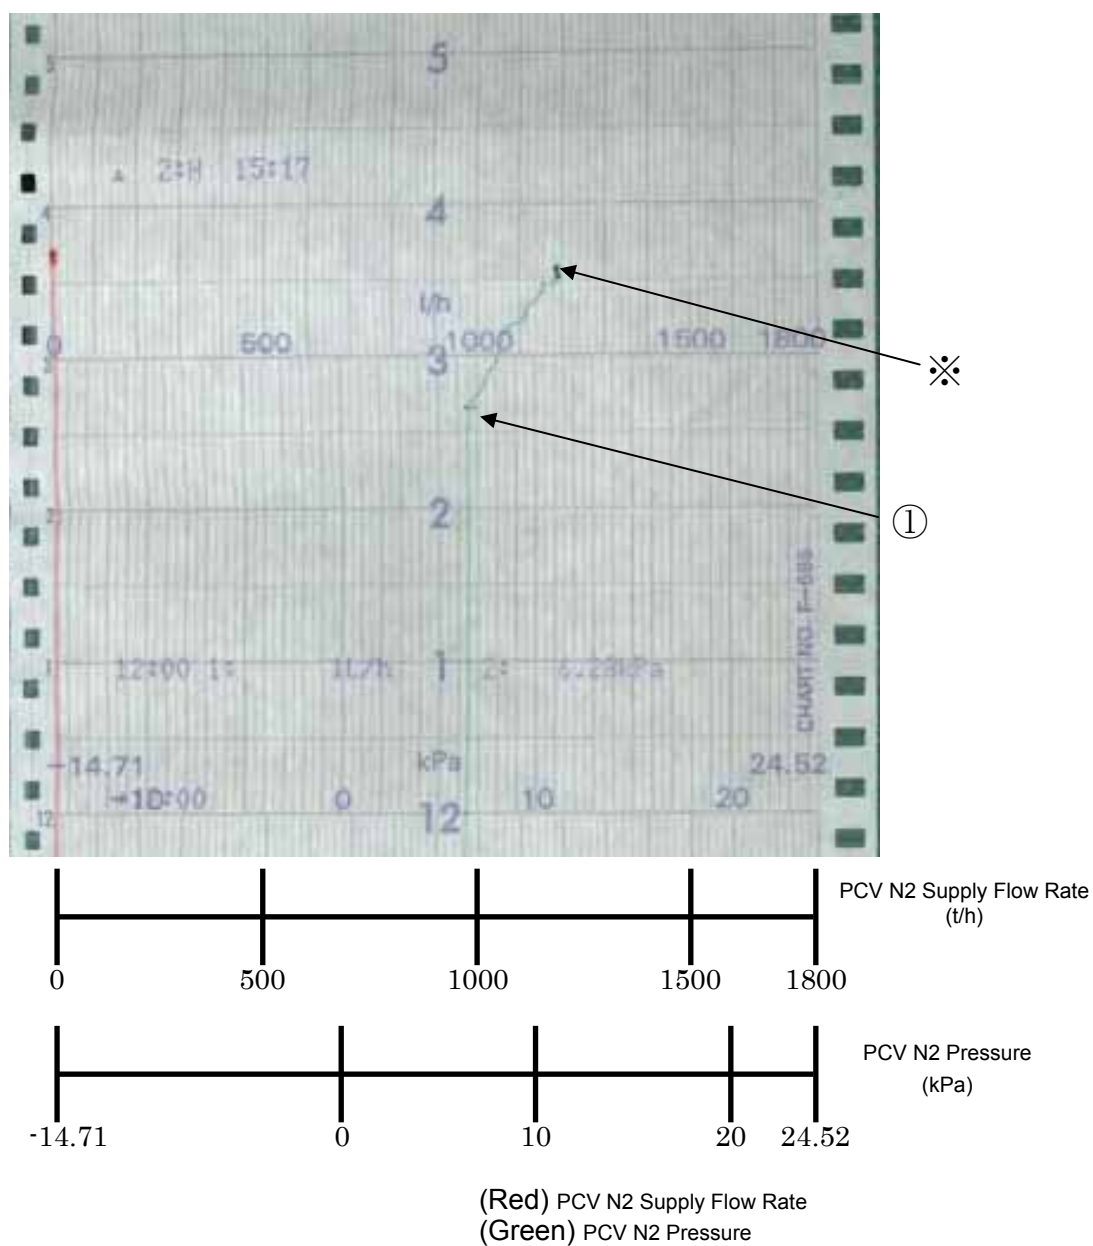
[Primary Containment Vessel Nitrogen Pressure /
Primary Containment Vessel Nitrogen (N₂) Supply Flow Rate]

① Scram triggered by earthquake at 14:47

* It is supposed that the tsunami arrived shortly after 15:30. It is assumed that the chart no longer gives an accurate reading due to the impact of the tsunami.

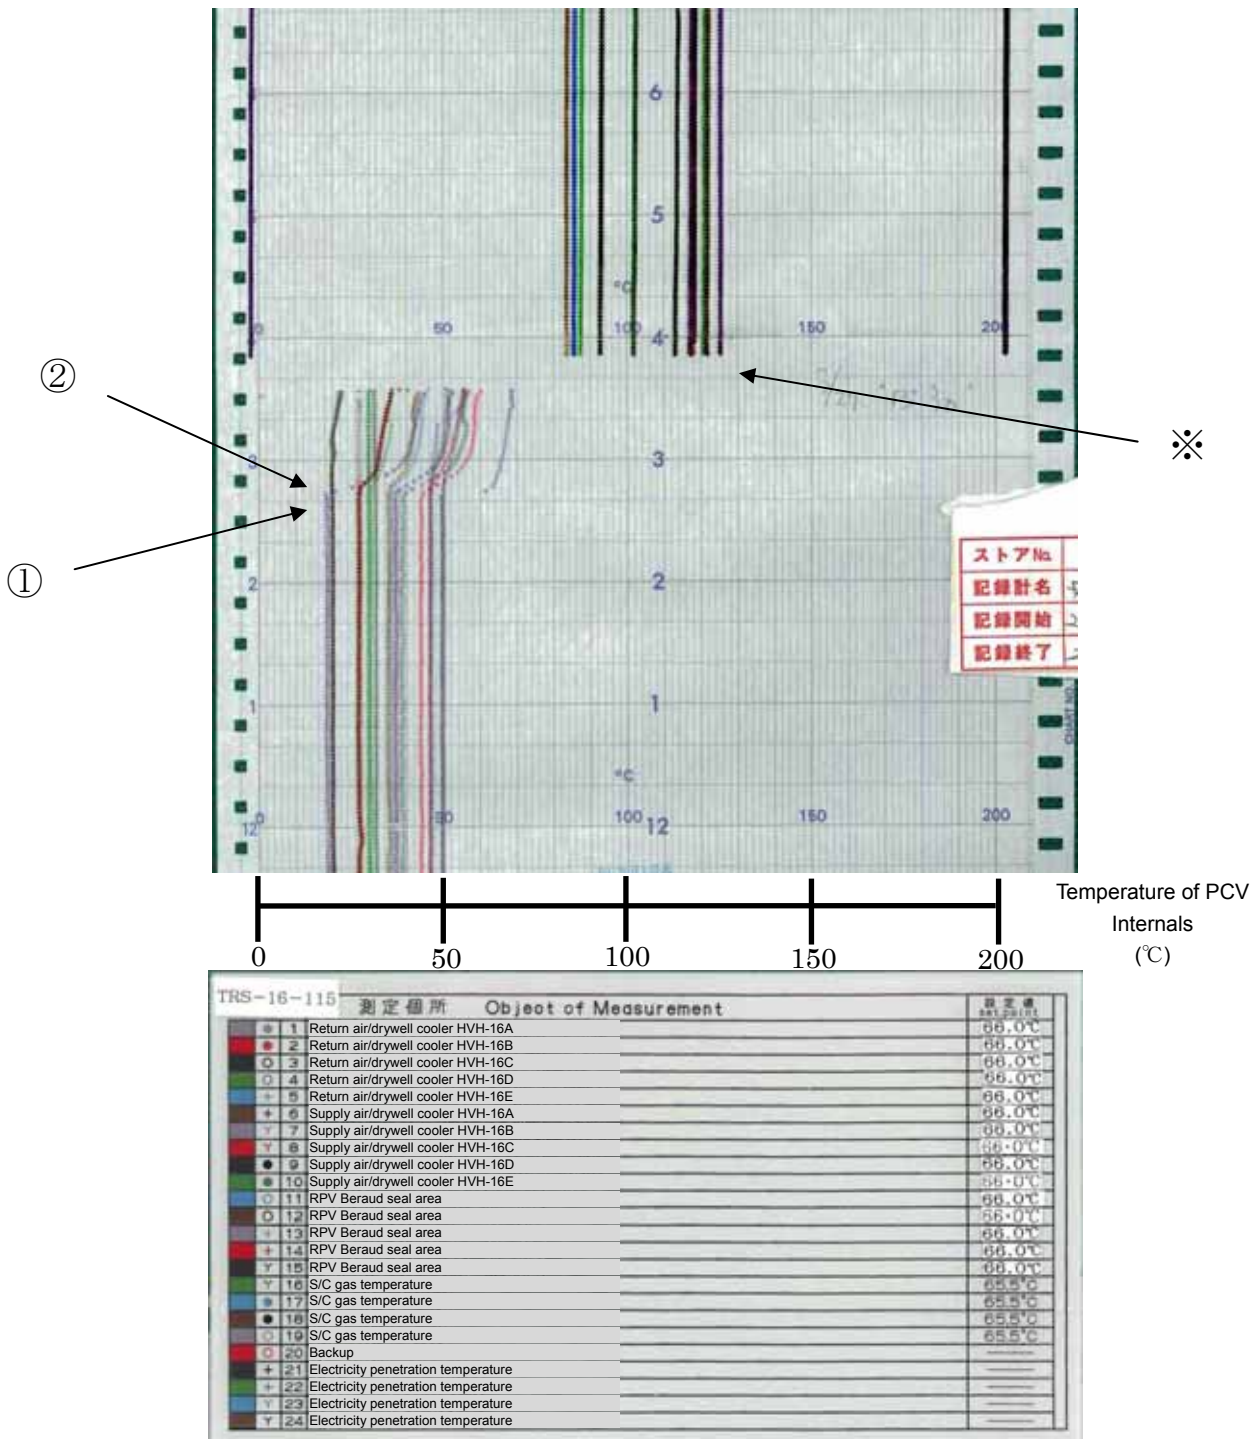
[Temperature of Primary Containment Vessel (PCV) Internals]

- ① Scram triggered due to Earthquake at 14:47
- ② Rise in PCV Temperature following shutdown of PCV air conditioning due to loss of power (Unable to confirm significant rise in pressure due to piping ruptures)

* It is supposed that the tsunami arrived shortly after 15:30. Recorders temporarily halted due to the impact of tsunami. Later, recorders restarted after connecting to temporary power. It is assumed that correct measurements are not indicated.

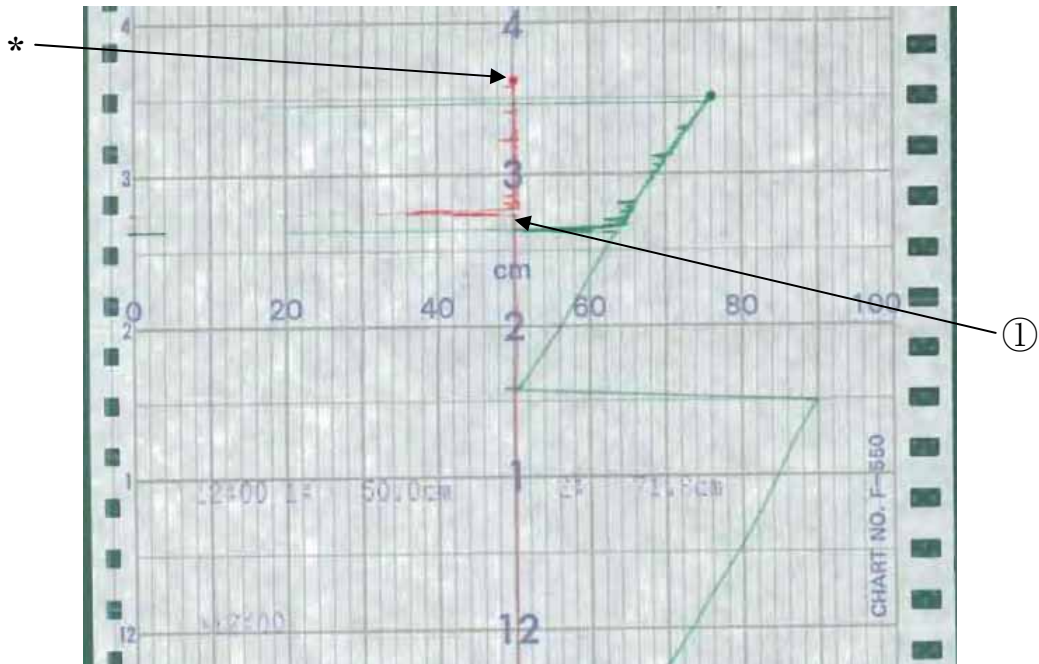
[Dry Well (D/W) Floor Drain Sump Water Level]

① Scram triggered by earthquake at 14:47.

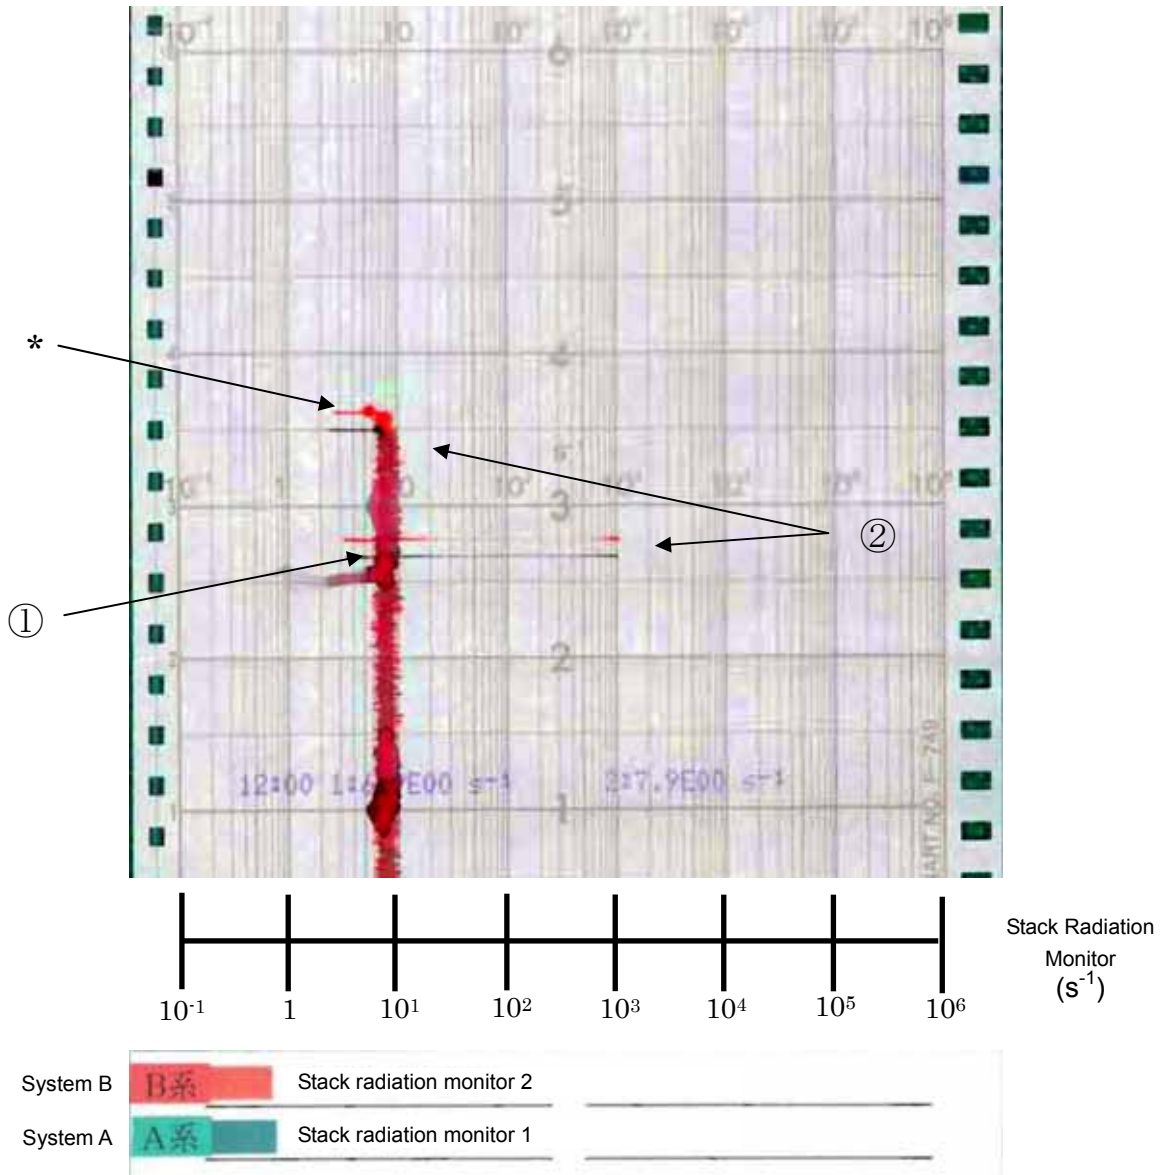
[Stack Radiation Monitor]
 (Stack Radiation Monitor is shared by Units 1 & 2)

① Scram triggered by earthquake at 14:46

② Signal thought to be noise

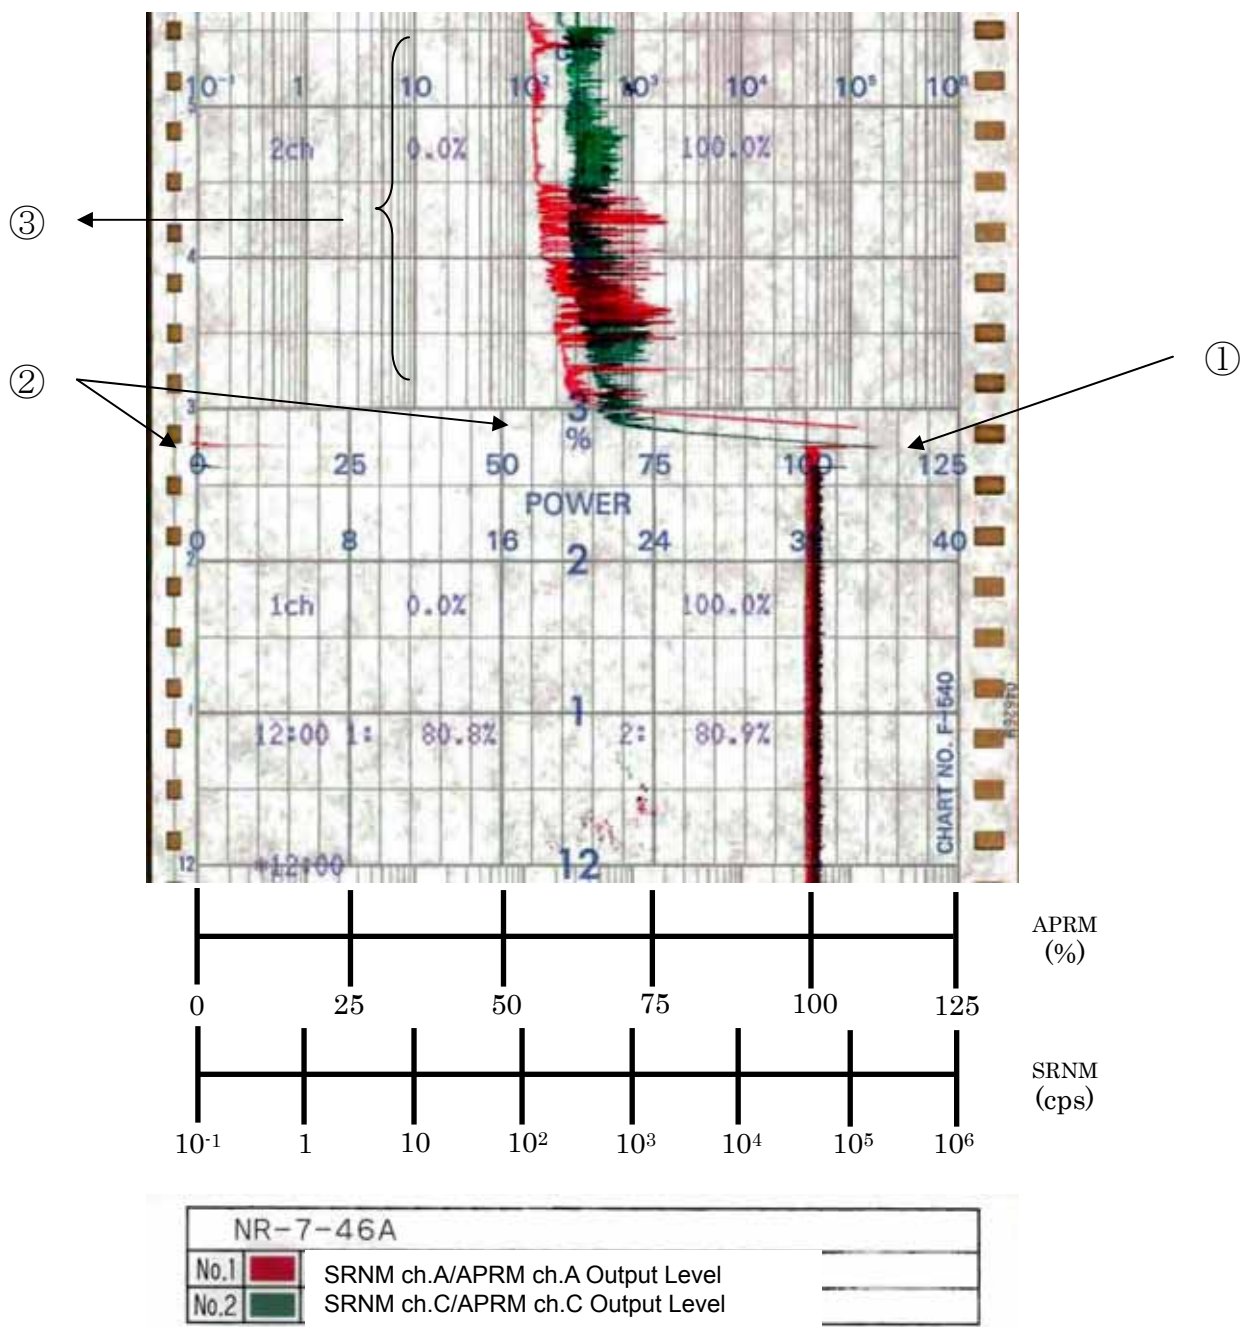
[Start-Up Range Neutron Monitor (SRNM), Average Power Range Monitor (APRM)]

- ① Scram triggered by earthquake at 14:47 and drop in output due to scram
- ② Below the range of Average Power Range Monitor (APRM) and switch to the Start-Up Range Neutron Monitor (SRNM)
- ③ Change in indication due to noise.

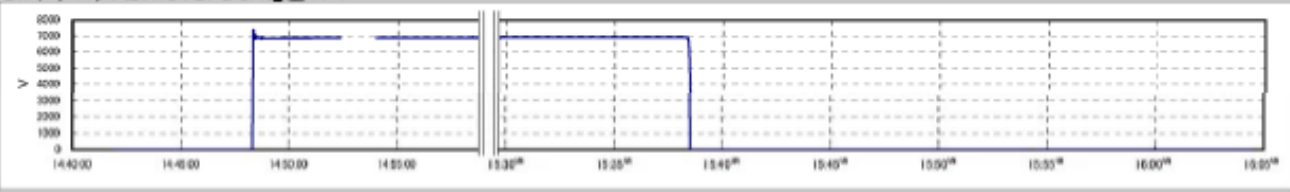
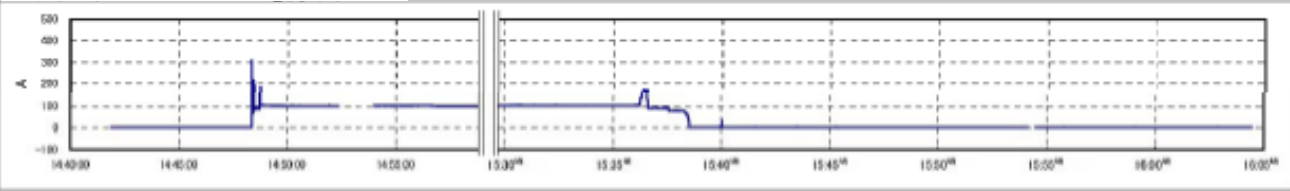
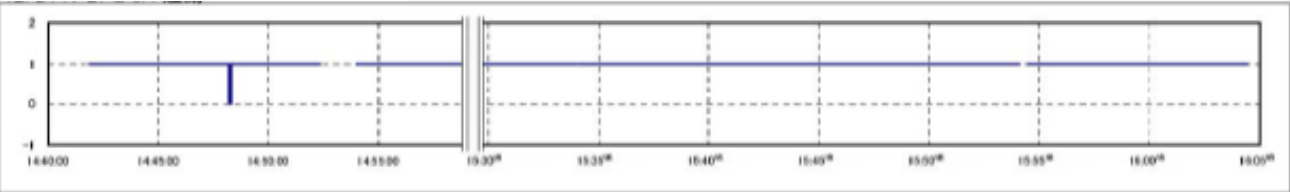
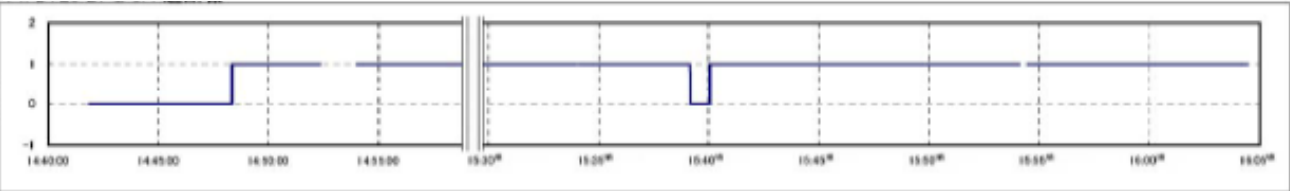
<p>It is assumed that the diesel generator (3A) stopped working between 15:35-15:40 supposedly due to the impact of the tsunami.</p>
<p>23. Analog PIDA 757 D/G 3A current (R)</p>
