Fukushima Nuclear Accidents Investigation Report

Attachment

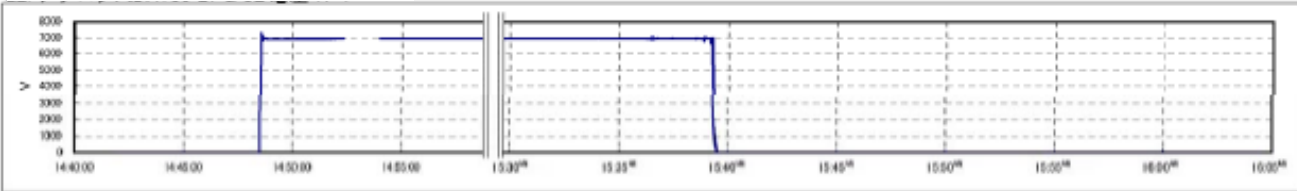
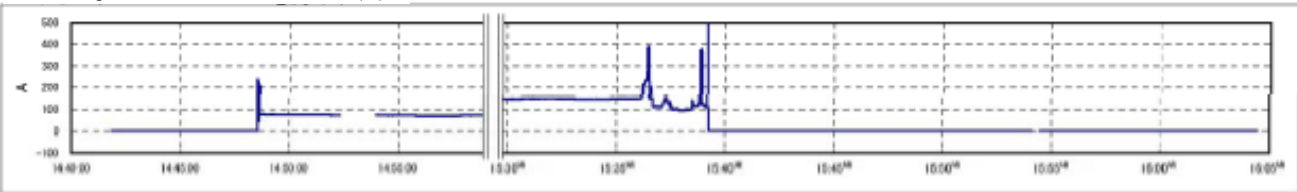
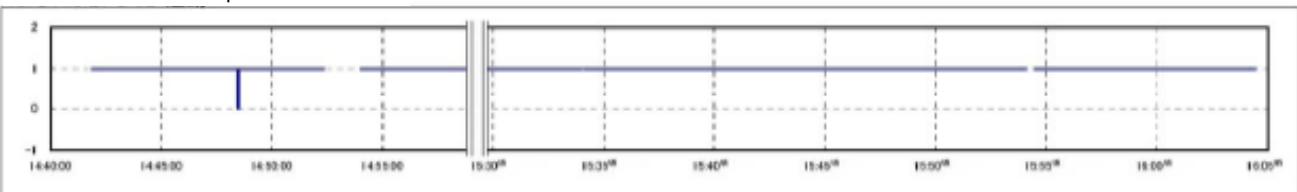
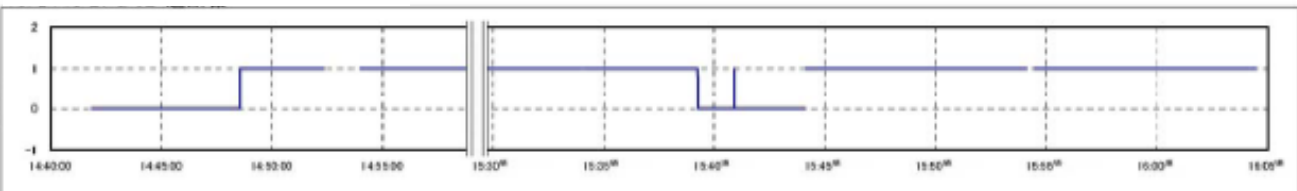
<p>It is assumed that the diesel generator (3B) stopped working between 15:35~15:40 supposedly due to the impact of the tsunami.</p>
<p>24. Analog PIDA 758 D/G 3B current (R)</p>

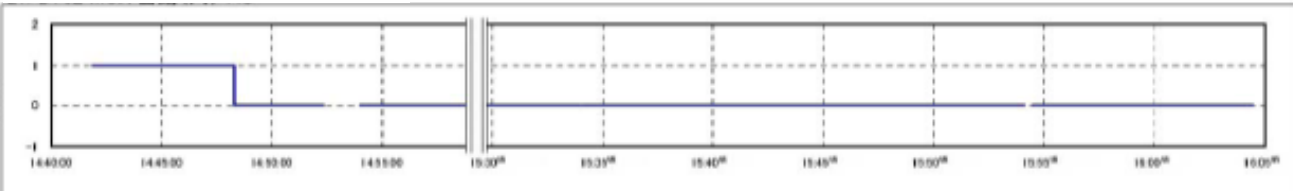
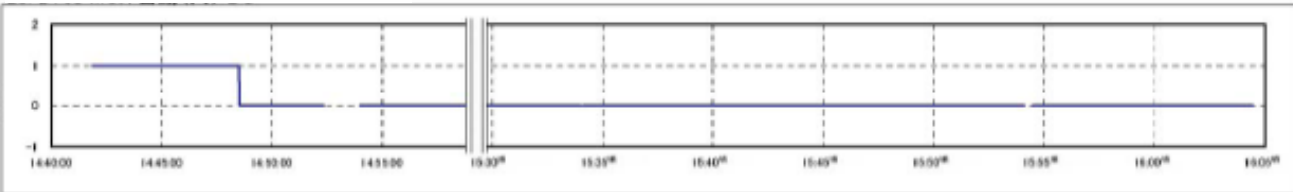
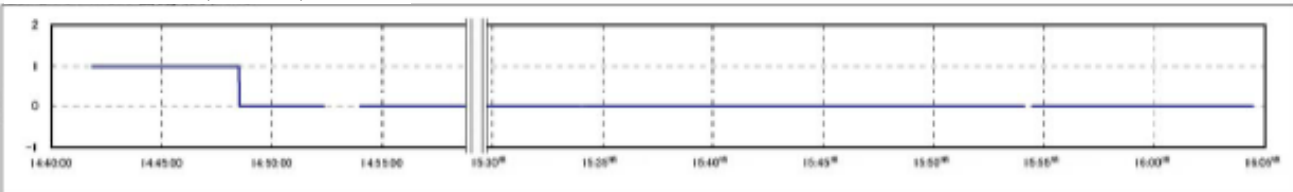
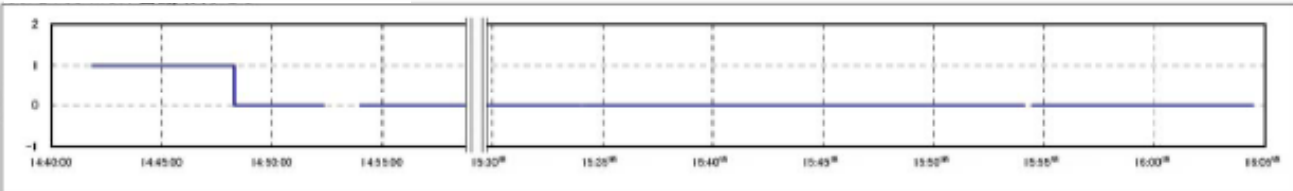
[Main Steam Isolation Valve (MSIV) Closure]

(Note) Before and after MSIV closure, abnormal signals such as rupture detection have been recorded, but it is observed that these abnormal signals were sent as a fail safe measure following the loss of power for the instruments due to the loss of off-site power as a result of the earthquake. Signs of abnormalities, such as the increase in steam flow rates, are not seen in the process of closing the MSIV.

<p>Close signals were sent for the inboard and outboard main steam isolation valves.</p>
<p>28. D763 MSIV auto (Inboard) DC</p>

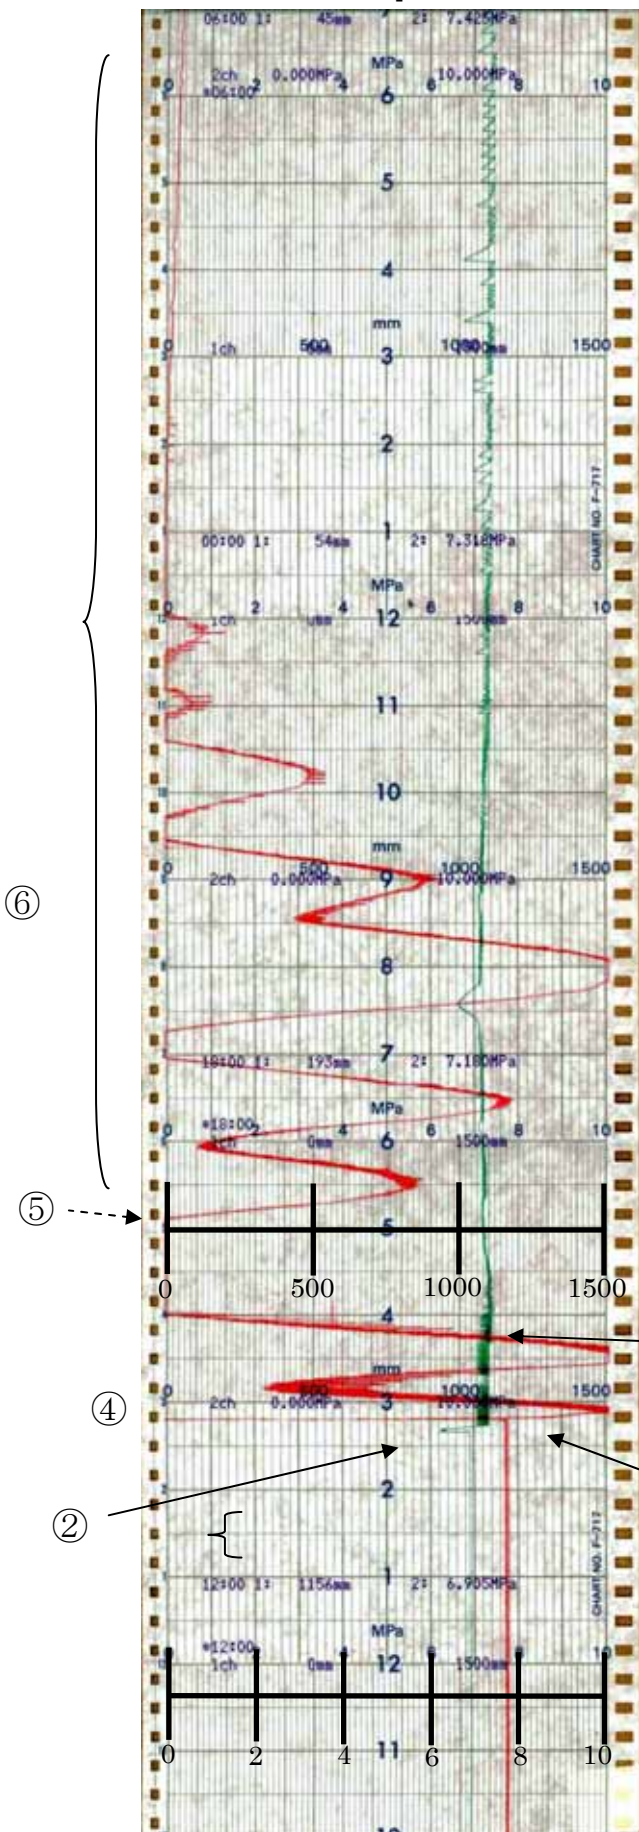
[Reactor water level, Reactor pressure (1/3)]

- ① 14:47 Scram triggered by earthquake
- ② Reactor pressure decrease due to decrease in output, followed by reactor pressure increase due to closure of the main steam isolation valve (MSIV)
- ③ Reactor pressure controlled using SRV
- ④ Water level fluctuations caused by opening/closing of SRV and RCIC startup/shut down
- 15:05: RCIC startup
- 15:25: RCIC trip (high water level)
- ⑤ Water level fluctuation in conjunction with RCIC startup
- 16:03: RCIC startup
- ⑥ Reactor pressure and water level maintained at 7MPa and within narrow band range (range of water level gauge used during normal operation that is set approx. 4m from the top of active fuel (TAF)), respectively, and remains stable.

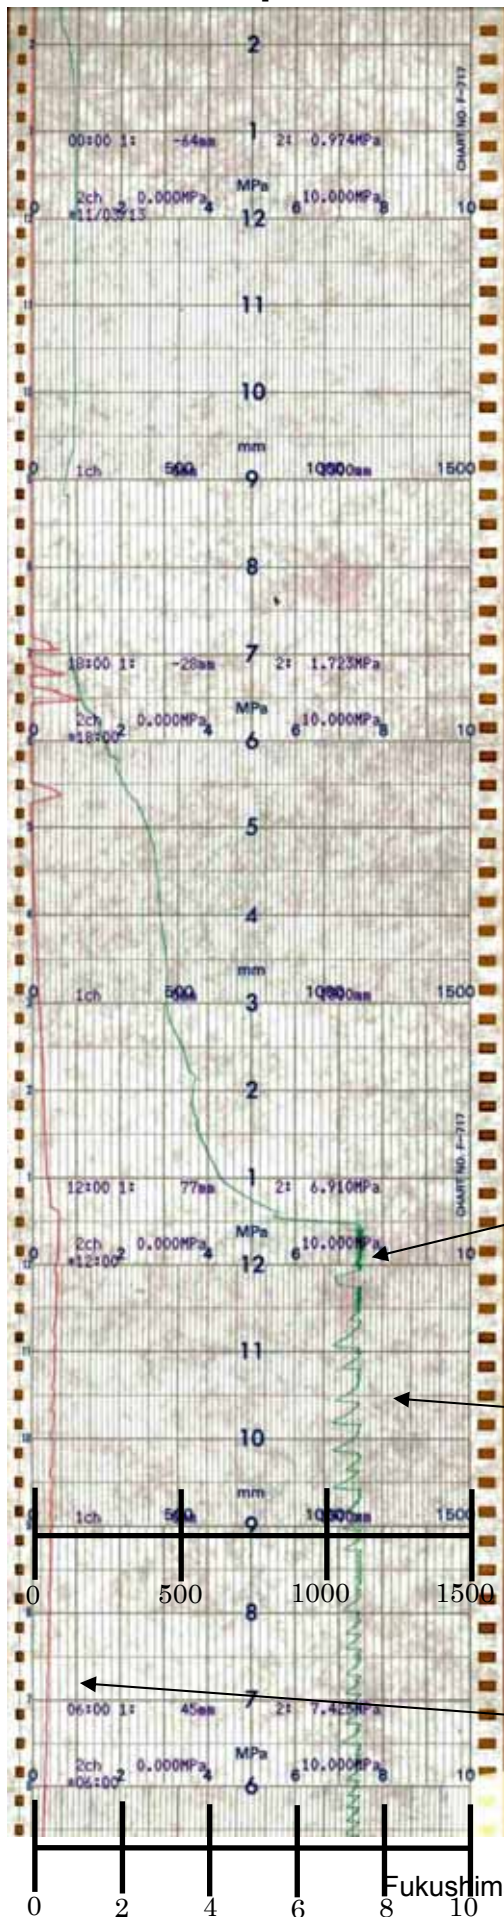
[Reactor water level, Reactor pressure (2/3)]

- ⑦ Water level maintained within narrow band range (range of water level gauge used during normal operation that is set approx. 4m from the top of active fuel (TAF)) and remains stable.
- ⑧ At around 11:30 on March 12 phase changes in pressure control (changes in small motions starting around 11:30)
11:36: RCIC shutdown
- ⑨ Reactor pressure decrease in conjunction with HPCI startup (12:35)
Pressure decreases over the next 6 hours

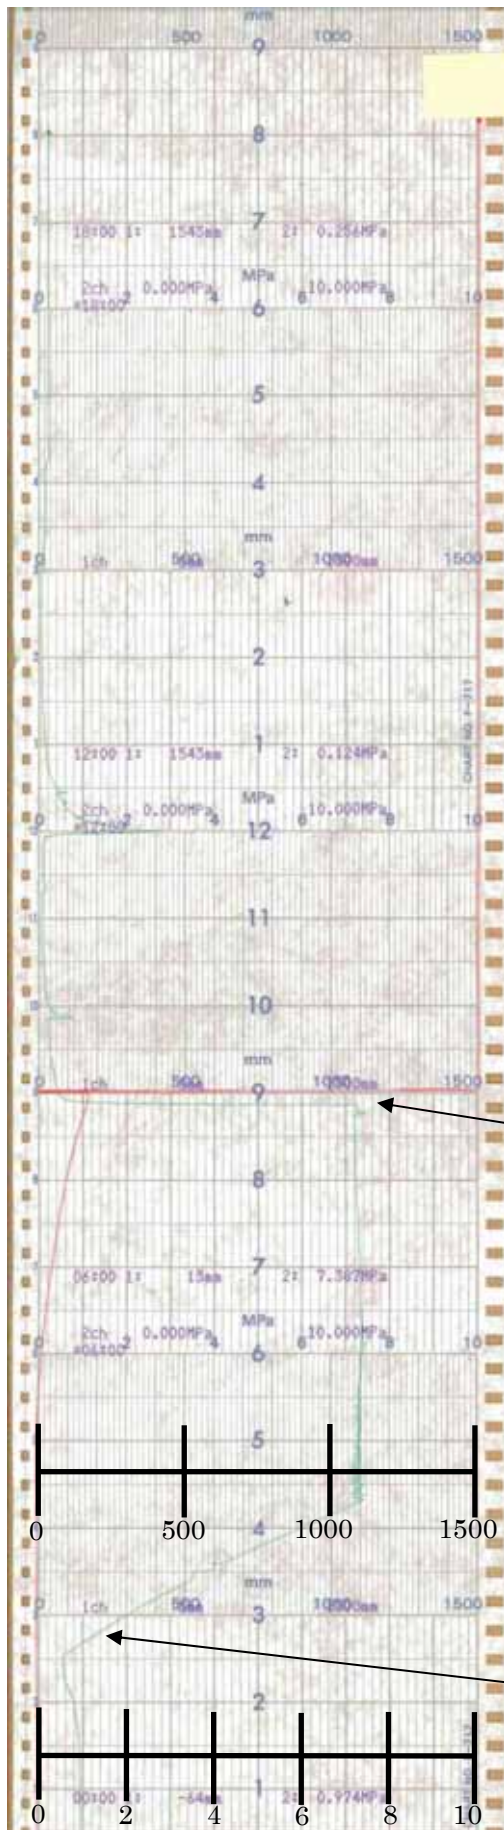
[Reactor water level, Reactor pressure (3/3)]

- ⑩ Reactor pressure increases in conjunction with HPCI shutdown (2:42)
- ⑪ Reactor depressurization from around 9:00 on March 13

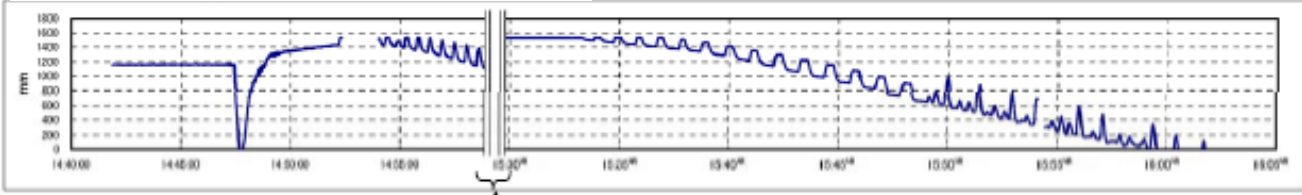
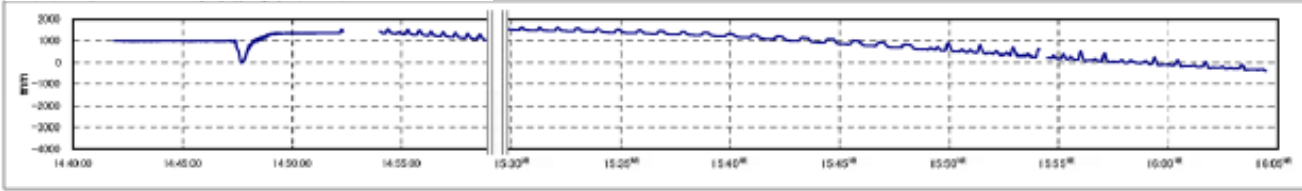
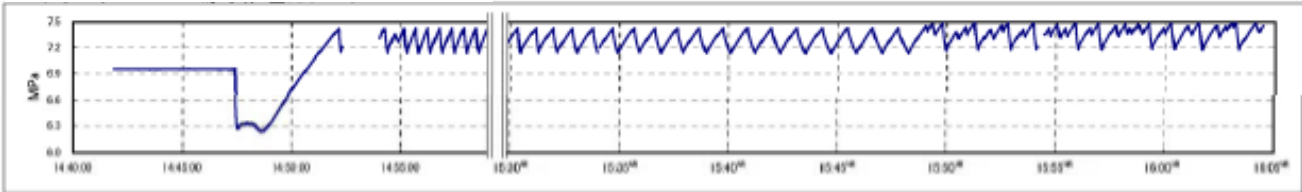
<p style="text-align: center;">About 30 min. of missing data (the same shall apply hereinafter in this page)</p>	<p>Reactor water level fluctuates due to the collapse of voids (bubbles) immediately after the scram but recovers to normal levels thereafter. From around 14:55 reactor water level cyclically fluctuates in conjunction with the opening and closing of the main steam safety relief valve. Water level also gradually decreases.</p>
<p>25. Analog PIDA 600 Reactor Pressure (N/R)</p>

<p>Reactor pressure decreases immediately after the scram. However, whereas pressure increases thereafter due to closing of the main steam isolation valve and decay heat, this pressure cyclically fluctuates due to opening and closing of the main steam safety relief valve.</p>

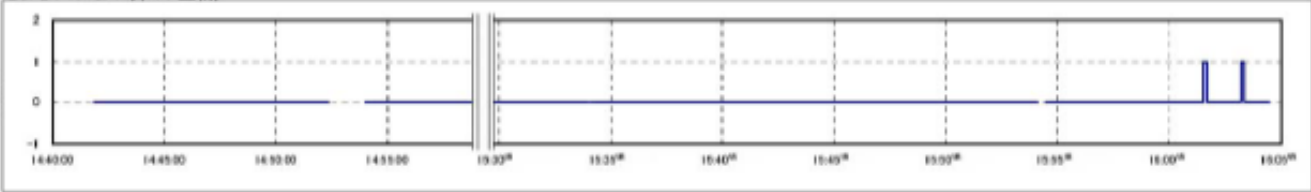
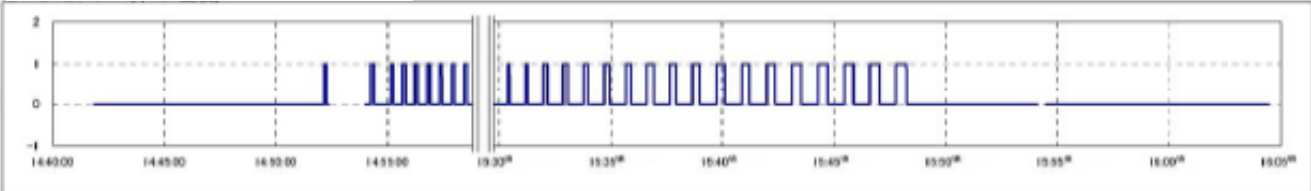
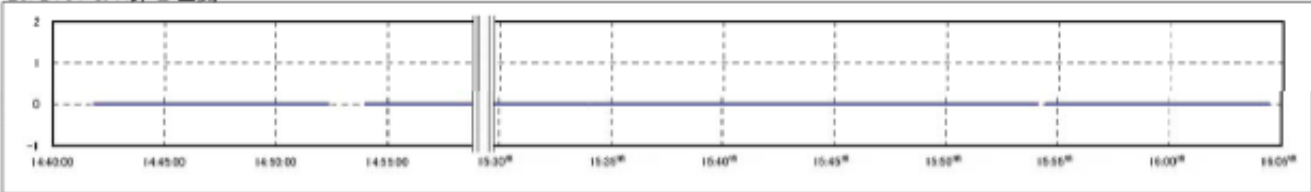
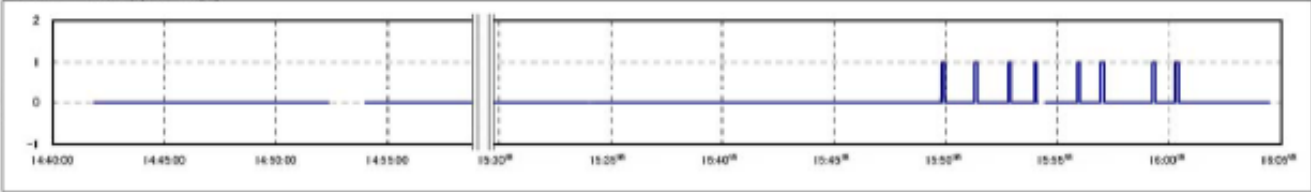
Parameters	Notes
<p>26. D747 S/R valve A full open</p>

<p>The main steam safety relief valve (SRV) was working cyclically from before around 14:55. It is presumed that firstly main steam safety relief valve C was activated but frequent activation and subsequent loss of operation pressure caused the switch over to valve G, after which the same phenomenon led to the switch over to valve A.</p>
<p>21. D728 S/R valve C full open</p>

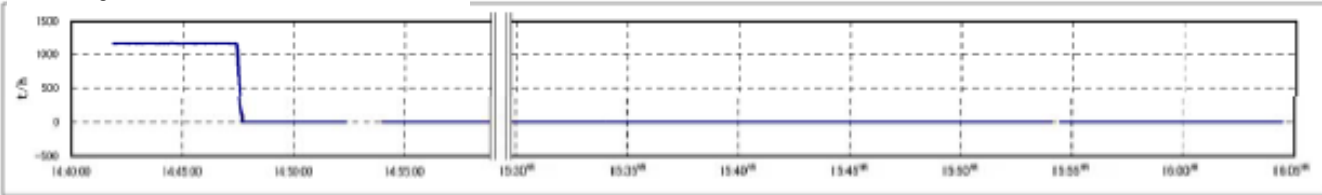
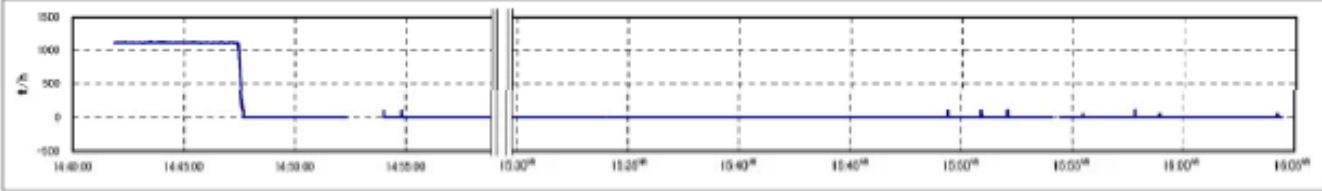
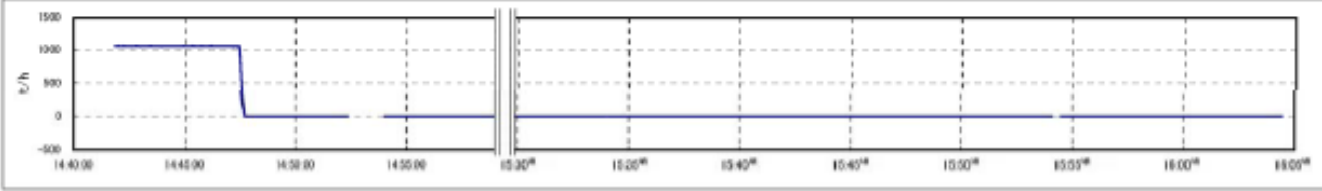
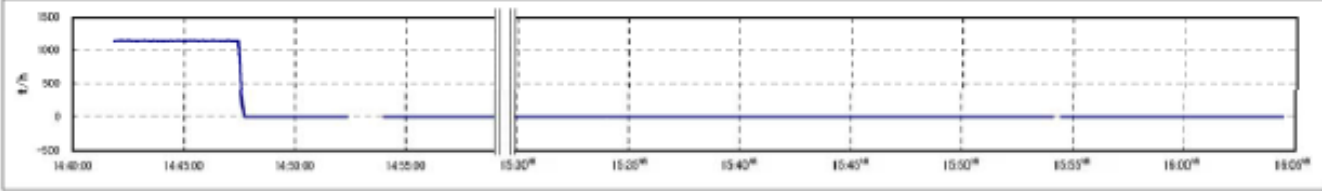
Parameters	Notes
<p>27. Analog PIDA 309 Main steam flow rate A</p>

<p>Main steam flow rate decreases in conjunction with the scram.</p>
<p>28. Analog PIDA 310 Main steam flow rate B</p>

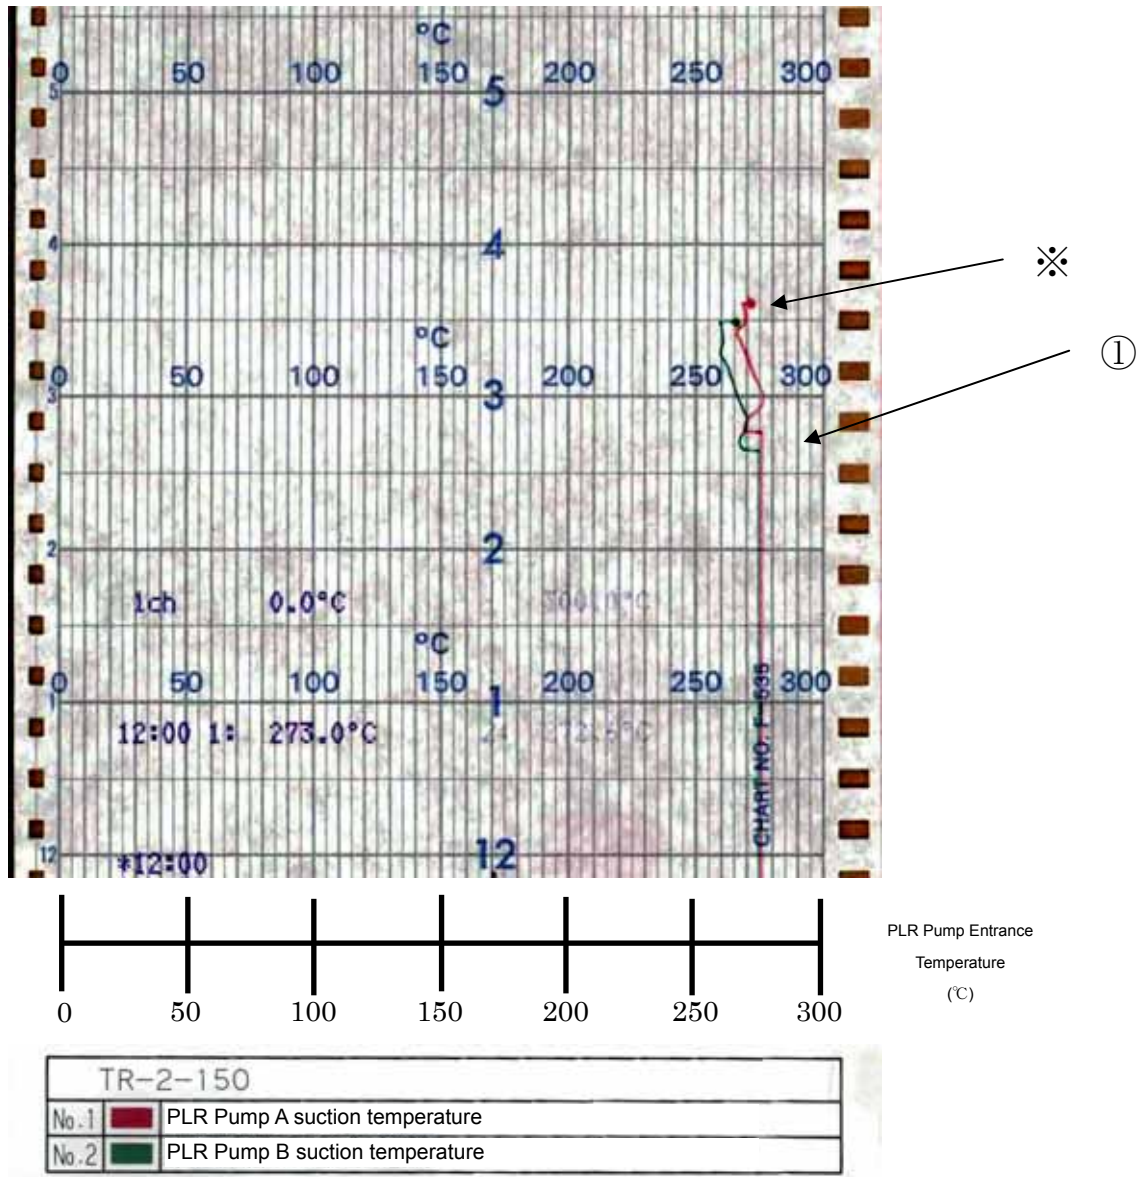
[Primary Loop Recirculating (PLR) Pump Suction Temperature]

① Scram triggered by earthquake at 14:47

*It is supposed that the tsunami arrived shortly after 15:30.

It is assumed that the record stopped due to the impact of the tsunami.

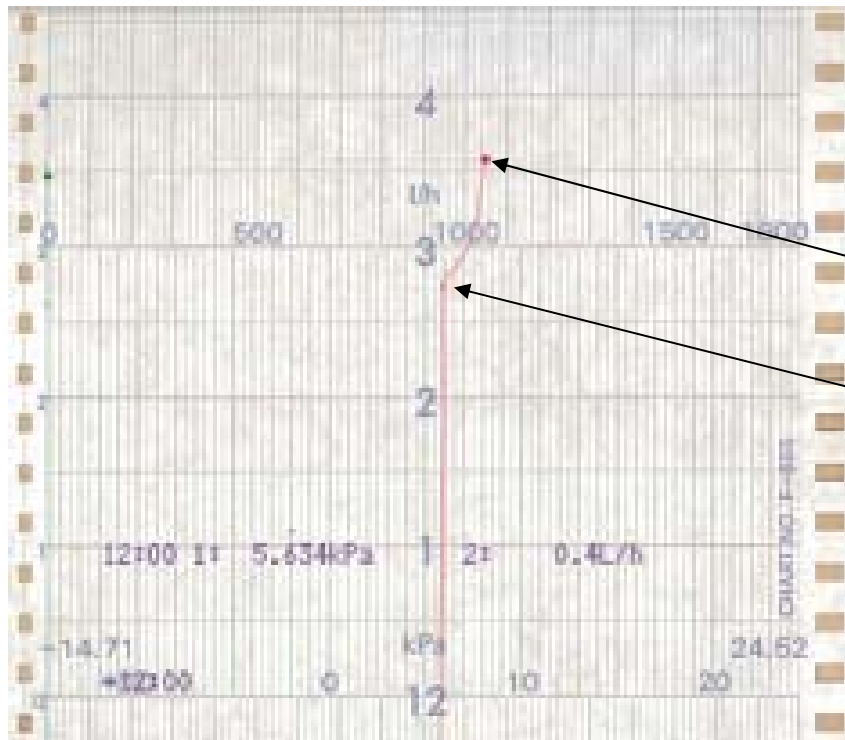
[Primary Containment Vessel (PCV) Nitrogen Pressure /
Primary Containment Vessel (PCV) Nitrogen (N2) Supply Flow Rate]

① Scram triggered by earthquake at 14:47

* It is supposed that the tsunami arrived shortly after 15:30. It is assumed that the chart no longer gives an accurate reading due to the impact of the tsunami.

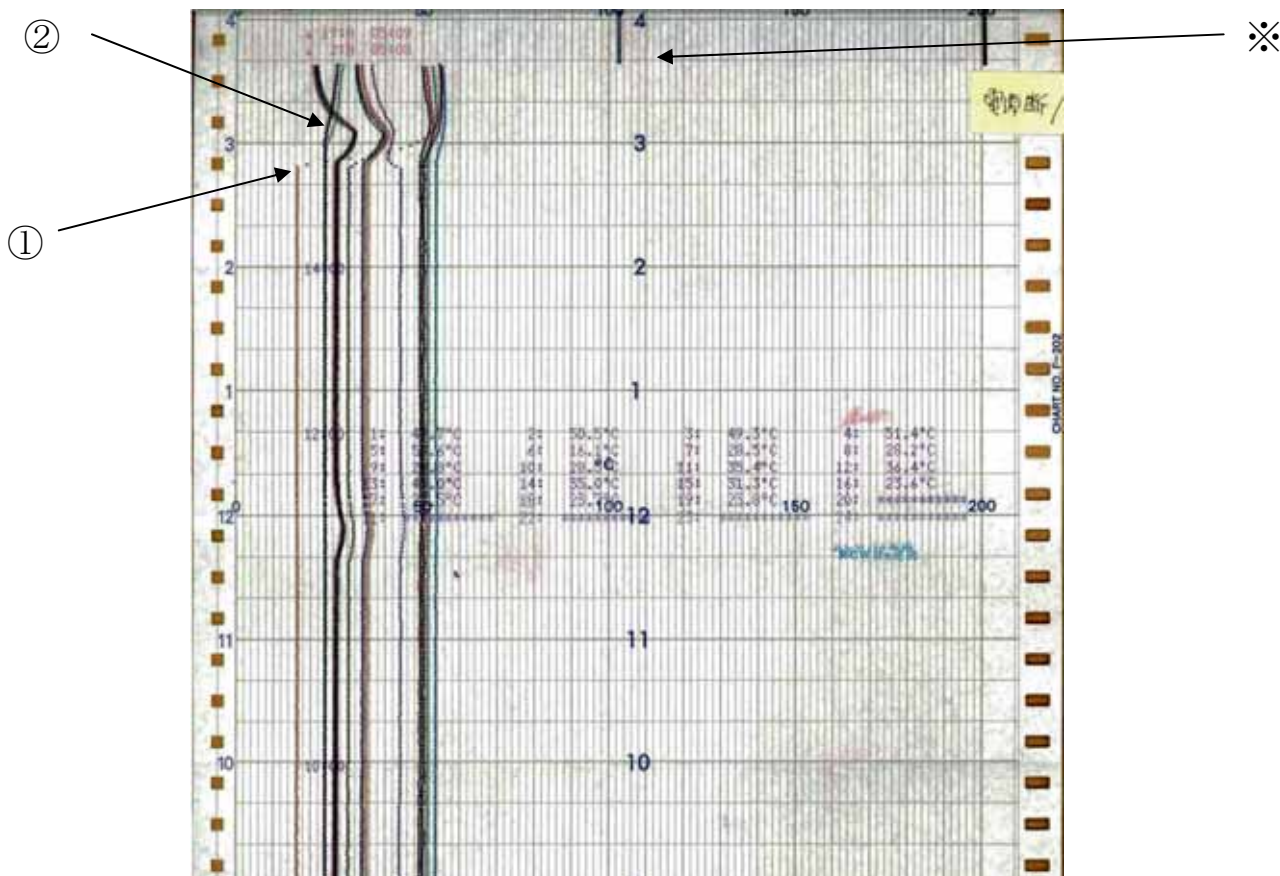
[Temperature of Primary Containment Vessel (PCV) Internals]

- ① Scram triggered due to Earthquake at 14:47
- ② Shutdown of PCV air conditioning due to loss of power, change in PCV temperature followed by drop in output triggered by scram (Unable to confirm rise in temperature due to piping ruptures)

*It is assumed that recorders temporarily halted due to loss of power caused by the tsunami that arrived shortly after 15:30.

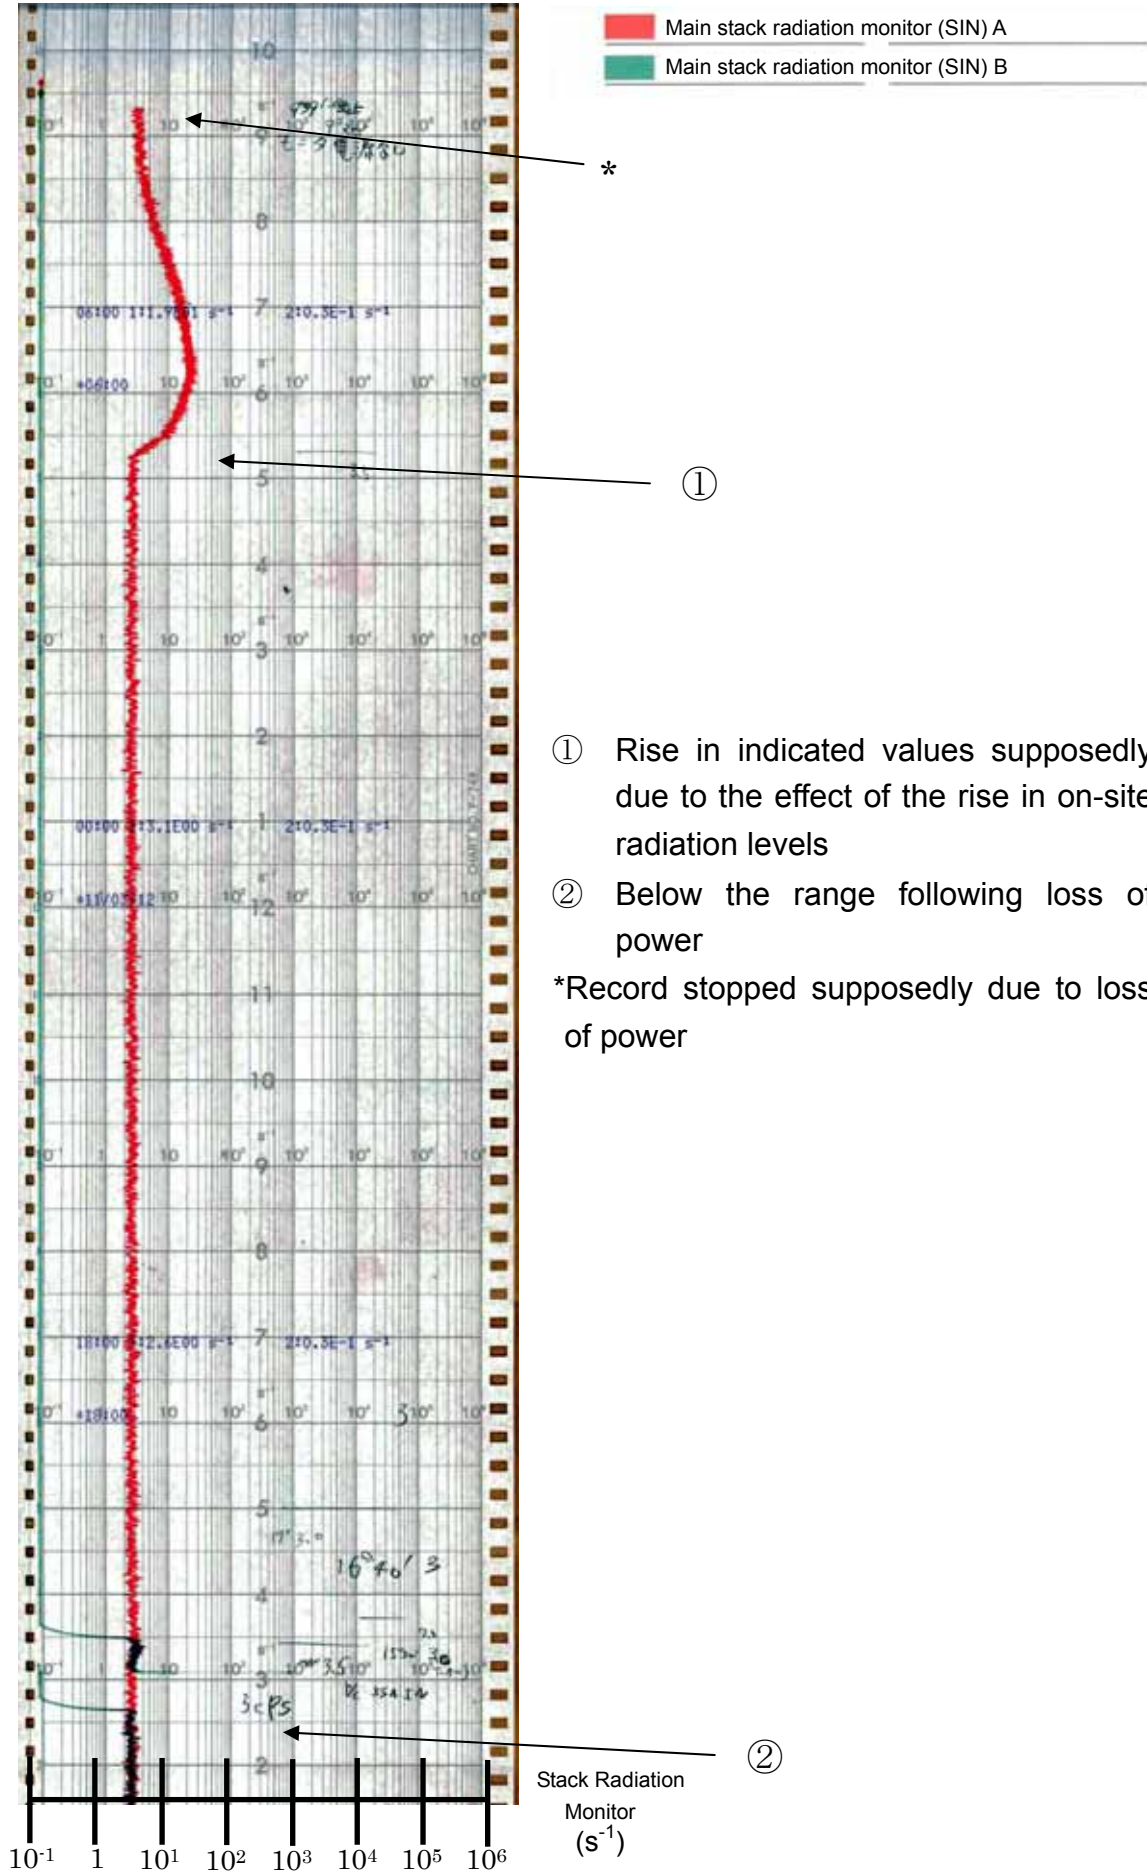
[Main Stack Radiation Monitor]

① Rise in indicated values supposedly due to the effect of the rise in on-site radiation levels

② Below the range following loss of power

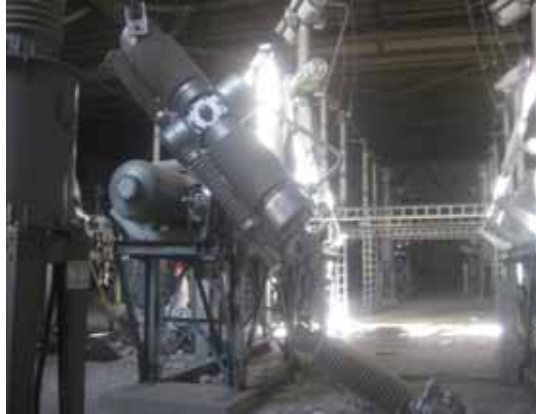
Figure 1. Fukushima Daiichi Nuclear Power Station
Okuma 1L circuit breaker

Yorunomori 1L	○ (receiving power)	Power not received due to collapsed tower.		Power not received due to water damage and submersion of site-side power receiving Unit 5, 6 normal high voltage power panel		3/22: received power at Unit 3, 4 low voltage power panel via Okuma 3L
	Yorunomori 2L	○ (receiving power)	Power not received due to collapsed tower.		Power not received due to water damage and submersion of site-side power receiving Unit 5, 6 normal high voltage power panel		3/21: pass through new route via Futaba Line transmission tower and received power at Unit 5, 6 existing power panel
(Standby)	TEPCO Nuclear Line	Charging up to disconnector on receiving side (disconnector "open")	Shut down		Found cable defect from receiving end to Unit 1 normal high voltage power panel	Power not received due to water damage and submersion of site-side power receiving Unit 1 normal high voltage power panel	3/20: received power on Unit 1,2 low voltage power panel after laying cable

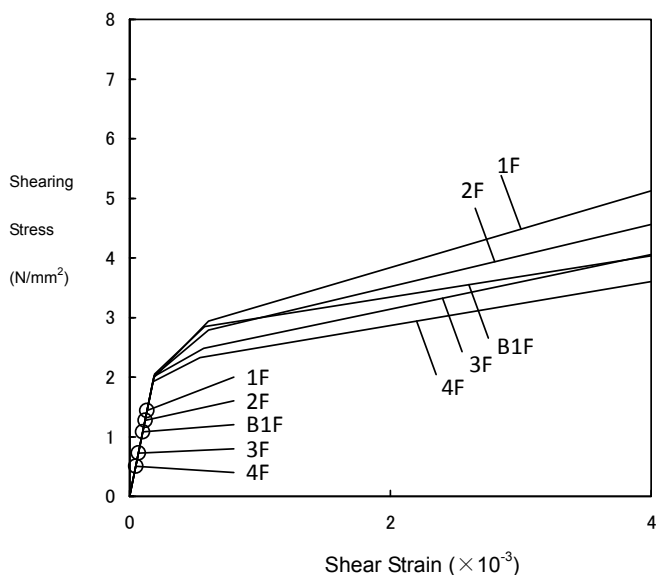
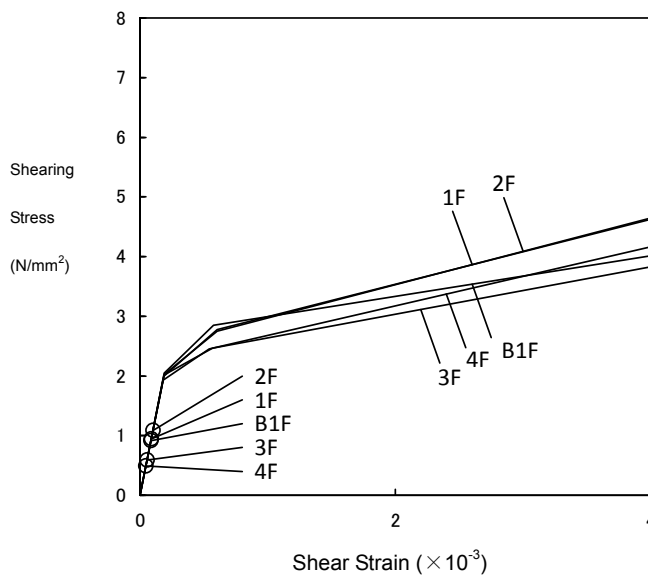
Figure 2. Shear strain of seismic wall (N-S)

Results of the analysis verified that the maximum shear strain for the seismic wall was 0.14×10^{-3} (N-S direction, first floor) and that the stress and deformation conditions for all seismic walls were at or below the first flexion point on the skeleton curve (Figure 2, 3).

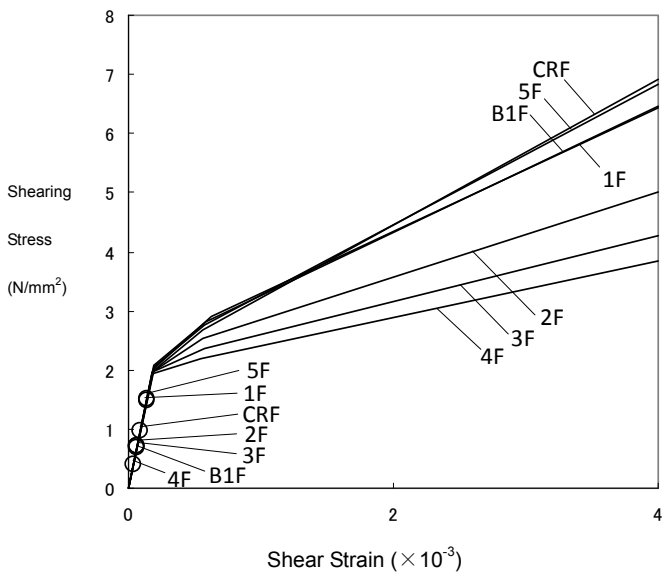
Figure 2. Shear strain of seismic wall (N-S)

Results of the analysis verified that the maximum shear strain for the seismic wall was 0.43×10^{-3} (E-W direction, fifth floor) and that the stress and deformation conditions for all seismic walls, excluding those in the E-W direction on the fifth floor, were at or below the first flexion point on the skeleton curve (Figure 2, 3).

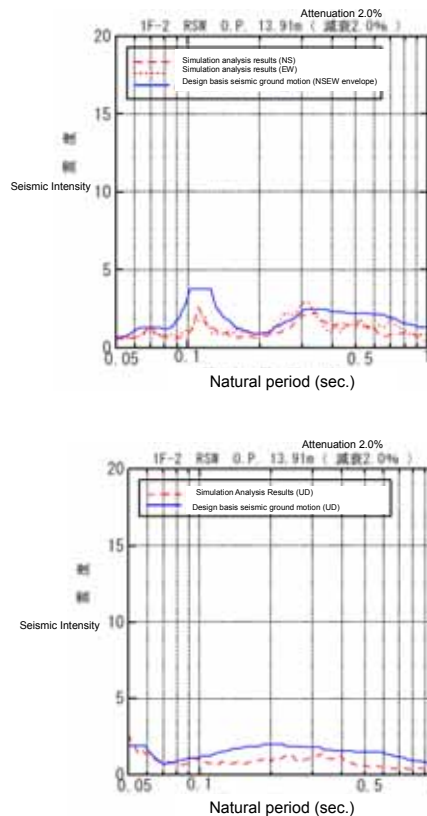
Floor response spectrum

The values for the earthquake was mostly below the values for the design basis seismic ground motion Ss, and only some values for the earthquake exceeded design basis seismic around motion Ss values.

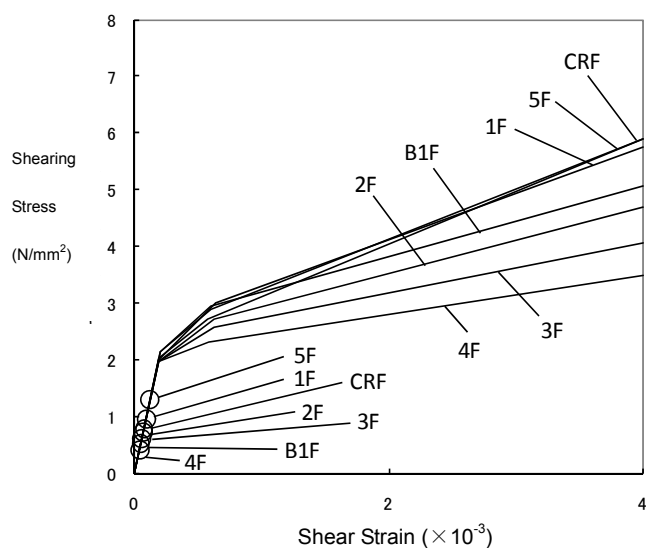
Figure 2. Shear strain of seismic wall (N-S)

Results of the analysis verified that the maximum shear strain for the seismic wall was 0.17×10^{-3} (E-W direction, fifth floor) and that the stress and deformation conditions for all seismic walls were at or below the first flexion point on the skeleton curve (Figure 2, 3).

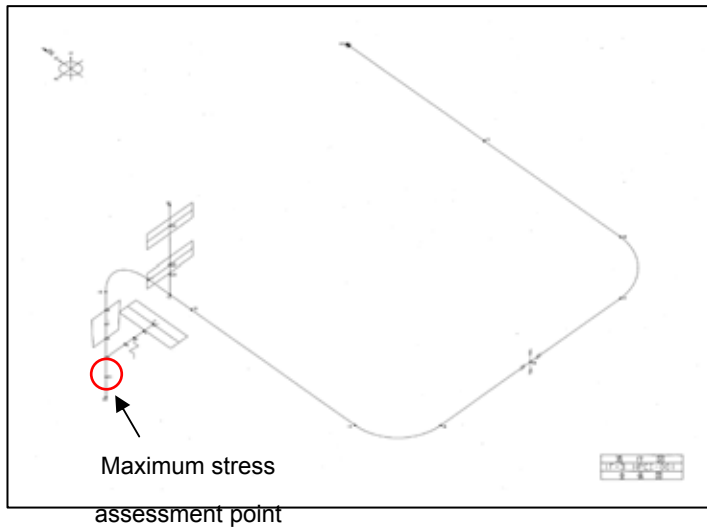
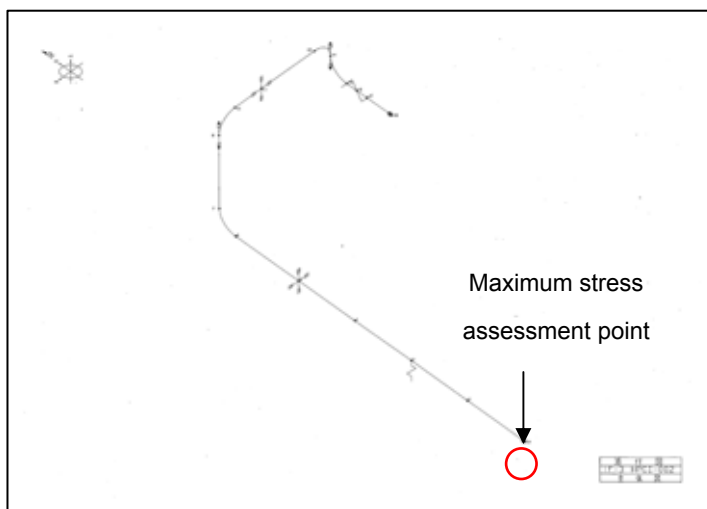
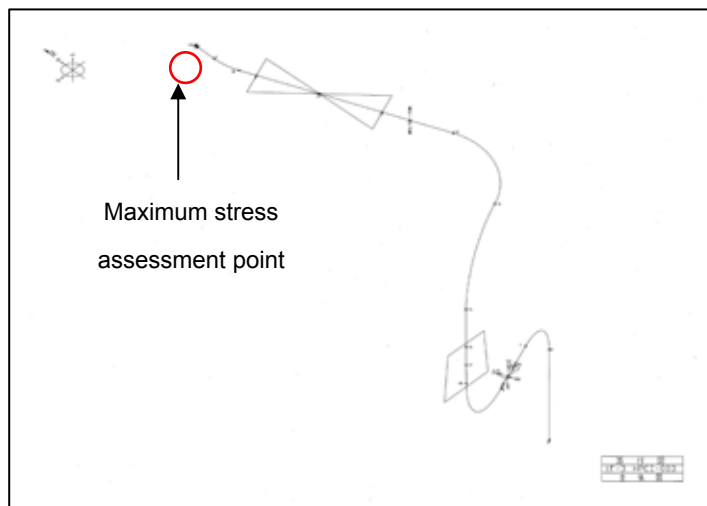
HPCI piping analysis model
(From top: HPCI-001, HPCI-002, HPCI-003)

Analysis model	Calculated value (MPa)	Assessment standard value (MPa)	Stress ratio (Calculated value/ Assessment standard value)
HPCI-001	113	335	0.34
HPCI-002	52	335	0.16
HPCI-003	75	335	0.22

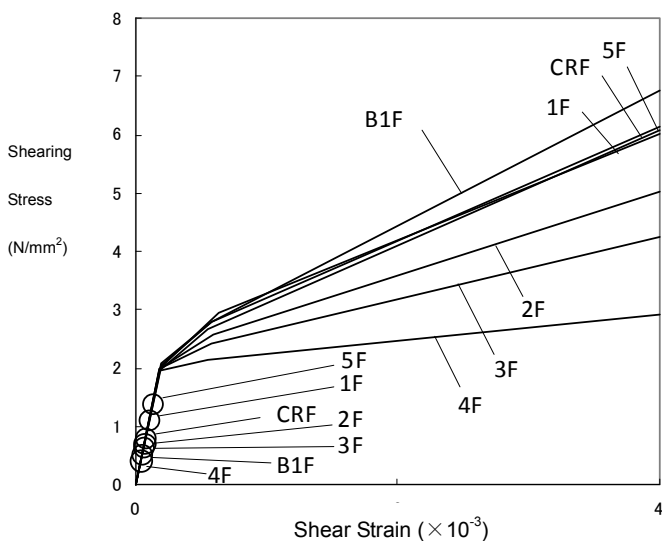
Figure 2. Shear strain of seismic wall (N-S)

Results of the analysis verified that the maximum shear strain for the seismic wall was 0.15×10^{-3} (E-W direction, fifth floor) and that the stress and deformation conditions for all seismic walls were at or below the first flexion point (Figure 2, 3).

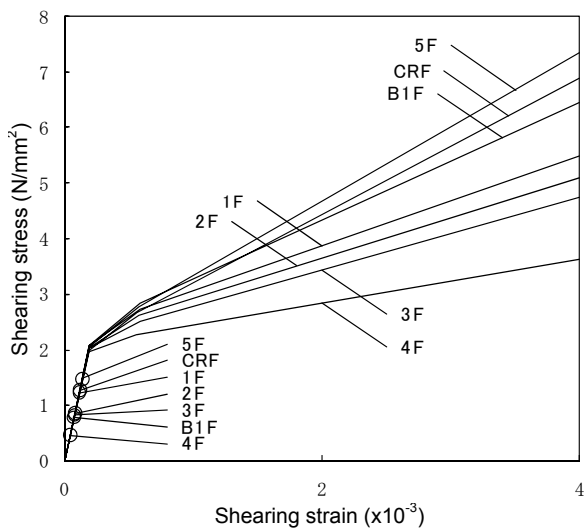
Figure 2. Shear strain of seismic wall (N-S)

Results of the analysis verified that the maximum shear strain for the seismic wall was 0.36×10^{-3} (E-W direction, fifth floor) and that the stress and deformation conditions for all seismic walls, excluding those in the E-W direction on the crane floor and fifth floor, were at or below the first flexion point on the skeleton curve (Figure 2, 3).

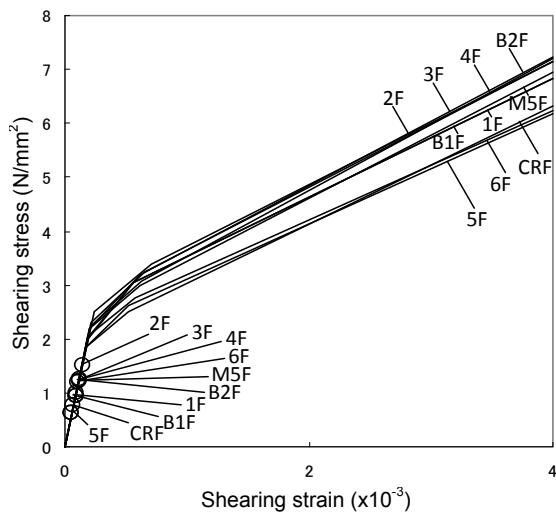
Figure 2 Shear strain of seismic wall (N-S)

Results of the analysis verified that the maximum shear strain for the seismic wall was 0.16×10^{-3} (E-W direction, fourth floor) and that the stress and deformation conditions for all seismic walls were at or below the first flexion point on the skeleton curve (Figure 2, 3).

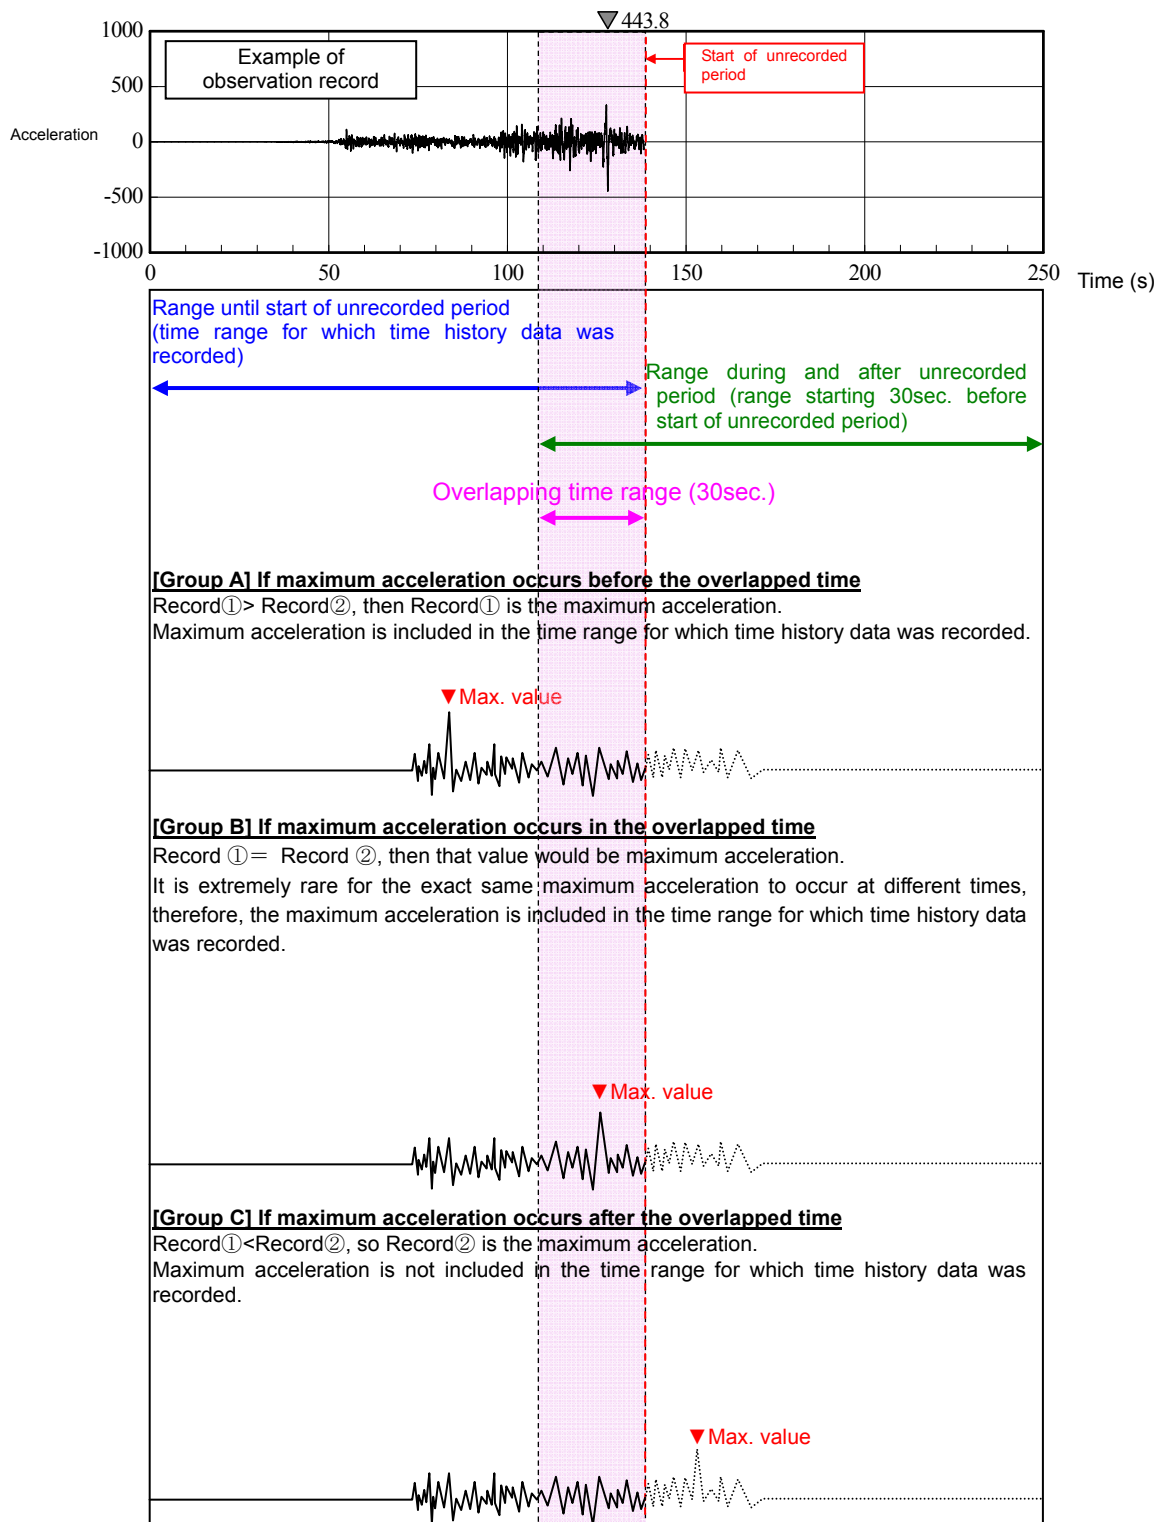
Figure-1.1 Time range for Record ① and ② and categorization by time when maximum acceleration occurred

- Figure-1.1. indicates the time range for which Record① and Record② was obtained. The time range for which Record② was obtained started 30 seconds before the unrecorded period. Within these 30 seconds, there is an overlap between Record① and Record② in terms of the time range.

- As shown in Figure-1.1, it is possible to categorize the size relationships of Record① and ② into Group A, B, C from the time at which maximum acceleration is recorded. The maximum acceleration observations points categorized as Group A or B occurs within the time range for which time history data was recorded.

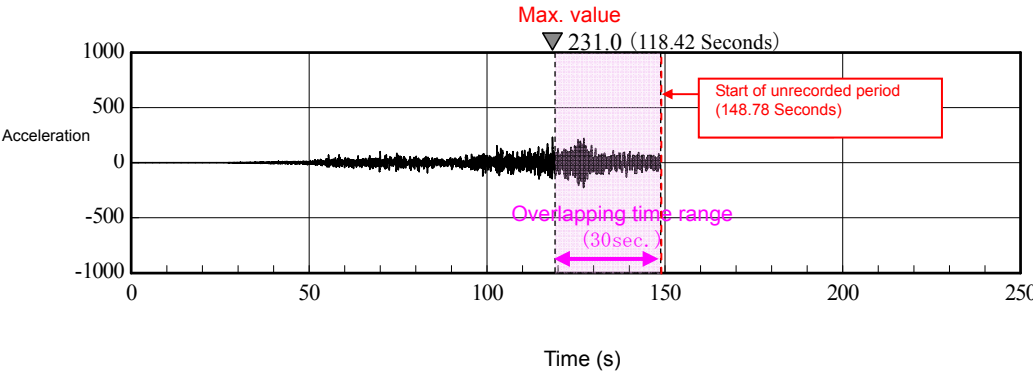
Figure-1.2 Group A Record (observation point 3-R2, vertical direction)

- Table-1.2 indicates the categorization results for each observation point. From Table 1-2, it can be verified that all observation points are categorized as A or B, and as indicated in Figure-1.2 and 1.3, the maximum acceleration value occurred within the time range for which time history data was available.

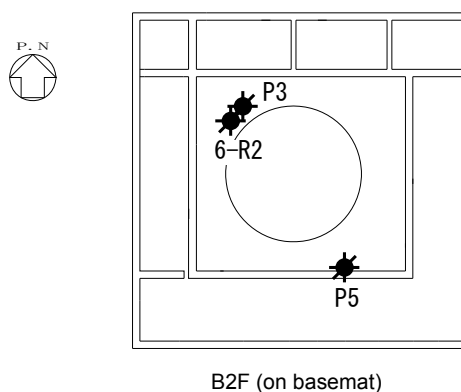
Figure-2.1 Layout of seismometers (Unit 6 R/B)

For observation point 6-R2 on the Unit 6 Reactor Building (R/B) base mat, whose observation records ceased in the middle, complete records were available for observation point P3 which was located nearby. Therefore, these two records were compared. The seismometer layout for Unit 6 R/B base mat is indicated in Figure-2.1.
