Fukushima Nuclear Accidents Investigation Report

Attachment

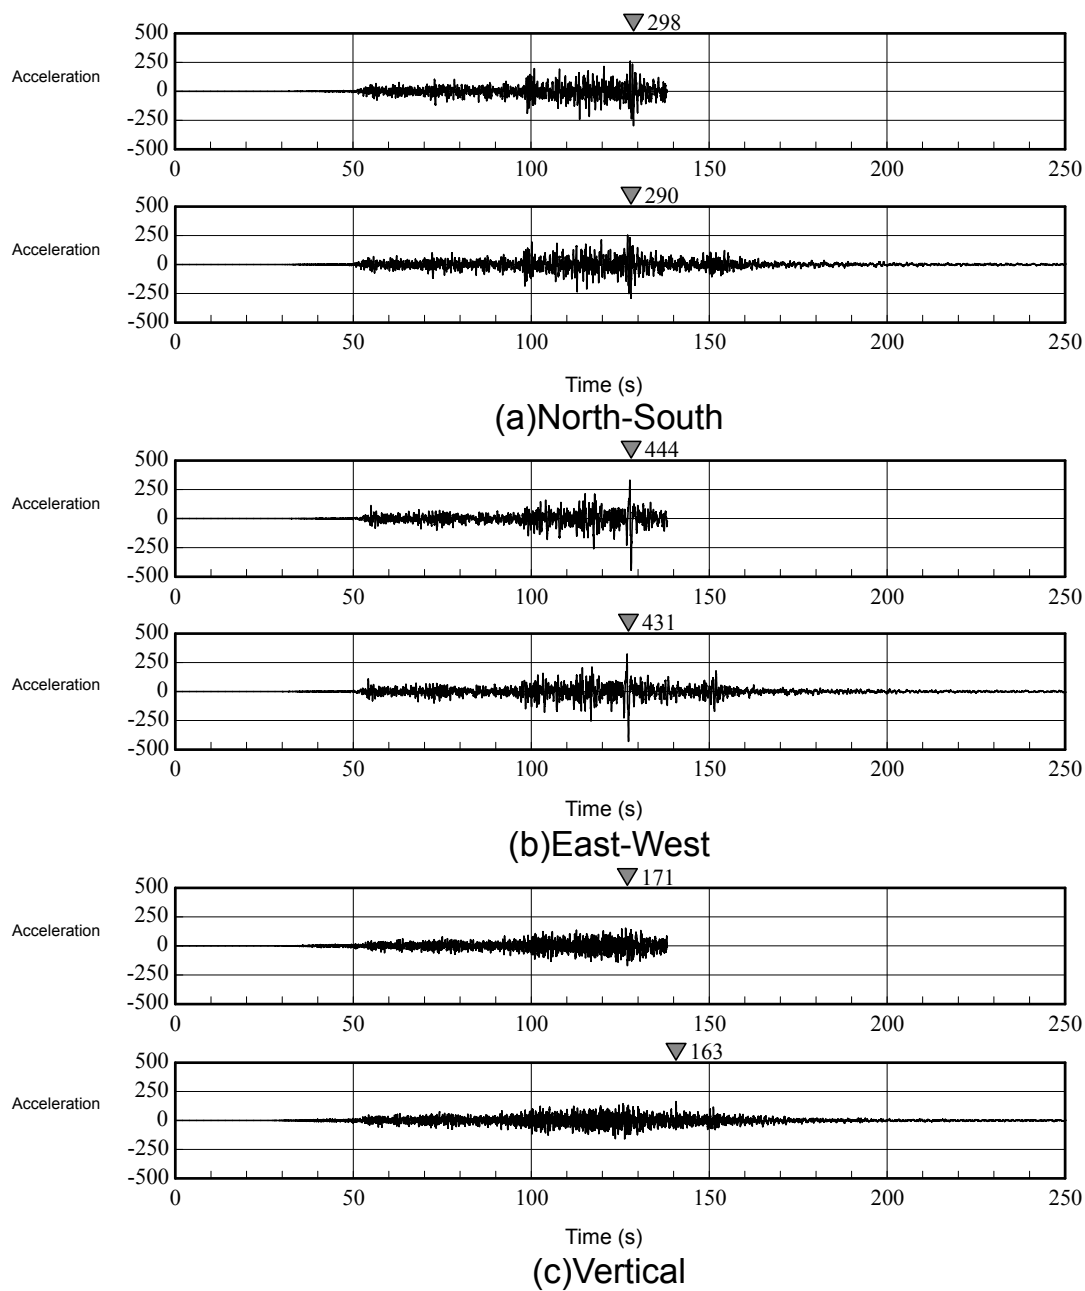
Figure-2.2 Comparison of acceleration time history waveforms of observation points closely located (on Unit6 R/B base mat)

Figure-2.2 compares the acceleration time history waveforms observed at observation points 6-R2 and P3. Their response spectra are compared in Figure-2.3.

According to Figure-2.2 and -2.3, the maximum acceleration and response spectra are roughly the same for both.

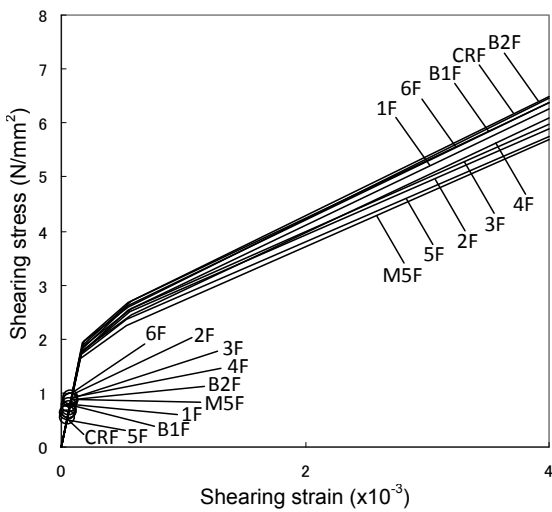
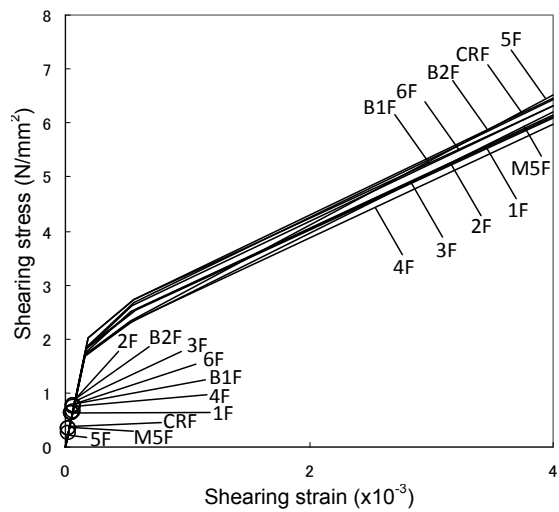
Results of the analysis verified that the maximum shear strain for the seismic wall was 0.09×10^{-3} (N-S direction, sixth floor) and that the stress and deformation conditions for all seismic walls were at or below the first flexion point on the skeleton curve (Figure-2, 3).

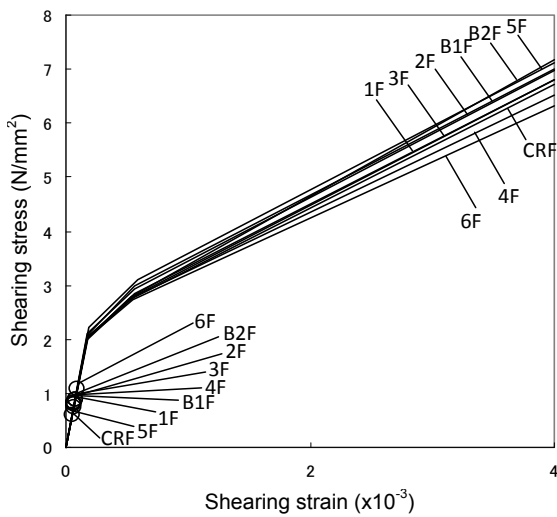
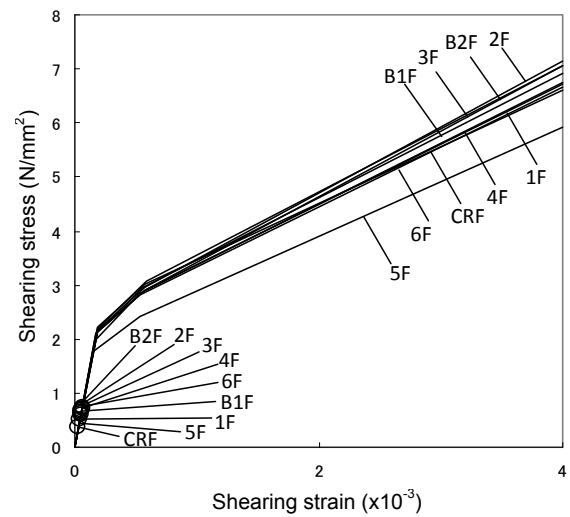
Results of the analysis verified that the maximum shear strain for the seismic wall was 0.10×10^{-3} (N-S direction, sixth floor) and that the stress and deformation conditions for all seismic walls were at or below the first flexion point on the skeleton curve (Figure-2, -3).

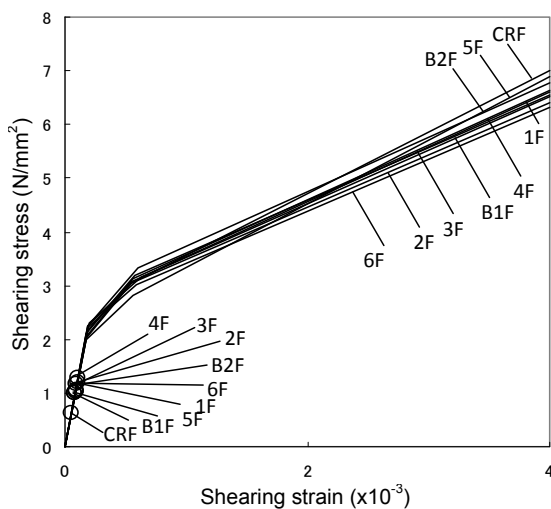
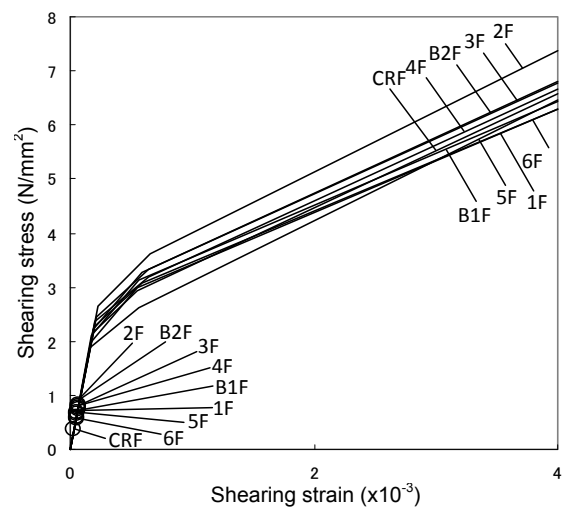
Results of the analysis verified that the maximum shear strain for the seismic wall was 0.11×10^{-3} (N-S direction, fourth floor) and that the stress and deformation conditions for all seismic walls were at or below the first flexion point on the skeleton curve (Figure-2, -3).

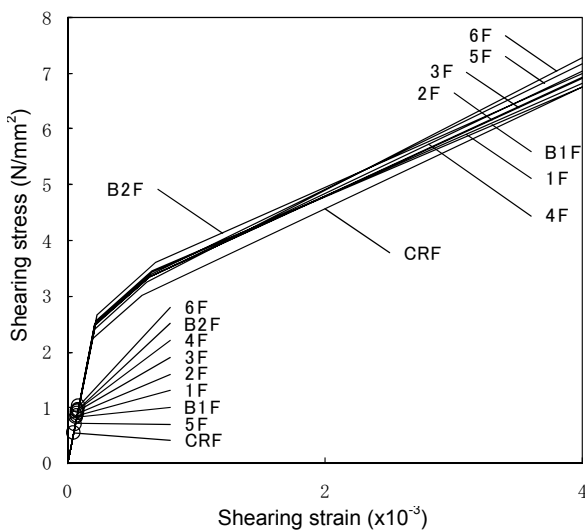
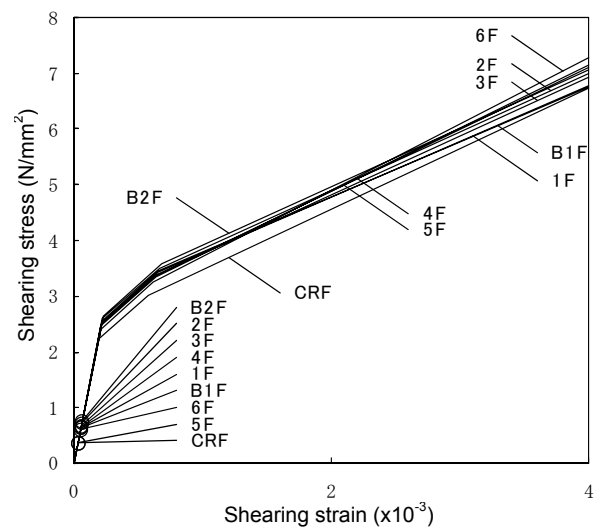
Results of the analysis verified that the maximum shear strain for the seismic wall was 0.09×10^{-3} (N-S direction, sixth floor) and that the stress and deformation conditions for all seismic walls were at or below the first flexion point on the skeleton curve (Figure-2, -3).

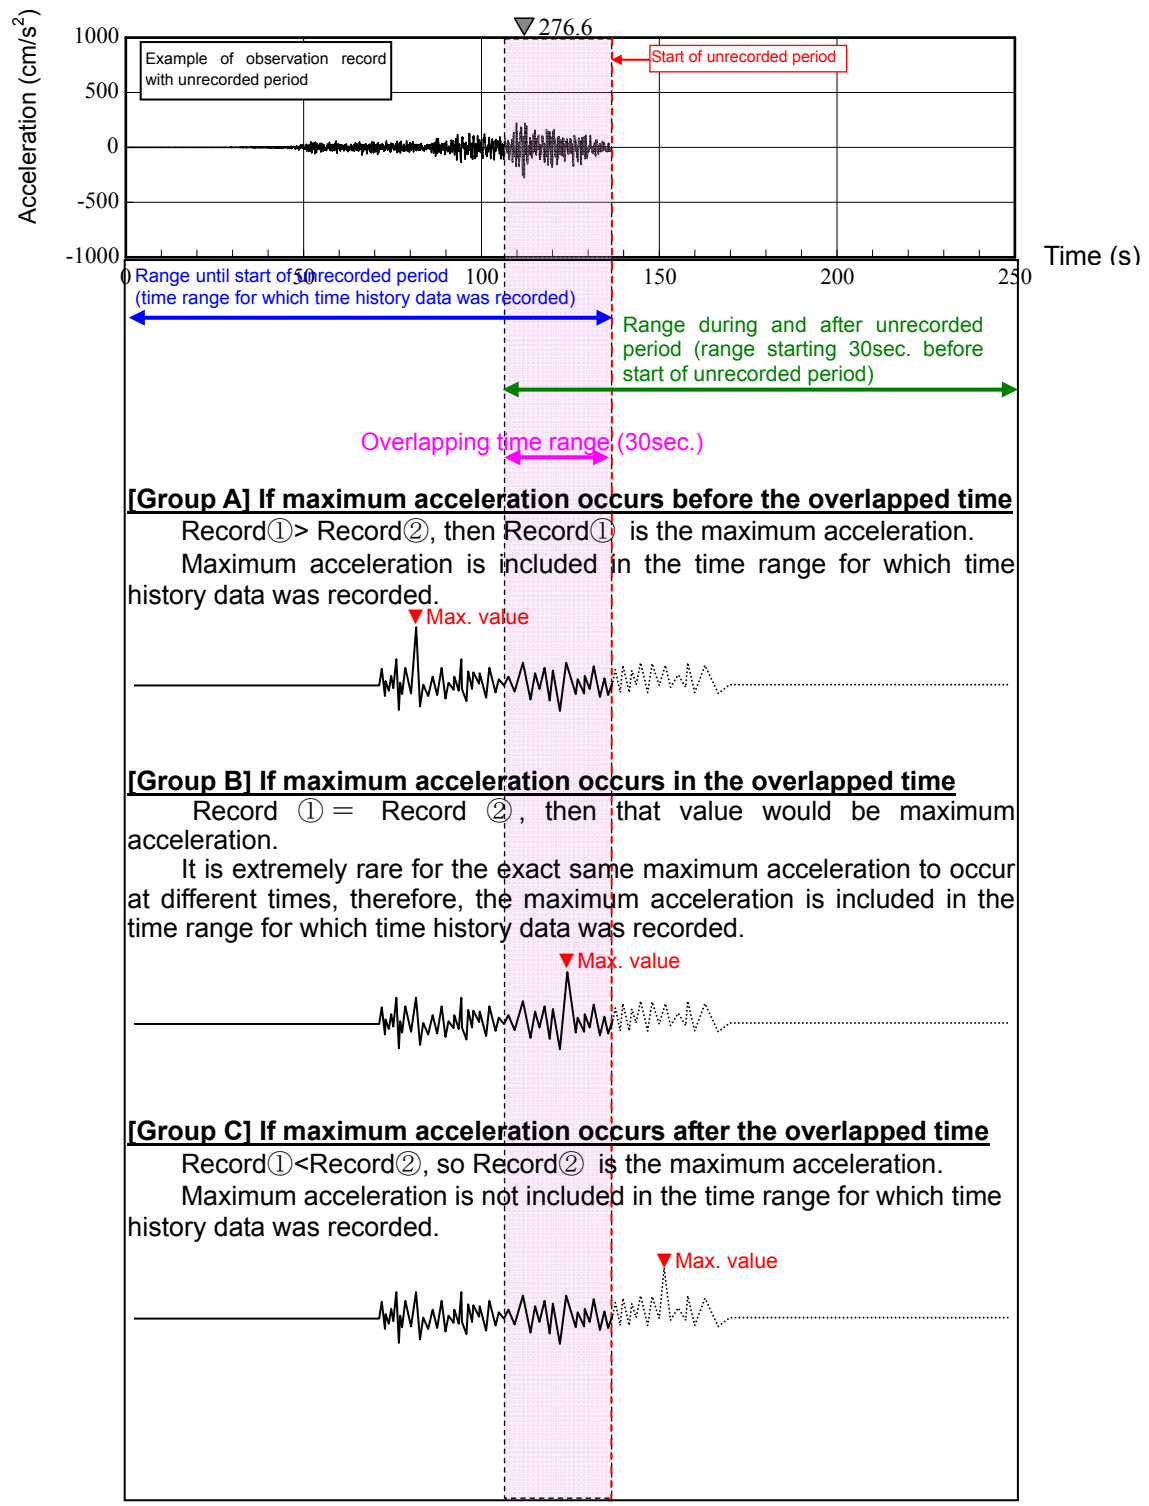
Figure-1.1 Time range for Record ① and ② and categorization by time when maximum acceleration occurred

- Figure-1.1. indicates the time range for which Record① and Record② was obtained. The time range for which Record② was obtained started 30 seconds before the unrecorded period. With these 30 seconds, there is an overlap between Record① and Record② in terms of the time range.

- As shown in Figure-1.1, it is possible to categorize the size relationships of Record① and ② into Group A, B, C from the time at which maximum acceleration is recorded. The maximum acceleration observations records categorized as Group A or B occurs within the time range for which time history data was recorded.

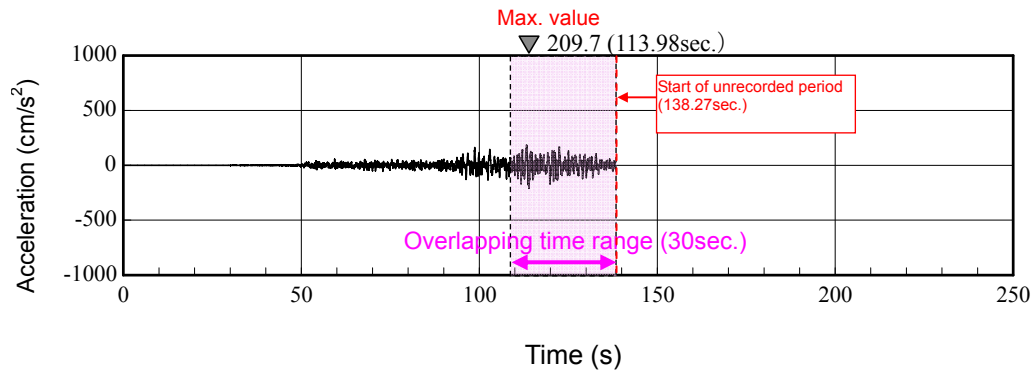
Figure-1.2 Group B Record
(Example of observation point 4-R2, south-north direction)

- Table-1.2 indicates categorization results. From Table 1-2, it can be verified that all observation points are categorized as B, and as indicated in Figure-1.2, the maximum acceleration value occurred within the time range for which time history data was available.

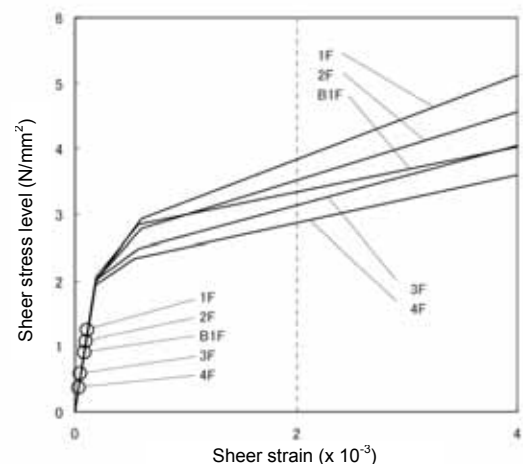
Figure 2. Maximum response value on shear skeleton curve (Unit 1, S_s -1, NS)

- Unit 1 R/B
 - For Unit 1 R/B, an event apparently being a hydrogen explosion occurred on March 12, the day after the Tohoku-Chihou-Taiheiyo-Oki Earthquake, which caused damage to the top of the fifth floor, operating floor. This information was incorporated into the lumped mass model to analyze the time history response of the design basis seismic ground motion, Ss, and to study whether the seismic wall would reach ultimate conditions of shear failure (Figure 1).
 - As a results of time history response analysis using design basis seismic ground motion Ss, the maximum shear strain generated for the remaining seismic wall on the fifth floor and lower floors is 0.12×10^{-3} (Ss-1, Ss-2, NS direction, 1F) and is significantly below 4×10^{-3} , the assessment standard value. Therefore, it is assessed that there is sufficient safety (Figure 2).

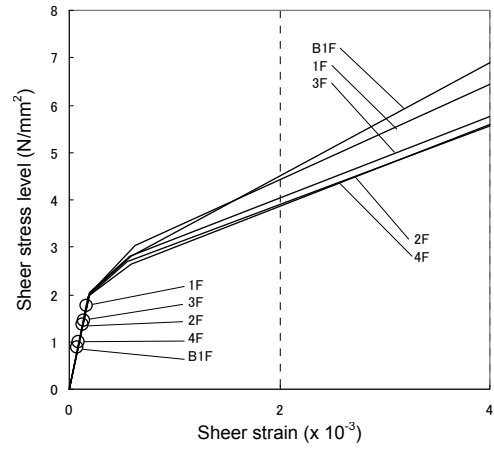
Figure 4. Maximum response value on shear skeleton curve (Unit 4, Ss-1, EW)

- Results of time history response analysis using design basis seismic ground motion S_s for lumped mass model indicated that the maximum shear strain of the remaining seismic walls on or above the fifth floor is 0.17×10^{-3} (S_s -1, S_s -2, EW direction, 1F), which is significantly lower than 4×10^{-3} , the assessment standard value. Therefore, it is assessed that there is sufficient safety (Figure 4).

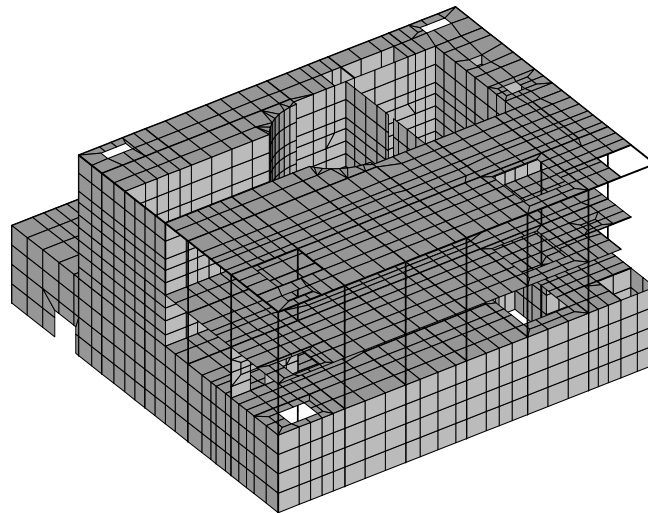
Figure 5. 3D FEM local assessment model (Unit 4)

- Results of seismic safety assessment using 3D FEM analysis (Figure 5) showed that the maximum strain on rebars of the spent fuel pool was 1230×10^{-6} when combining the seismic load due to the design basis seismic ground motion S_s and other loads. This has significant margin against the assessment standard value of 5000×10^{-6} of plastic limit strain. The stress generated at the location where the out-of-plane shear force has the smallest margin is 800 (N/mm) and has sufficient margin against 1150 (N/mm), the assessment standard value. Therefore, it is assessed that there is sufficient safety.

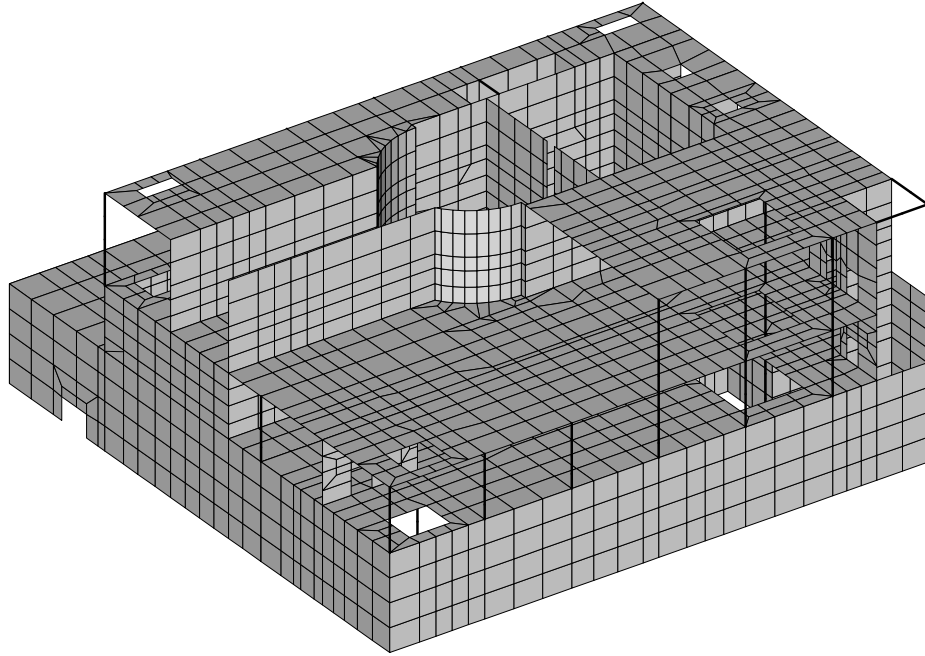
Figure 3. 3D FEM local assessment model (Unit 3)

the maximum strain on rebars of the spent fuel pool was 1303×10^{-6} when combining the seismic load due to the design basis seismic ground motion S_s and other loads. This has a significant margin against the assessment standard value of 5000×10^{-6} of plastic limit strain. The stress generated at the location where the out-of-plane shear force has the smallest margin is 1,689 (N/mm) and has sufficient margin against 3,130 (N/mm), the assessment standard value. Therefore, it is assessed that there is sufficient safety.

- A similar assessment was conducted for the shell wall on the outer side of the RPV. The maximum strain on rebars was 469×10^{-6} and has sufficient margin against the assessment standard value of 5000×10^{-6} of plastic limit strain. The stress generated at the location where the out-of-plane shear force has the smallest margin is 2,475 (N/mm) and has sufficient margin against 3,270 (N/mm), the assessment standard value. Therefore, it is assessed that there is sufficient safety.

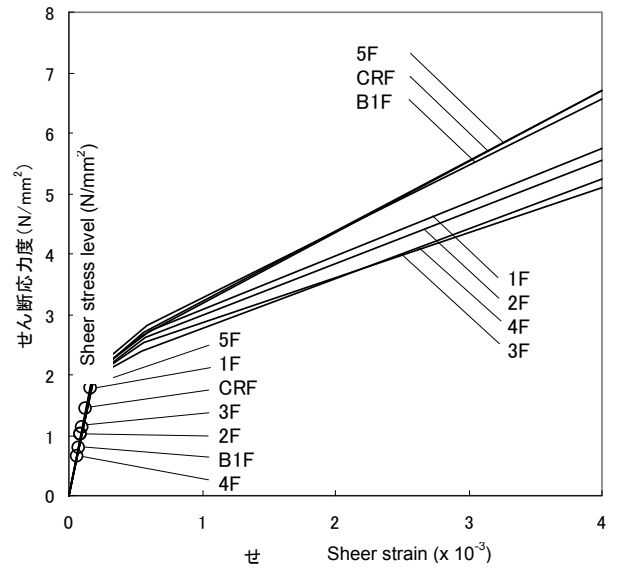
Figure 2. Maximum response value on shear skeleton curve (Unit 2, Ss-1, EW)

- Unit 2 R/B
 - For Unit 2 R/B, though the blow-out panel on the exterior wall of the east-side was released, there is no visible external damage. Access to the interior of the building is restricted due to high radiation, so the conditions are unclear but it is understood that there is no damage at this point. Considering such conditions, the seismic performance of the building was assessed using the analysis results for the seismic back-check as-is (‘Fukushima Daiichi NPS Interim Report on seismic safety assessment results pursuant to the revision of “Regulatory Guide for Reviewing Seismic Design of Nuclear Power Reactor Facilities”(Revision 2)’ April 19, 2010)

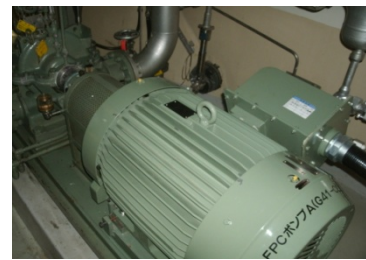
Fuel pool cooling & clean up pump
•No external equipment abnormality

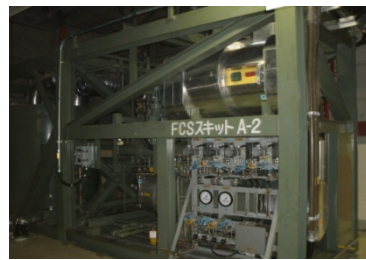
Flammability control system
•Subsystem A has no external equipment abnormality
•Subsystem B (installed on 3F) has had defect in cooler in B-2 recombiner since before earthquake

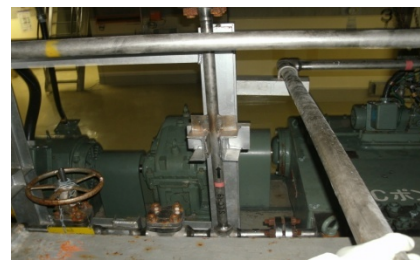
SLCS pump
•No external equipment abnormality

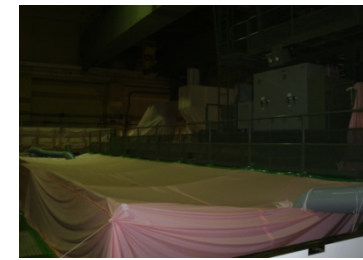
SPF
•No external equipment abnormality (covered for condensation)

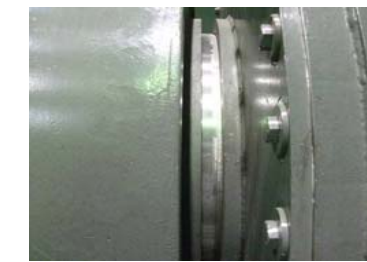
Low pressure turbine
•Sliding marks on No.3 bearing high pressure side rotor
•Sliding marks on No.3, No.8 bearing rotor
•Sliding marks on No.8 bearing generator side rotor

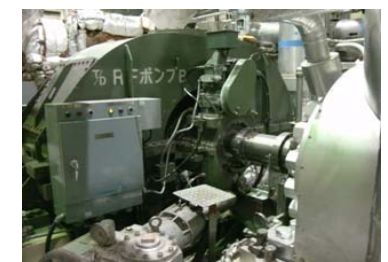
Turbine-driven reactor feedwater pump
•No external equipment abnormality

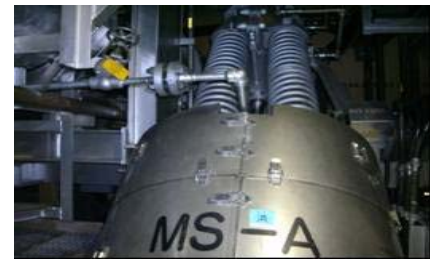
MSIV
•No external equipment abnormality

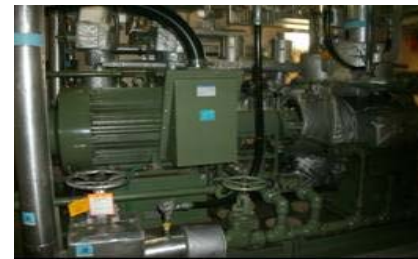
Reactor clean-up water pump
•No external equipment abnormality

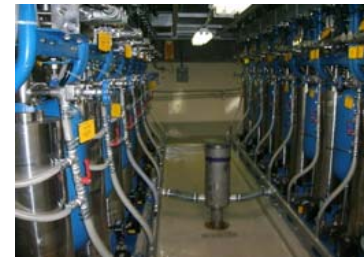
Hydraulic control unit
•No external equipment abnormality

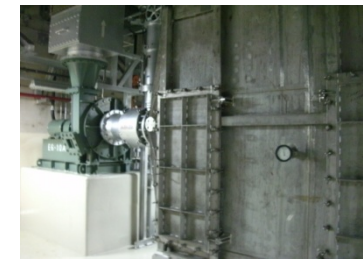
SGTS
•No external equipment abnormality
A/B alternating operation

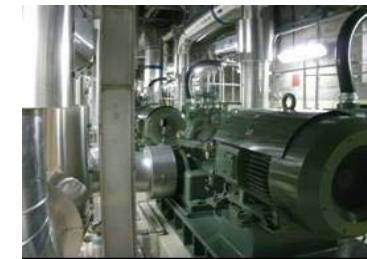
Reactor component cooling pump
No external equipment abnormality

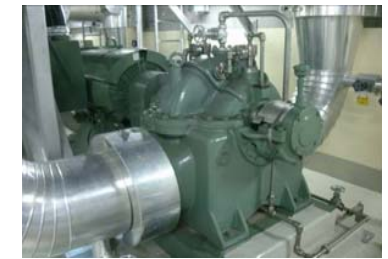
Turbine component cooling pump
•No external equipment abnormality

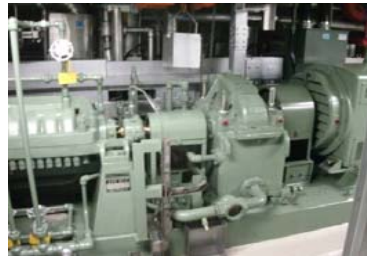
CRD pump
•No external equipment abnormality

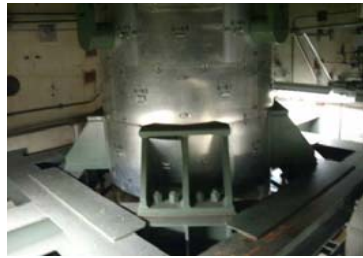
RHR heat exchanger
•No external equipment abnormality

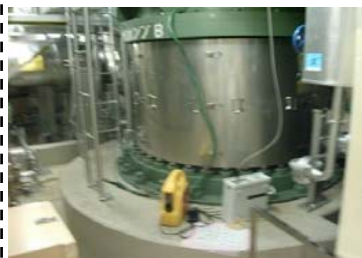
RHR pump
•No external equipment abnormality

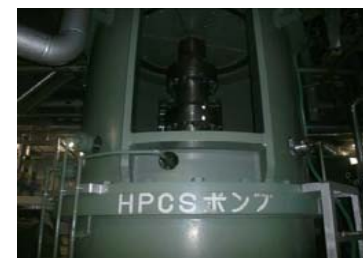
HPCS pump
•No external equipment abnormality

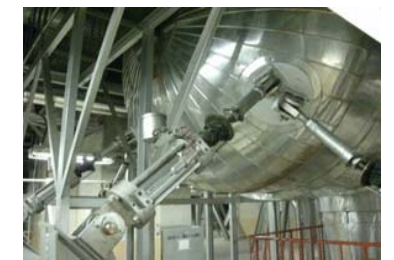
Moisture separator
•No external equipment abnormality

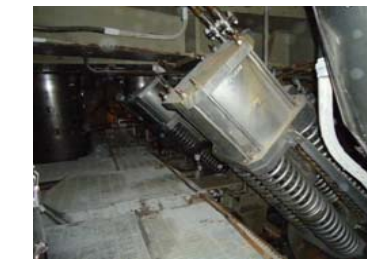
MSIV
•No external equipment abnormality

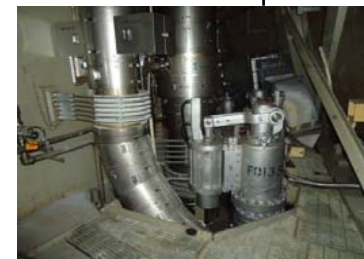
SRV
•No external equipment abnormality

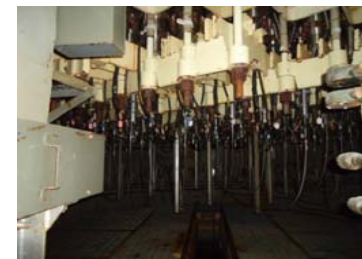
In pedestal
•No external equipment abnormality

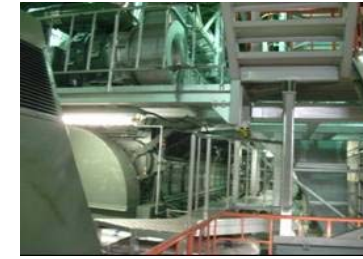
EDG 6A
•No external equipment abnormality
•Standby

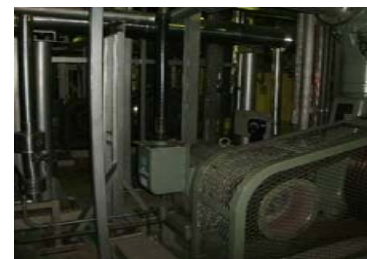
Instrumentation air compressor
•No external equipment abnormality

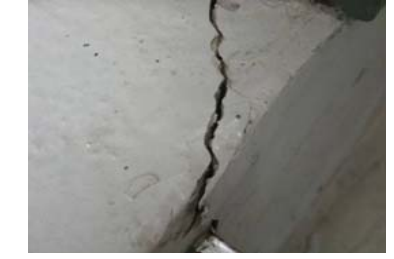
Feedwater heater
•There is slight cracking on the fixed leg foundation for feedwater heater 5B but there is no other external equipment damage.

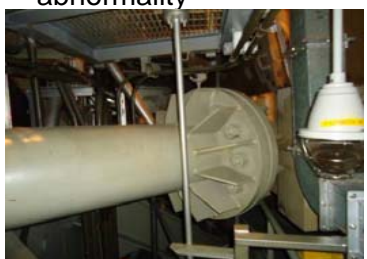
Stabilizer (in PCV)
•No external equipment abnormality

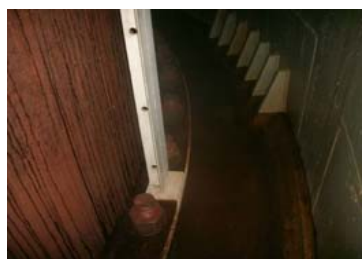
RPV support skirt
•No external equipment abnormality though some rust on foundation bolts.

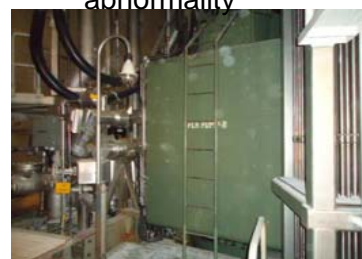
Reactor recirculation pump
•No external equipment abnormality though some rust on mount bolts and nuts.

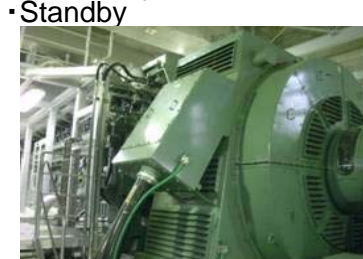
EDG (HPCS)
•No external equipment abnormality

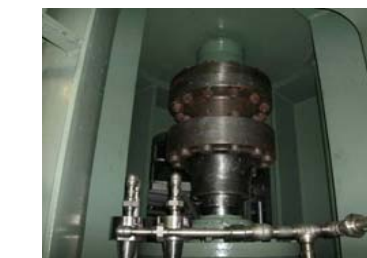
Low pressure condensate pump
•No external equipment abnormality

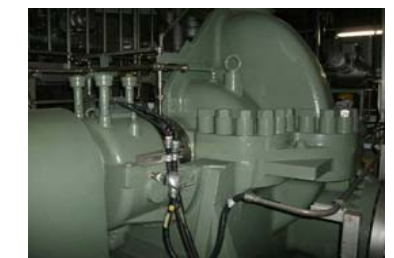
High pressure condensate pump
•No external equipment abnormality

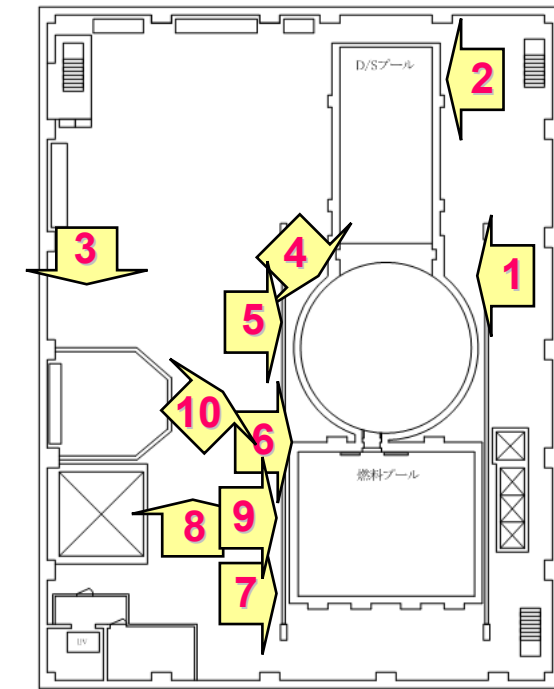
Around the SFP on the R/B 5F, inundation prevention fences and temporary partition fences on the outside were not damaged or fallen, Work boots were lined up on the floor in an organized manner.

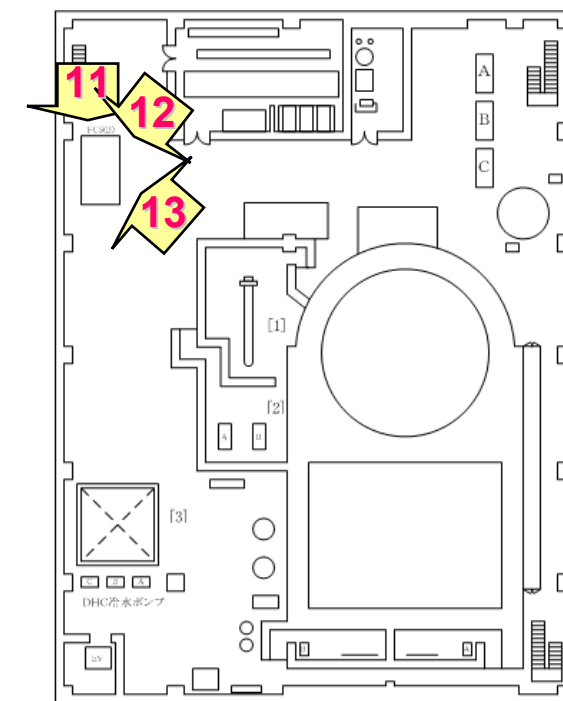
Flammability control system
 -No external equipment damage found

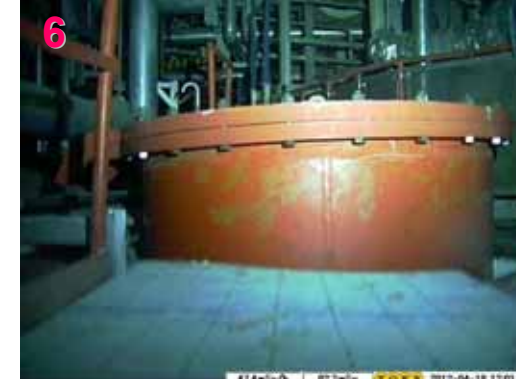
6 North S/C manway

•Removal of insulation cover

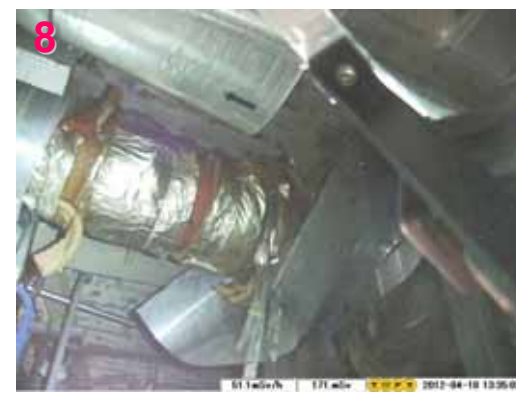
8 Southeast S/C manway upper area

•Removal of insulation cover

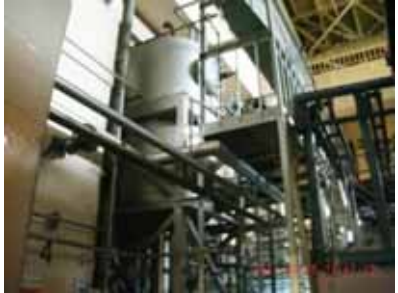
<p>T/B closed cooling water system surge tank •No major damage to equipment externally</p> <p>HVAC duct •HVAC duct is bulging •Upper duct is damaged in some places</p>

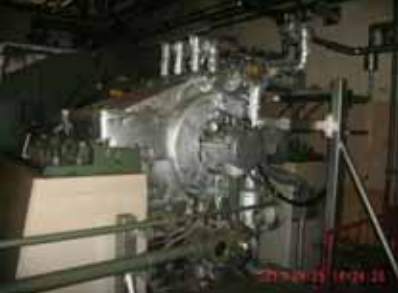
<p>Jib crane support •No major damage to equipment externally</p> <p>Turbine driven reactor feedwater pump •No major damage to equipment externally</p>	    <p>Exciter room •No major damage to equipment externally</p> <p>T/B closed cooling system surge tank •No major damage to equipment externally</p>
1F

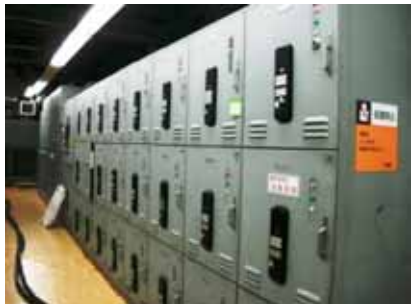
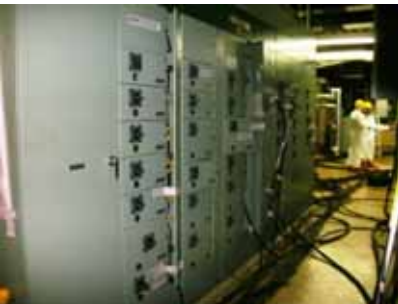
<p>6.9kV M/C1A •Tsunami watermark found •No major damage to equipment externally</p> <p>480V T/B MCC 1B •Tsunami watermark found •No major damage to equipment externally</p>

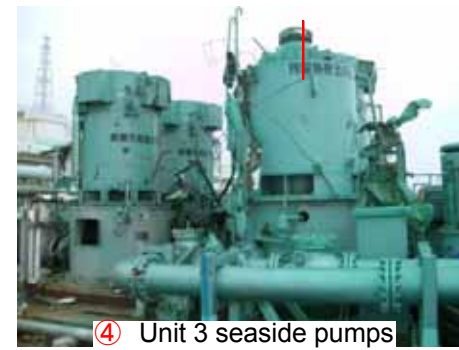
④ Unit 3 seaside pumps

• No motor cover on Unit 3 RHR seawater pump (D)

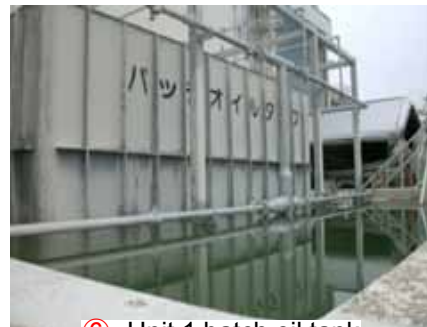
⑥ Unit 1 batch oil tank
• No major external abnormalities including oil barrier

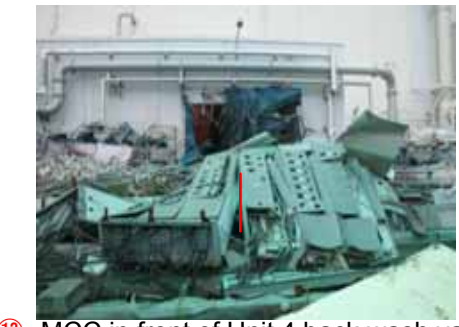
⑬ MCC in front of Unit 4 back wash valve
• MCC collapsed

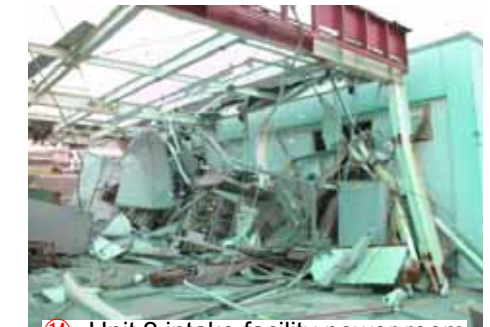
⑭ Unit 2 intake facility power room
• Unit 2 power room collapsed

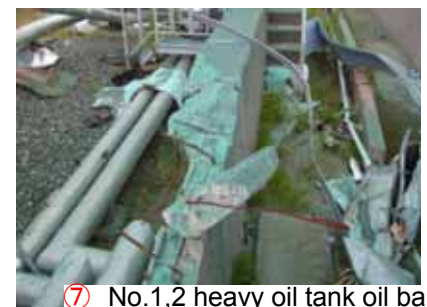
⑦ No.1,2 heavy oil tank oil barrier
• Found cracks in oil barrier

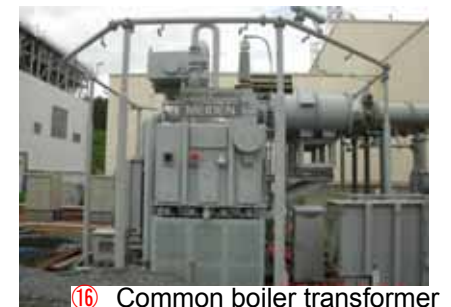
⑯ Common boiler transformer
• No major external damages

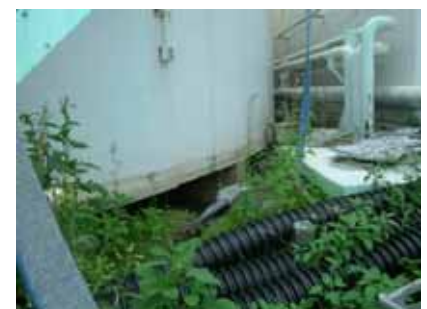
⑧ Unit 2 Condensate storage tank lower area
• Ground under tank collapsed. No leakage

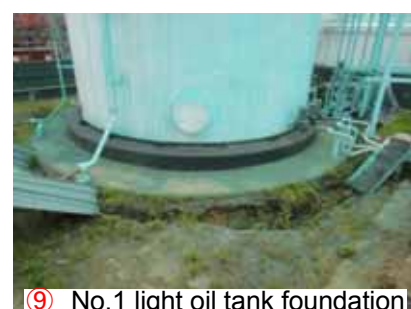
⑨ No.1 light oil tank foundation

• Some subsidence of light oil tank foundation soil was found but no leakage.
• D/G3A, 3B fuel day tank is in the building but no external abnormalities were found.

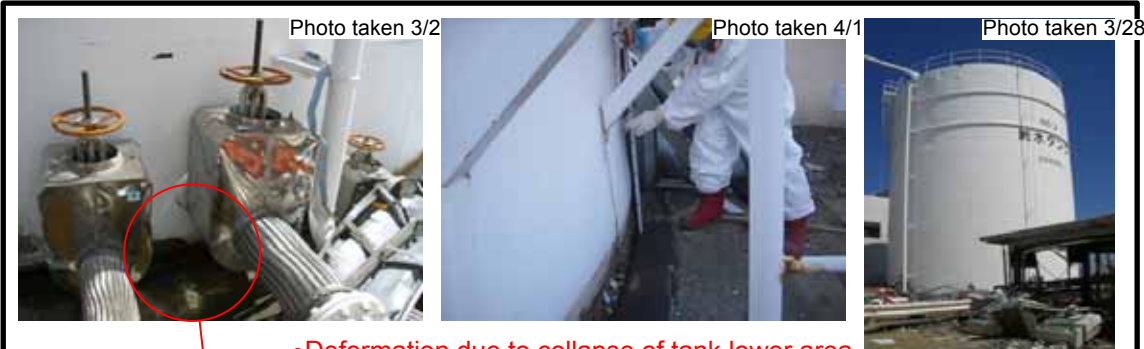
• Deformation due to collapse of tank lower area

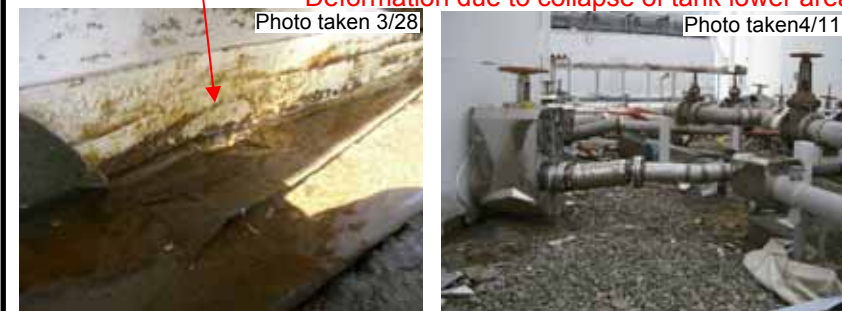
• Leakage from bottom of tank

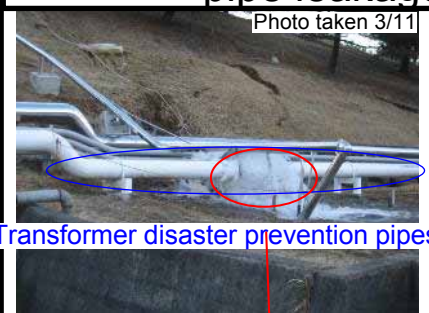
④ Transformer disaster prevention pipe leakage conditions

• Support for another pipe at a joint for the transformer disaster prevention pipe (filtered water tank source) became slanted due to collapse of the slope. Said joint made contact and caused leakage.

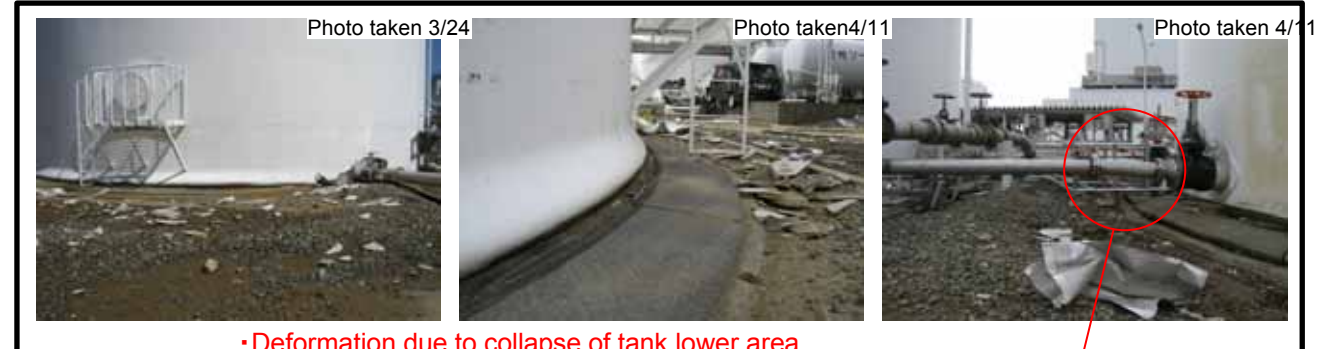
• Deformation due to collapse of tank lower area

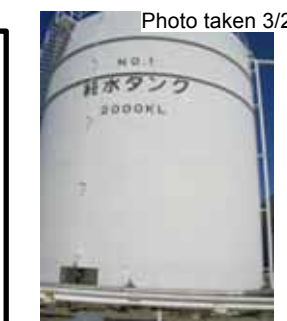
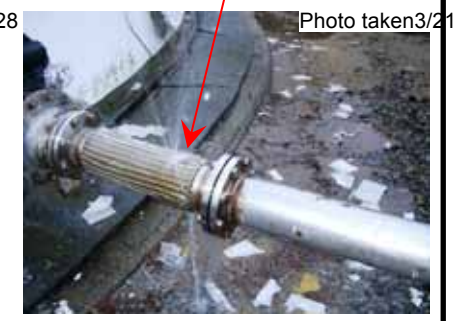
• Leakage after earthquake, tank outlet root valve open.

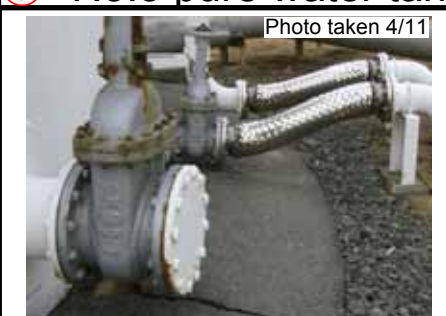
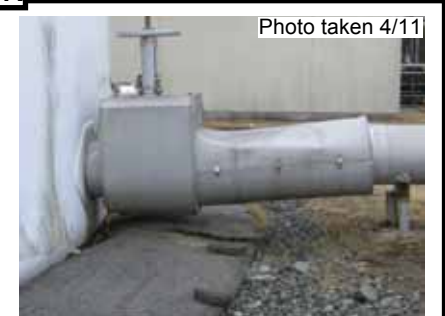
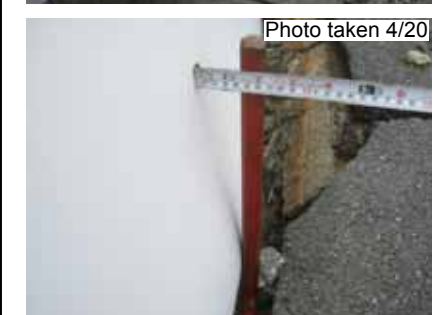
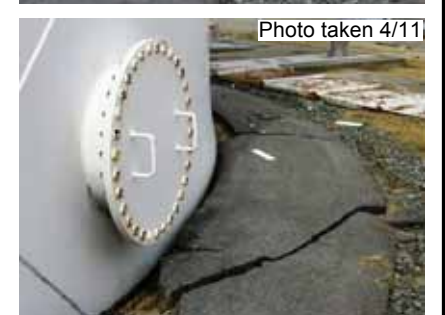
③ No.3 pure water tank

• Deformation due to collapse of tank lower area

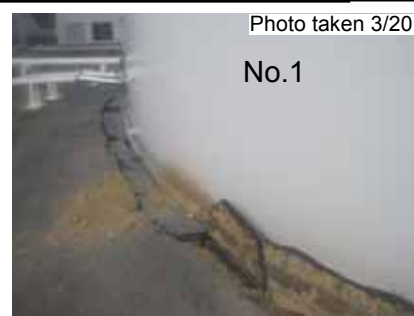
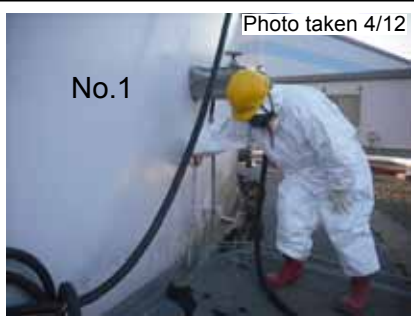
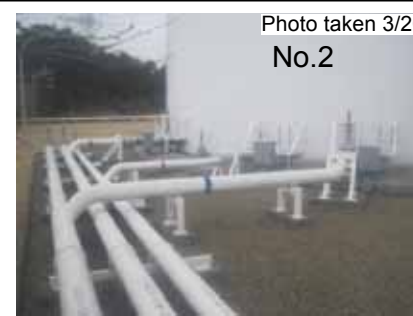
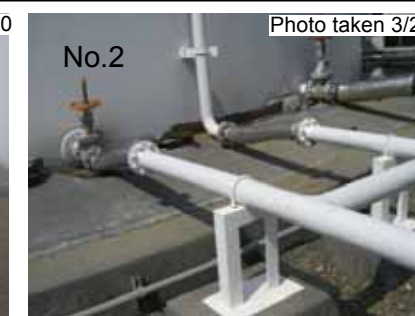
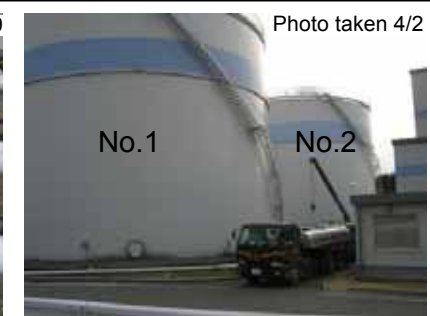
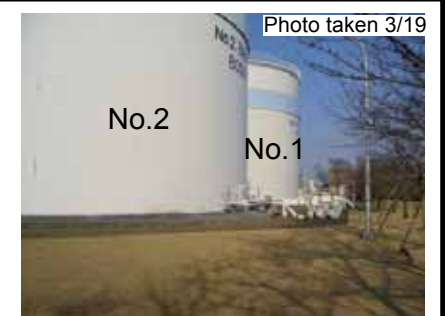
⑤ Filter water tank

• Deformation due to collapse of tank lower area

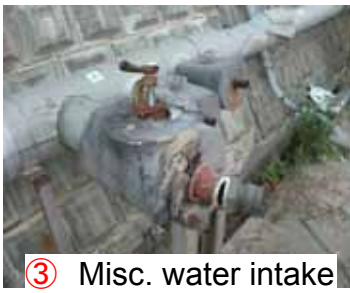
③ Misc. water intake
• Intake damage (presumed to be tsunami impact)

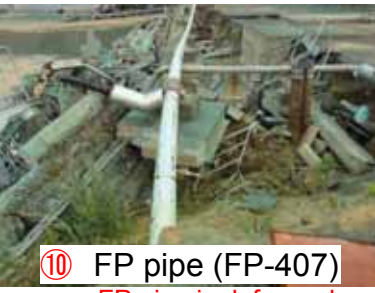
⑩ FP pipe (FP-407)
• FP pipe is deformed

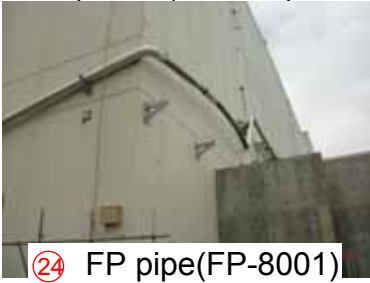
㉔ FP pipe (FP-8001)

• FP pipes removed from support and dislodged (presumed to be tsunami impact)

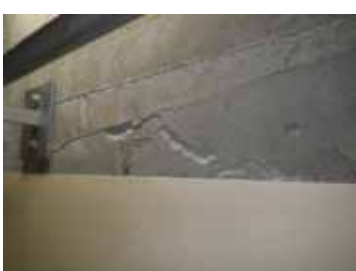
Heater room west (BF)

<ul style="list-style-type: none"> •No damages to major structures (pillars, beams, walls) including adverse structural cracks 		<ul style="list-style-type: none"> •Damages to expansion cover 	<ul style="list-style-type: none"> •No damages to major structures (pillars, beams, walls) including adverse structural cracks 		
T/B	Building interior

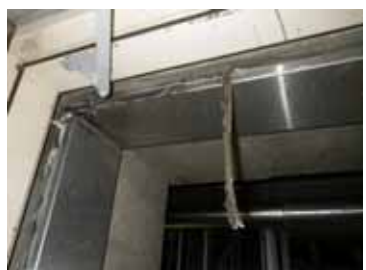
Operating floor west side (2F)

Unit 5/6 wall between turbines (2F)
		<ul style="list-style-type: none"> •Damage to shielding block mortar 	<ul style="list-style-type: none"> •Dislodged concrete fragments from partition wall 		<ul style="list-style-type: none"> •Damage to mortar around partition wall shielding block 	<ul style="list-style-type: none"> •Deformation of metal portion of expansion joint 	<ul style="list-style-type: none"> •Deformation of metal portion of expansion joint

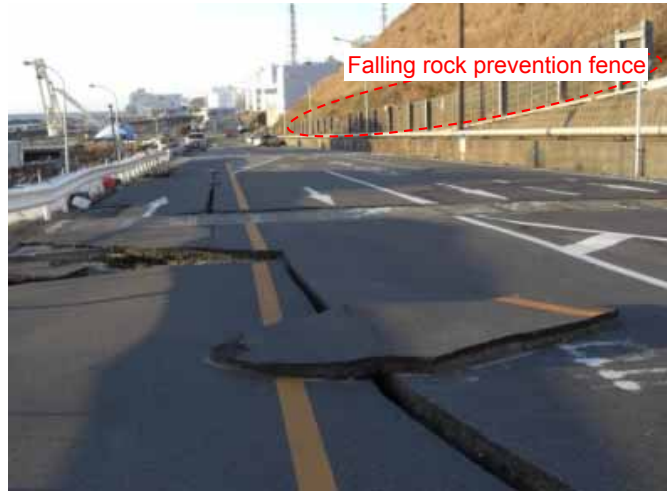
One side of the road on the seaside was cracked and subsided in parallel with road. West side was accessible. Photo taken 3/17

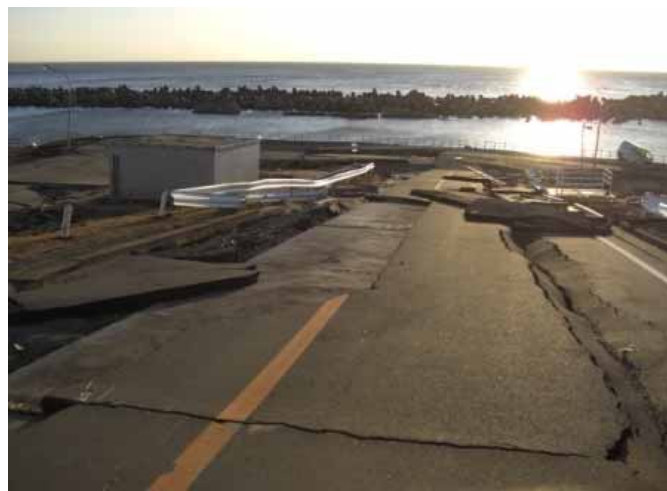
Reinforcement work was conducted on this road, but cracks and subsidence was found on both sides of the road which were not reinforced. Photo taken 3/17

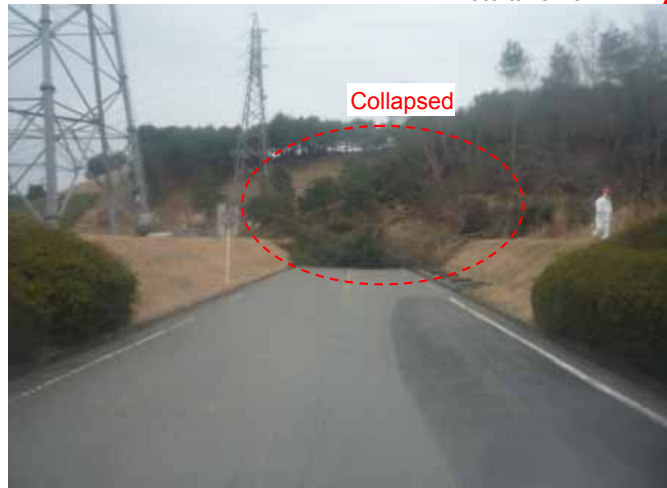
Though not a priority emergency route, the slope failed and the road was blocked and impassable. Photo taken 3/20

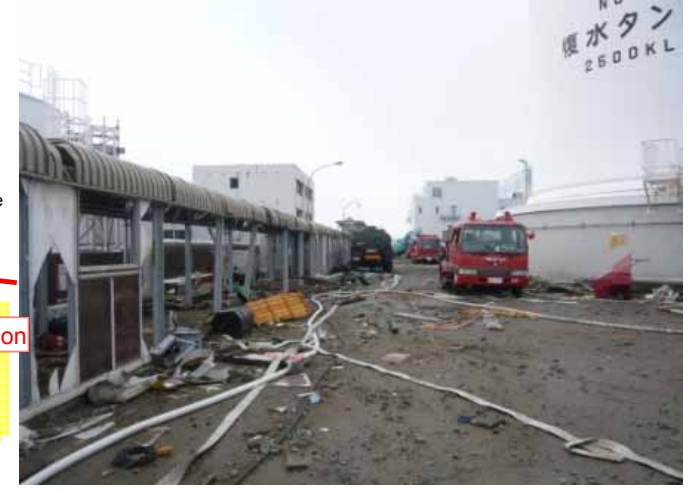
No particular abnormality with the road but scattered rubble. Photo taken 3/16

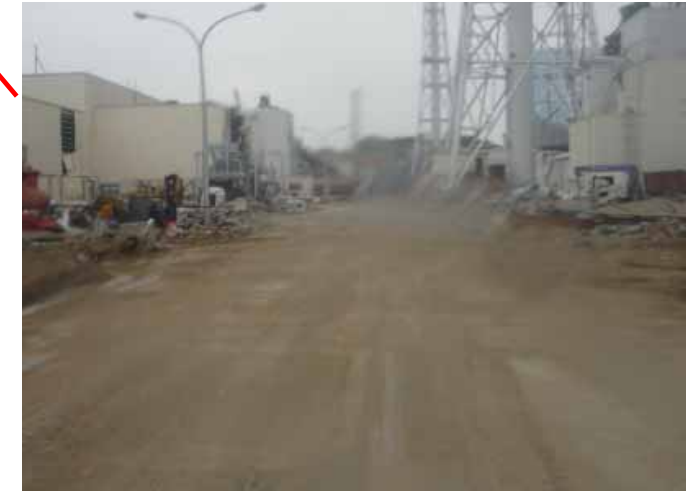
No particular abnormality with Units 1 to 4 west side road. Rubble was scattered when Units 1, 3, 4 R/B were damaged. Photo taken 3/20

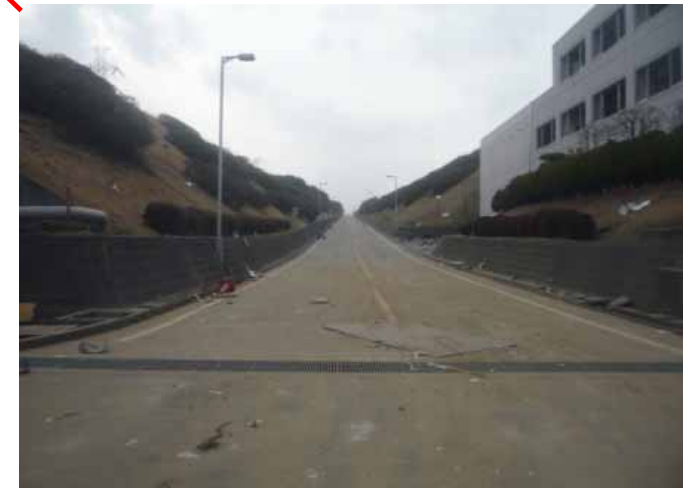
Some rubble scattered but no particular damage to roads. Photo taken 3/20

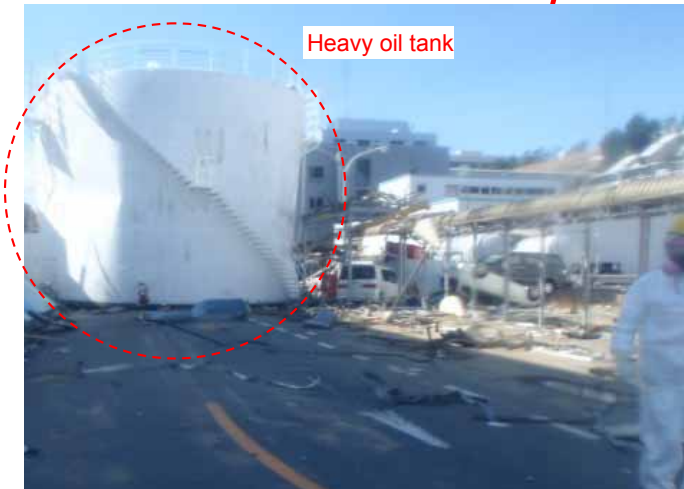
No major damage to the road, but the heavy oil tank carried by the tsunami blocked the road making it impassable. Photo taken 3/17

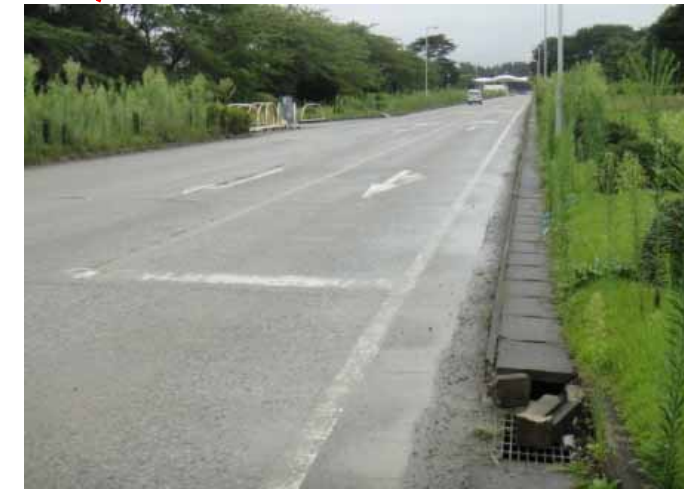
No particular abnormality found with straight road from main gate. Photo taken 8/26
