Fukushima Nuclear Accidents Investigation Report

Attachment

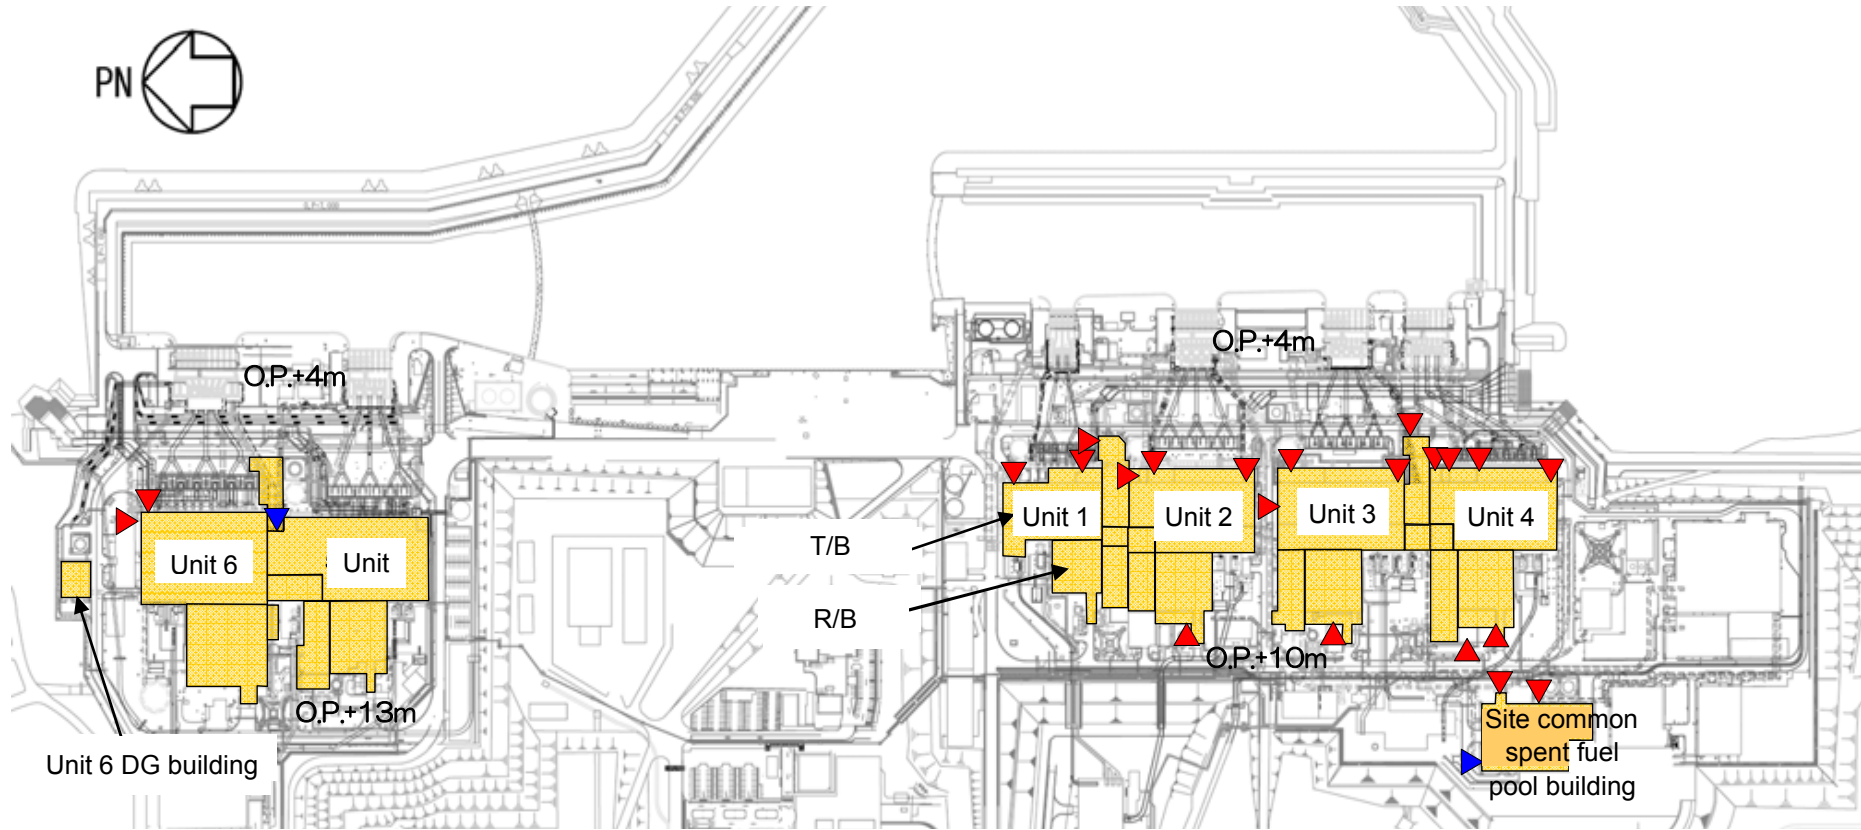
Location of Openings That May Be Water Flow Pathways Into Major Buildings

- ▲ : Above-ground openings assumed to be water flow pathways into major buildings
- ▼ : Openings connecting to underground trenches/ducts assumed to be water flow pathways into major buildings

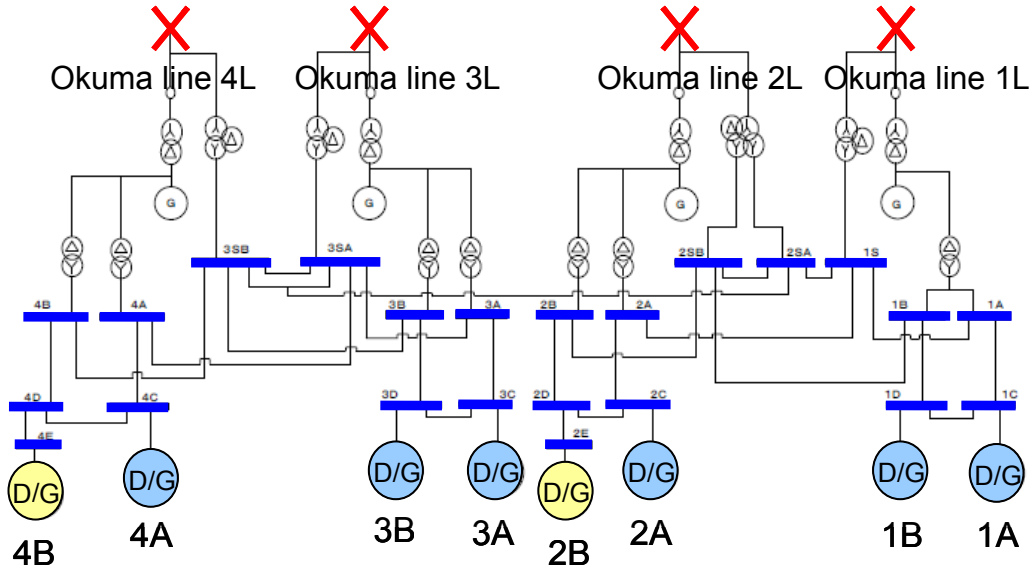
Fukushima Daiichi Nuclear Power Station
 State of Damage of Power Systems by Tsunami
Units 1 to 4

■ : Power panel suffered water damage or submerged by tsunami

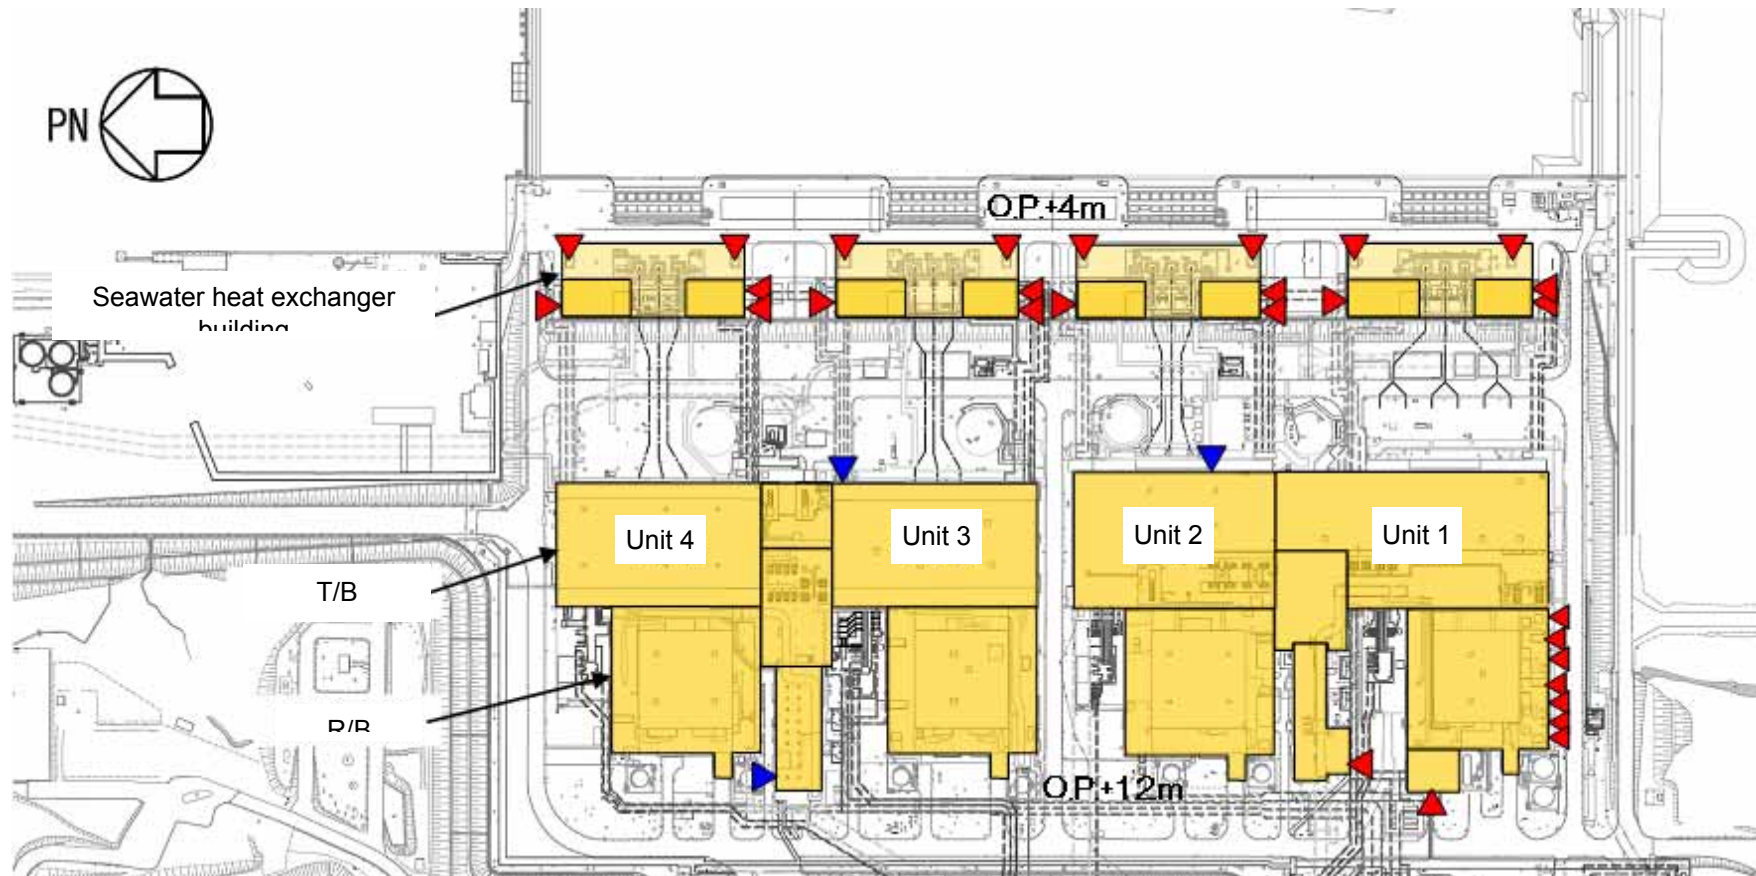
Location of Openings That May Be Water Flow Pathways Into Major Buildings

- ▲ : Above-ground openings assumed to be water flow pathways into major buildings
- ▼ : Openings connecting to underground trenches/ducts assumed to be water flow pathways into major buildings

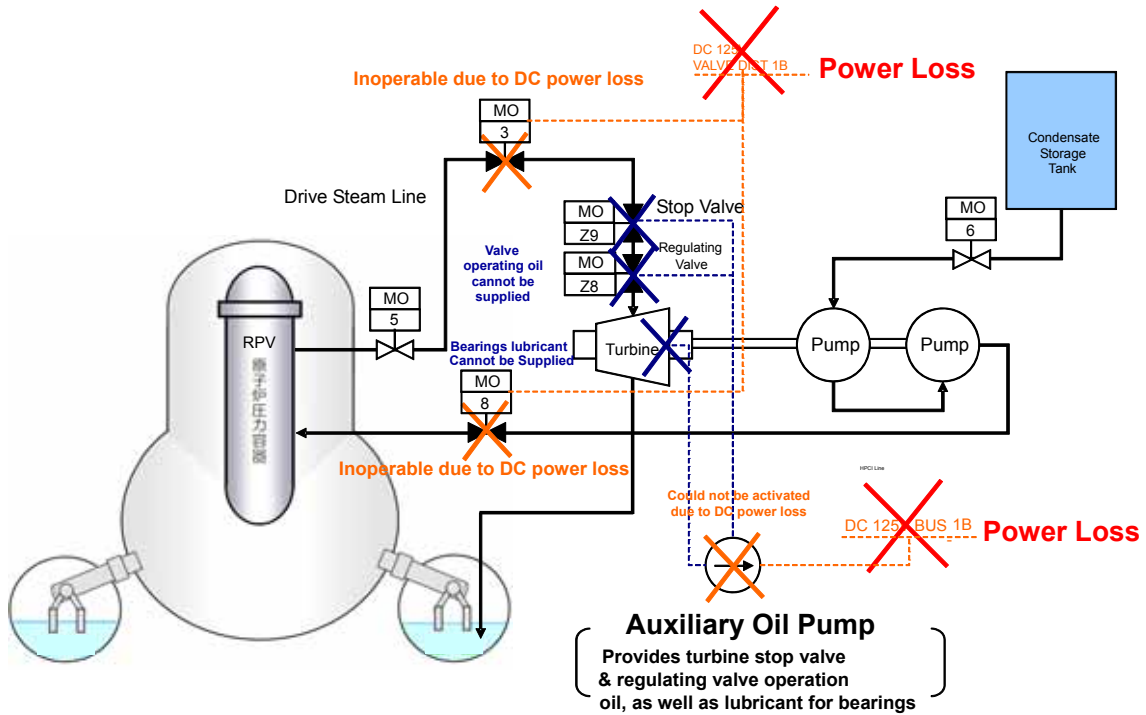
Fukushima Daiichi Unit 1 HPCI

When the HPCI is activated, the auxiliary oil pump normally activates first. This supplies operating oil to the turbine stop valve and regulating valve, allowing HPCI turbine activation. However, the auxiliary oil pump could not be activated due to DC power loss, resulting in HPCI inoperability.

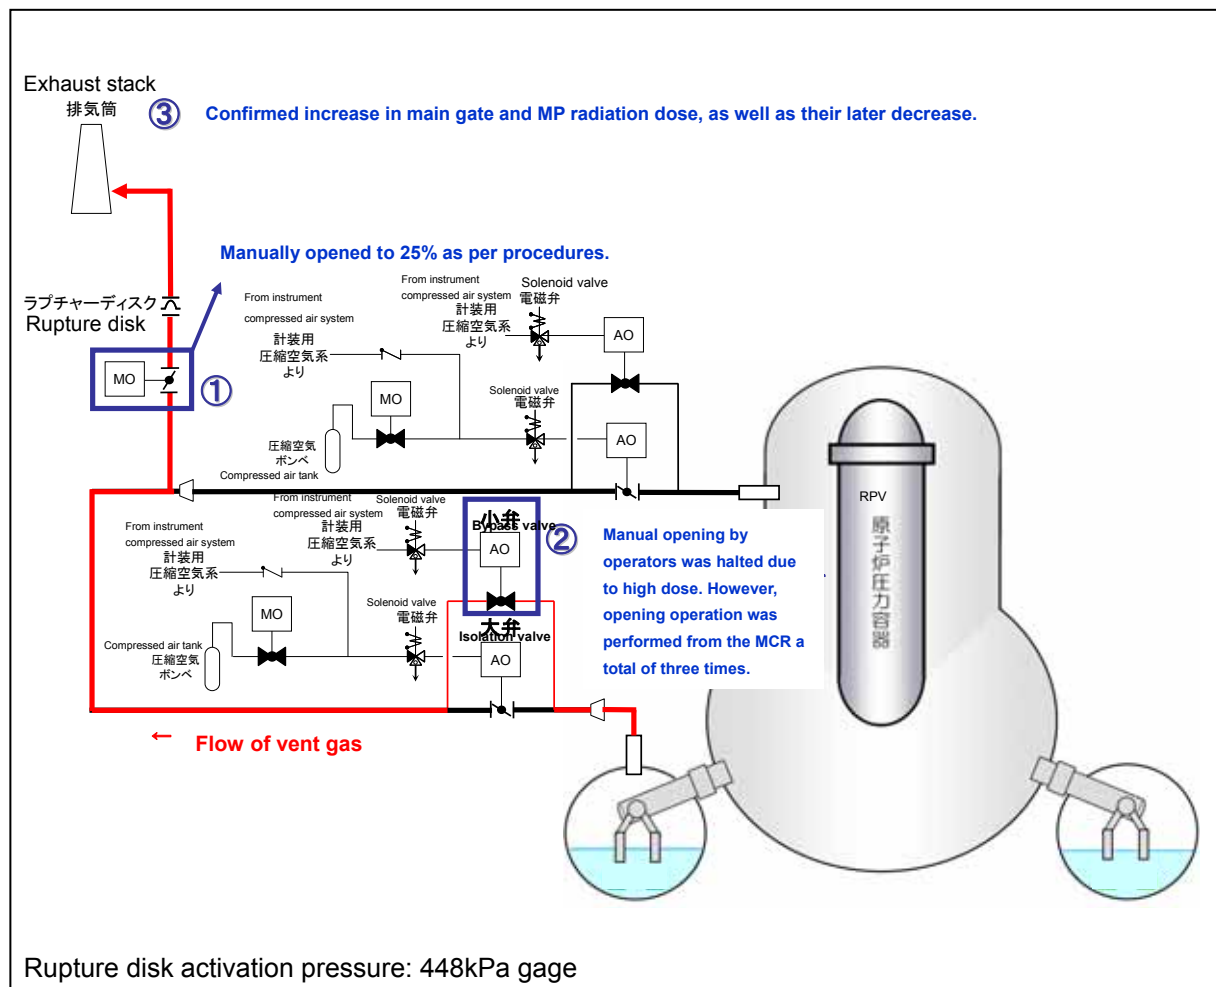
Bypass valve use at 10:40 on March 12

Since radiation levels near the station main gate and nearby monitoring posts were rising, the station ERC considered it highly likely that radioactive materials had been released due to venting. However, since radiation levels dropped at 11:15, it was confirmed that venting was not sufficiently effective.

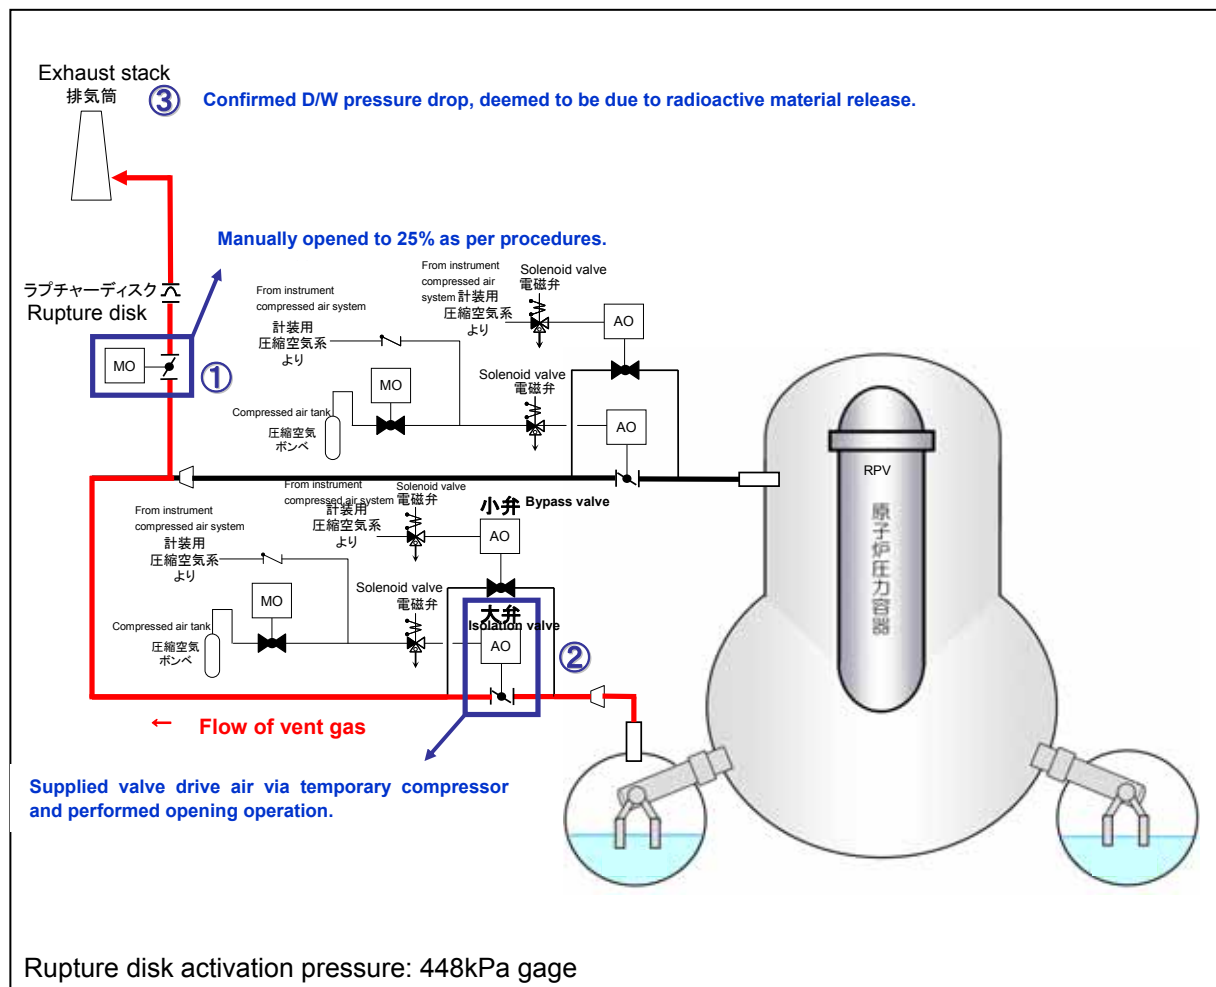
Isolation valve use at 14:30 on March 12

Confirmed drop in D/W pressure, deemed to be caused by "release of radioactive materials" via venting.

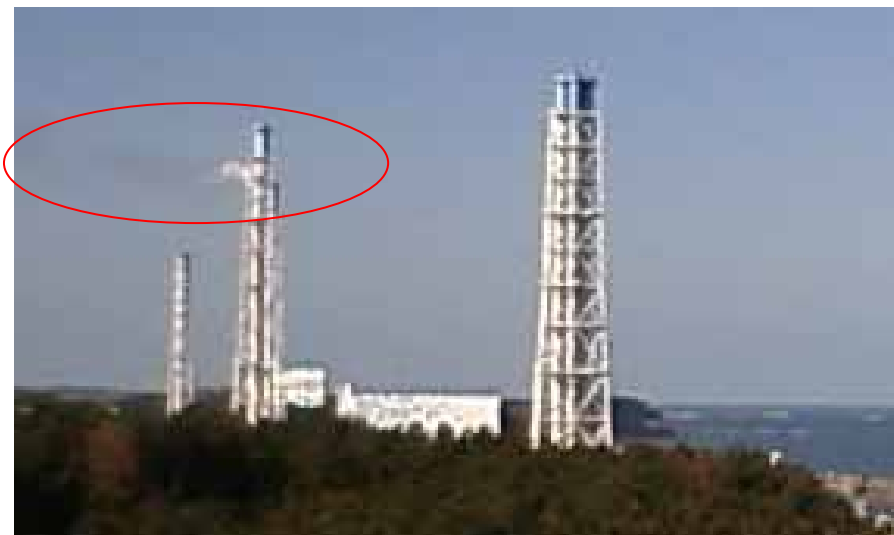
■ Taken at 15:00 on March 12

Steam-like mass seen toward mountain side of Units 1/2 exhaust stack
(Not seen in photos taken after 16:00)

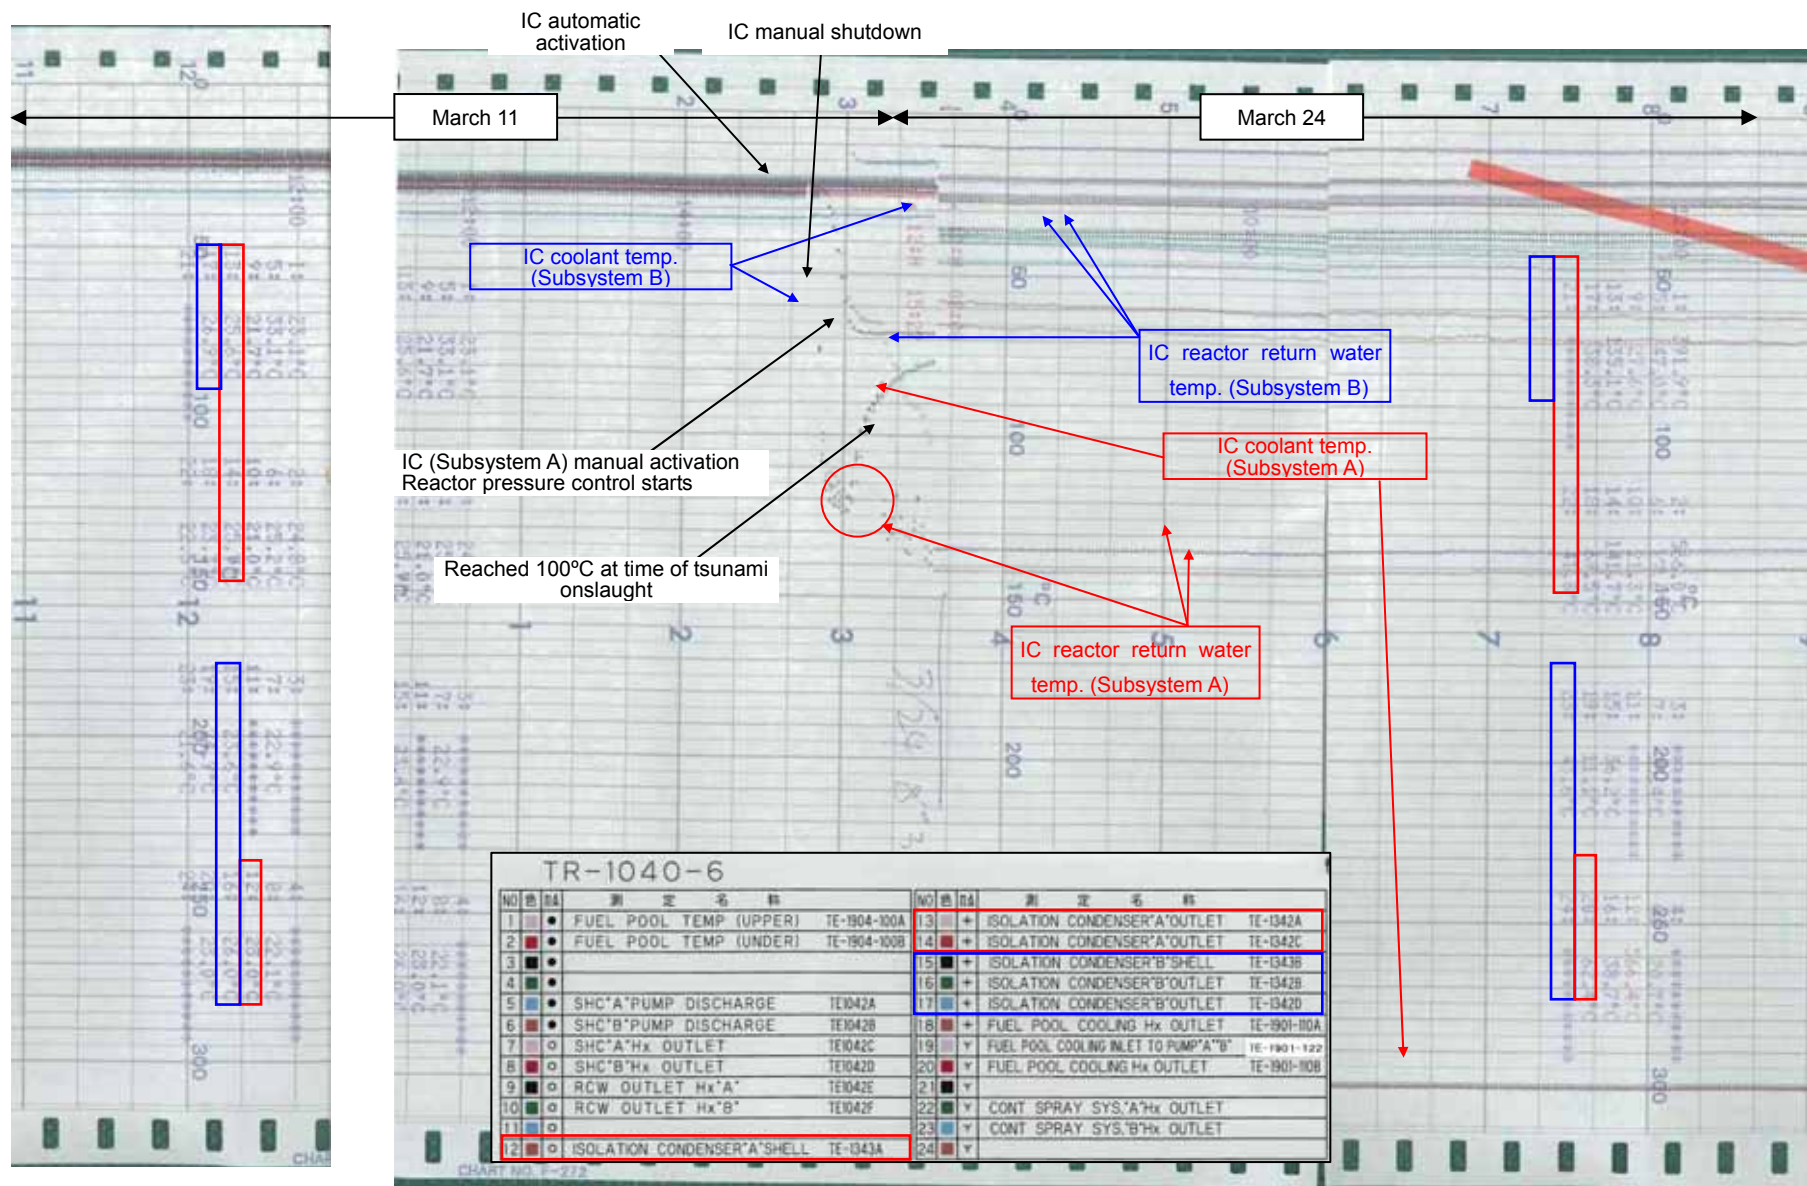
Fig. 2 Temperature near IC

*3: Still recorded as 574.5 degrees as of October 27. Since atmospherically released IC coolant temperature could not have greatly exceeded 100°C, this is thought to be caused by measurement equipment failure.

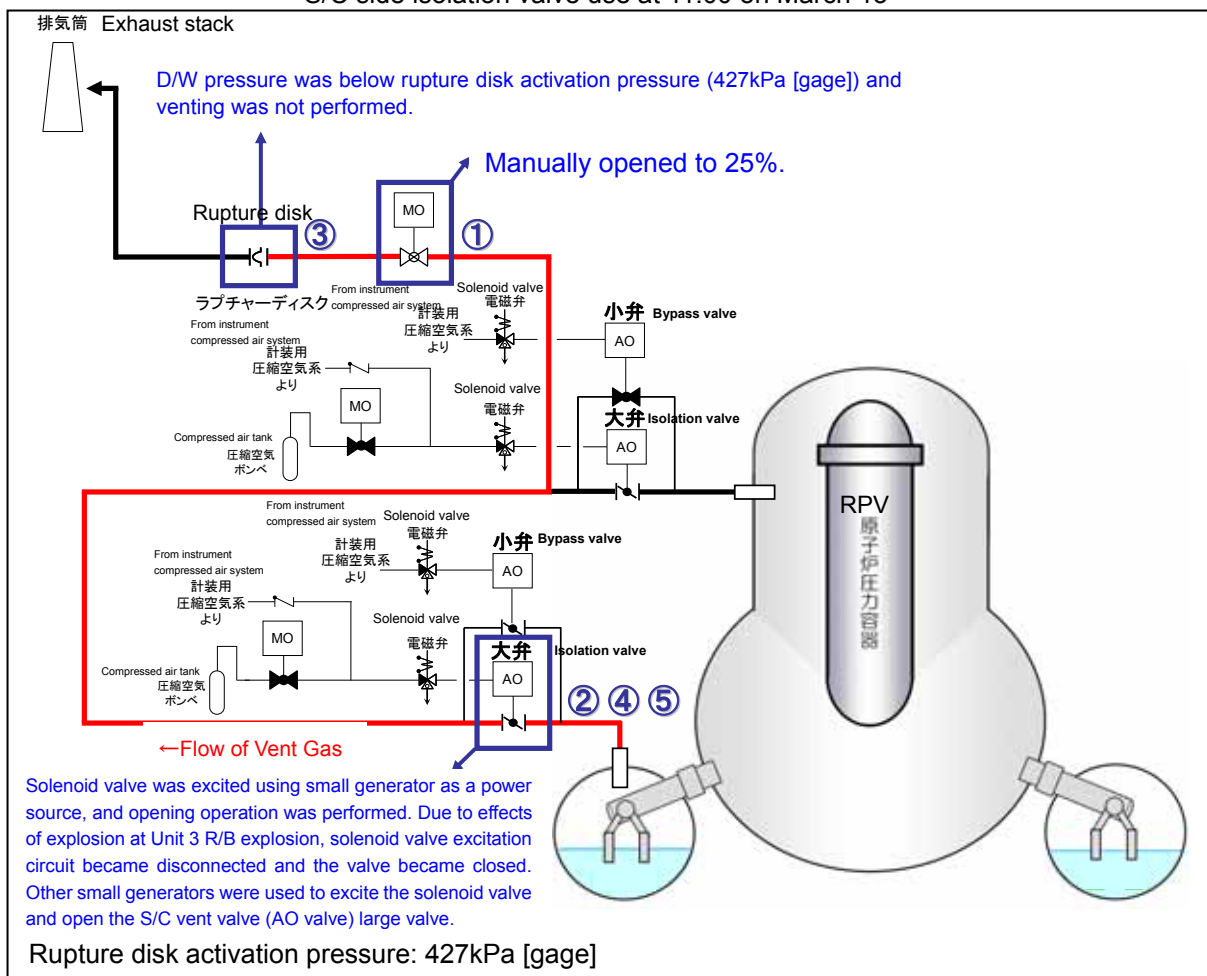
S/C side isolation valve use at 11:00 on March 13

The small generator shut down due to excessive voltage, so other small generators were used to excite the solenoid valve and open the S/C vent valve (AO valve) isolation valve.

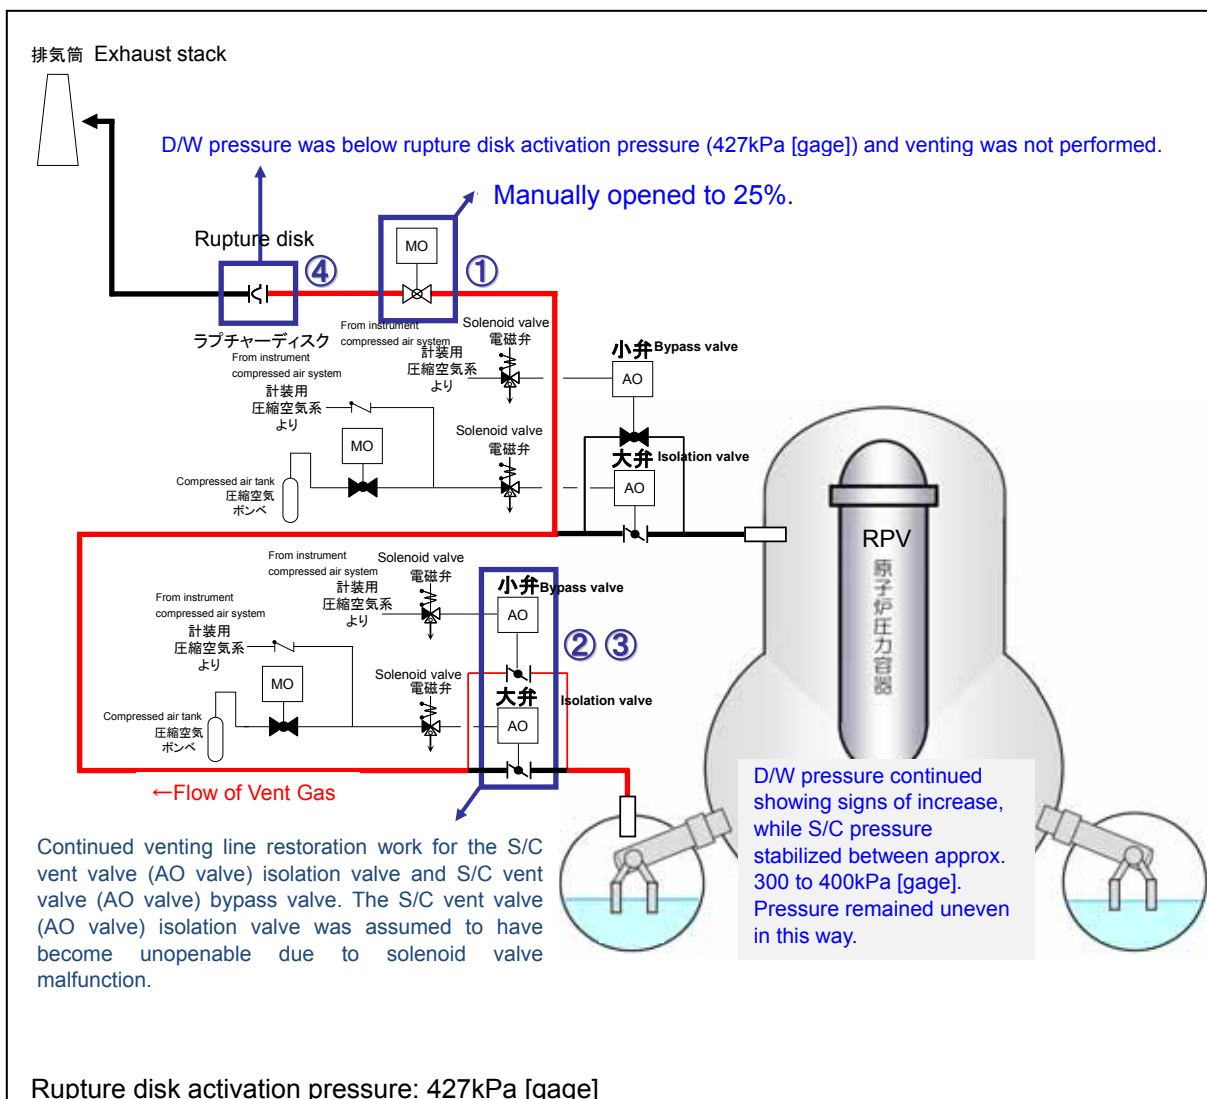
S/C side bypass valve use around 21:00 on March 14

D/W pressure was below rupture disk activation pressure (427kPa [gage]) and venting was not performed. Vent valve was kept open and D/W pressure monitoring continued.

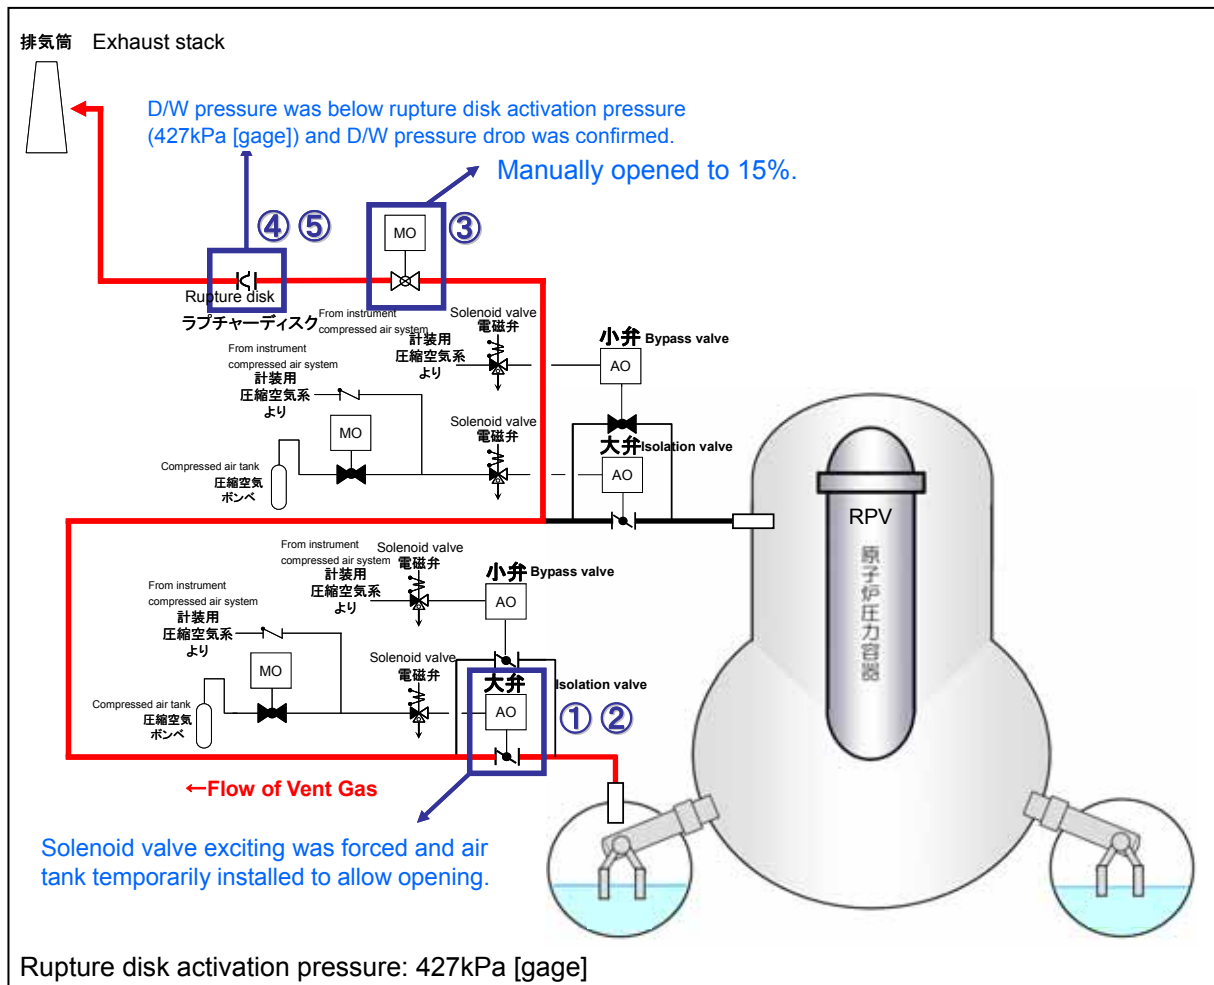
PCV venting line assembly at 08:41 on March 13

After D/W pressure rose to 637kPa [abs] (09:10), it was confirmed to have dropped to 540kPa [abs] (09:24). It was reported to the Station ERC around 09:20 that venting had been performed.

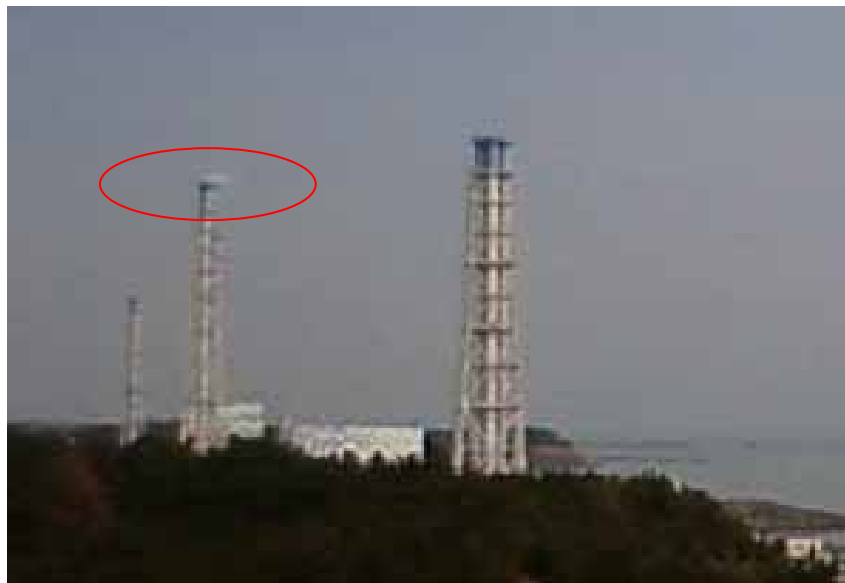
■ Taken at 10:00 on March 13

Faint steam-like mass seen toward sea side of Units 3/4 exhaust stack
(Not seen in photos taken at 11:00 or 12:00)

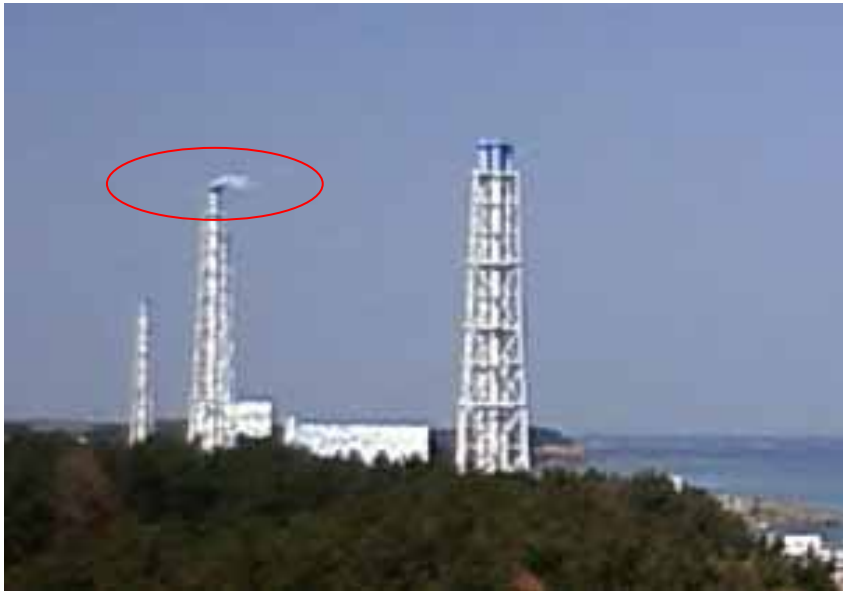
■ Taken at 13:00 on March 13

Faint steam-like mass seen toward sea side of Units 3/4 exhaust stack

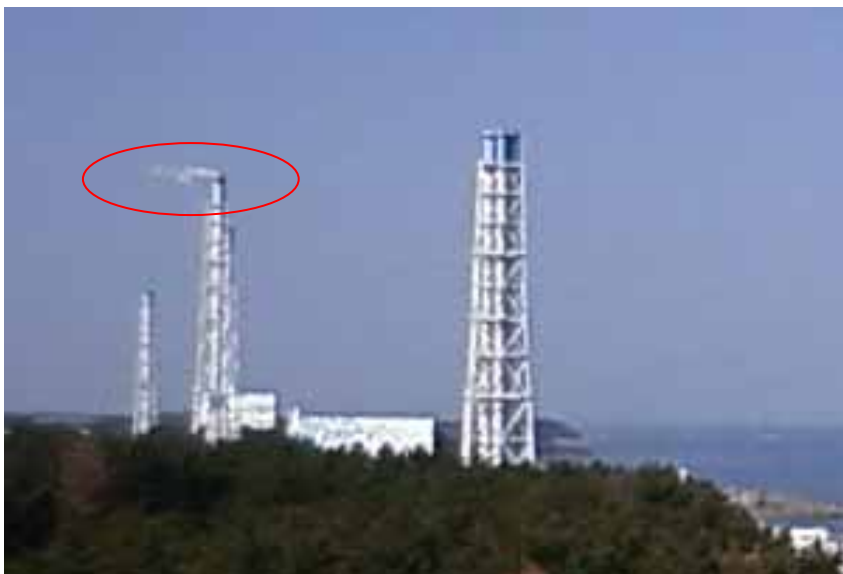
■ Taken at 14:00 on March 13

Faint steam-like mass seen toward mountain side of Units 3/4 exhaust stack

(Not seen in photos taken after 15:00)

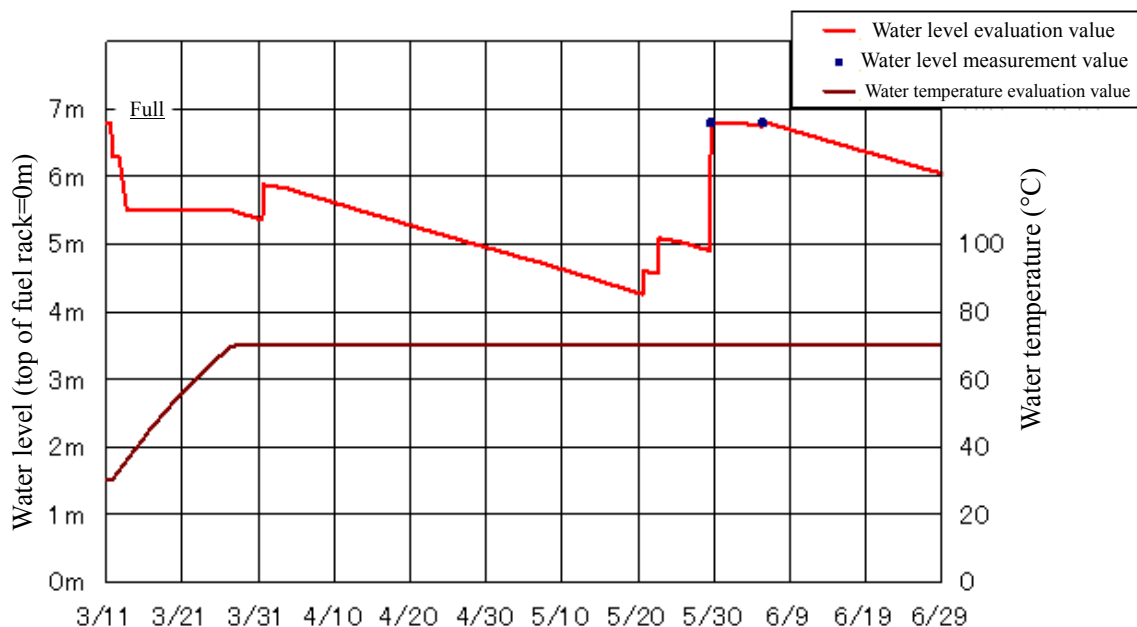
Figure 3 Unit 1 SFP evaluation results

Figure 3 shows the results of the Unit 1 SFP evaluation. Results of the valuation estimate that water levels decreased by March 13 as a result of explosions and sloshing caused by the earthquake. Thereafter water level

was maintained until the water temperature reached the evaporation commencement temperature of 70°C after which water level is estimated to have dropped as a result of evaporation. Water level was replenished as a result of the cooling water injection of March 31 and the cooling water injection via a PC piping at the end of May and the SFP was confirmed to be full of water due to an increase in skimmer surge tank levels on May 29 and June 5 [Figure 4]. 413 tons of cooling water had to be injected to fill the SFP and since it is difficult to imagine that all of this water found its way into the SFP, it is assumed that the amount of water lost from the time of the accident until the SFP was confirmed to be full is lower than this amount. Abnormal water level the SFP holds approximately 1,000t, and since the depth of the SF P is approximately 3 times that of the active length of the fuel, it is assumed that the water level of the Unit 1 SFP was maintained and that the fuel did not become exposed. Furthermore, in comparison with the SFP of other units, since the Unit 1 SFP has a smaller decay heat even though cooling water was not injected for over a month the decrease in water level was minimal and it has been evaluated that as of the end of June the water level was approximately 6 m above the fuel racks.

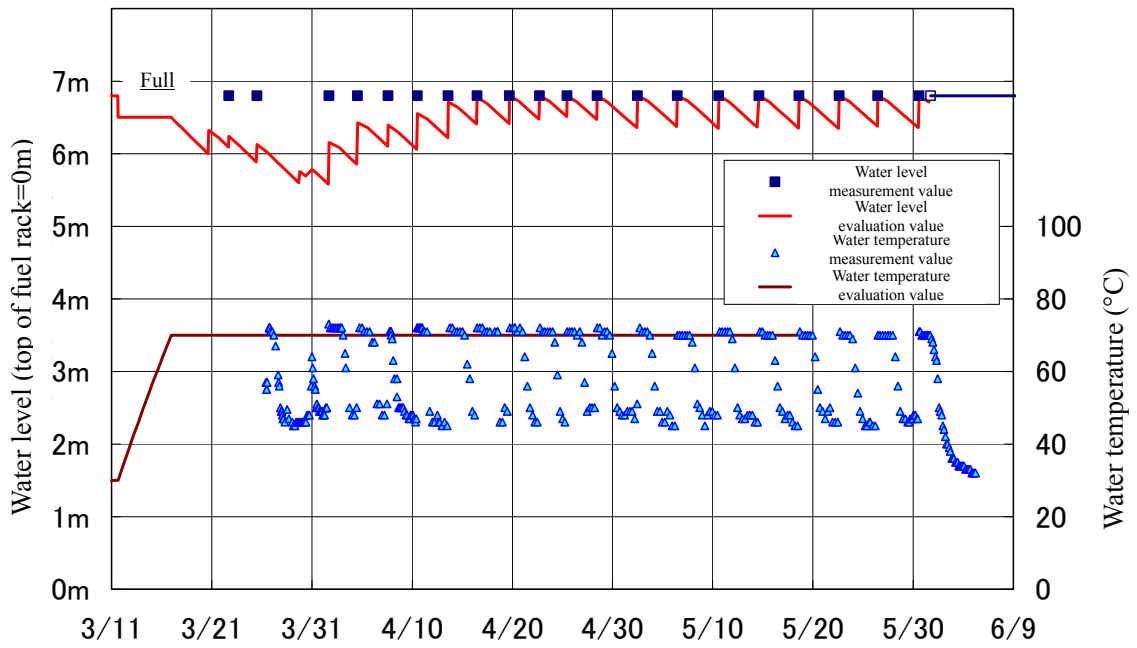
Figure 3 Unit 2 SFP evaluation results

Furthermore, at Unit 2 the existing SFP water thermometer is operational and periodically used to take measurements which are shown in the figure. Immediately after cooling water injection the water temperature rises to near 70°C and then decreases to approximately 50°C 1 to 2 days later, a pattern which is repeated thereafter. This is because the thermometer was exposed as SFP water level increased, so the temperature indicated is not the temperature of the water but rather of the surrounding atmosphere.

After the alternate cooling system was put in service at 17:21 on May 31, cooling of the SFP water continued and water temperature became approximately 30°C (34°C as of 14:00 on July 7).

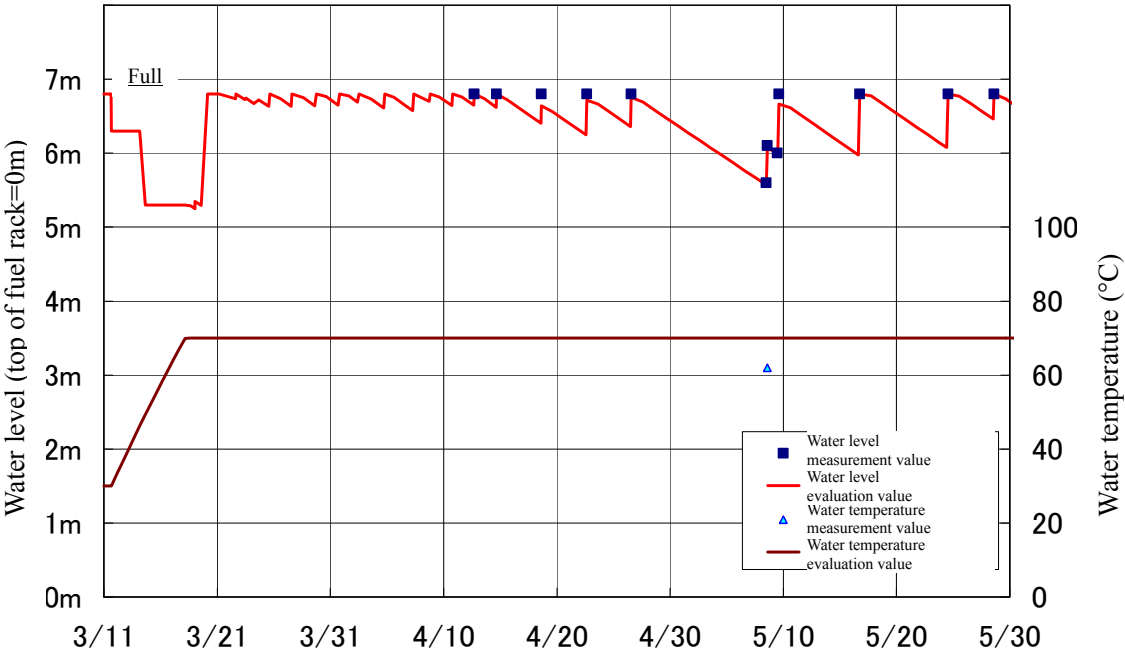
Figure 2 Unit 3 SFP evaluation results

consideration of replenishing water that was lost through leaks, etc.) for approximately 80t (results as of April 10), it is assumed that water level decreased only as a result of decay heat.

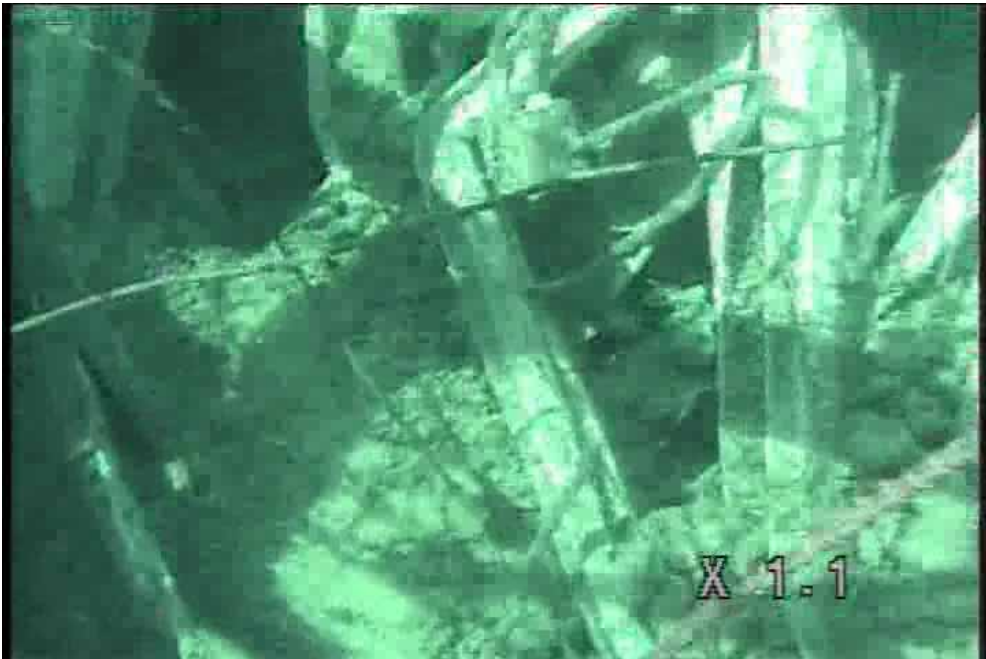
Figure 3 Conditions under the Unit 3 SFP water

On May 8, sampling of the SFP water was recorded on video. An image that was taken is shown in Figure 3. The condition of the fuel stored in the SFP could not be confirmed due to the large amount of debris present in the water.

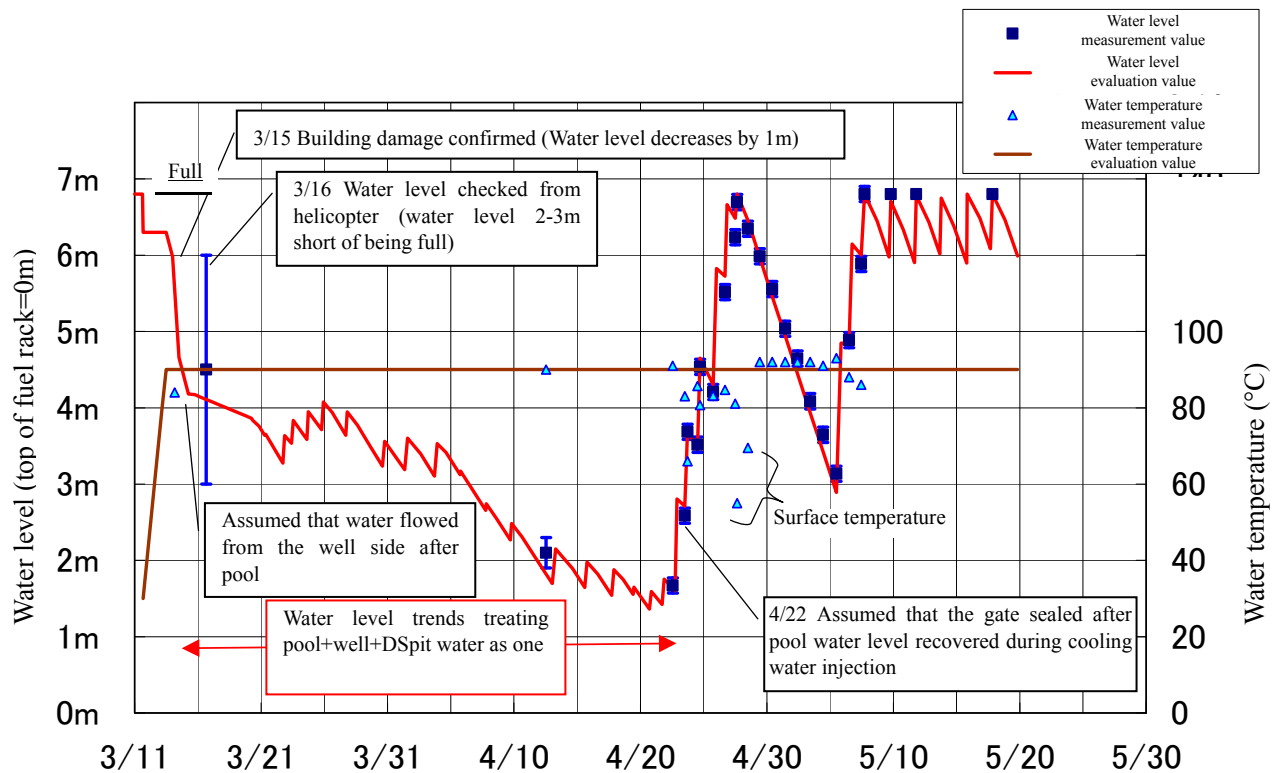
Figure 2 Unit 4 SFP evaluation results

Water temperature was measured by lowering a thermocouple from a concrete pump truck at which time water level was also measured. Many of the measurement results were around 90°C, which is high compared to the measurement result of 70°C for Unit 2, however this is because the decay heat of the fuel in the Unit 4 SFP is high which causes the quasi-stationary temperature to be on the high side. There are a few measurements in Figure 2 that are below 70°C but this is assumed to be because water was sampled from the surface of the SFP.

*Water level evaluation considers that water flowed from the well/DSPit side to the pool side since the reactor well side was completely full of water at the time the earthquake occurred.

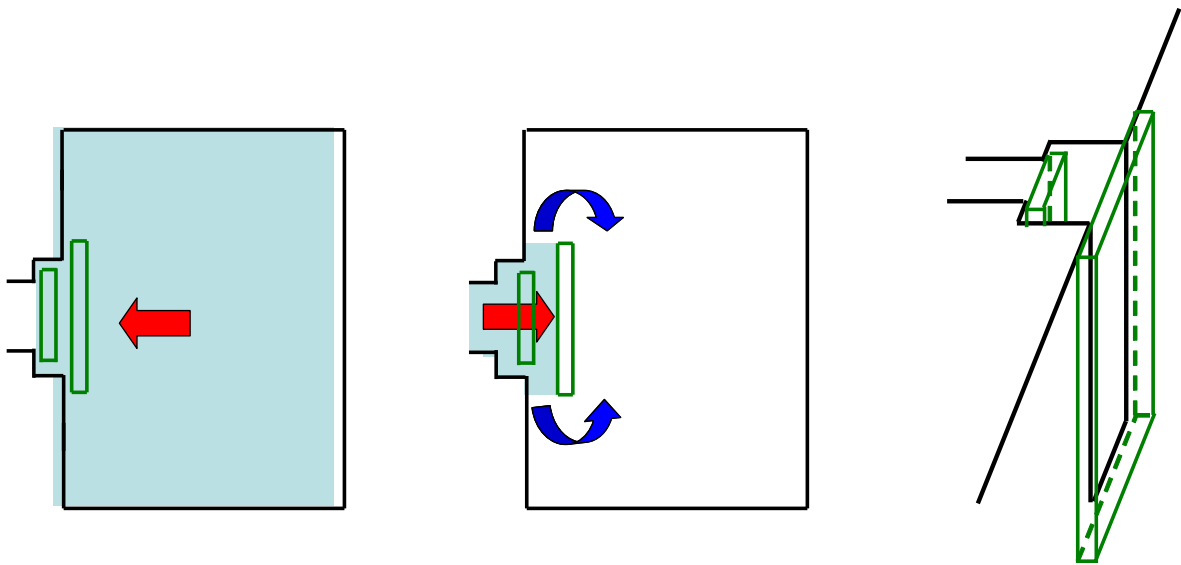
Figure 4 Mechanism of water flowing from the pool gate (1)

watertightness is maintained by the water pressure of the SFP. During operation a great amount of water pressure acts on the pool gate since there is no water in the reactor well. However, Unit 4 was undergoing periodic inspection so water was stored in the reactor well side which means that after FPC cooling function was lost the water on the SFP side began to evaporate thereby causing the water level on the reactor well side to be higher than the water level on the SFP side. As shown in Figure 4 and Figure 5, in this case water pressure was acting on the pool gate from the opposite side than normal which caused the pool gate to fail to remain watertight due to its construction and for water to flow from the reactor well side until water levels on both sides were equal. The water level behavior evaluation shown in (2) indicates a gradual decrease in SFP water level because it assumes the effect of this migrating water. However, SFP water level recovered after the cooling water injection of April 22, and it is estimated that as a result reactor well side water level fell below the water level on the SFP side thereby enabling the pool gate to regain watertightness. The results of an evaluation performed based on this hypothesis closely match measurement results.
