Fukushima Nuclear Accidents Investigation Report

Attachment

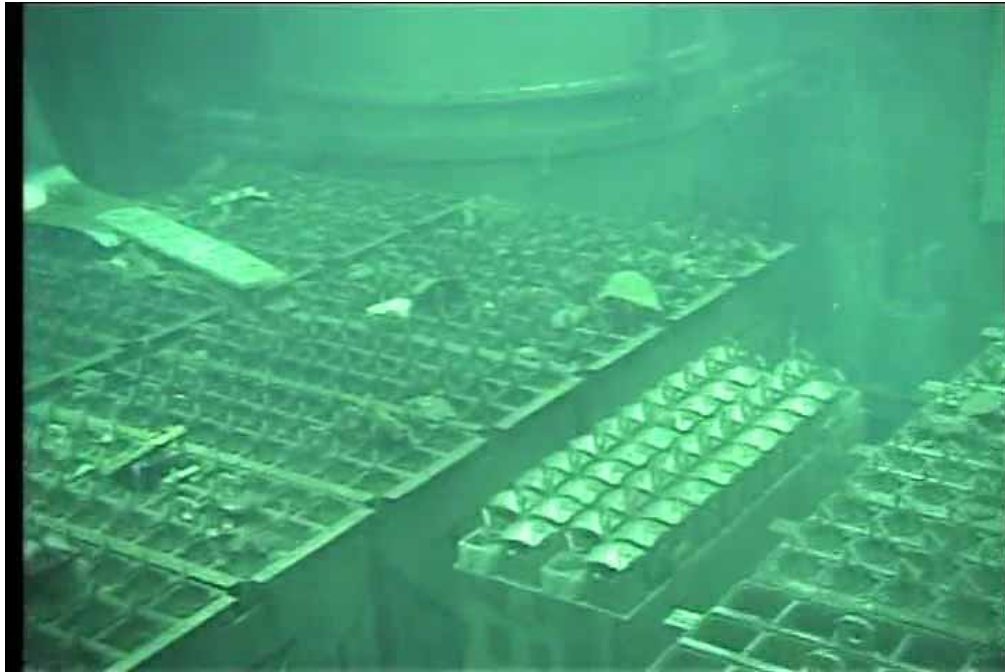
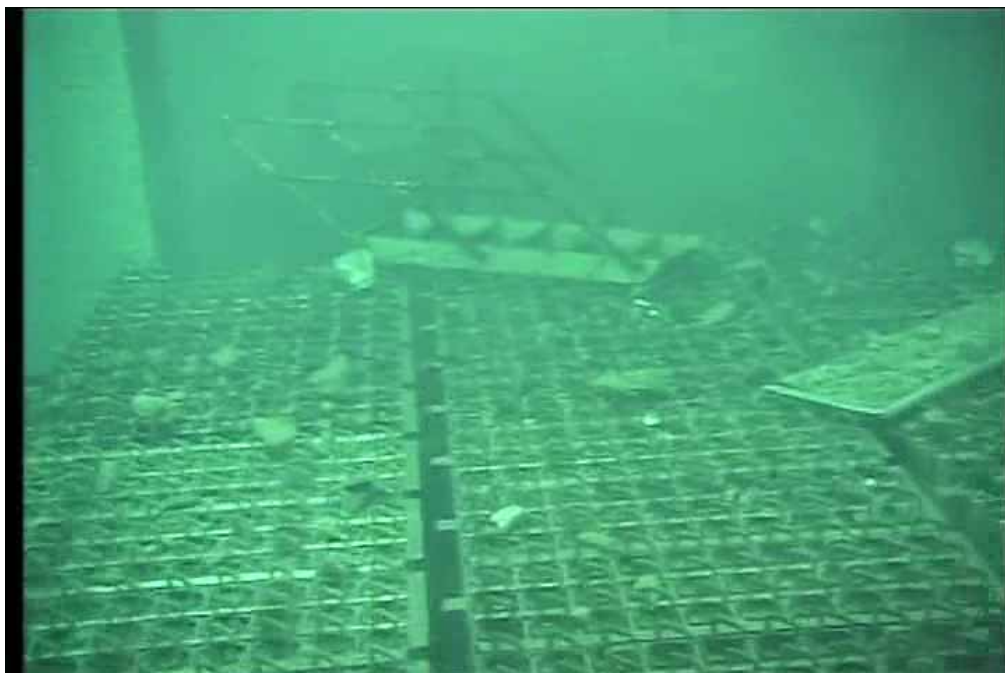
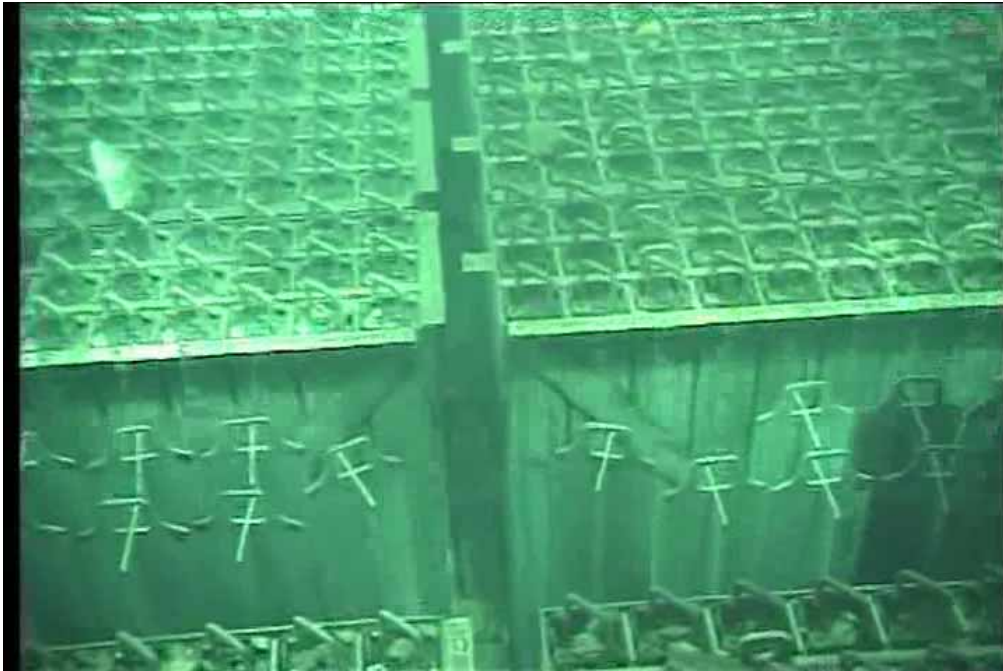
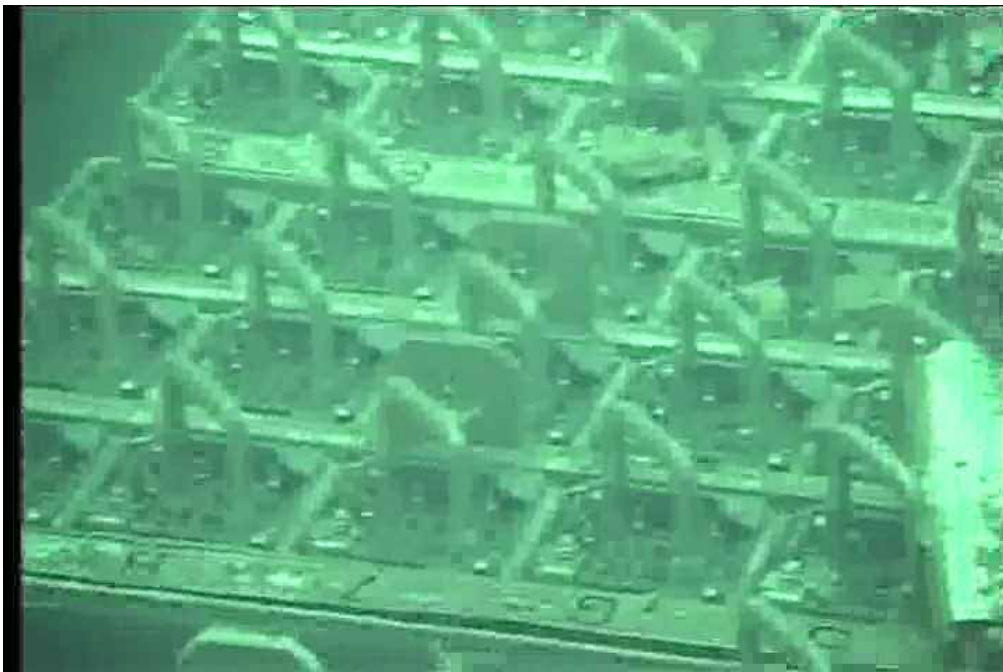
On May 7 sampling of the SFP water was recorded on video. Images that were taken are shown in Figure 6, Figure 7, Figure 8 and Figure 9. Large and small sized debris have fallen into the SFP, but the fuel stored in the SFP is still in the racks and it was confirmed that there is not a lot of fuel damage.

Figure 6 Conditions within Unit 4 SFP (1)

Figure 7 Conditions within Unit 4 SFP (2)

Figure 8 Conditions within Unit 4 SFP (3)

Figure 9 Conditions within Unit 4 SFP (4)

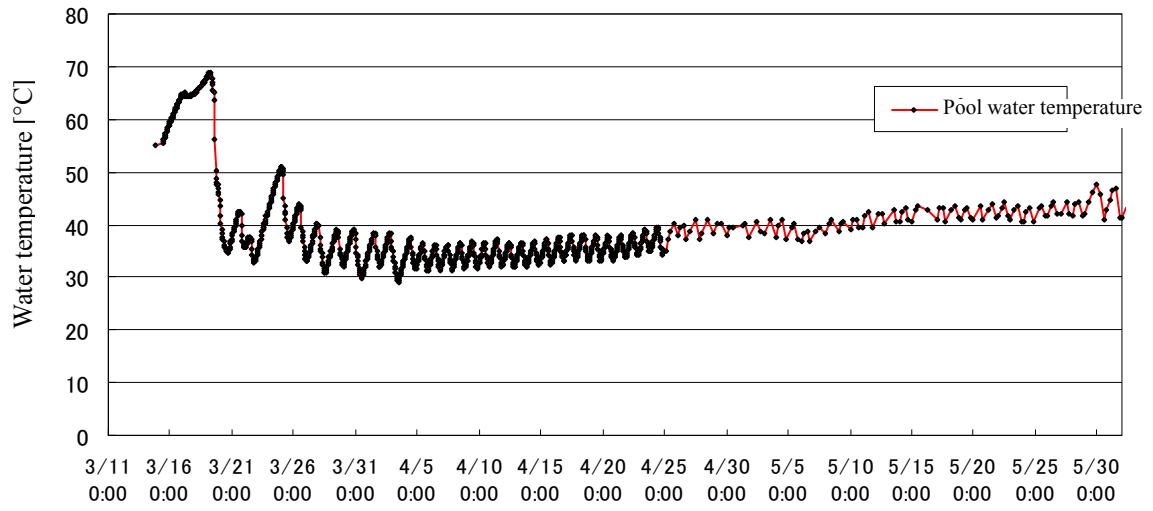
Figure 1 Unit 5 SFP water temperature trend

When the tsunami caused by the Tohoku-Chihou-Taiheiyo-Okai Earthquake that occurred at 14:46 on March 11 struck, all AC power sources were lost and SW pump function was lost, thereby causing a loss of SFP cooling and filling function.

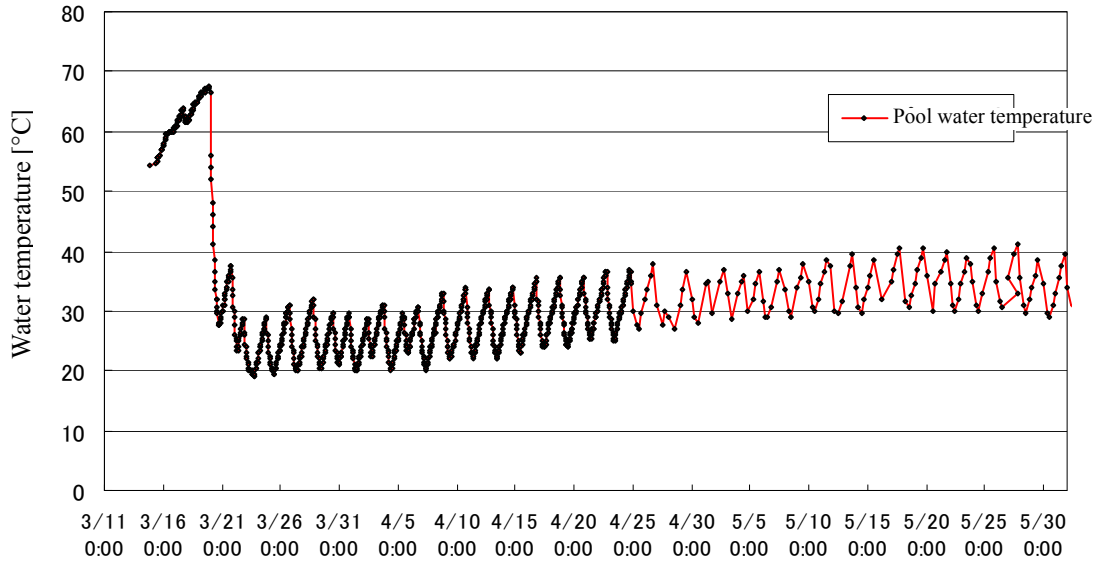
Figure 1 Unit 6 SFP water temperature trend

When the tsunami caused by the Tohoku-Chihou-Taiheiyo-Okai Earthquake that occurred at 14:46 on March 11 struck, all AC power sources were lost and SW pump function was lost (however, D/G 6B function was maintained), thereby causing a loss of SFP cooling function.

Thereafter increases in air temperature, etc. caused SFP water temperature to stabilize at between 30 to 50°C.

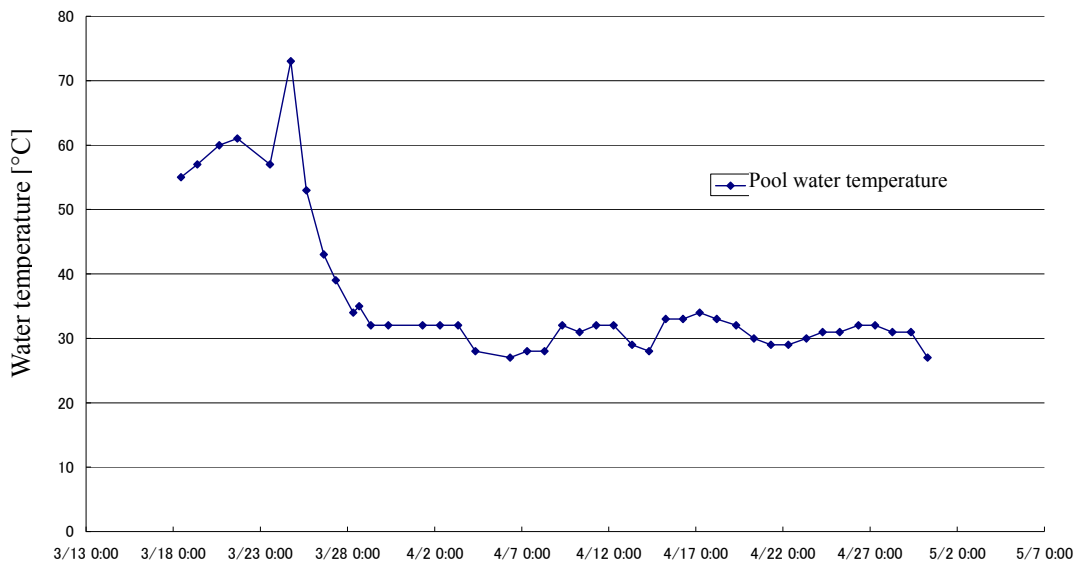
Figure 1 Common pool water temperature trend

When the tsunami caused by the Tohoku-Chihou-Taiheiyo-Okai Earthquake that occurred at 14:46 on March 11 struck, all AC power sources were lost thereby causing a loss of common pool cooling and filling function.

- The absolute value of the radioactivity detected from the common pool water sampled on May 13 is low and common pool water level has been maintained since the accident, so it is estimated that the possibility of damage to fuel assemblies in the common pool is low.

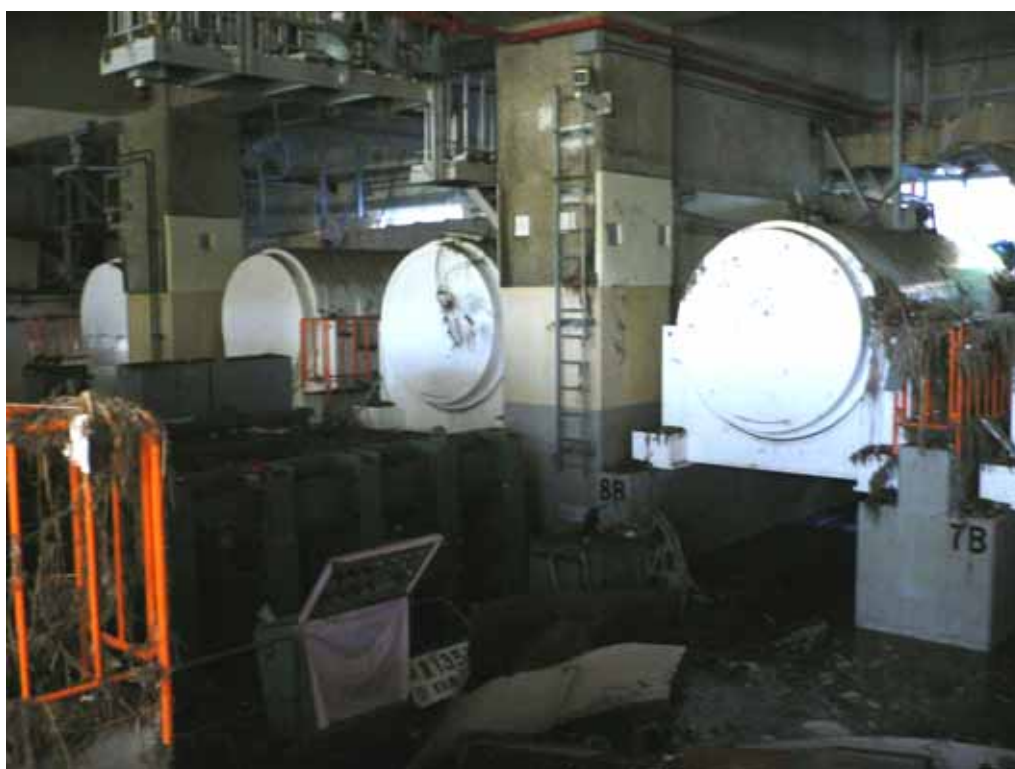
Figure 3 Conditions inside the dry storage cask storage building

The dry storage cask storage building was inspected multiple times after March 17. The building had been flooded with water up to the dry storage cask storage area floor, and the louvers and doors were damaged. However, the flow of air needed to cool the casks through natural convection was not hindered and it was confirmed that there were no problems with cooling.

Even though scattered debris pushed into the building by the tsunami has adhered to the dry storage casks, the casks themselves are bolted to the foundation and did not move from their original position, and visual inspections have revealed no problem with soundness.

Furthermore, compared with background radiation levels, the radiation levels within the dry storage casks storage building (~several tens of $\mu\text{Sv/h}$) are not abnormal. Dry storage casks have excellent airtight performance because they are constructed to maintain airtightness with a primary and secondary lid. It is assumed that this airtight performance is being maintained. However, since direct confirmation through leak tests has yet to be obtained the dry storage casks will be carried out from the dry storage cask storage building and airtight performance will be verified directly. Figure 3 is a picture of the conditions inside the dry storage cask storage building.

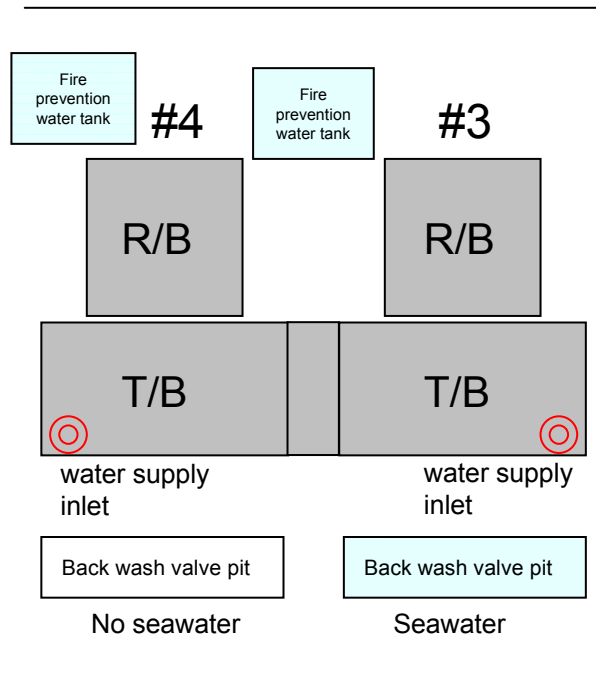
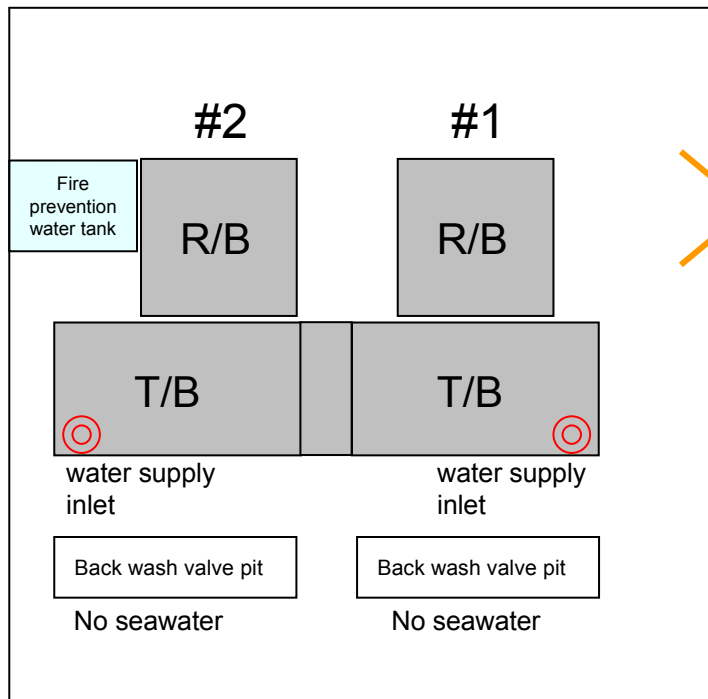
Access impossible due to road damage and debris from the tsunami

Tank washed inland by tsunami blocked road preventing access

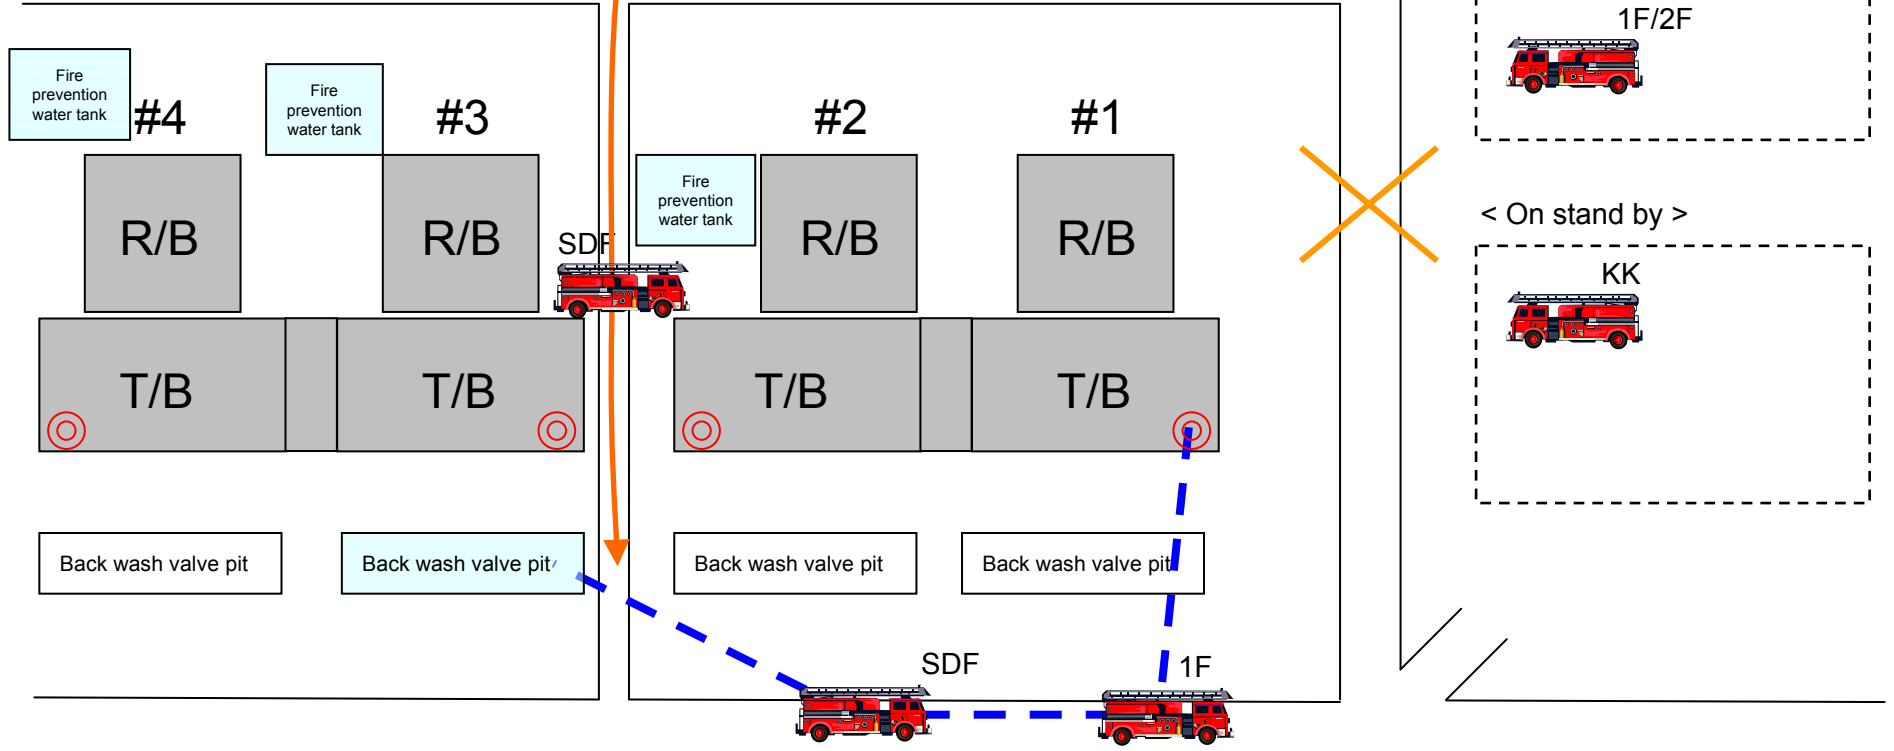
⑤ Unit 1 hydrogen explosion
(3/12 15:36)

- After the explosion all workers retreated to the seismic isolated building.
- Hoses prepared for seawater cooling water injection damaged by explosion and rendered unusable.

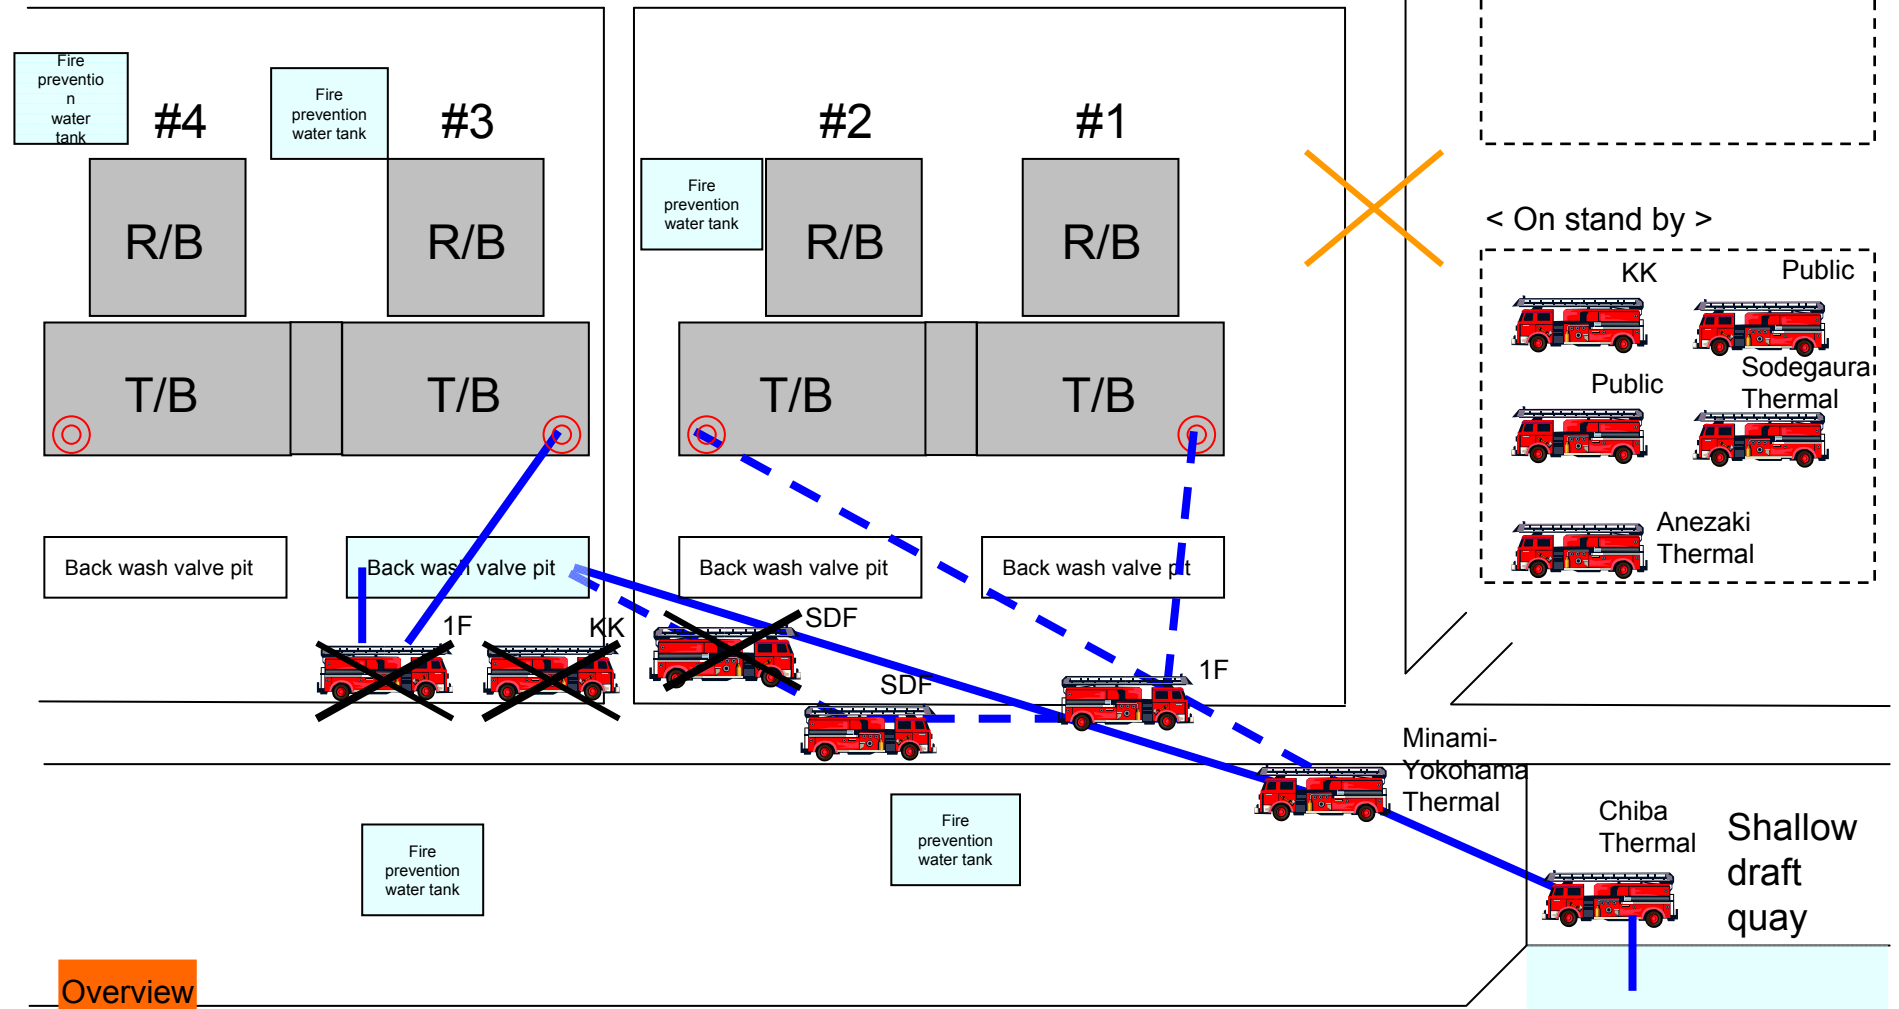
⑫ Unit 3 hydrogen explosion (3/14 11:01)

- After the explosion all workers retreat to the seismic isolated building.
- The explosion damages fire trucks in the vicinity and cooling water injection stops.

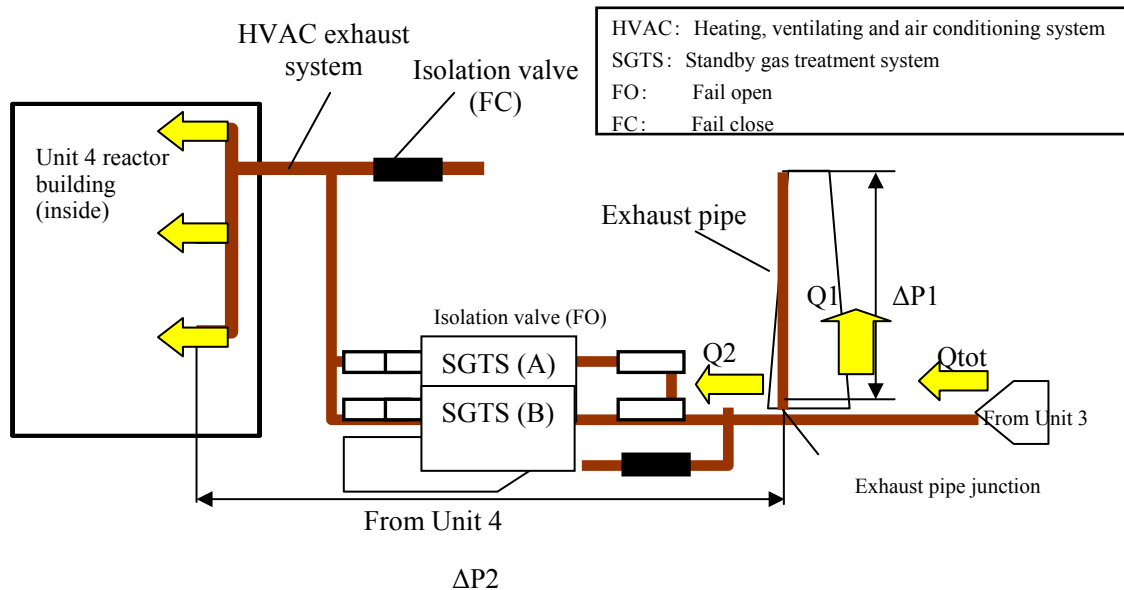
Figure 1 Evaluation model

It has been evaluated that approximately 40% of the volume that flowed into the main stack from the venting of Unit 3 flowed into the Unit 4 side.

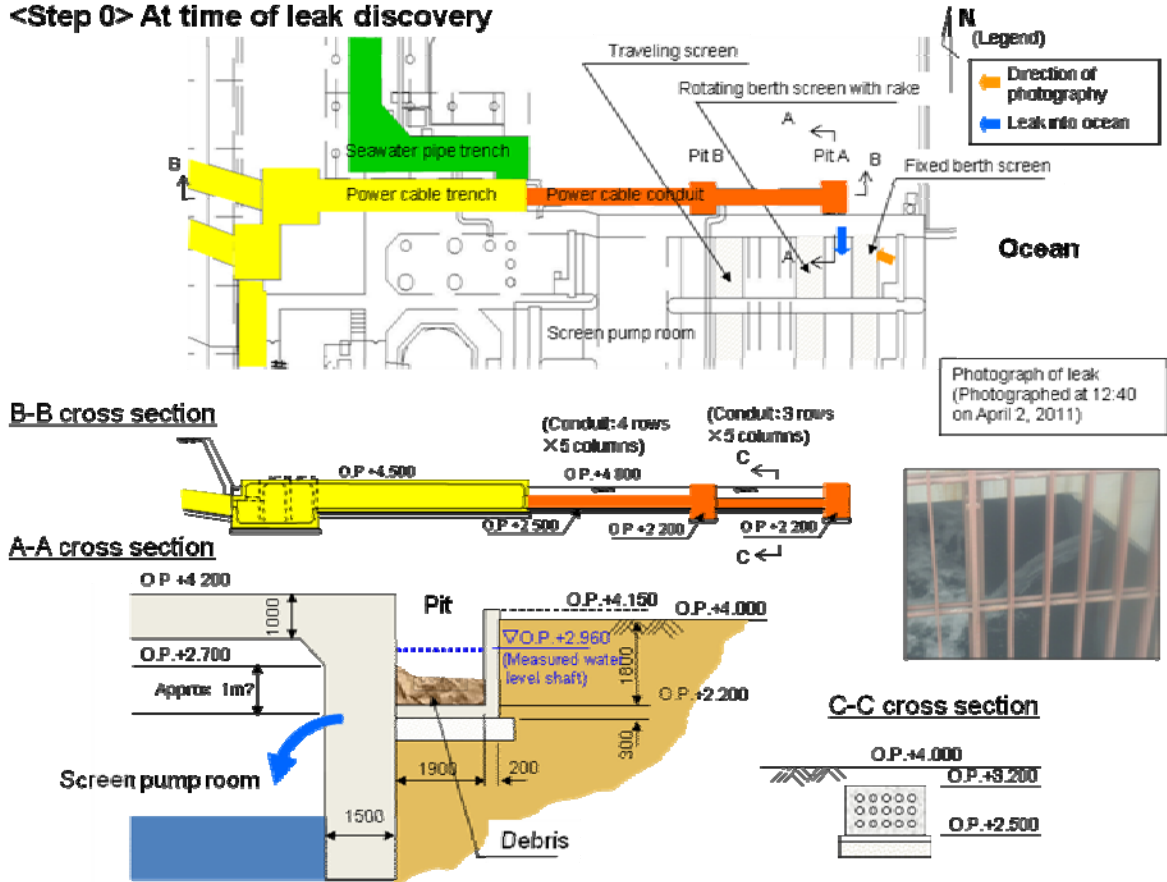
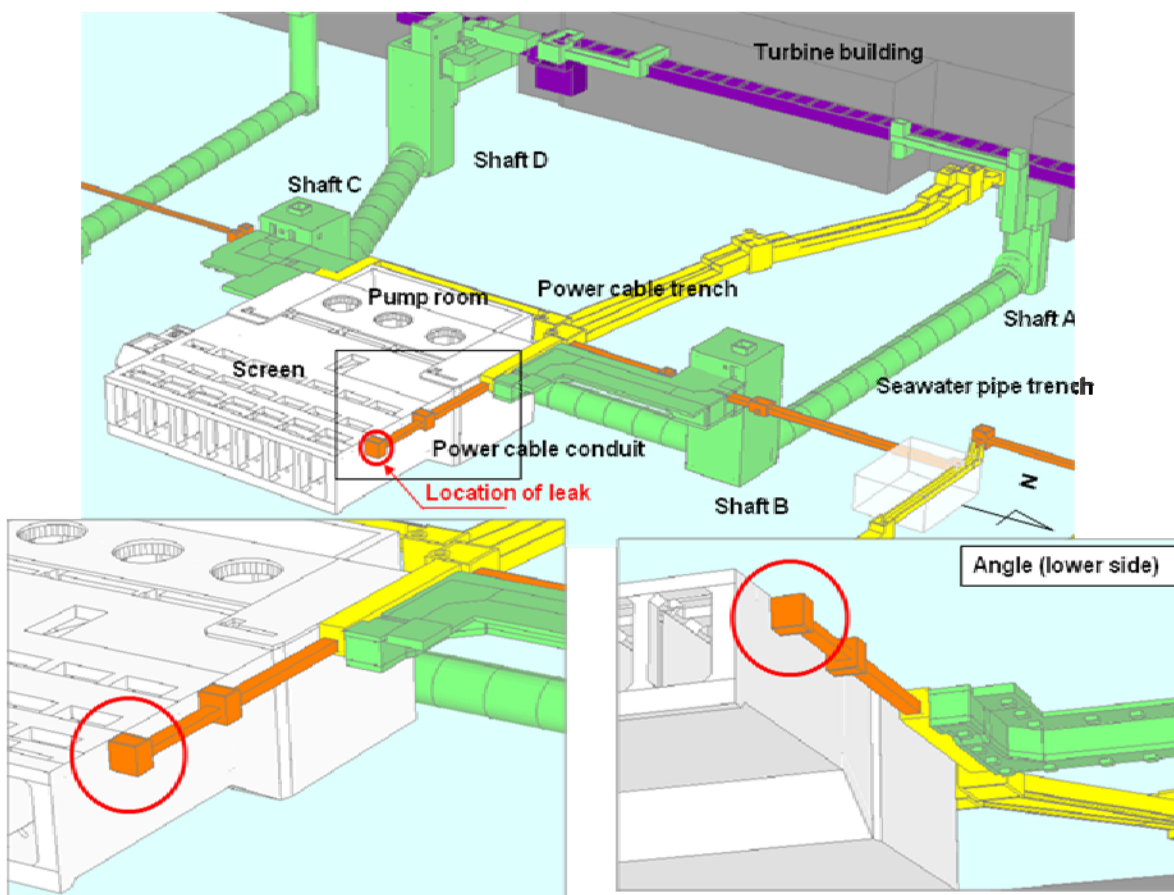
<Step 0> At time of leak discovery

At around 9:30 on April 2, a TEPCO employee discovered that water with radiation levels that exceed 1000mSv/h had accumulated inside the trench pit where power cables are housed near the Unit 2 intake, that there were cracks in the concrete portions of the pit walls, and that the aforementioned water inside the pit was leaking into the ocean. (Step 0)

A radionuclide analysis of the leaking water and the contaminated water within the pit revealed that the concentration of radioactive materials was approximately the same, so it is estimated that the water that leaked was the contaminated water from within the pit. Furthermore, since the pit and the Unit 2 trench are structurally connected the water that leaked most likely leak into the ocean from the Unit 2 turbine building (T/B) via the Unit 2 trench.

After the leak was discovered, methods for stopping the leak were immediately deliberated and the following action was taken.

- At 14:52 on April 2, a concrete mixer truck arrived at the nuclear power station, and at 16:25, concrete started to be poured into the pit on the upstream (mountain) side (until around 16:50). At 19:02 concrete started to be poured into the pits on the downstream (ocean) side (~19:13), and the pouring of concrete was terminated when the pit was filled with concrete almost to the top, however the pouring of concrete did not stop the leak. (Step 1)

- At 12:07 on April 3, the trench duct top plate started to be destroyed in order to stop the leak by filling the pit with sawdust and a macromolecule polymer. The top plate was completely dismantled at 12:22, and at 13:47 five barrels of sawdust were poured into the pit. Thereafter, 80 bags of polymer and five barrels of sawdust were thrown into the pit. At 14:05 10 bundles (3 kg per bundle) of newspaper were added, and at 14:30 more sawdust was thrown in. Workers then retreated after alarmed pocket dosimeters (APD) started to sound. The sawdust was dry so at 17:42, in order to mix it with water, a mixer truck was brought to the pit opening in order to inject water which concluded at 17:52 with no effect. (Step 2)

- ◇ At 14:18 two holes were drilled (bored) in the pit (No. 1, 2) and tracer was injected at 14:23 (through hole No. 1) and the leak was checked (the same was done through hole No. 2 at 14:34).
- ◇ At 15:07 coagulant was injected (No. 1, 2) and at 16:00, 1500 liters of coagulant was injected.
- ◇ At 20:02 another hole was bored (No. 5) (No. 6 was bored at 20:16), and tracer was injected at 20:42 (No. 5) (tracer was injected into No. 6 at 21:50).
- ◇ At around 22:00 coagulant was injected (No. 5, No. 6) and at 22:45 coagulant injection into No. 5, 6 was terminated.
- At 0:38 on April 6, holes No. 7, 8 were deepened and at 1:53 coagulant was injected into No. 7 and No. 8. At 5:17 No. 9 was bored (directly above the pit) and coagulant was ejected (-5:30).
- ◇ At around 5:38 it was confirmed that the leak into the ocean had been stopped.

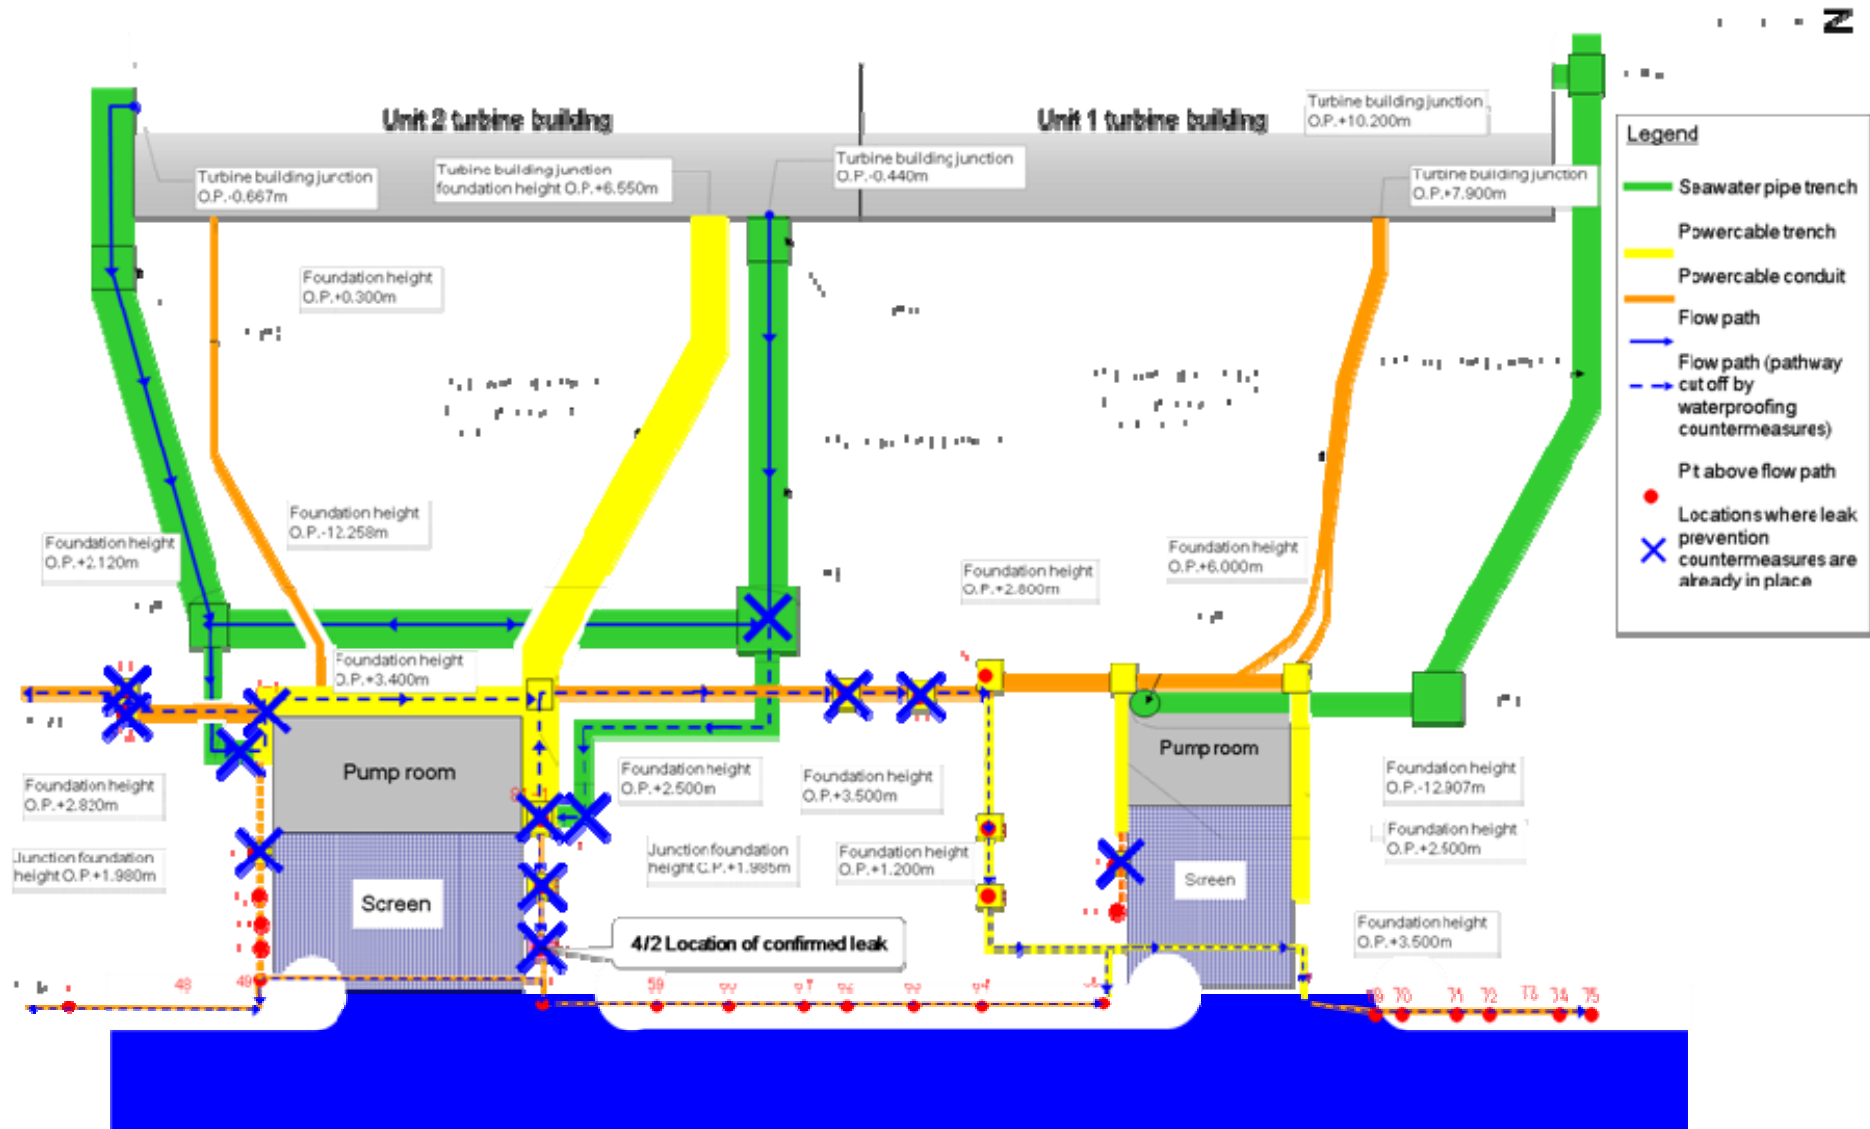
Unit 2 seawater pipe trench diagram

- -The exposure of contract workers on March 24 prompted an investigation into the risks associated with contaminated water leaking from the turbine building. The turbine building and seawater piping trench are connected at a relatively low elevation via piping penetrations and it was confirmed that contaminated water from within the turbine building was flowing into the trench.

- -It became clear that even though the aforementioned trench is not directly connected to the ocean, since the opening to the shaft is at O.P. +4,000mm if the water level in the trench exceeds the elevation of the inlet contaminated water may leak to the outside.

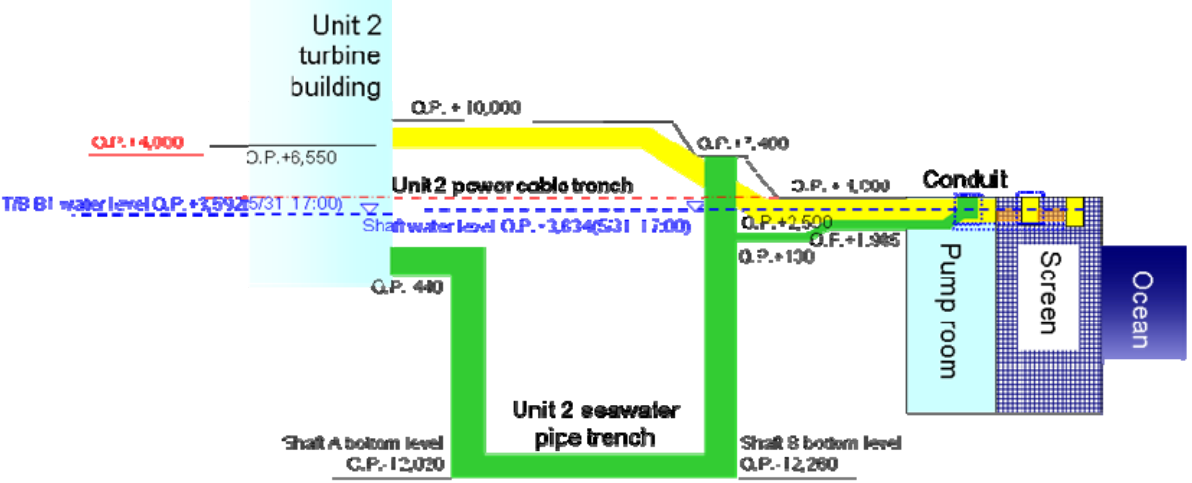
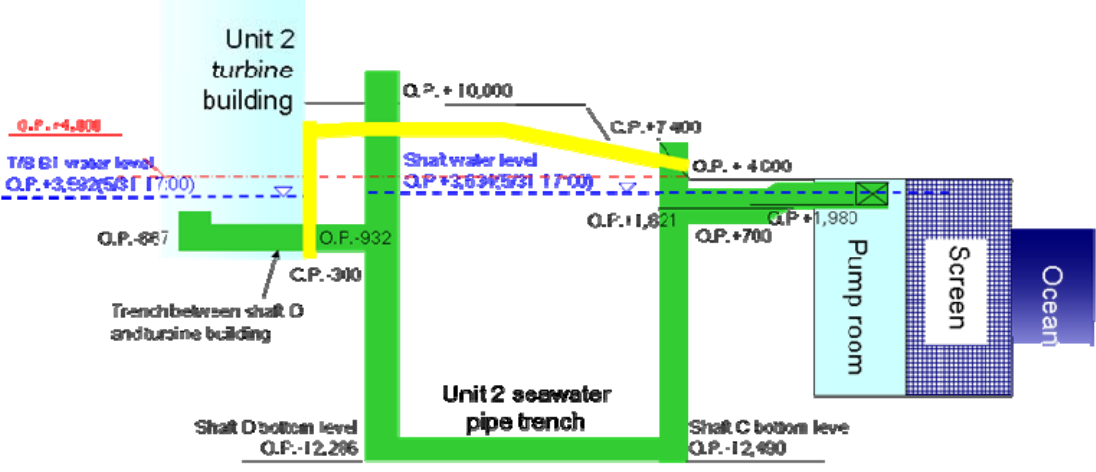
Unit 2 seawater pipe trench (b-b cross section)

- On April 2, it was discovered that some extremely highly contaminated water from Unit 2 had leaked directly into the water outlet from cracks in the pit. In order to stop the leak and minimize ocean contamination, many attempts were made to stop the leak, such as by injecting concrete and water glass. At the same time it was predicted that the pit might overflow or start leaking from a different place if the pit was adequately waterproofed, so it was determined that a alternative building or tank to which the water could be transferred was needed as soon as possible and that the concentrated radwaste building was the best option.

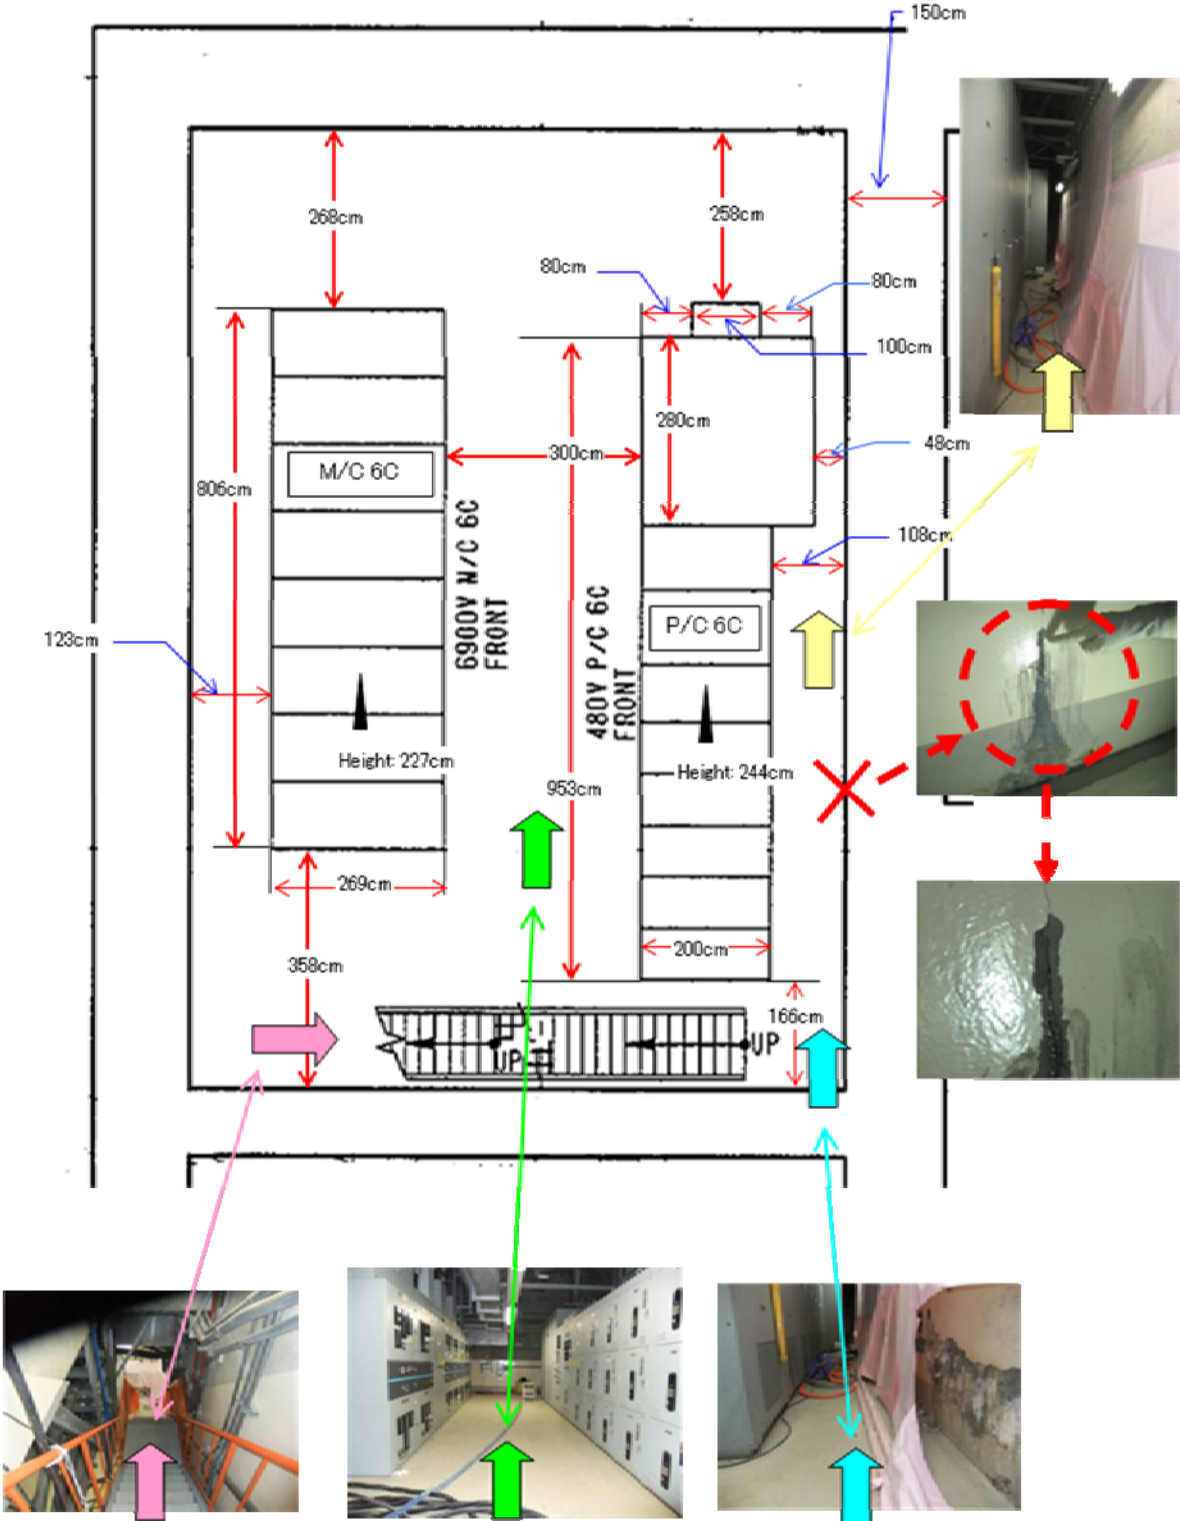
Unit 6 M/C room flooding (enlarged diagram-1 (1))
(March 26)

- From the time the earthquake occurred it was considered that ground water leaked into the building through pipe penetration seals, etc., and accumulated thereby affecting electrical equipment and the building soon if water in the subdrain could not be drained.
- Contaminated water from the Unit 6 radwaste building was seeping through the wall of the neighboring M/C (6C) room of Unit 6 (with power source cross-ties to the Unit 5 residual heat removal system (RHR)) and was bailed out by hand after March 19th. Even though some of the aforementioned contaminated water was transferred to the Unit 5 condenser between April 1 and April 2, the transfer was terminated when it became apparent that only a small amount could be transferred to the condenser. The leak to the M/C (6C) room continued along with the danger of loss of power.

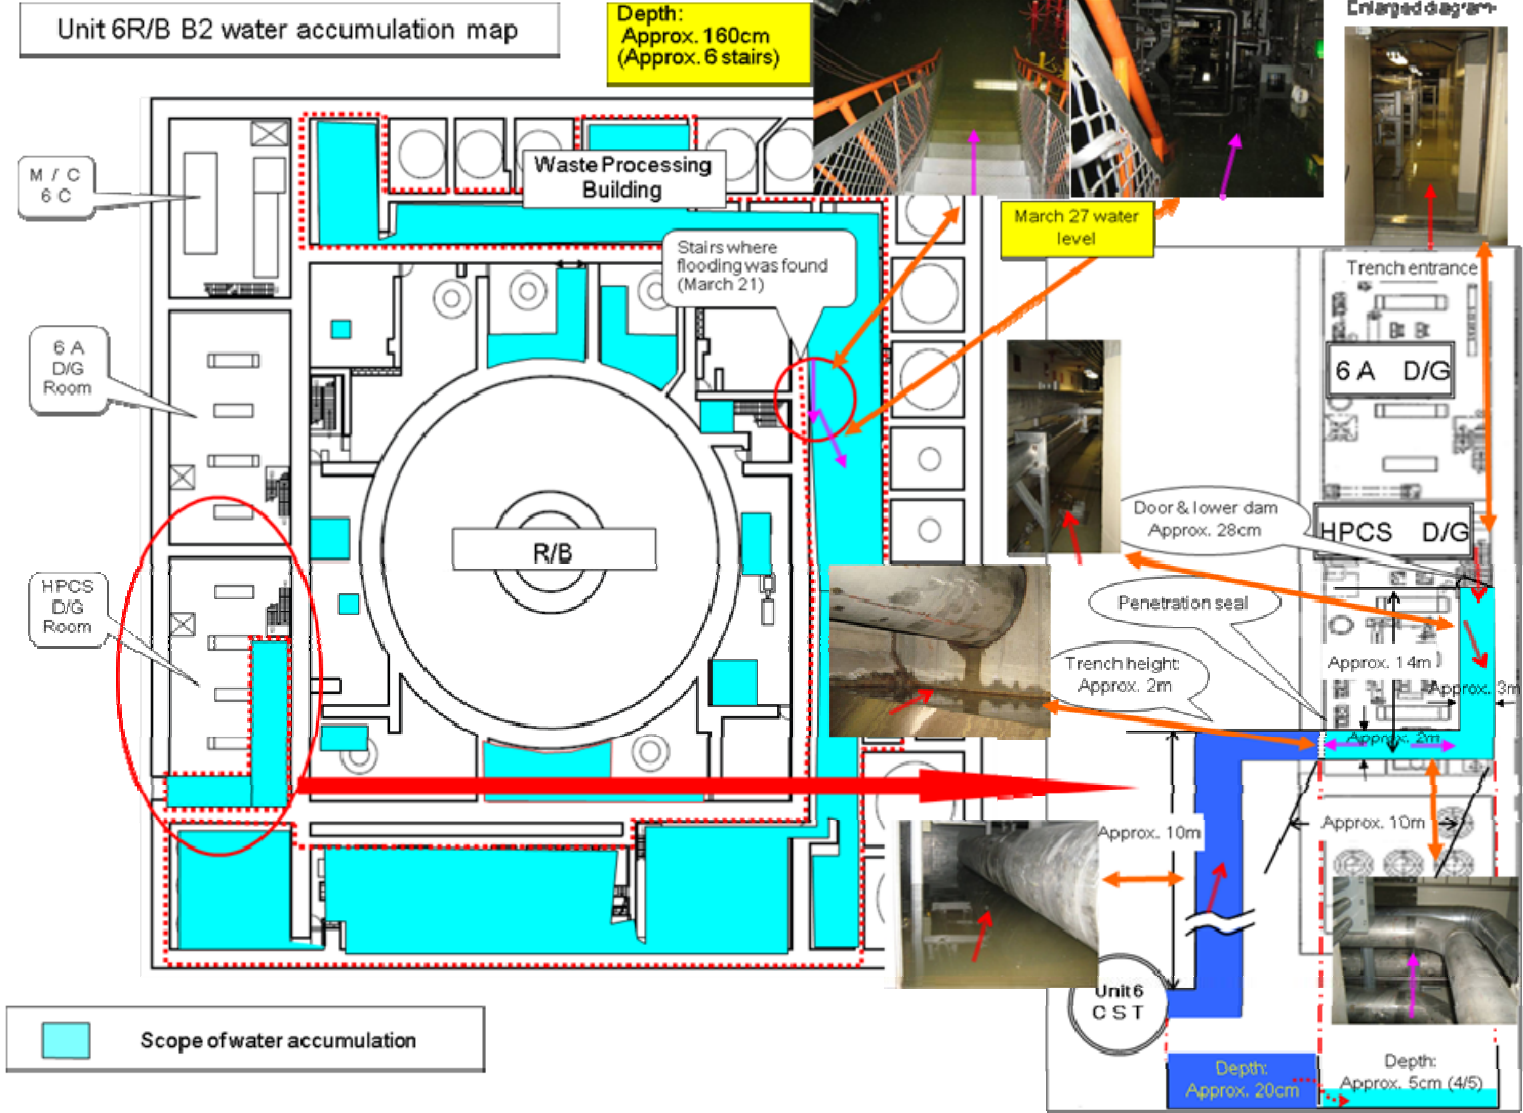
Unit 6 R/B B2 accumulated water map

- On April 3, a leak with approximately 1 centimeter in the diameter was discovered coming through the penetration seals of the trench which neighbors the Unit 6 high-pressure core spray (HPCS) diesel generator room. An initial assessment predicted that water would exceed the barrier at the entrance to the trench room (approximately 28cm) in approximately 5 days and it was feared that this would impact the diesel generator.

- Much water leaks into rooms for safety related system in Unit 6 became noticed. There was more aftershocks since even though it was the beginning of April, and it was feared that more damage to walls (cracks) from aftershocks as well as heavy rains may quickly increase the volume of leakage thereby causing heat removal/cooling function loss and plunging Unit 5, which shares power source cross-ties for heat removal equipment with M/C (6C), into the same situation as Units 1-3.
- Therefore, in order to quickly reduce the risk associated with groundwater leaking into the Unit 6 building and remain on the safe side amidst an unpredictable future, it was necessary to reduce the water level of the sub-drain surrounding buildings which is the fundamental cause of the groundwater inflow to the buildings. Therefore existing pumps were used to discharge some drain water into the ocean.
