Fukushima Nuclear Accidents Investigation Report

Attachment

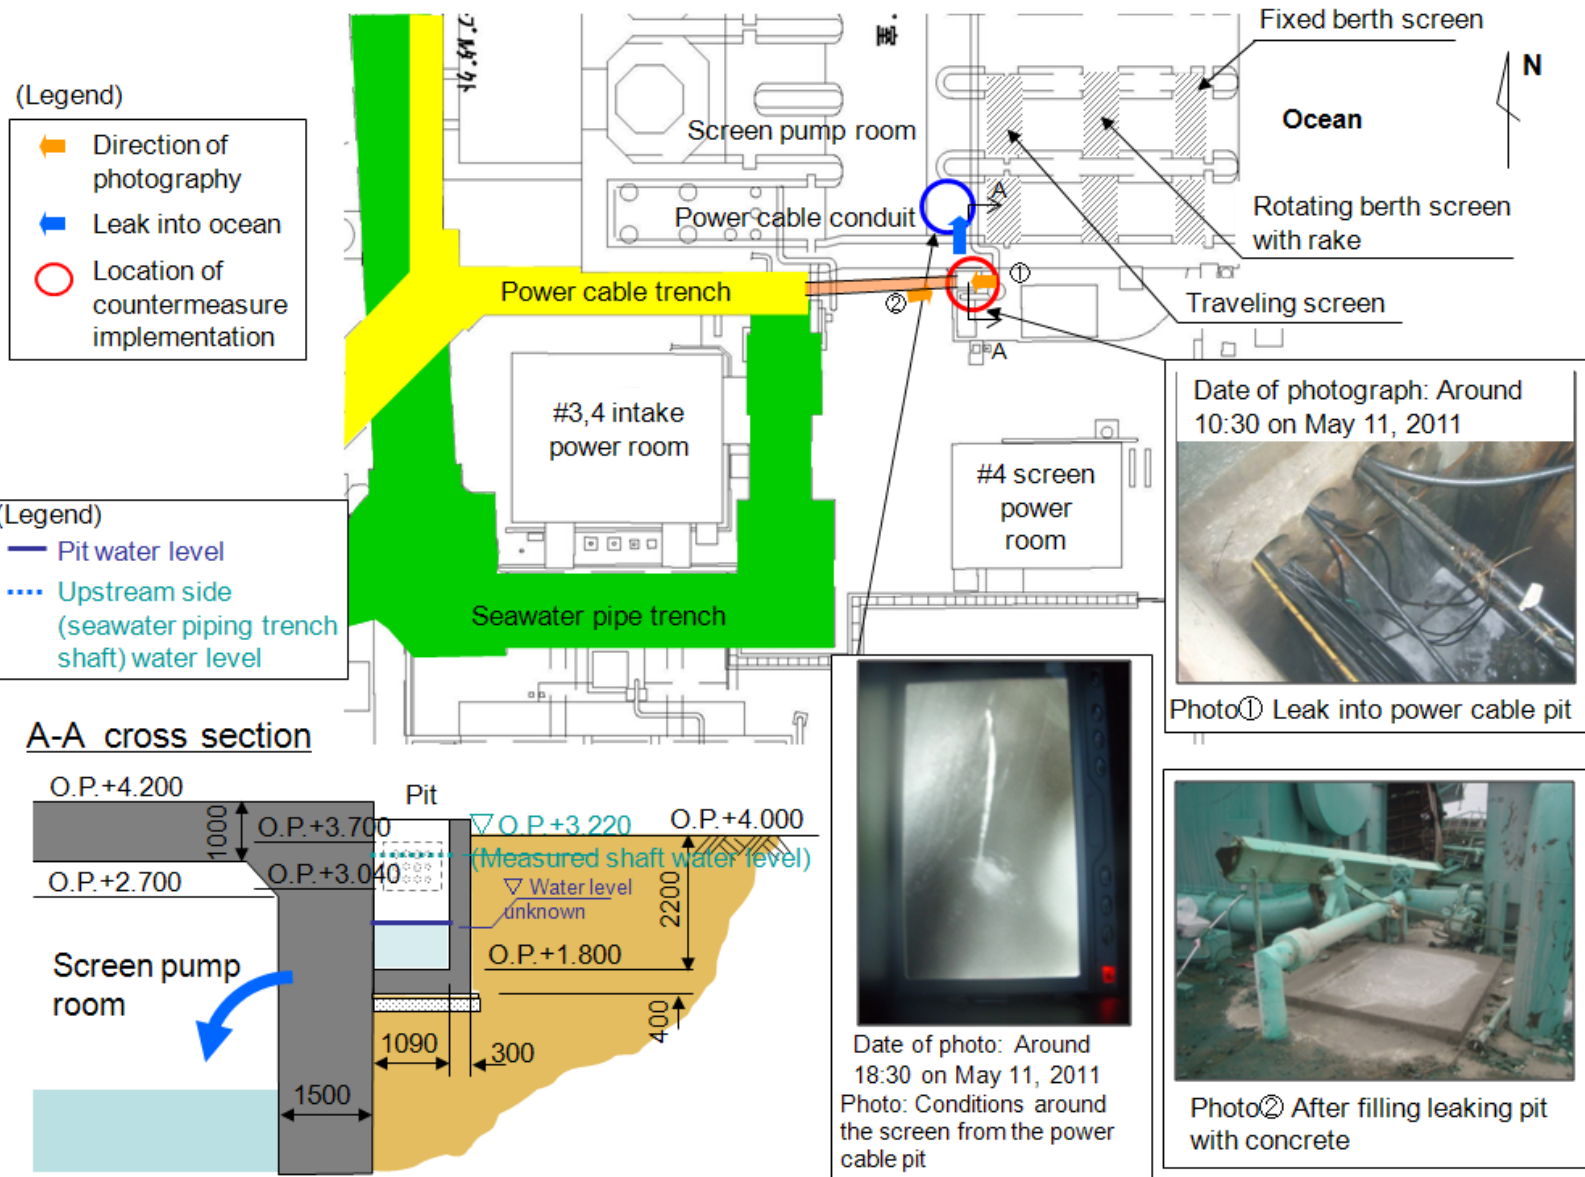
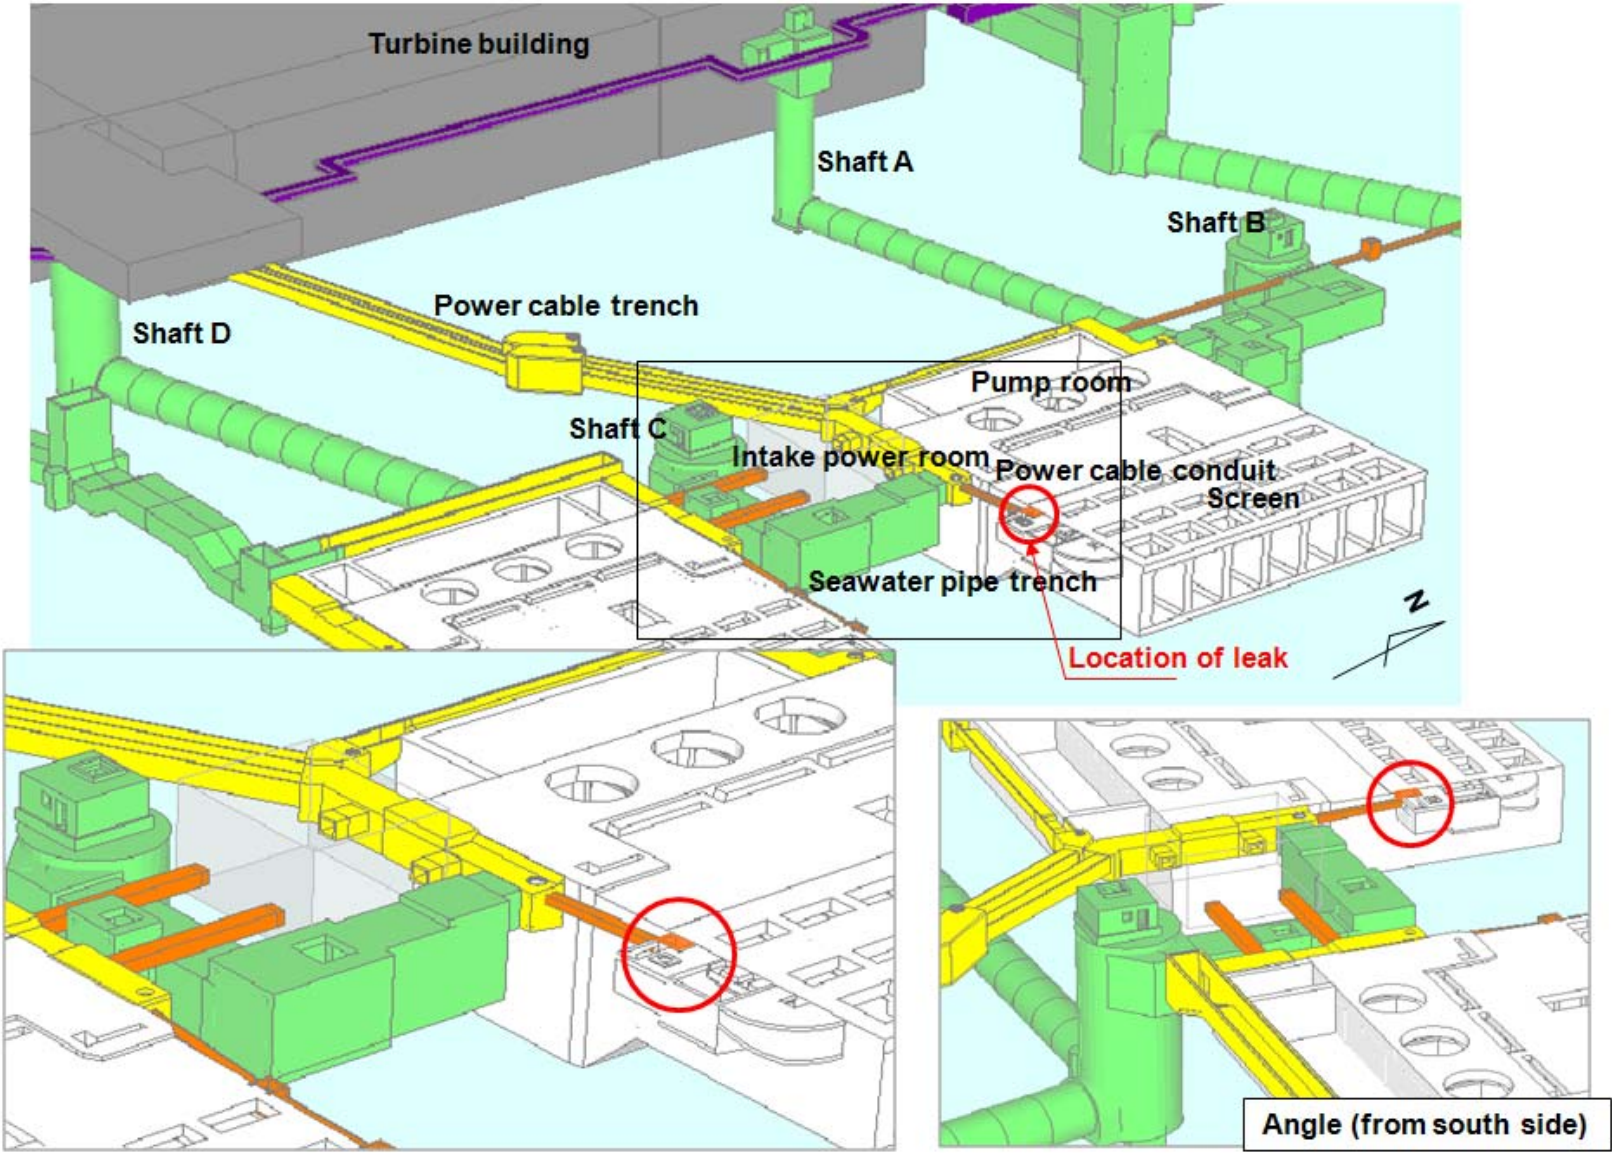
Thereafter when the area was checked again by opening the cover hatch and inserting a CCD camera inside the screen room, it was confirmed at around 16:05 on the same day that water was leaking from the pit into the screen area.

The leaking water contained high concentrations of radioactive materials. Therefore, it was assumed that drainage water from the Unit 3 turbine building side that had leaked into the power cable pit on the T/B ocean side through power cable pipes from the power cable trench interface via the seawater pipe trench had leaked from the penetration seals in the concrete wall between the power cable pit on the north side of the aforementioned pit and the screen pump room into the Unit 3 intake screen area.

It was clear from the radionuclide analysis results of the leaking water and the contaminated water inside the pit that the radioactive material concentration was approximately the same, and therefore estimated that the leaking water was from the contaminated water in the pit. Furthermore, since it was known that the pit and the Unit 3 trench are connected structurally it was assumed that the leaking water had leaked into the ocean from the Unit 3 turbine building via the Unit 3 trench.

After confirming that there was a leak from the aforementioned pit into the screen area power line pipe cables inside the pit were immediately shut off, waste cloth were stuffed into the leak and the pit was sealed with concrete. As a result it was confirmed using a CCD camera at 18:45 on May 11 that the leak had been stopped.

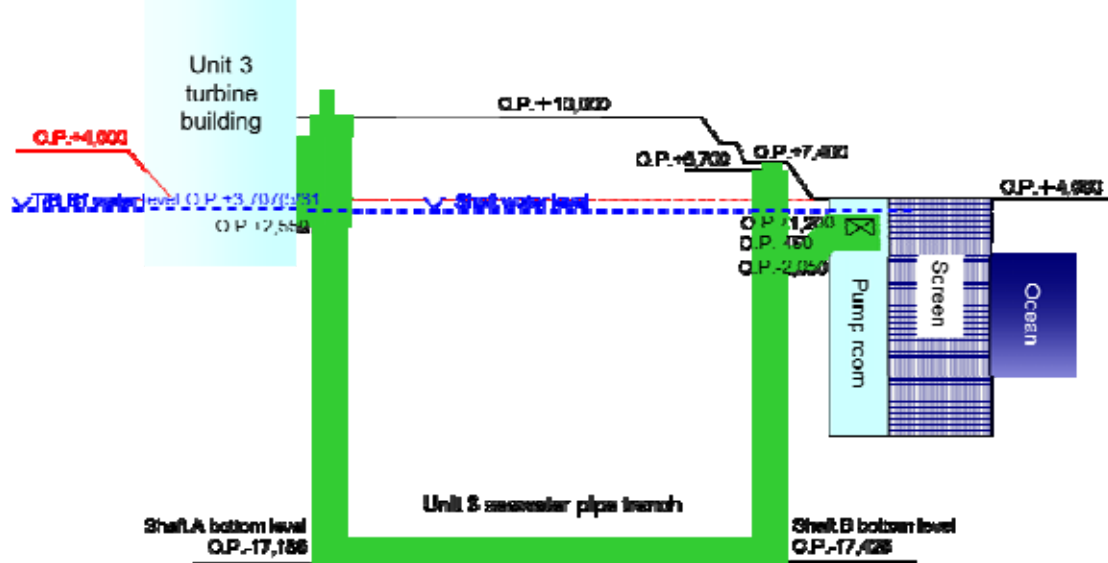
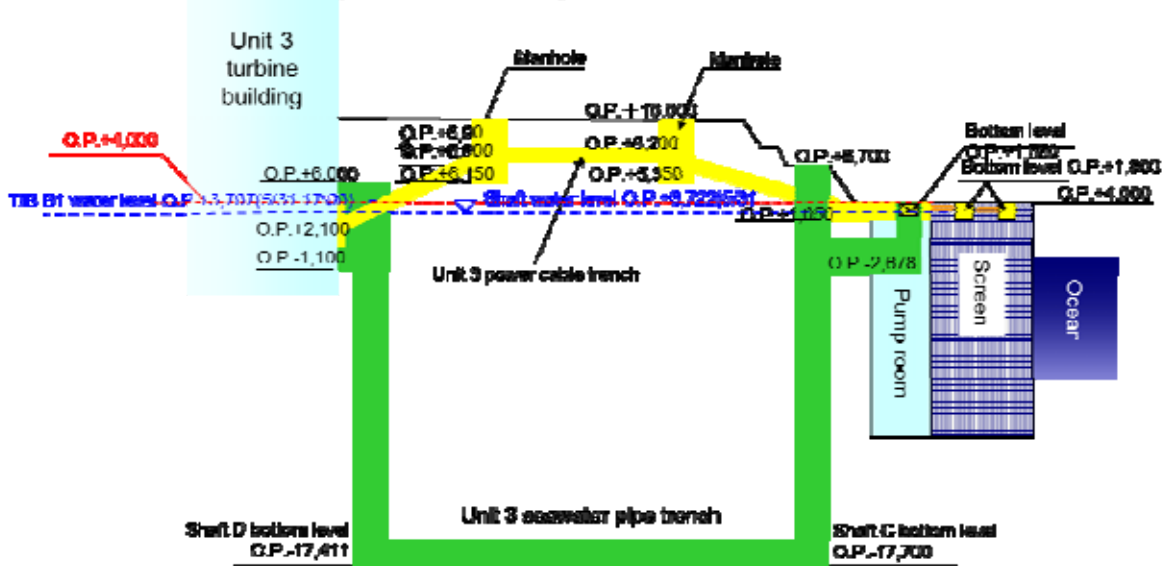
Unit 3 seawater pipe trench (c-c cross section)

- The seawater pipe trench, which served as the path of leakage, has a shaft opening at OP+4,000mm so the water level inside the shaft was continually monitored.

- In order to prevent water from overflowing topside from the shaft, it was decided that the above-ground opening would be sealed shut and that the joint between the seawater pipe trench on the downstream side and the intake power cable trench would also be sealed off. To do this, rubble around the screen was being removed at which time the leak was discovered.

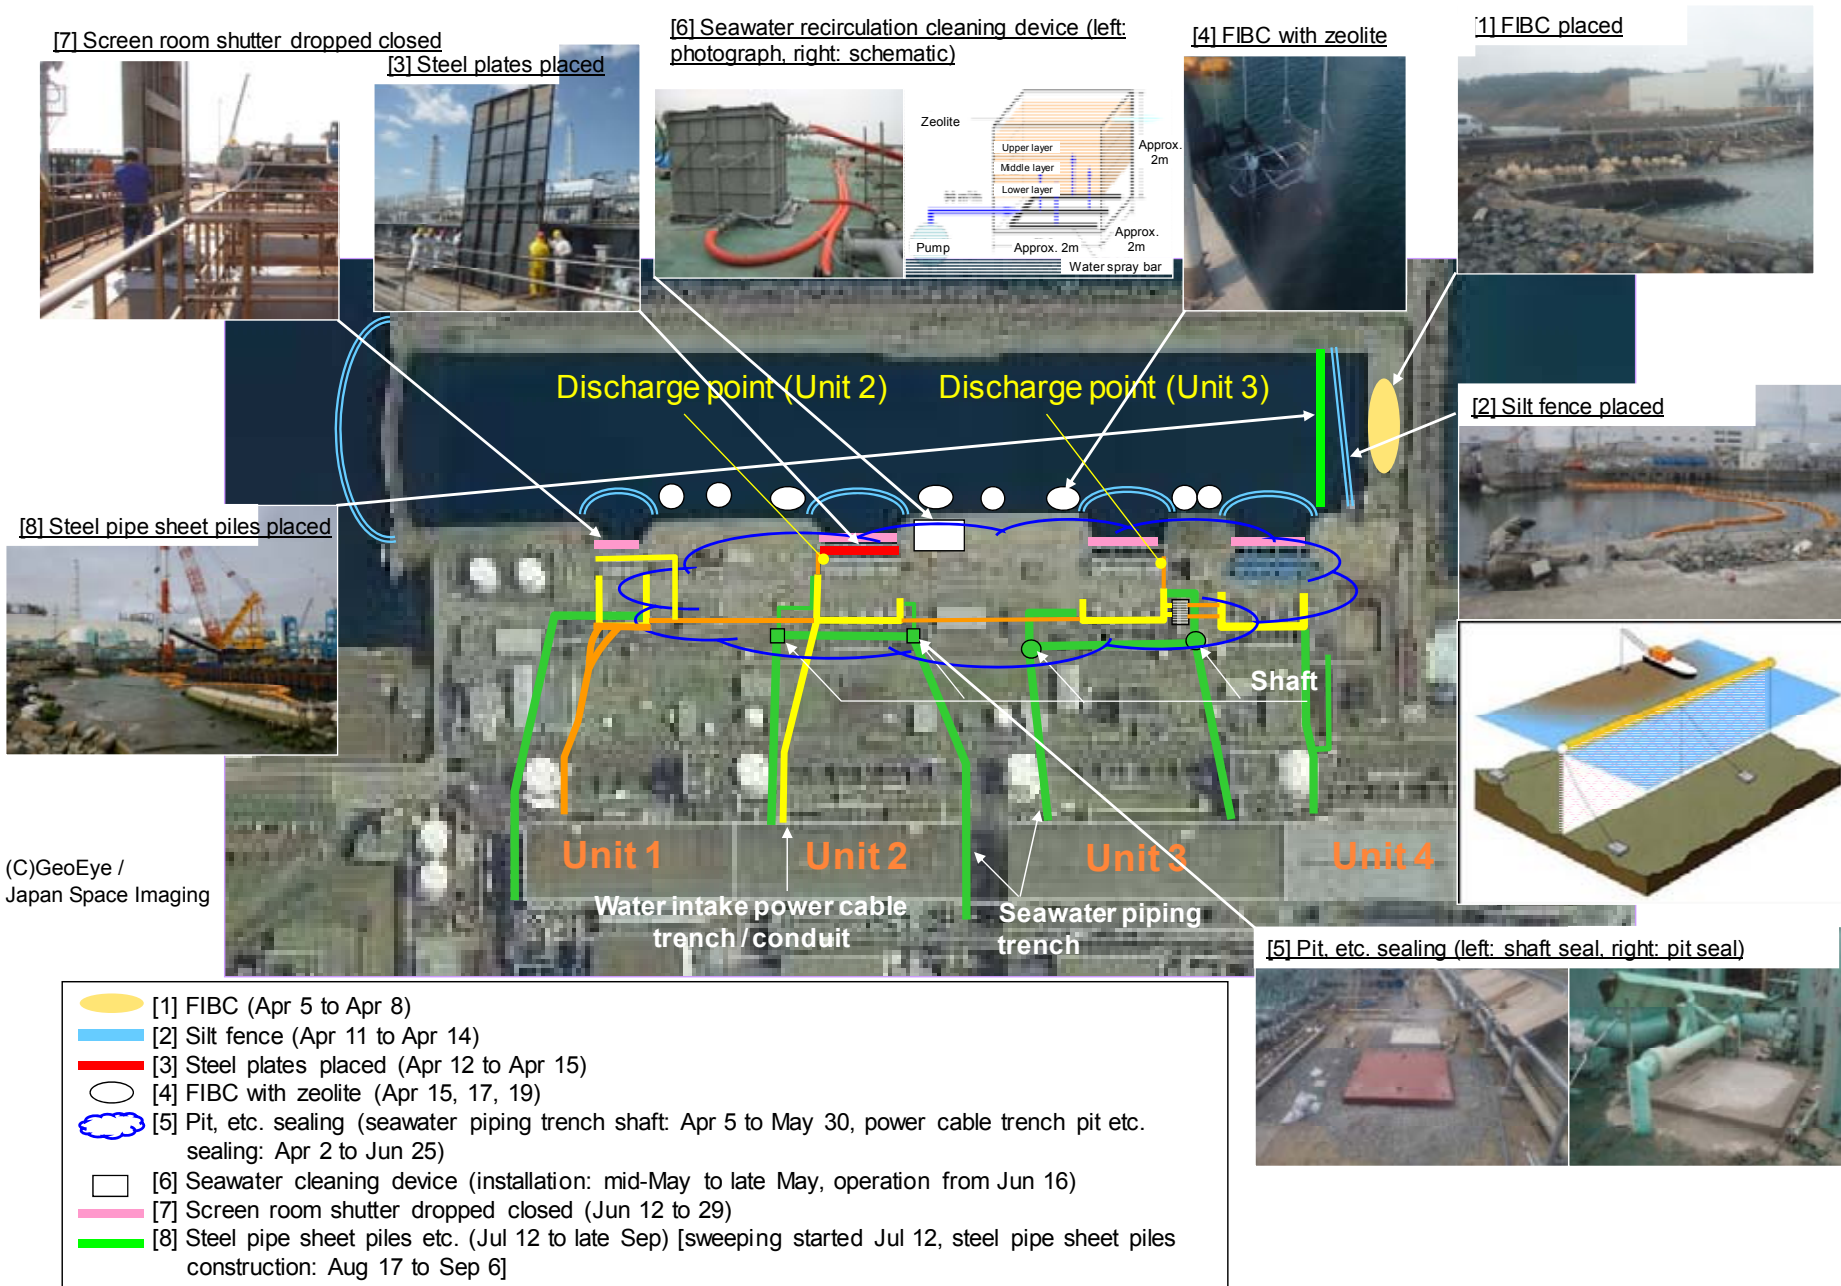
In consideration of the confirmed leakage path the following leak prevention countermeasures were implemented along with diffusion control countermeasures in case of a leak (some countermeasures are being implemented and others are planned). Furthermore, countermeasures for stopping highly contaminated water from accumulating in buildings in trenches, recovering and processing this water, and controlling the flow of groundwater are proceeding as part of the plan to remove any obstacles hindering decommissioning.

- ① Leak prevention countermeasures
 - Sealing off of sea water pipe trenches located upstream of leakage paths [5]
 - Sealing off of pits that are at risk of leaking [5]
 - Sealing damaged areas of seawall [5]
 - Isolating the Unit 1~4 screen pump room [3, 7]
 - Building silt fences and large sandbags [1, 2]
 - Repairing damaged permeation prevention structure [8]
 - Sealing off the Unit 2, 3 pump room circulating water pump delivery valve pit [5]

- ③ Stopping highly contaminated water accumulated in buildings and trenches, and collecting and processing this water [11]

- ④ Countermeasures for controlling the flow of groundwater
 - Reducing the volume of groundwater flow by decreasing water levels in subdrains [12]
 - Reducing the volume of groundwater inflow by building an groundwater bypass system [13]
