Permanent installation of a power panel (P/C 1D-2) in Unit 1 Seawater Heat Exchanger Building (December 27)

Carry-in and installation of the auxiliary facilities of emergency diesel generator (A system) in Unit 1 Reactor Building Annex (December 12)

Carry-in and installation of the charger and battery for the DC power supply (H system) in Unit 1 Reactor Building Annex (December 18)

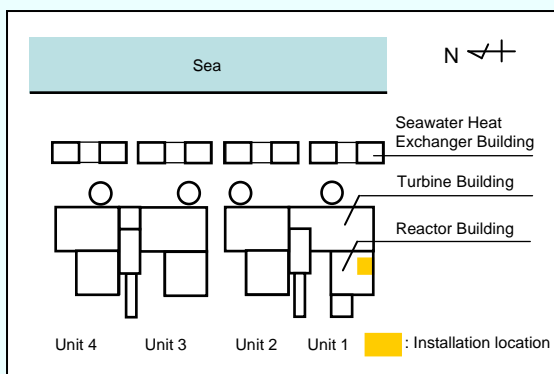
As for the emergency diesel generator (A) which was damaged by the Tsunami in Unit 1 Reactor Building Annex, the newly manufactured auxiliary facilities have been carried in and installed on December 12.

Electric motor installation (Fresh water heater pump*1) (Photo taken on December 11, 2012)

*1 Fresh water heater pump: Used for cooling the high temperature parts of the diesel engine such as the cylinder.

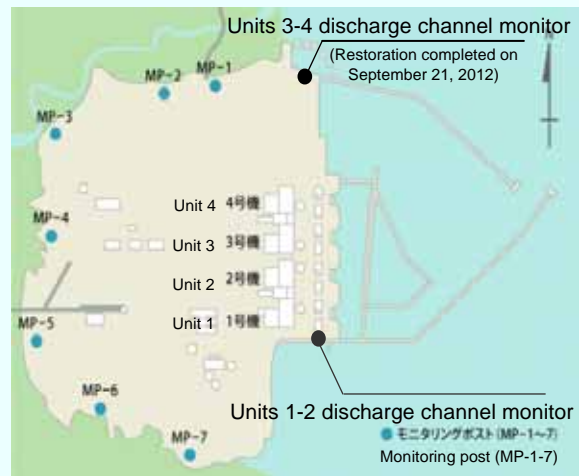
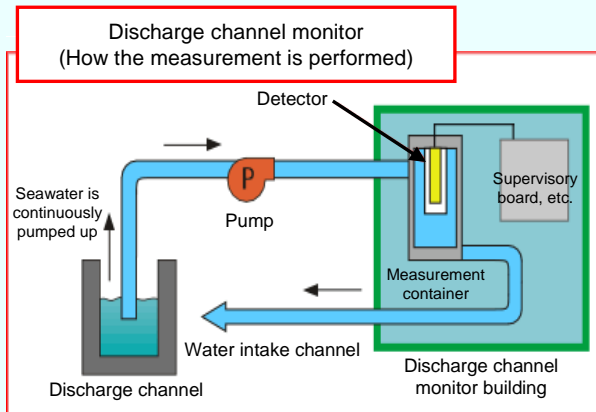
Units 1-2 discharge channel monitor which was damaged by the Tsunami was replaced with a newly manufactured one. The new discharge channel monitor has been carried in and installed on December 10. A function check is to be performed.

Units 1-2 discharge channel monitor (detector) installation (Photo taken on December 18, 2012)
