Report on the Investigation and Study of
Unconfirmed/Unclear Matters

In the Fukushima Nuclear Accident

Progress Report No.2

Tokyo Electric Power Company, Inc.

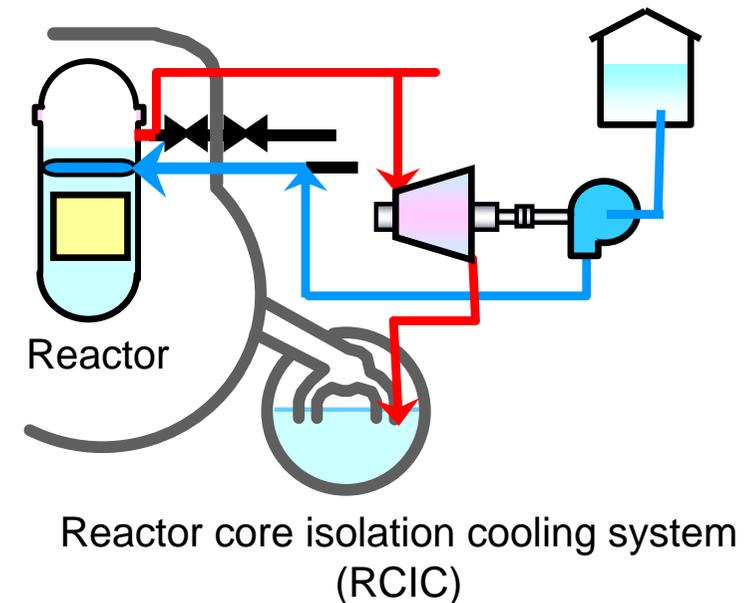
The RCIC shutdown occurring in Unit 3 at 11:36 of March 12 is likely to have been caused by an electric trip, due to high turbine exhaust pressure.

In addition to measures to bolster the HPCI system's functions, **an operational procedure to release the turbine exhaust pressure interlock is being prepared as part of tsunami response procedures.**

As part of review aiming to voluntarily improve the power station's safety, this will be reflected onto Tsunami Accident Management procedures. (January 2012)

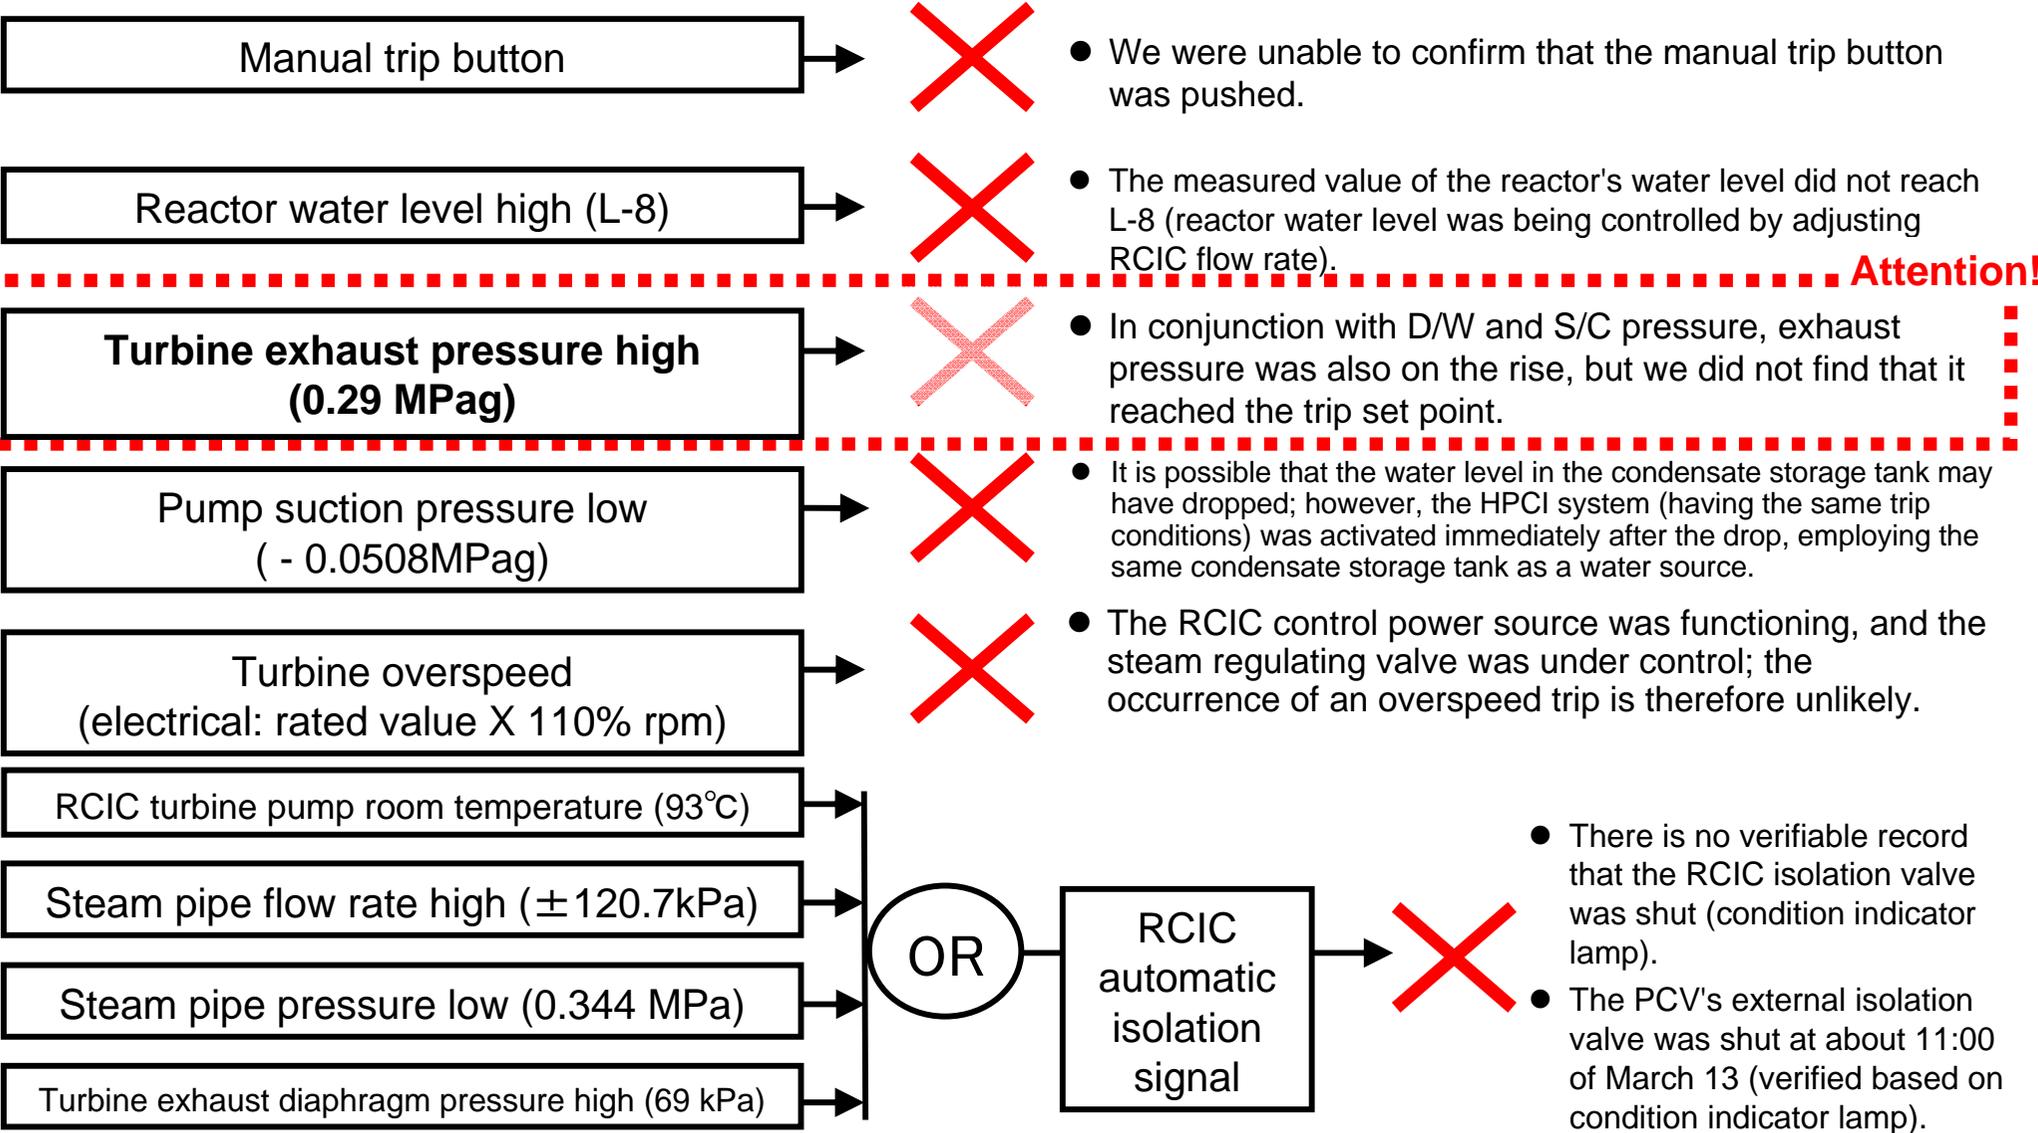
(4) Likelihood of trip conditions forming

None of the trip conditions required under electrical trip logic was confirmed.

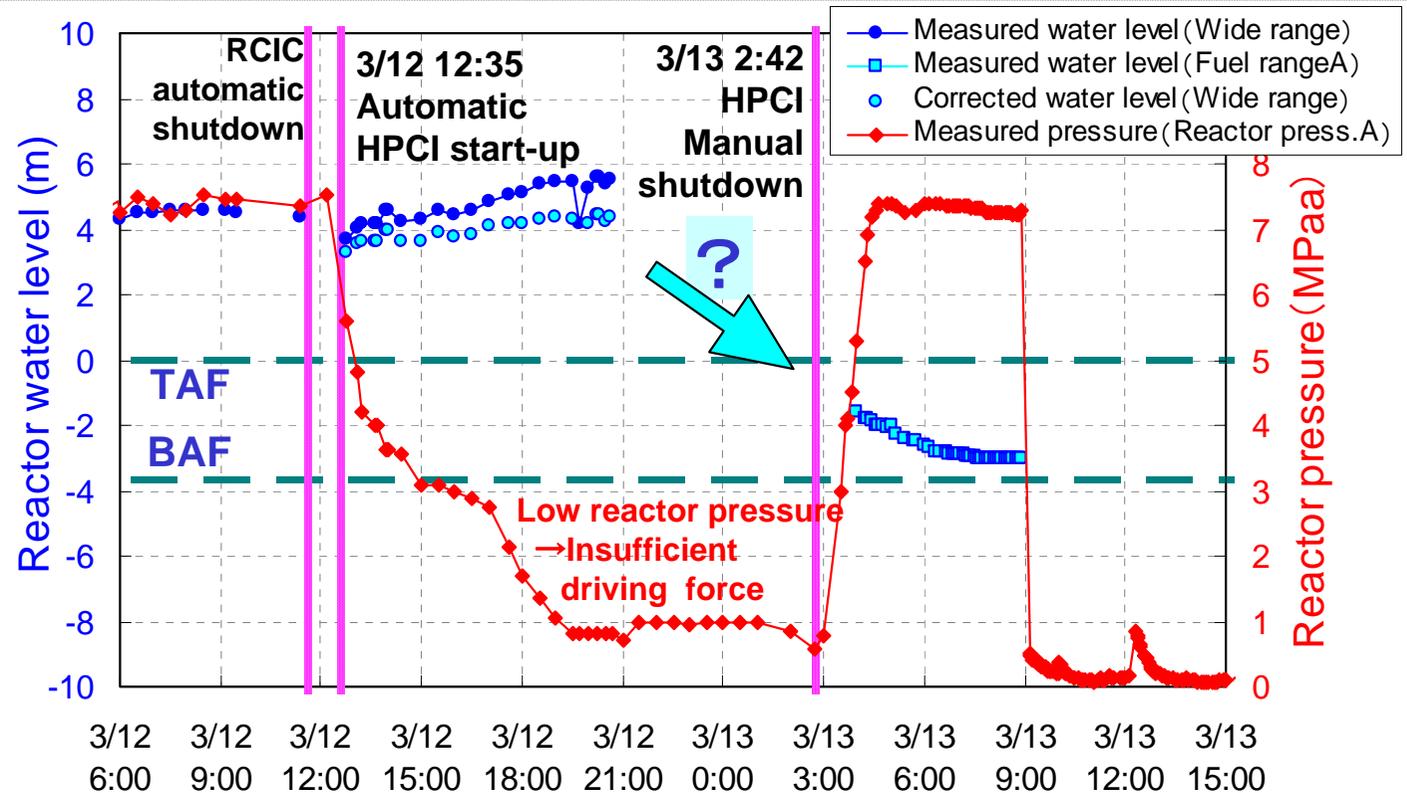
Process leading up to fuel melting

A zirconium-water reaction caused as the water level dropped resulted in fuel melting before the **water level reached the fuel's bottom.**

While uncertainty in the model and in the quantity of cooling water injected from fire engines makes the results of analysis somewhat unreliable, **the RPV did rupture, causing the majority of fuel to drop into the PCV.**

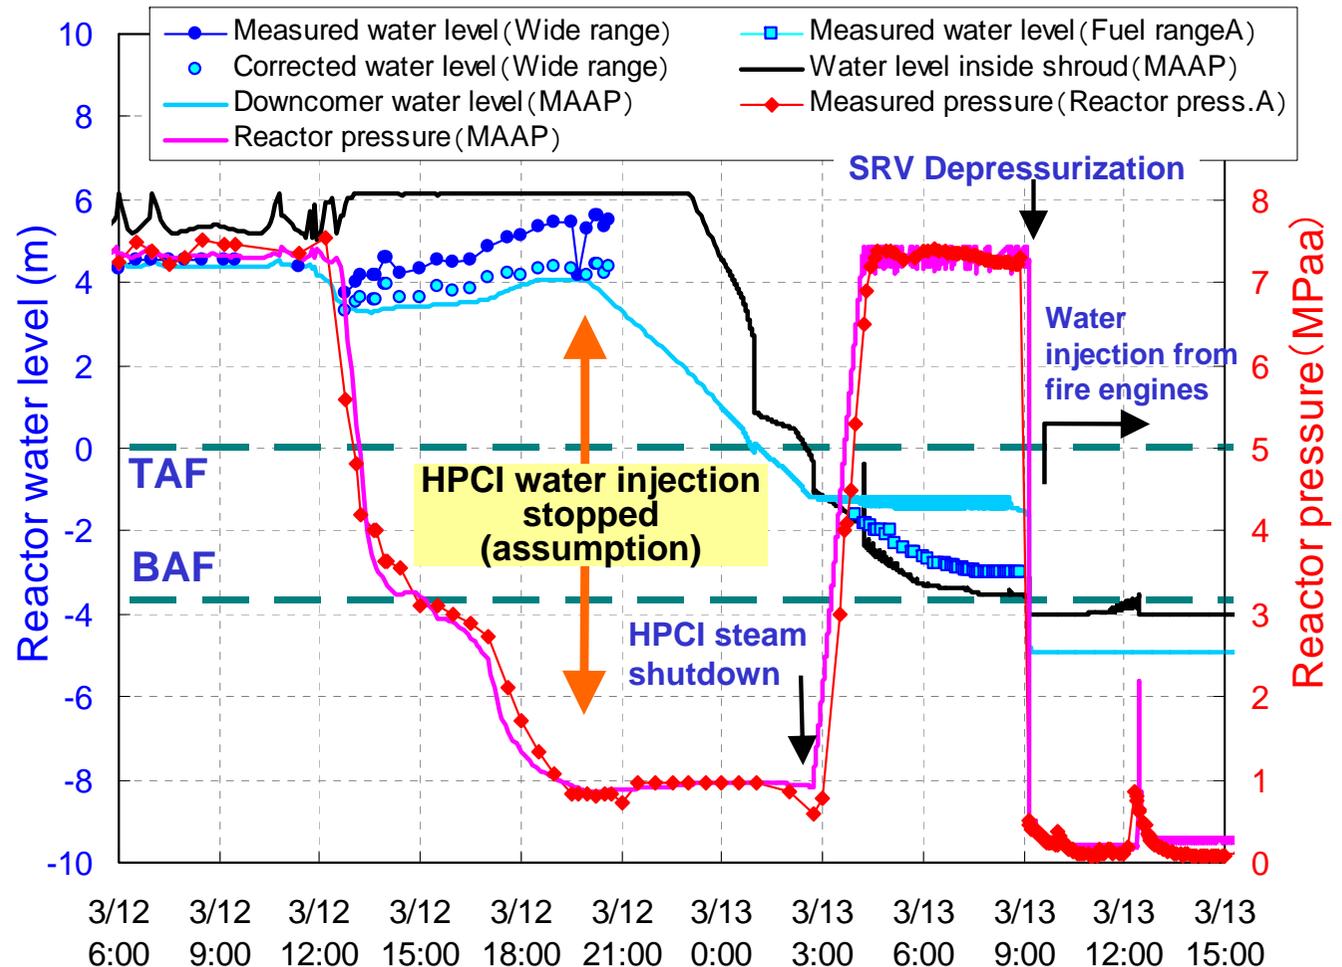
(3) Process of fuel melting reflecting the state of HPCI operating status

Fuel began melting before the water level reached the fuel's bottom.
We estimate that it was the heat from the zirconium-water reaction caused as the water level dropped to cause the fuel to melt.

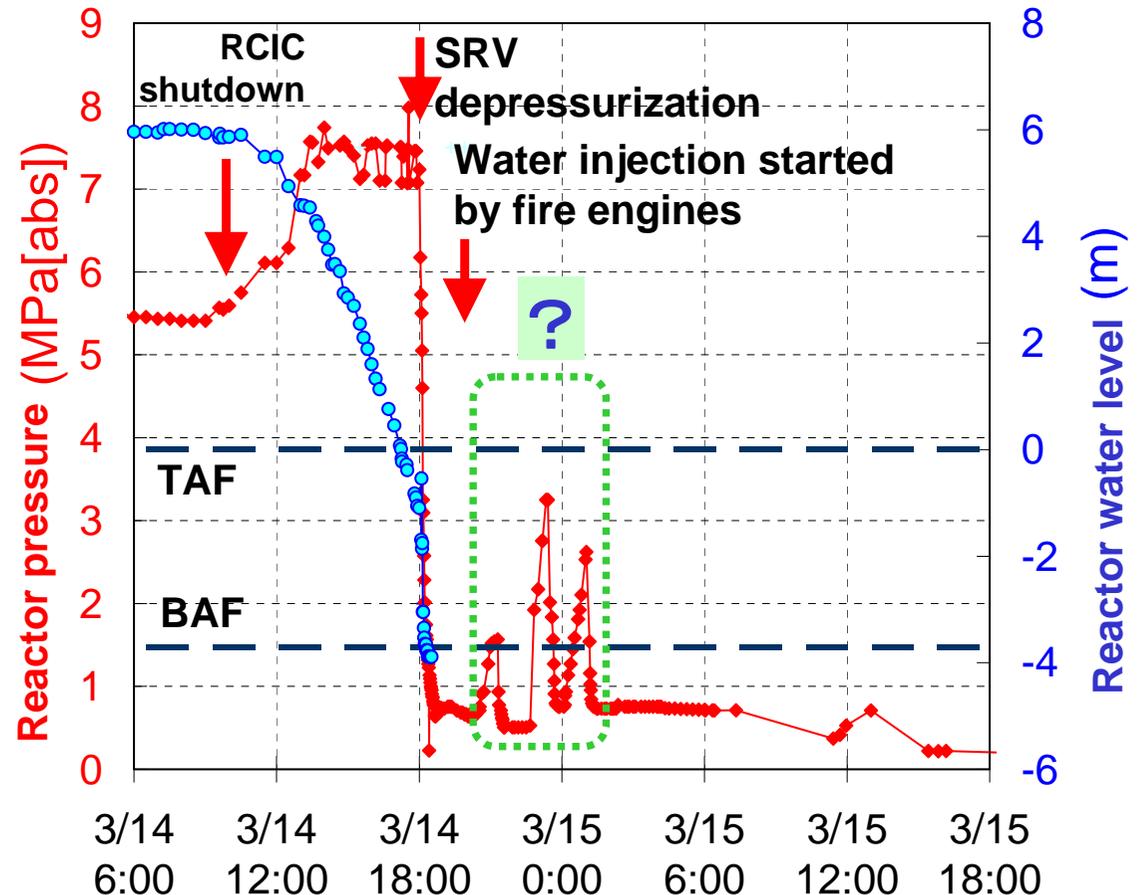
(2) Process leading up to fuel melting

We estimate a scenario where, after reactor depressurization, the steam generated by cooling water injection from fire engines caused a zirconium-water reaction, in turn causing reactor pressure to rise and lead to fuel melting.

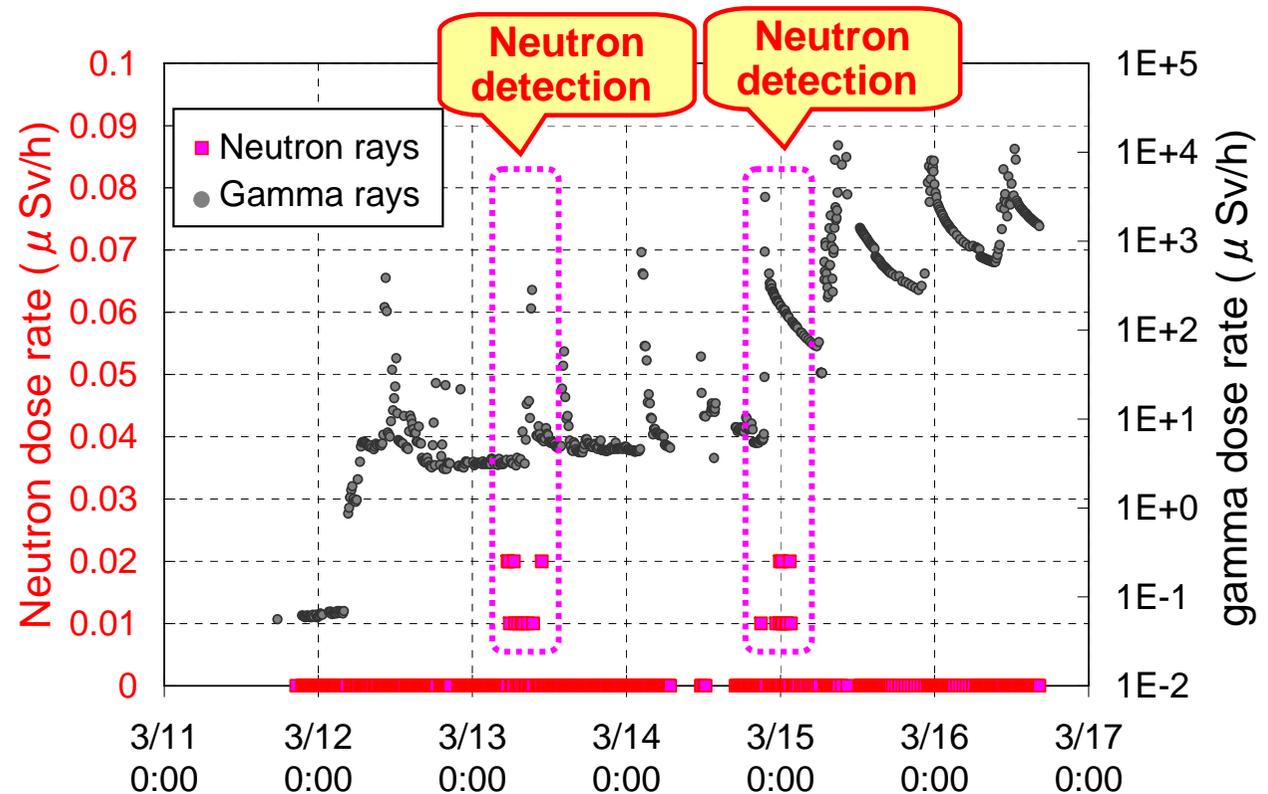
The timing of neutron detection and the increase in the gamma dose rate are not correlated.

The neutrons detected in the morning of March 13 and in the night of March 14 were released in the course of fuel melting at Units 3 and 2, respectively. Neutrons may have been generated by the spontaneous fission of released actinides.

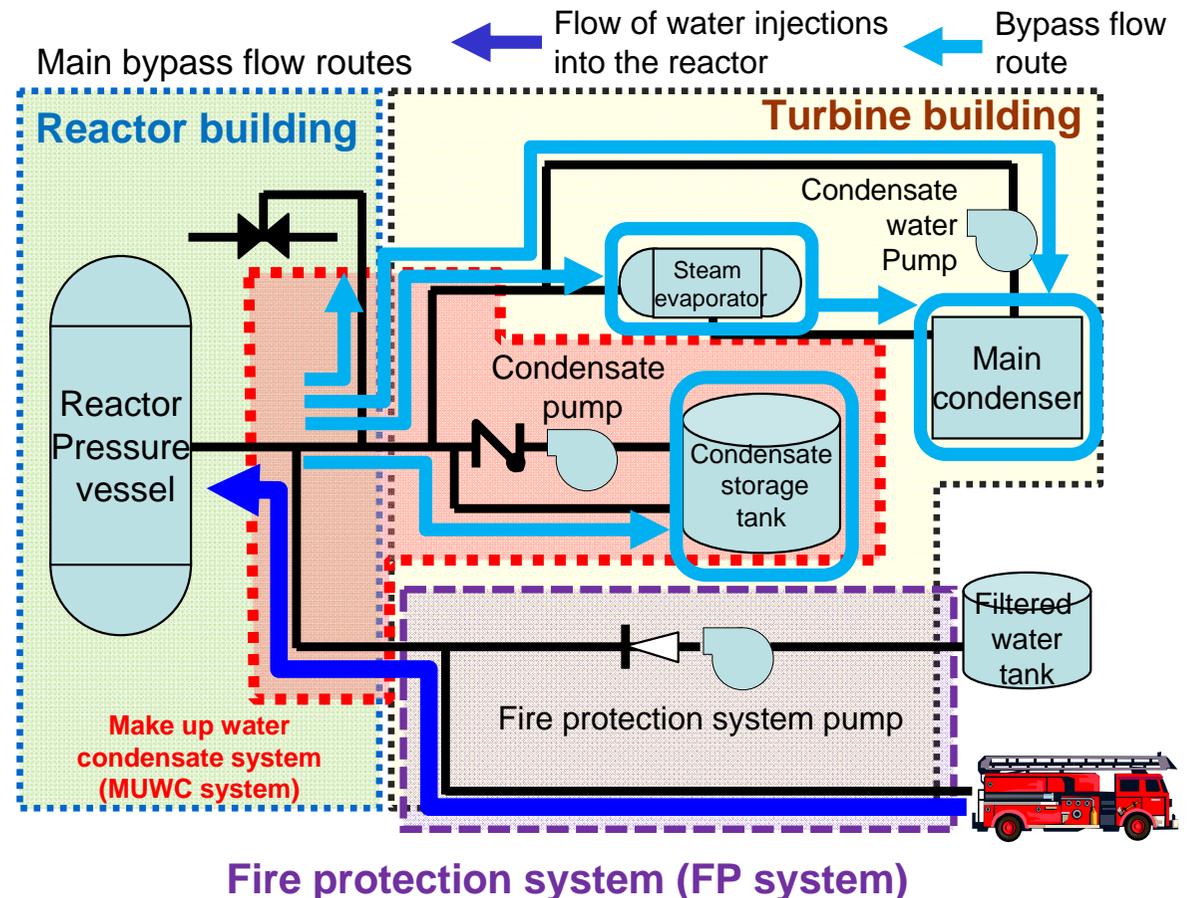
(2) Evaluation results

20% to 50% of cooling water may have been injected into the reactor.

Note, however, that records of discharge pressure and flow rate, etc. from fire engines are few, and leave many aspects unclear; therefore, we will need to continue our review by conducting sensitivity analysis and comparison with plant response.

If we assume fire engine discharge pressure to have been constant at 1MPa, then about 20% to 50% of water injected reached the reactor.
