Evaluation of the situation of  
cores and containment vessels of  
Fukushima Daiichi Nuclear Power Station  
Units-1 to 3 and examination into unsolved  
issues in the accident progression

Progress Report No. 2

August 6, 2014

Tokyo Electric Power Company, Inc.

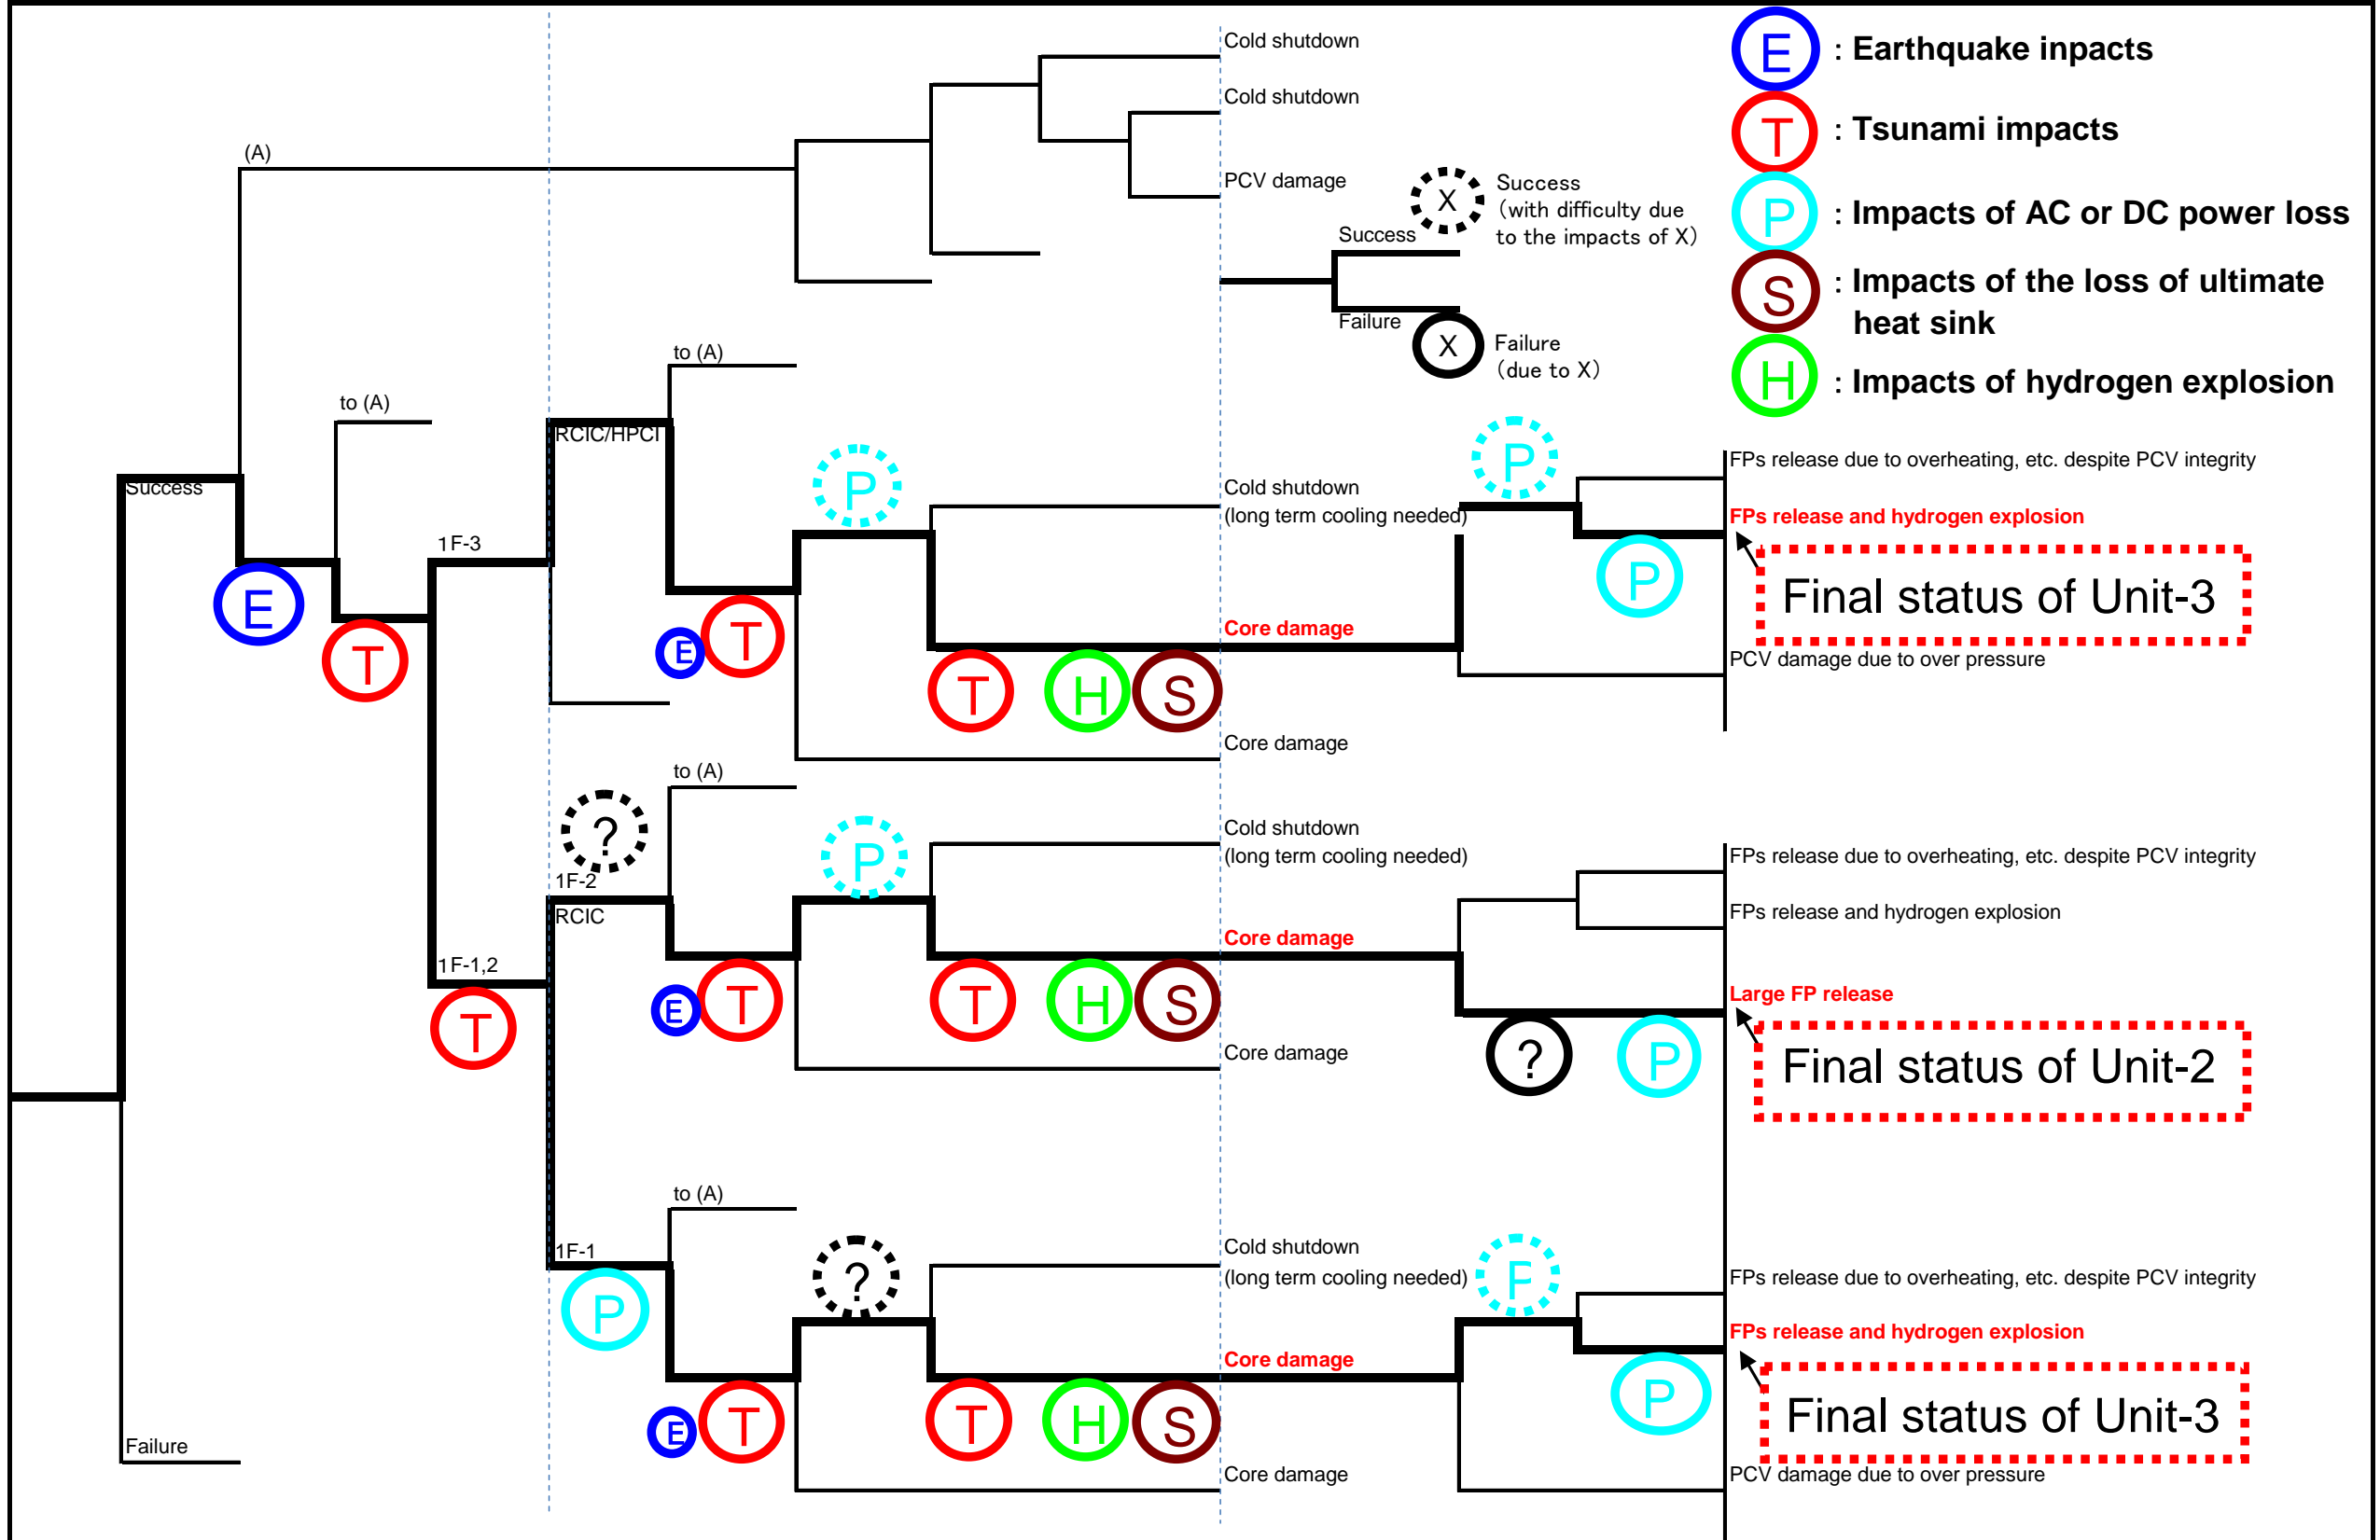
Fig. 1 Event-tree analysis results of Units-1 to 3 of Fukushima Daiichi Nuclear Power Station

Below are detailed explanatory remarks about the event-tree analysis illustrated in Figure 1 of the first chapter. An event-tree analysis is a means to analyze what sequences a system follows starting at an initiating event to the ultimate status via junctions such as a loss of function of safety-related equipment. Generally at a junction, a branch above (success) leads an accident progression in the direction of cold shutdown, while a branch below (failure) leads in the direction to a severe accident. The more outcomes going to branches below, the more dangerous the ultimate plant conditions would be. Junctions are defined as a success or failure of functions of safety-related systems or equipment, etc. in an accident progression. Basically a junction follows a junction at its left, but the time difference between the two is not fixed, and varies according to the accident progression features at each unit.
