List of issues to be investigated

List of issues

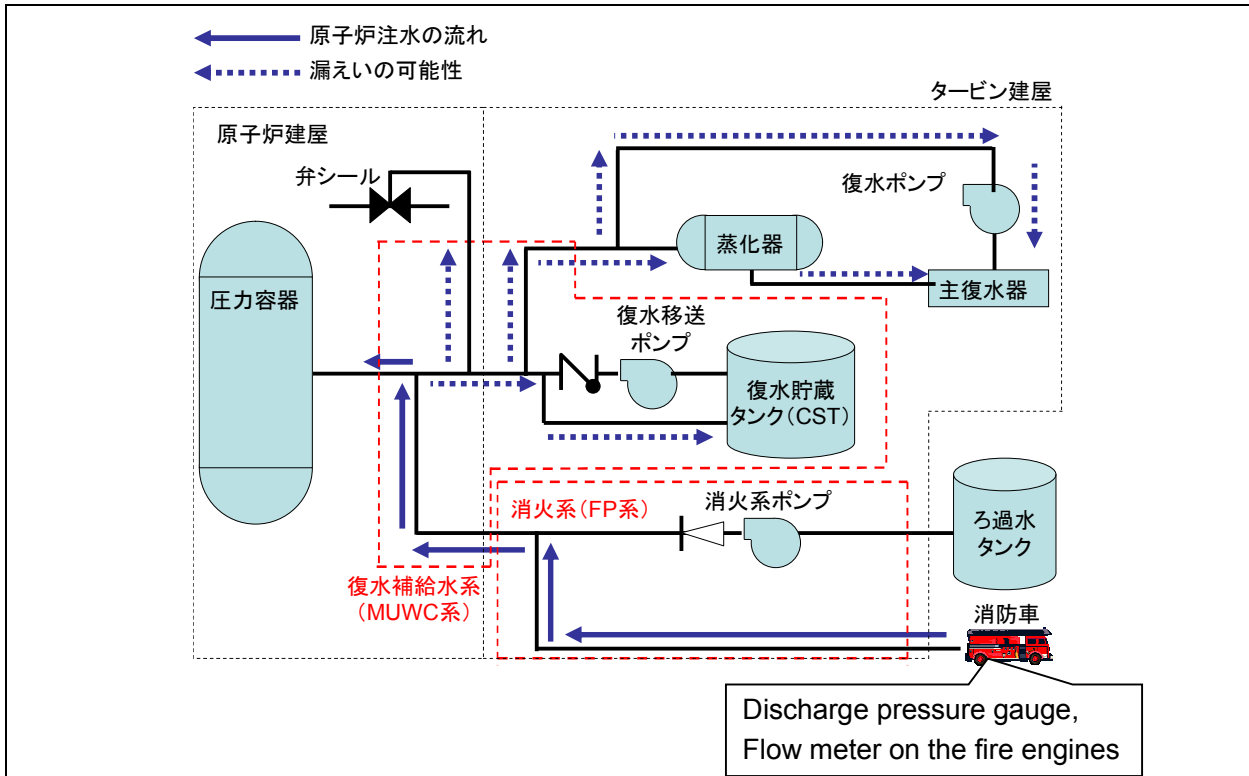
Common/Issue-2	Common	Category A③	Class (1)	Safety measures in [1]: p36
Amounts of water injected to the reactor by fire engines				Results: Attachment 1-4, 1-5
<p>Ultimately, Unit-1 to Unit-3 lost all their water injection functions which had been expected to work in an accident, and fire engines were alternatively used for the emergency water injection.</p> <p>The information relevant to the amount of water injected was compiled as the estimated amount (daily average of the amount injected) based on the discharge pressure of fire engines and flow rate indicator readings at the time of the accident. But their accuracies are not satisfactory, and part of the water injected is considered to have flowed to other systems and equipment, bypassing the water injection line to each reactor unit.</p> <p>At Unit-1, for instance, water injection was interrupted at 01:10 on March 14th. At 20:00 on the same day, water injection was resumed (via the reactor core spray system), but no reactor pressure increase was observed, indicating a possibility of no water, or only a small amount, being injected. At 02:33 on March 23rd, when the reactor feedwater system started to inject water, the reactor and PCV pressure increased, probably due to steam generation. This indicates a possibility of no water, or only a small amount, having been injected before.</p> <p>In the MAAP analysis, the amount of water injected to the reactor was set substantially less than the amount of water injected by fire engines, in order to simulate the observed PCV pressure changes. The amount of water injected to the reactor is of critical importance in examining the accident progression. Therefore, the actual amount of water injected to the reactor needs to be clarified because it has a big uncertainty.</p>

Figure Schematics of alternative water injection lines using fire engine pumps

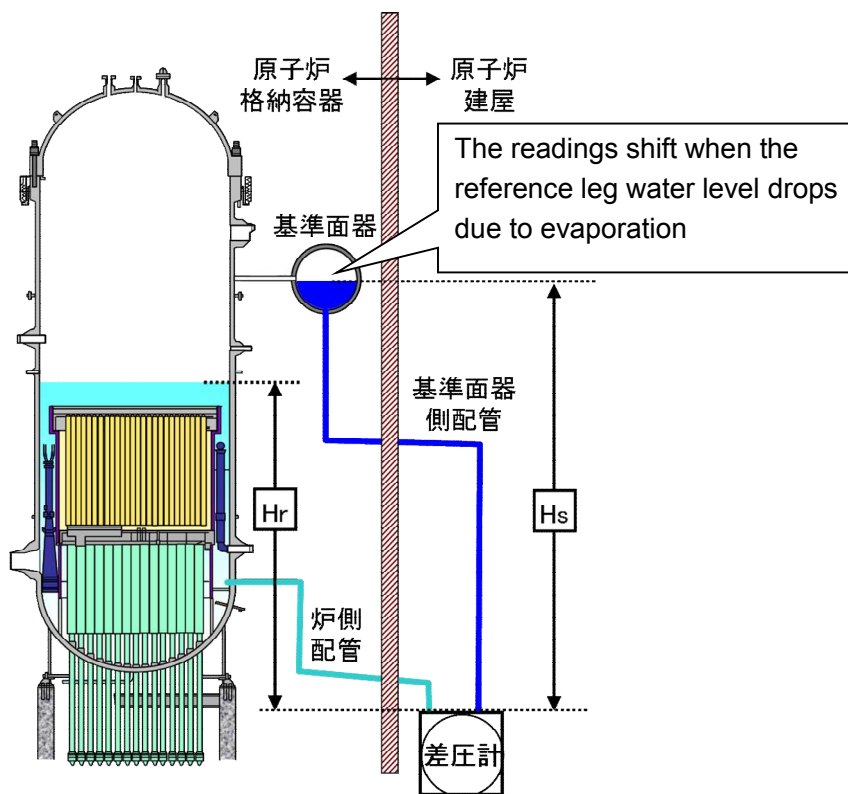
At Unit-1, the reactor water level could not be temporarily measured after the station blackout caused by the tsunami. When the reactor water level indicators were restored by temporary battery supplies at 21:19 on March 11th, the water level indicators showed an increase despite the fact that no water was being injected into the reactor. In view of the measurement principle of water level indicators, the apparent increase of the water level is considered to be due to incorrect readings caused by water evaporation in the reference leg (piping on the reference water level side) of the water level indicators. Ultimately it is considered that Unit-2 and Unit-3 also experienced similar incorrect readings of the water level indicators.

Examination is to be done to clarify when and why the water level indicators began to give incorrect readings, because it may provide some clues to estimate the reactor situations at those times.

Figure Working principle of reactor water level indicators

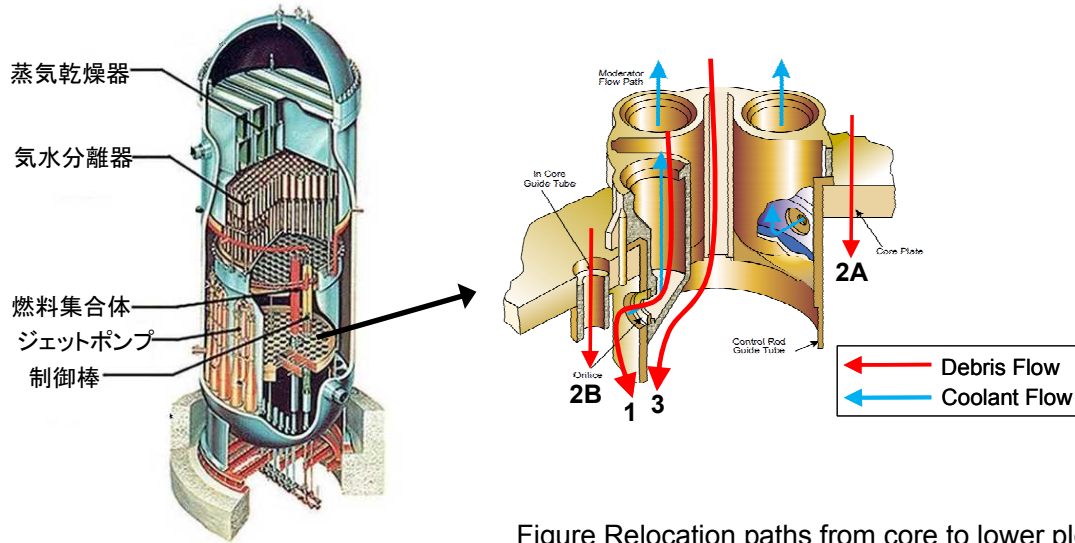
Common/Issue-6	Common	Category B②	Class (2)	Safety measures in [1] -
Molten core behavior on falling to the lower plenum				Results: Attachment 1-8
<p>MAAP employs basically Three Mile Island (TMI) knowledge in simulating the molten fuel relocation mechanism to the lower plenum, in which molten fuel destructs the core support plate and reaches the lower plenum. On the other hand, BWRs have complex lower structures, which could configure other molten fuel relocation paths to the lower plenum: via the coolant flow paths through a side entry orifice at the fuel support; or via the surrounding bypass region (whereto the molten fuel could migrate in the radial direction from the core) and, by damaging the shroud, further through the outer shroud region (downcomer region).</p> <p>In the MAAP analysis of Unit-1 to date, the reactor pressure showed a sharp peak at around 22:00 on March 11th. This comes from the model in the analysis that the molten fuel stayed temporarily on the core support plate for a while and, as soon as the core support plate was damaged, the molten fuel dropped instantaneously to the lower plenum, generating a large amount of hydrogen gas.</p> <p>It is necessary to clarify the molten fuel behavior during relocation to the lower plenum in order to contribute to understanding of the accident progression and estimation of the situation in the core and PCV.</p>

Figure Relocation paths from core to lower plenum

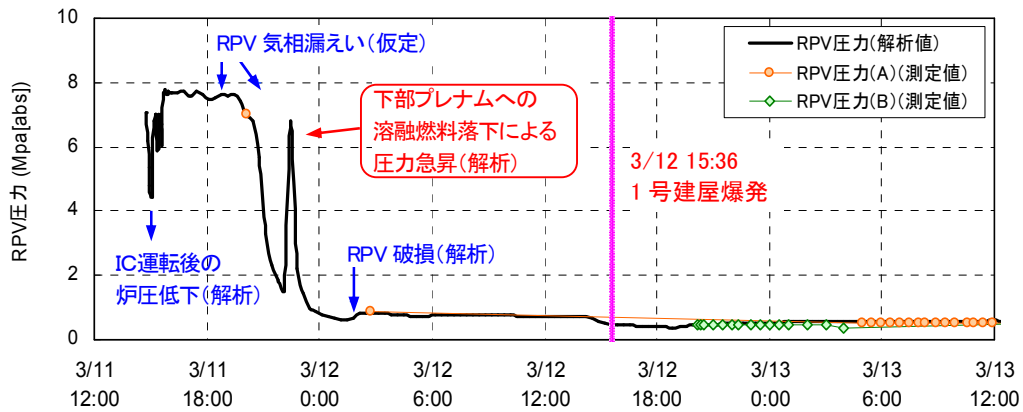
RPV 気相漏えい(仮定)	Gaseous leak from RPV (assumed)
下部プレナムへの溶融燃料落下による圧力急昇(解析)...	Sharp pressure increase due to debris slumping to lower plenum
IC運転後の炉圧低下(解析)	Pressure decrease after IC operation (anal.)
RPV 破損(解析)	RPV failure (anal.)
3/12 15:36 1号建屋爆発	At 15:36 March 12 th Unit-1 R/B exploded

Figure Reactor water level and PCV pressure changes in Unit-1

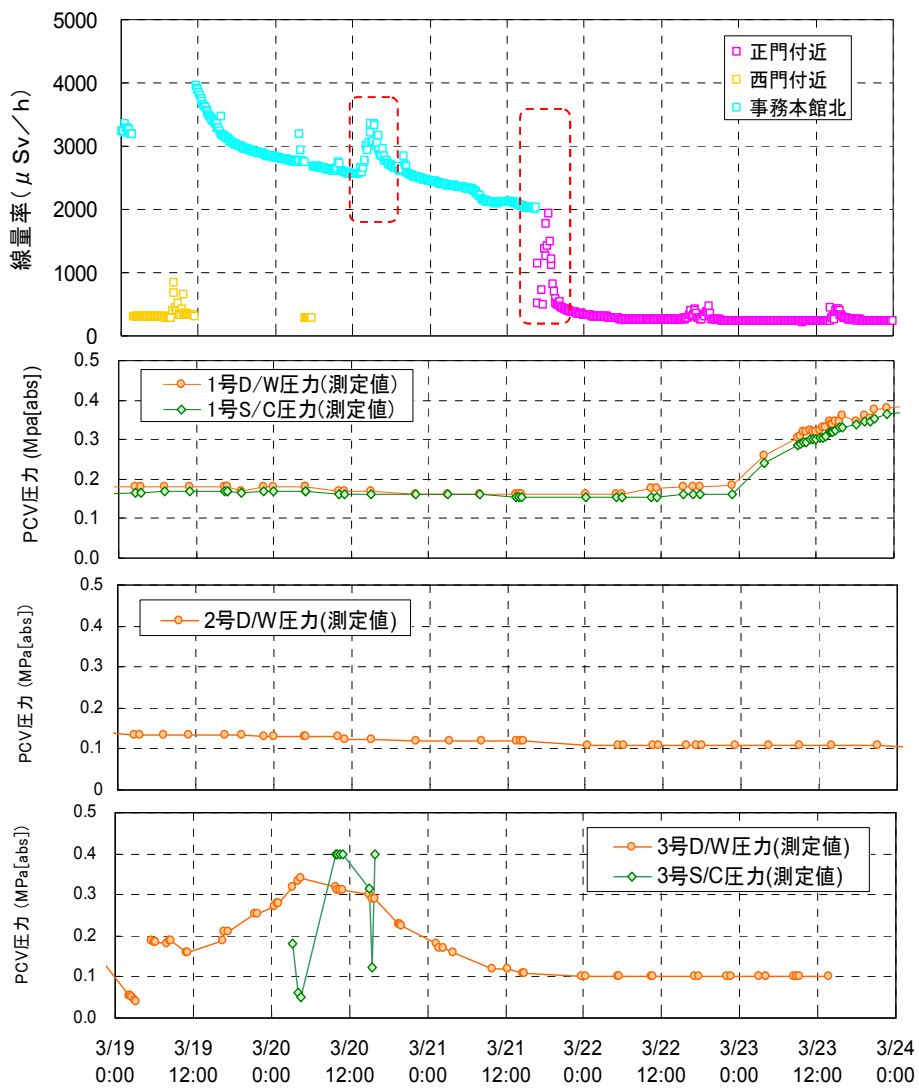
Common/Issue-9	Common	Category B⑤	Class (2)	Safety measures in [1]: -
Air dose increases on around March 20 th				Results: Attachment: 3-6
<p>At Unit-1 and Unit-3, the water injection rate observed on the Accident Management (AM) panel showed a big decrease from March 20th and 21st for several days. This may indicate that the reactor cooling was not sufficient to prevent the release of radioactive materials. Further, at about 16:00 on March 21st when black smoke rose at Unit-3, a sharp increase was observed in the air dose rate near the main gate, although no significant changes were noticed in the DW pressures and the RPV pressures.</p> <p>The analysis using MAAP is terminated in about a week at the maximum after the earthquake. This is because the uncertainties of the analysis become larger with the extended time of analysis and the reliabilities of the results are significantly lowered.</p> <p>Fission products released around March 20th and 21st from the Fukushima Daiichi NPS might have caused radiation dose increases in parts of the Kanto region, depending on the wind directions, and might have led to some recommendations to refrain from tap water intake due to increased radioiodine concentration levels. Details of radioactive materials release behavior need to be clarified.</p>

Figure Air dose rates at the Fukushima Daiichi NPS from March 19th to 23rd

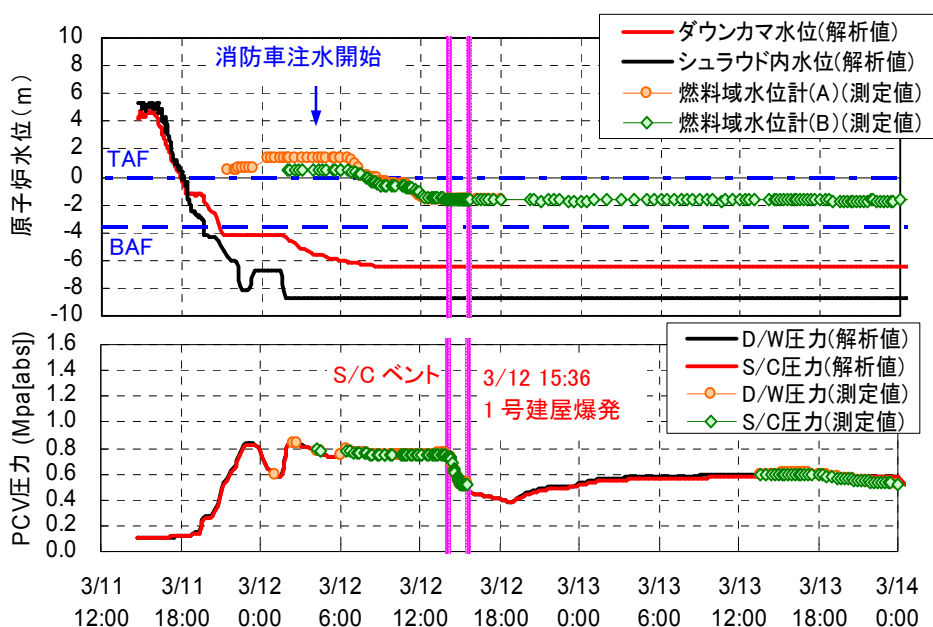
At Unit-1, the D/W pressure decrease was confirmed from 14:30 through around 14:50 on March 12th following the large S/C vent valve opening operation. At 15:36 on that day, hydrogen exploded in this reactor building and the roof and the outer walls of the top floor were heavily damaged.

These hydrogen explosions are considered to have been caused by hydrogen gas generated mainly by zirconium-water reactions which leaked out with steam to the reactor buildings. It is necessary to clarify the amounts of hydrogen gas generated and leak paths.

Figure RPV water level and PCV pressure changes at Unit-1 until the hydrogen explosion occurred

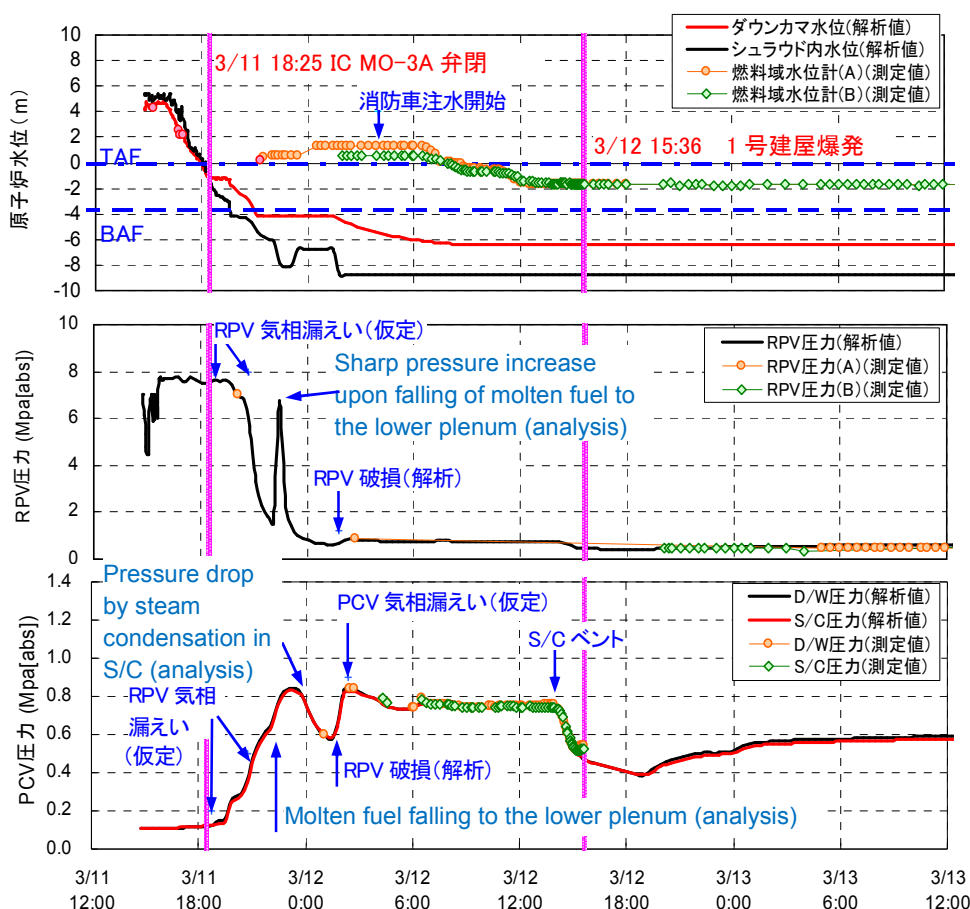
Unit-1/Issue-2	Unit-1	Category A⑤	Class (2)	Safety measures in [1]:
Plant behavior if the Unit-1 ICs had functioned				Results: Attachment 1-7
<p>At Unit-1, the reactor pressure was being controlled after the earthquake by intermittent operation of the emergency isolation condensers (ICs). Immediately before all power supplies were lost due to tsunami, the IC operation had been incidentally in a halted situation. In the station blackout condition, the shift operators in the MCR noticed the display lamps indicating the IC (Sub-system A) isolation valves (MO-2A, MO-3A) as “Closed” outside the PCV at around 18:00 on March 11th. They took action to open the valves at 18:18 on March 11th, and confirmed the steam generating sounds and saw the steam when looking above the reactor building, but the amount of steam was limited and it stopped a while later. Concerned about the water inventory left in the IC shell side tank, at 18:25 the operators closed the isolation valve (MO-3A) on the return line.</p> <p>Post-accident surveys of the water level in the IC shell side tank showed that the water level of Sub-system A had been 65% (normal level was 80%) and the water in the tank had been sufficient. If the isolation valve (MO-3A) on the return line had not been closed at 18:25 on March 11th, the reactor cooling by the IC might have been continued.</p> <p>Therefore, the reason why the amount of steam generation was limited upon the opening of the IC Sub-system A isolation valves outside the PCV and why it stopped after a while (Unit-1/Issue-1) will be investigated. In addition the effect on the accident progression will be investigated, if the isolation valve of IC (Sub-system A) outside the PCV had been kept open after 18:25 on March 11th.</p>

Figure Changes of Unit-1RPV water level, RPV pressure and PCV pressures

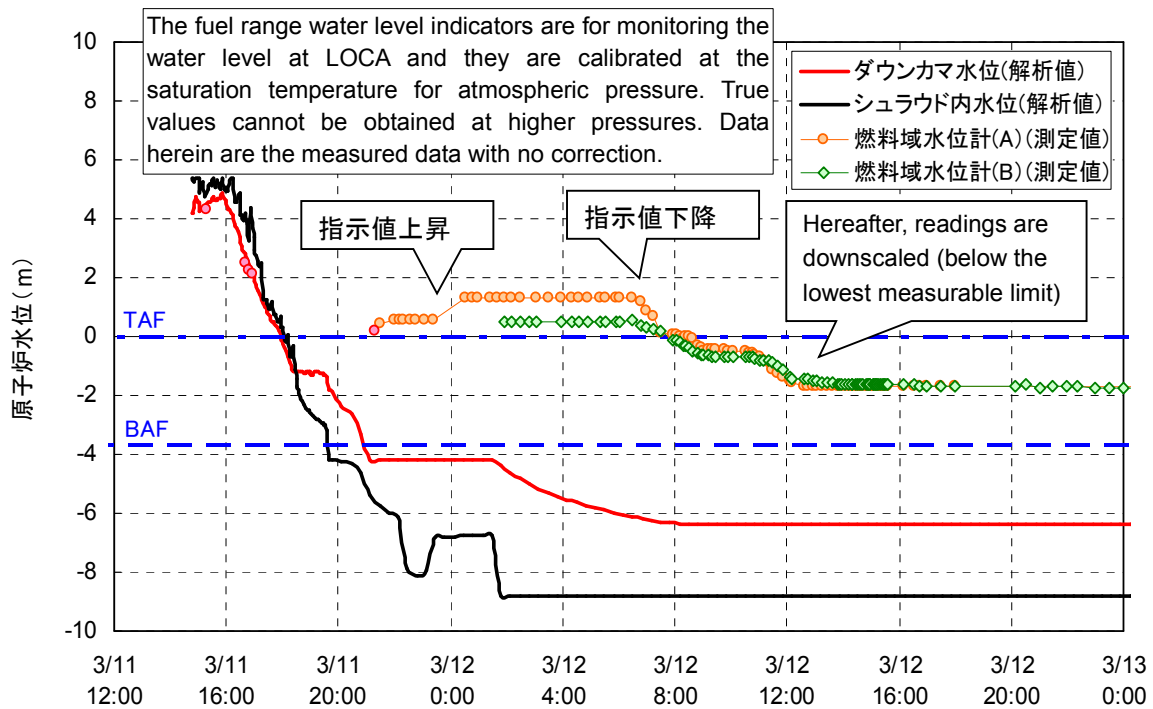
The fuel range water level indicators of the condensing water chamber type cannot show true values when the PCV temperature rises or the reactor pressure decreases, because the water in the piping in the condensation chamber evaporates. Therefore, the fuel range reactor water level indicators seem to have been already malfunctioning when restored by the temporary power supply.

But the water levels indicator readings tell the pressure difference between the reference leg and variable leg. It is possible that some information might be obtained on the reactor depressurization timings or reactor water levels.

Figure Reactor water level changes at Unit-1

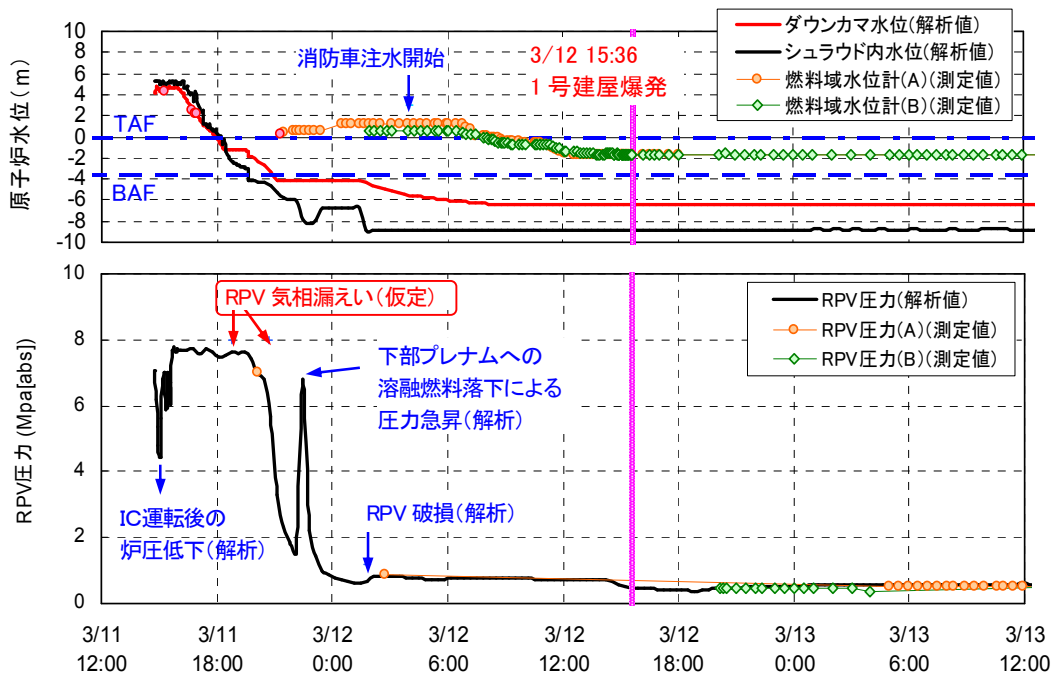
Unit-1/Issue-5	Unit-1	Category B③	Class (2)	Safety measures in [1]: pp27-36
Leaks in gaseous phase from Unit-1 RPV				Results: -
<p>At Unit-1, the RPV pressure measured 7.0MPa[abs] at 20:07 and the D/W pressure measured 0.6MPa[abs] at about 23:50 on March 11th, while the D/W pressure was 0.84MPa[abs] at 02:30 and the RPV pressure was 0.9MPa[abs] at 02:45 on March 12th. Although the exact timings are unclear, it was confirmed that the PCV pressure showed a big increase. And the RPV pressure decreased despite no depressurization operation.</p> <p>If the reactor water level drops and the core starts to be uncovered, the heat transfer from the overheated core and the overheated steam heat up the RPV pressure boundary above its normal temperatures. There may be a possibility that leak holes form for leaks in the gaseous phase at some of these upper locations before the molten fuel penetrates the RPV bottom, and the RPV pressure may decrease if the leak holes are big enough. Should that have occurred, it would affect the timings of RPV damage and the thermal and mechanical loads to the PCV after the RPV damage.</p> <p>The MAAP analysis assumed that the core temperatures were elevated by the overheating of the uncovered core and molten fuel, resulting in gaseous leaks from the RPV to the D/W through the in-core instrumentation dry tubes or the SRV flanges on the main steam line.</p> <p>But there is no direct evidence of measured plant parameters or observations that confirms leaks through these leak paths. Clarification is needed for grasping the core and PCV conditions.</p>

Figure RPV and PCV pressure changes at Unit-1

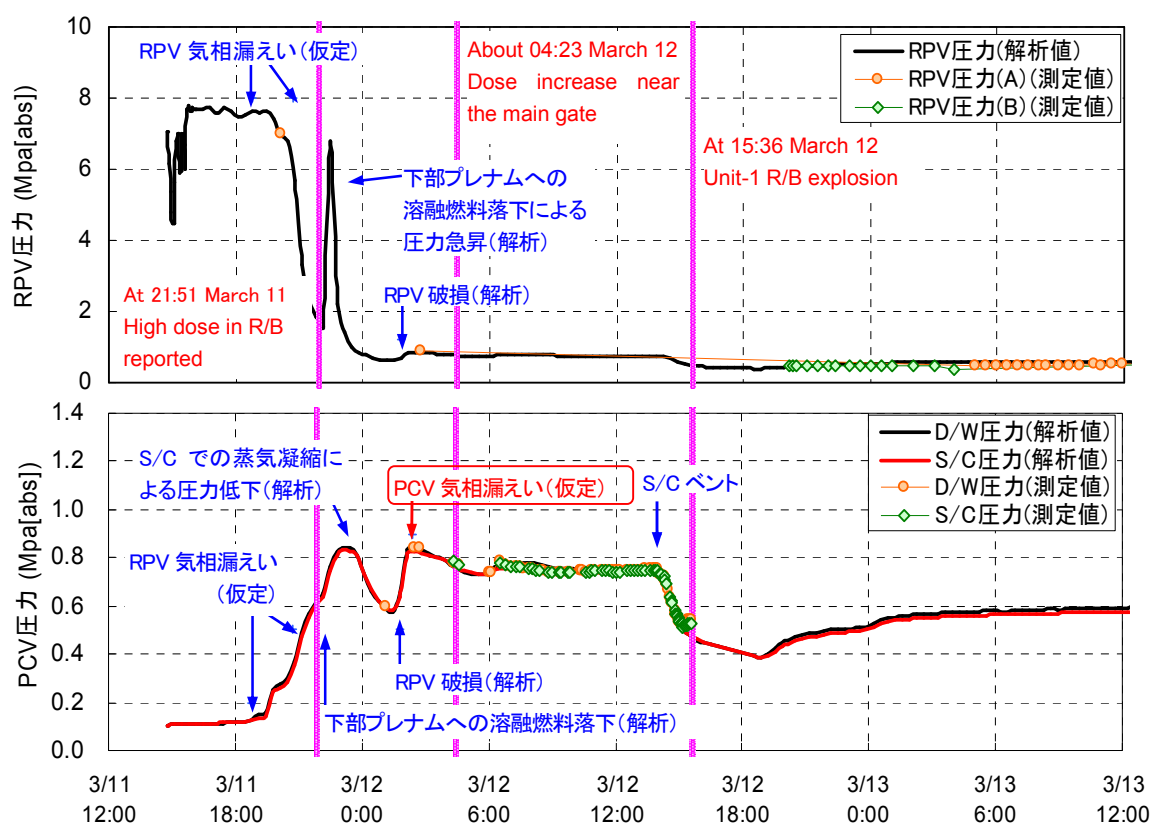
Unit-1/Issue-6	Unit-1	Category B④	Class (1)	Safety measures in [1]: pp.27-43
Leaks in gaseous phase from Unit-1 PCV				Results: -
<p>The Unit-1 DW pressure measured 0.6MPa[abs] at about 23:50 on March 11th, 0.84MPa[abs] at about 02:30 on March 12th and then stayed between 0.7MPa[abs] and 0.8MPa[abs] until it decreased at about 14:30 by the venting operation.</p> <p>Steam generation by water injection, the PCV temperature increases, the gas production by core-concrete reactions, etc. are likely to increase the PCV pressures. Nevertheless, it remained at a level which may indicate possible leaks from the PCV.</p> <p>In the meantime, shift operators entered the reactor building at about 21:00 on March 11th, when their APDs measured 0.8mSv instantaneously. They reported it upon return to the MCR at 21:51. At about 04:00 on March 12th and onward, the dose rates increased in wide areas near the main gate.</p> <p>The MAAP analysis assumed gaseous leaks from the PCV to the reactor building at about 03:10 on March 12th, about 12 hours after the earthquake. It was so assumed to roughly simulate the measured PCV pressure changes. But there is no direct evidence of measured plant parameters or observations that confirms the timing of leaks and their paths.</p> <p>Clarification is needed for grasping the PCV conditions.</p>

Figure RPV and PCV pressure changes at Unit-1

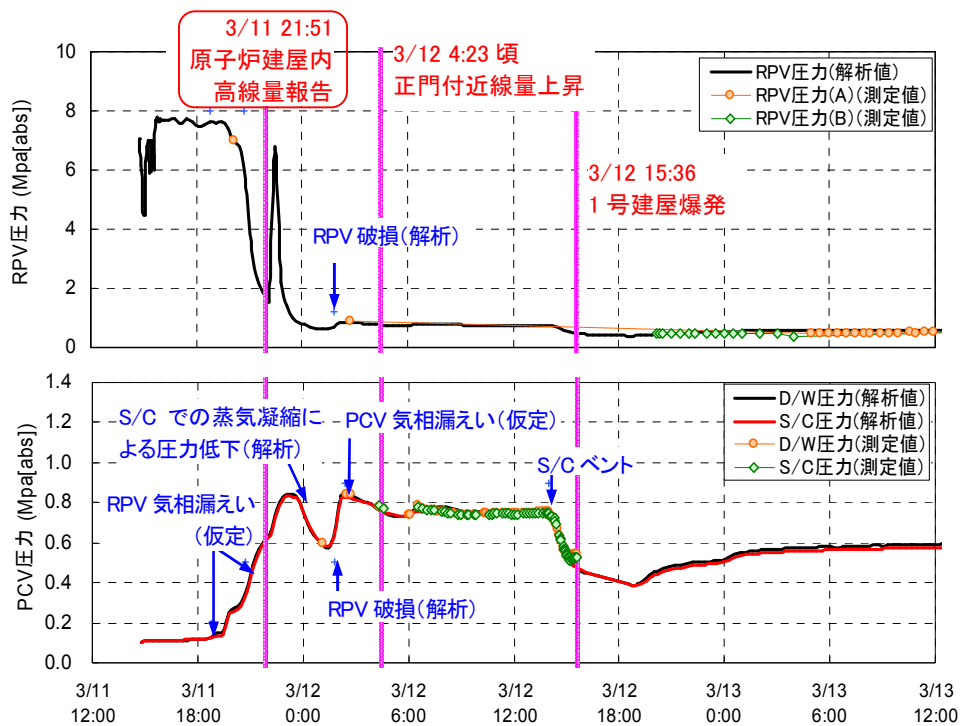
Unit-1/Issue-7	Unit-1	Category B⑤	Class (2)	Safety measures in [1]: pp.27-36 (strengthening of water injection means)
Dose rate increase in Unit-1 reactor building on March 11 th				Results: -
<p>At 17:19 on March 11th, shift operators approached the Unit-1 reactor building, carrying a GM survey meter for contamination inspections, in order to check the RPV pressure indicators and the IC shell side remaining water levels. When they opened an outer airlock door, their GM survey meter gave a value higher than normal (recording 300cpm, about three time the usual background). They returned to the MCR to report this at 17:50.</p> <p>There is a further record that at about 21:00 on March 11th, when shift operators entered the reactor building, their APDs measured 0.8mSv instantaneously and they reported it upon return to the MCR at 21:51.</p> <p>By referring to the written records on the MCR whiteboard for consideration, the dose rate at the spot could be 288mSv/h, <i>if</i> "instantaneously" were assumed as 10 seconds. When compared to the dose limit 100mSv for emergency operations, this dose rate (288mSv/h) is high enough to impede the accident management operations.</p> <p>It is not clear whether the dose rates in the reactor building were high, when shift operators entered the reactor building at 20:07 on March 11th to check the RPV pressure indicators. It has been confirmed that, later at 23:00, the dose rates before the airlock doors of the reactor building were high (1.2mSv/h in front of the outside of the north airlock door, and 0.52mSv/h in front of the outside of the south airlock door).</p> <p>Thus, the high dose rates are recognized at an early stage of the accident at Unit-1, but there is no direct evidence which shows the exact timings and paths of fission product leaks. It is necessary to clarify them, in combination with the Unit-1/issue-8 and 9, in order to assess the accessibility to the reactor building for accident management operations as well as to estimate the conditions of the core and the PCV.</p>

Figure RPV and PCV pressure changes at Unit-1

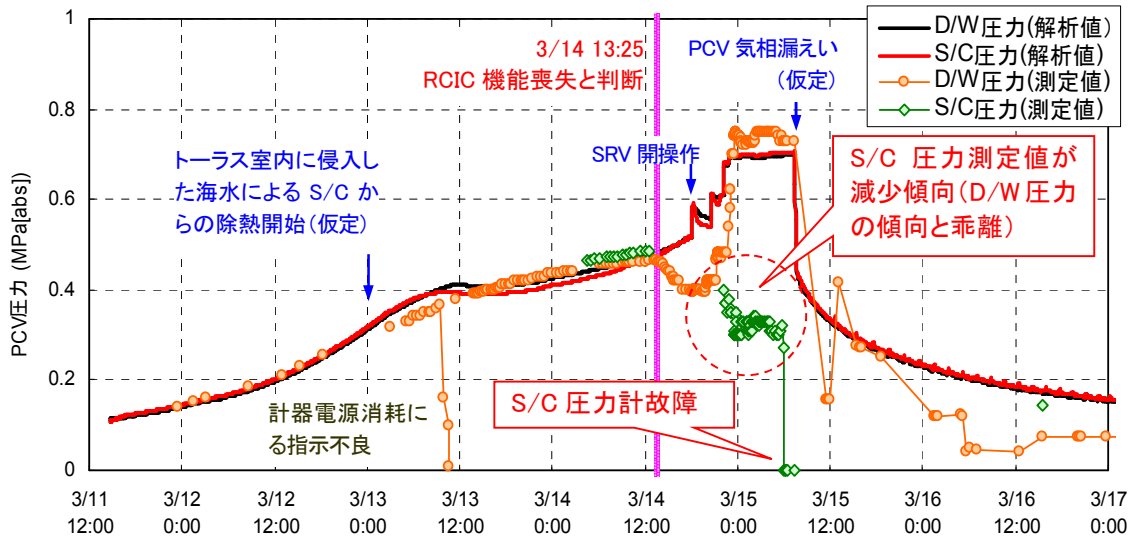
Unit-2/Issue-3	Unit-2	Category A⑤	Class (2)	Safety measures in [1]: -
Behavior of S/C pressure of Unit-2 after 21:00 on March 14 th				Results: -
<p>The D/W pressure of Unit-2 gradually increased while the RCIC was in operation, and after the RCIC was shut down it began to decrease at about 13:00 on March 14th. Thereafter it increased at about 20:00, about 21:00, about 23:00 and reached about 0.75MPa[abs] probably due to incondensable gas accumulation in the D/W because of hydrogen generation and the SRV opening.</p> <p>In the meantime, the S/C pressure measured about the same value as that of the D/W from 04:30 to about 12:30 on March 14th by the pressure indicator originally installed to this plant. The measurement was interrupted thereafter by defective readings. When the measurement was resumed at 22:10 by an S/C pressure indicator introduced for accident management (AM), it showed a lower value than that of the D/W. The S/C pressure indicator for AM was to measure the reference leg pressure of the S/C water level indicator mounted on a branch line off the S/C venting line.</p> <p>Such a discrepancy between the D/W and S/C pressures is very unrealistic for the PCV structural reasons. These pressure indicators should indicate consistent values. For this reason, the S/C pressure indicator is likely to have indicated wrong values. Eventually, the S/C pressure indicator downscaled at 06:00 on March 15th and the instrumentation system seems to have gone out of service. There is a possibility that the behavior of these pressure indicators and the timing of their failure may provide some meaningful information.</p>

Figure PCV pressure changes in Unit-2

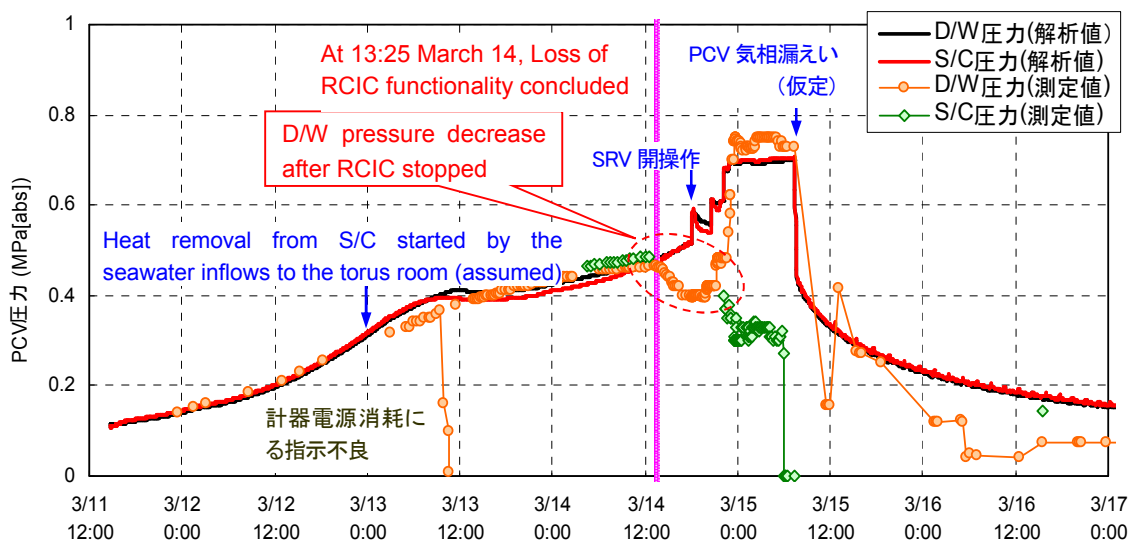
The D/W pressure of Unit-2 increased gradually while the RCIC was in operation. It began to decrease at about 13:00 on March 14th after the RCIC had been shut down. Theoretically, the decay heat in the RPV is transferred to the S/C by steam whether the RCIC is in operation or shutdown, and the D/W pressure is anticipated to increase gradually.

The above-mentioned D/W pressure decrease could be explained by possible leaks from the PCV. But it cannot explain the pressure increase afterward. Another possible interpretation was that the D/W pressure decrease was due to the continued total S/C energy inventory decrease by the heat removal by the water accumulated in the torus room, because the energy could not be transferred to the PCV (D/W) via the S/C by the RCIC turbine until starting energy transfer via SRV. However, the latest MAAP analysis could not reproduce the phenomena of the PCV pressure decrease. There is another inconsistency: the PCV pressure decrease started more than 1 hour later than 12:00 noon when the RCIC is estimated, from the RPV pressure increasing trend, to have completely stopped. This timing almost coincides with the timing when the energy transfer from the SRV to the S/C started; therefore, the scenario of continued heat removal through the S/C walls combined with the energy flow (to the S/C from the RCIC turbine) termination cannot be explained.

Figure PCV pressure changes in Unit-2

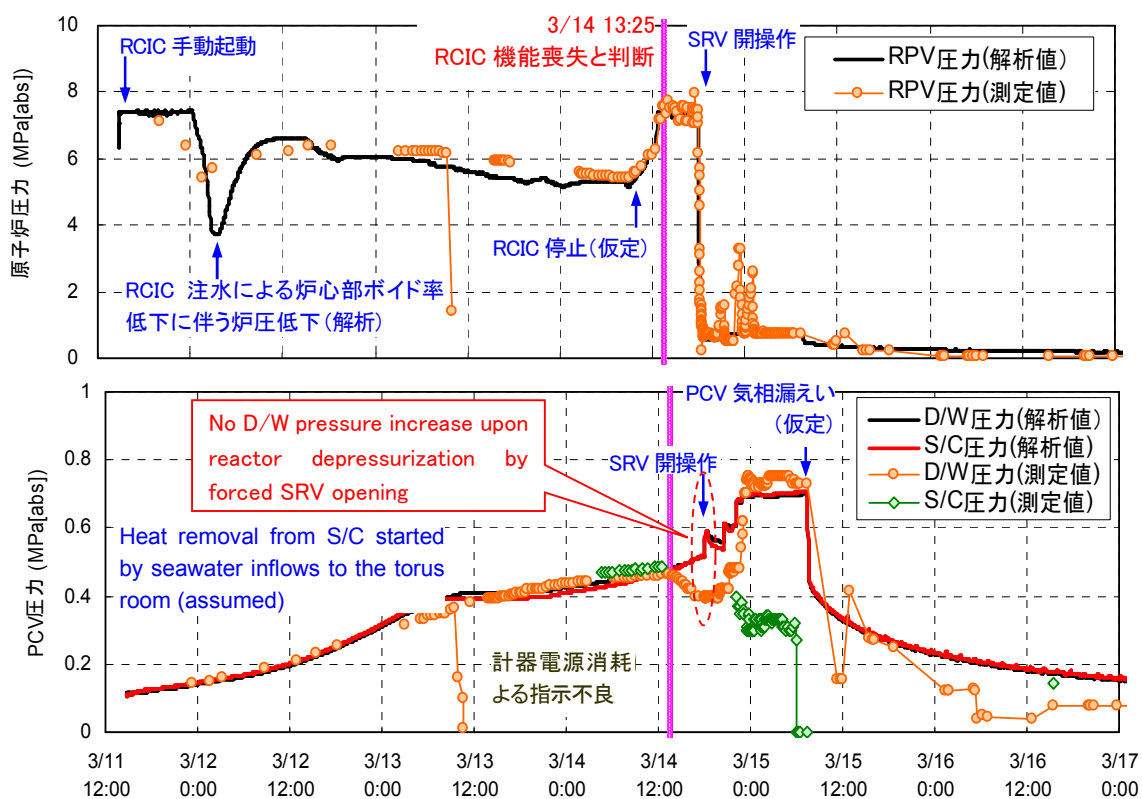
Unit-2/Issue-6	Unit-2	Category B①	Class (2)	Safety measures in [1]: -
PCV pressure behavior upon forced SRV opening at Unit-2				Results: Attachment 2-6
<p>At Unit-2 the manual forced depressurization of the reactor was successfully completed at 18:02 on March 14th by the opening operation of the SRV(s). Theoretically, the D/W pressure should increase by a large amount of steam (energy) flow into the S/C upon forced depressurization by the SRV(s). Nevertheless, it remained at about 0.4MPa[abs] from 17:00 through 20:00.</p> <p>It should be noted that, thereafter at about 20:00, 21:00 and 23:00 on March 14th, the D/W pressure showed an increase and reached about 0.75MPa[abs], probably due to the accumulation of the incondensable gases.</p> <p>The MAAP analysis predicted the pressure increase upon forced depressurization. It is necessary to clarify the pressure change behavior upon forced depressurization by the SRV(s).</p>

Figure Pressure changes of RPV and PCV at Unit-2

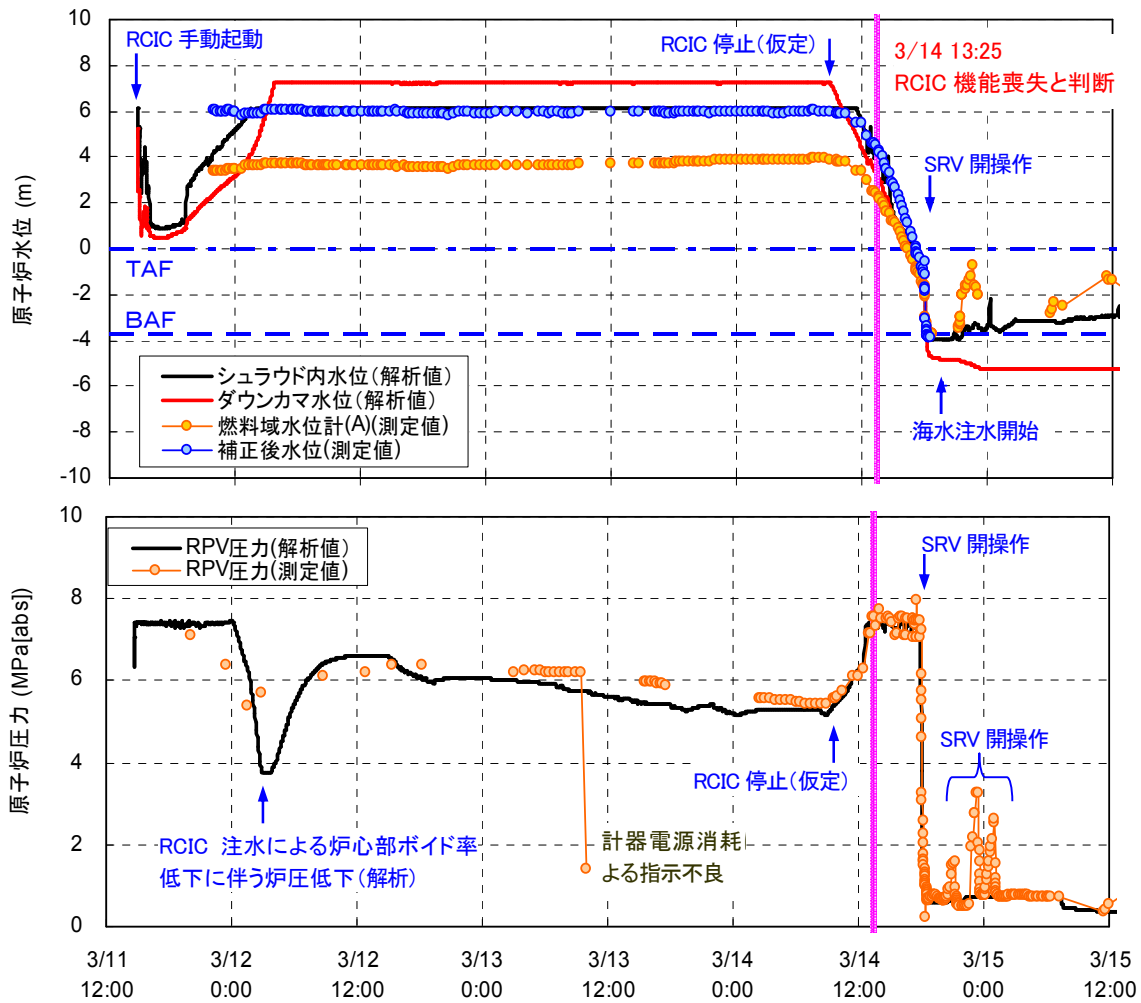
Unit-2/Issue-8	Unit-2	Category B③	Class (1)	Safety measures in [1]: pp.27~36
Leaks in gaseous phase from Unit-2 RPV				Results: Attachment 2-10
<p>At Unit-2 the forced depressurization of the reactor was successfully completed at 18:02 on March 14th by the opening operation of the SRV(s).</p> <p>The SRV(s) were repeatedly opened thereafter in order to control the intermittent reactor pressure increase. But the operation records of SRV opening and the RPV pressure decrease do not always coincide. For instance, the operations of manual opening are recorded twice at 21:20 on March 14th and at 01:10 on March 15th, but no record of confirming the SRV manual opening exists at the time of reactor pressure increase and decrease at about 23:00 on March 14th.</p> <p>The reactor water level indicator readings showed about the BAF level at the time of the forced depressurization, and the core melting progressed thereafter. In view of this, gaseous leaks might have occurred from the reactor vessel, due to, for example, damage of TIP tubes, which composed the pressure boundary. In addition, no further operations of SRV opening for depressurization were taken after a certain time.</p> <p>But there is no direct evidence in the measured plant parameters or observed events which shows when and from where the leaks actually occurred. Clarification is needed.</p>

Figure RPV water level and pressure changes at Unit-2

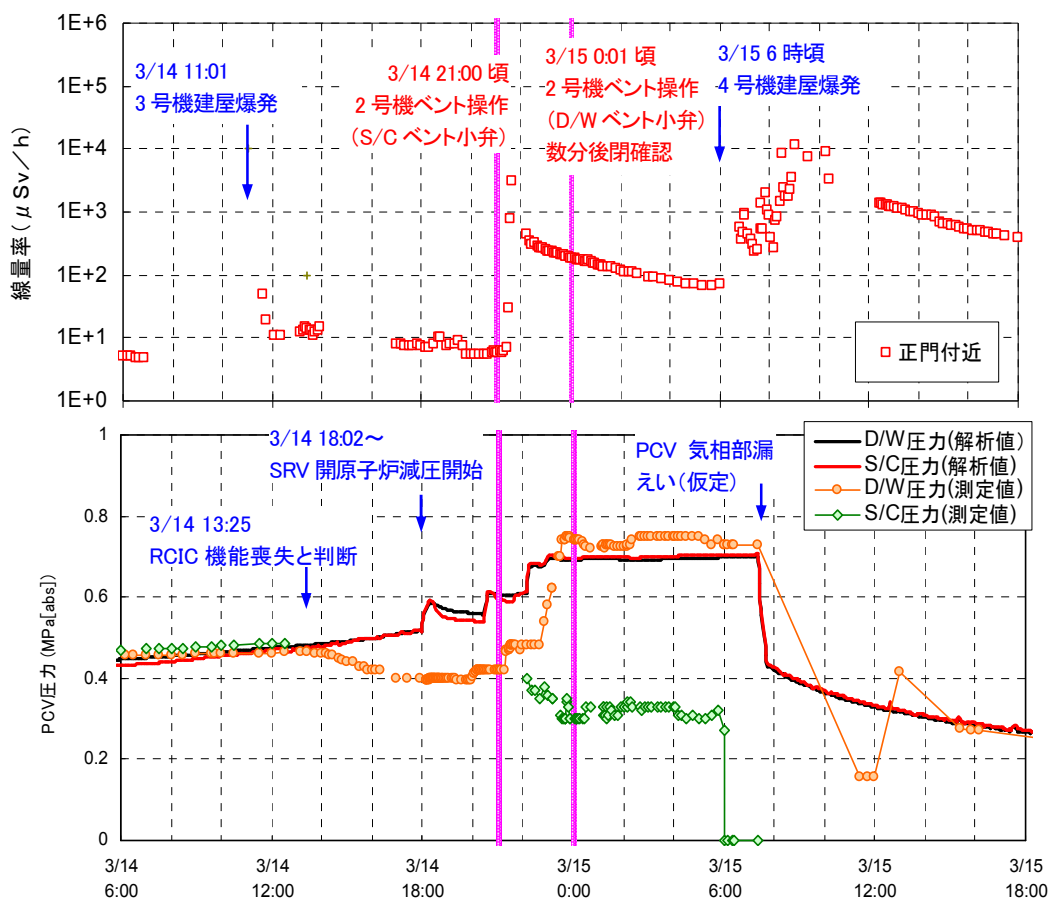
Unit-2/Issue-9	Unit-2	Category B①	Class (2)	Safety measures in [1]: p.40
Consideration of possible rupture disc actuation at Unit-2				Results: Attachment 4
<p>At Unit-2 the RCIC could continue injecting water with no power source for control, which had been lost due to the tsunami. But, since the need to vent the PCV was foreseen in due course, the venting line was configured by 11:00 on March 13th except for the rupture disc actuation.</p> <p>However, the large S/C vent valve (AO-valve) was confirmed to have been closed by the impacts of the explosion of the Unit-3 reactor building. Finally, the valve is considered to have become inoperable for opening actions due to the defective solenoid valve.</p> <p>At about 21:00 on March 14th, the small S/C vent valve was slightly opened by activating its solenoid valve. The venting line configuration was completed again except for the rupture disc actuation, but it was reported that the small S/C valve had been in the “Closed” position at 23:35 on March 14th.</p> <p>The S/C venting was thus being prepared for, but no clear evidence exists whether it actually was successful. Even if the S/C pressure indicators did not provide true values, the measured D/W pressure exceeded the rupture disc working pressure (528kPa[abs]) at about 23:00 on March 14th (540kPa[abs]). The S/C venting flow rate with the opened small S/C vent valve is limited, and so the D/W pressure decrease also will be limited. On the other hand, the monitoring car measured a sharp radiation dose increase near the main gate at about 21:20 on March 14th when the SRV opening was recorded.</p> <p>Clarification is needed to interpret the causes of the radiation dose increase, including the possibilities of PCV venting being implemented and the rupture disc actuation.</p>

Figure Radiation dose near the main gate and PCV pressure changes upon Unit-2 venting
[Back to List of Issues/Unit-2](#)

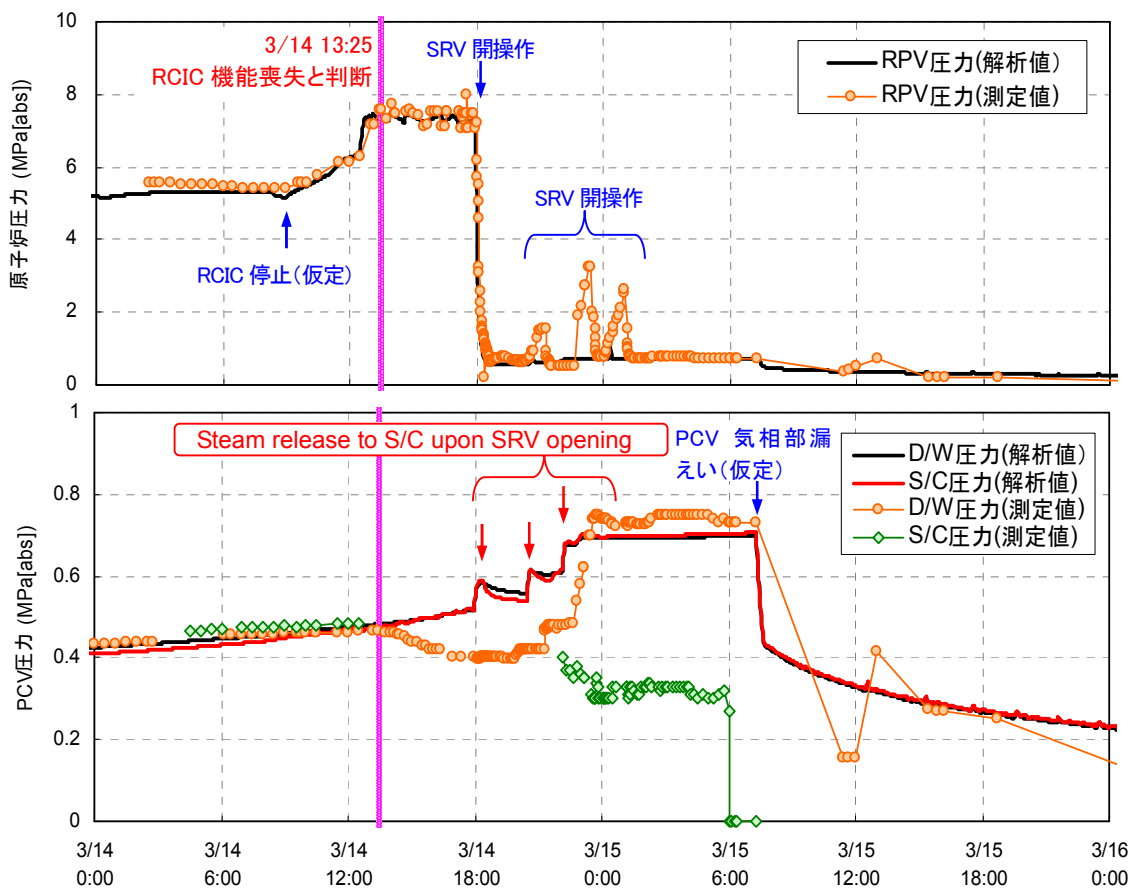
Figure RPV and PCV pressure changes at Unit-2

At Unit-2 the forced depressurization of the reactor was successfully completed at 18:02 on March 14th by the opening operation of the SRV. Further at about 21:00 on March 14th, an attempt was made to open another SRV because the reactor pressure had increased, but the pressure did not decrease. Further a third SRV was then actuated and the reactor pressure decreased at 21:20.

The reactor pressure was about 1.5MPa when it increased at about 21:00, when the core melting is considered to have been already progressing. Therefore, the exhaust upon reactor depressurization would have contained a large amount of hydrogen gas, a non-condensable gas. The non-condensable gas in the exhaust will cause pressure increase behavior different from that due to only steam in the exhaust. Clarification is needed concerning possible impacts on the S/C integrity due to hydrogen-rich steam release.

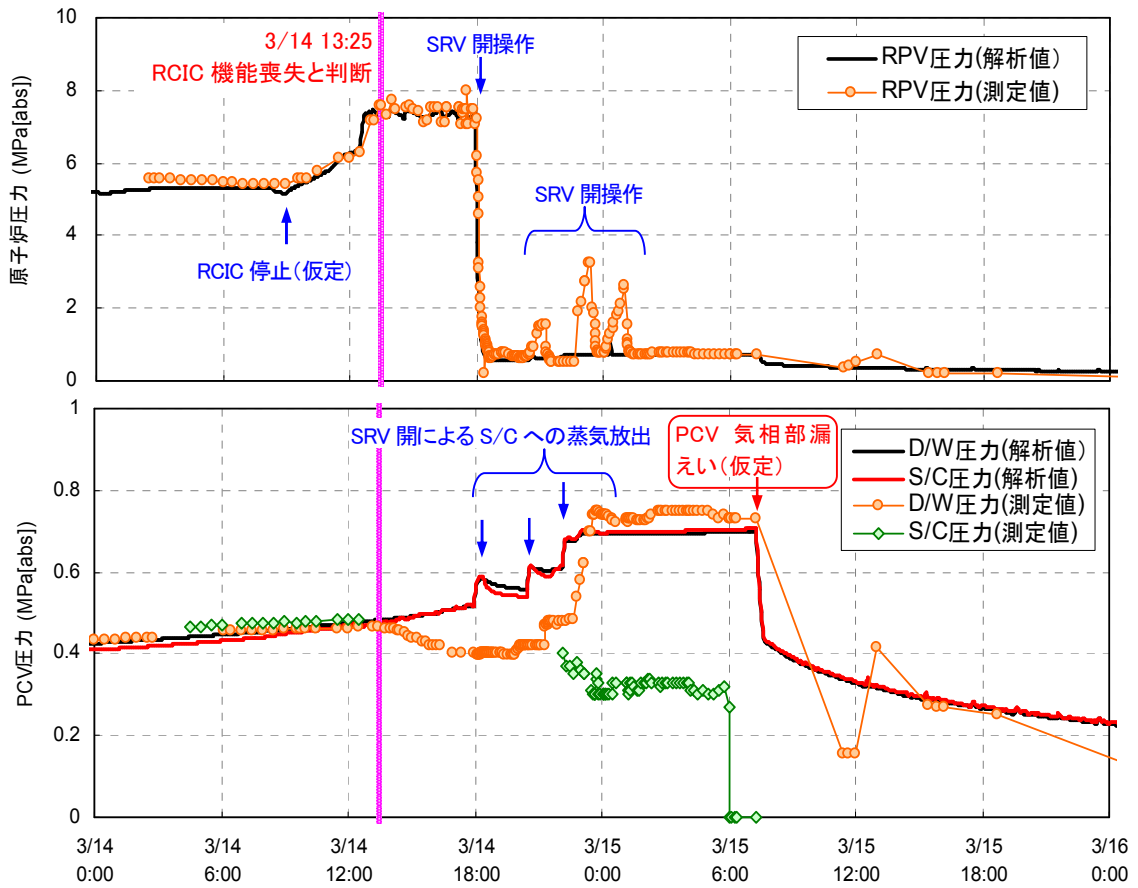
Figure RPV and PCV pressure changes at Unit-2

Unit-2/Issue-11	Unit-2	Category B①	Class (1)	Safety measures in [1]: pp 27-43
Leaks in gaseous phase from the Unit-2 PCV				Results: -
<p>The PCV pressure of Unit-2 gradually increased while the RCIC was in operation, and after the RCIC was shutdown increases, probably due to hydrogen production and the opening of SRVs, occurred at about 20:00, about 21:00, and about 23:00; PCV pressure reached about 0.75MPa[abs].</p> <p>Thereafter at about 07:20 on March 15th, the measured PCV pressure was 0.73MPa[abs], and that decreased to 0.155MPa[abs] by 11:25. It is not certain when the PCV pressure started to decrease, because the workforce at the Fukushima Daiichi NPS was then temporarily reduced and the points of measurements available are insufficient. However, it is likely that the PCV pressure started to decrease during the morning, since (i) steam was confirmed as being discharged in the dawn of March 15th from the blow-out panel located in the Unit-2 reactor building wall, and (ii) the air dose rate near the main gate increased. The steam discharge is estimated to have been repeated from the morning till night on March 15th, and the radioactive materials released during this time period are considered to have caused contamination of the adjacent areas including Iitate Village.</p> <p>It can be further considered that the leaks had started sometime between about 23:30 on March 14th, when the PCV pressure had changed above 0.7MPa[abs], and about 07:20 on March 15th.</p> <p>But no direct evidence has been identified from the measured plant parameters or observed facts concerning at what time and at what point the leaks actually occurred. Clarification is needed.</p>

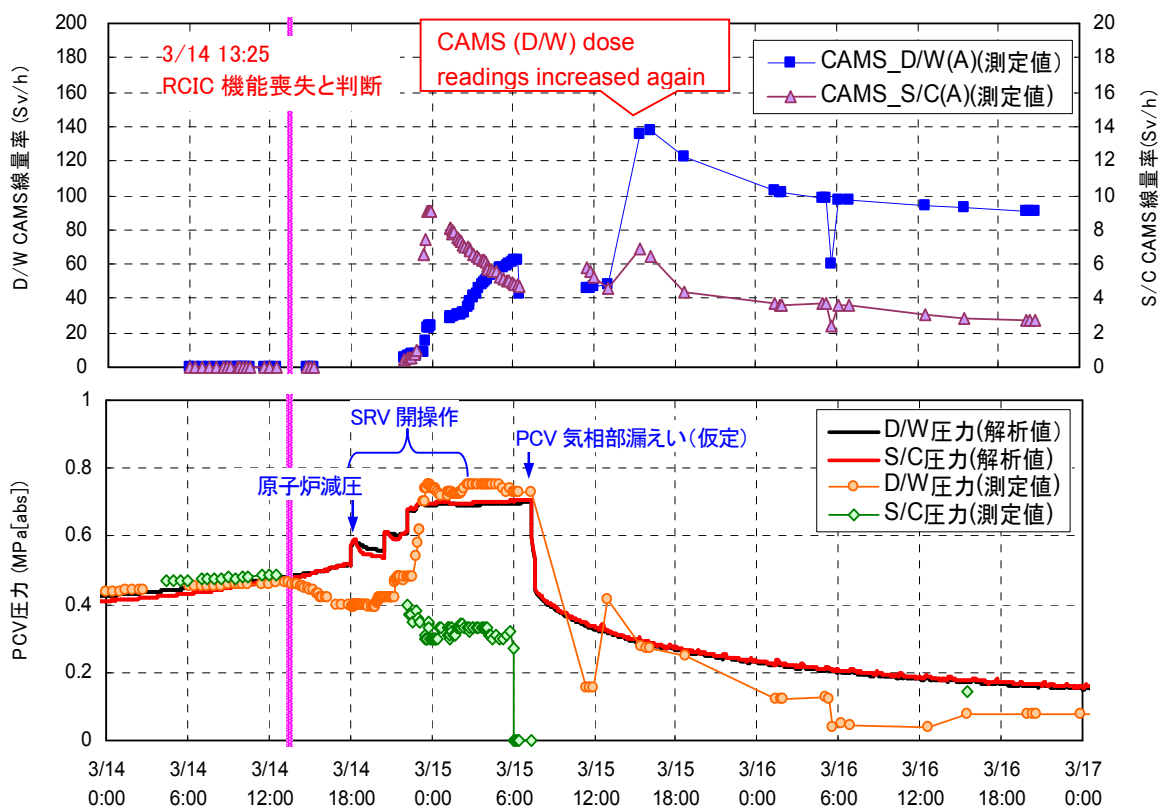
Figure Changes of CAMS readings and PCV pressures at Unit-2

The CAMS (D/W) readings of Unit-2 recorded from the morning of March 15th were monotonically increasing before around 06:00 (63Sv/h at 06:20). After about a 6-hour blank period, it read 46Sv/h at 11:25. This can be interpreted as having reflected the dose rate decrease in the PCV as the result of FP release to the environment.

Thereafter, the CAMS (D/W) recorded a rapid increase to 135Sv/h at 15:25 on March 15th. This rapid increase may have been caused by some unknown changes of the situation in the RPV and PCV. It will be investigated what phenomena could have occurred around this time period.
