List of issues to be investigated

List of issues

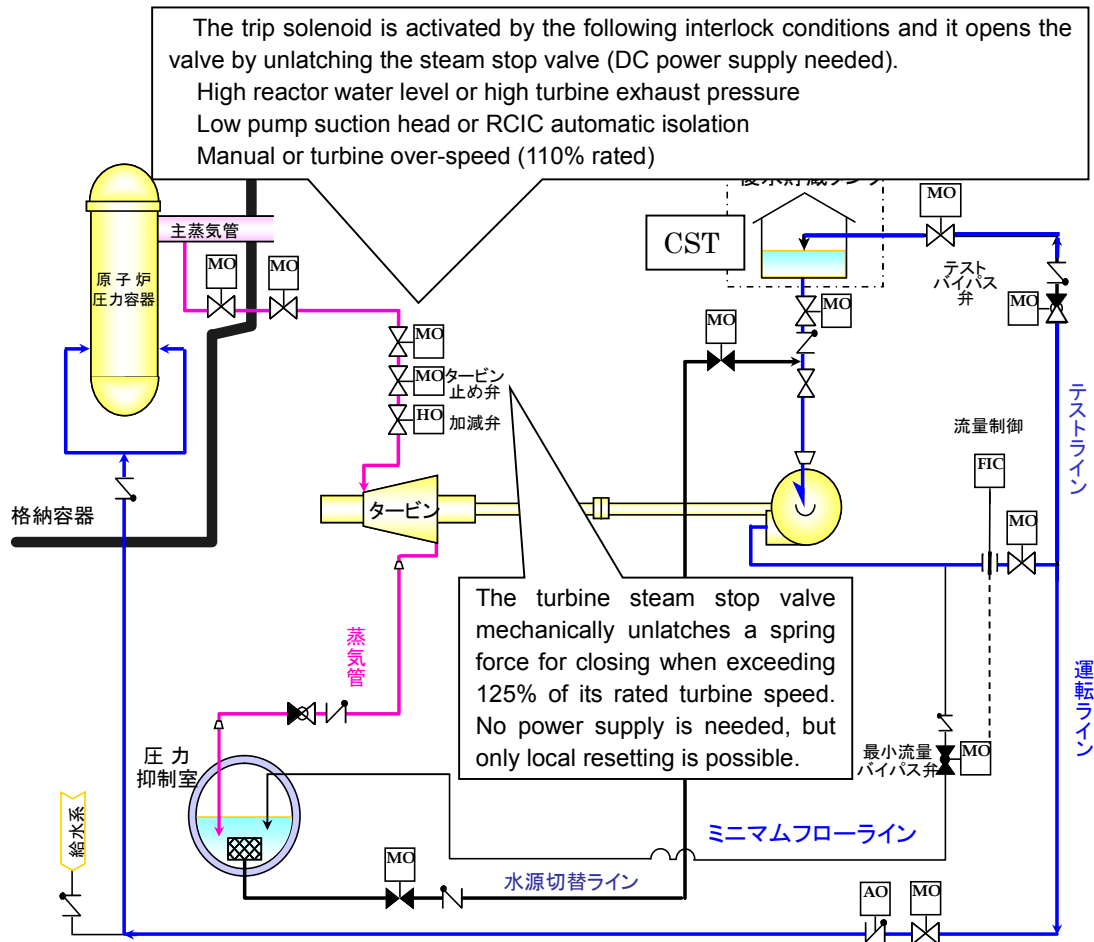
Figure Schematic RCIC line configuration

At 11:36 on March 12th, the status indicator lamp on the MCR control panel showed shutdown of the RCIC, and the flow meter and discharge pressure indicator readings all became zero. The RCIC was thus confirmed to have shut down. The shutdown condition was locally confirmed in the RCIC room, too, afterward. It was attempted to restart the RCIC after resetting it from the MCR control panel, but immediately after attempting the restart, the steam stop valve trip mechanism was unlatched, the steam stop valve was closed and the RCIC was shut down.

On the next day after the HPCI stopped operating, it was attempted to restart the RCIC again at 05:08 on March 13th after the steam stop valve mechanism had been properly latched, adjusted, and the pre-service status had been checked, but again the steam stop valve was closed and the RCIC restart attempt failed.

The RCIC could continue working beyond its design condition of 8 hours, but, in order to increase the RCIC system reliability, it is necessary to clarify the battery capacities and real loads, and the reason why the stop valve mechanism was unlatched.

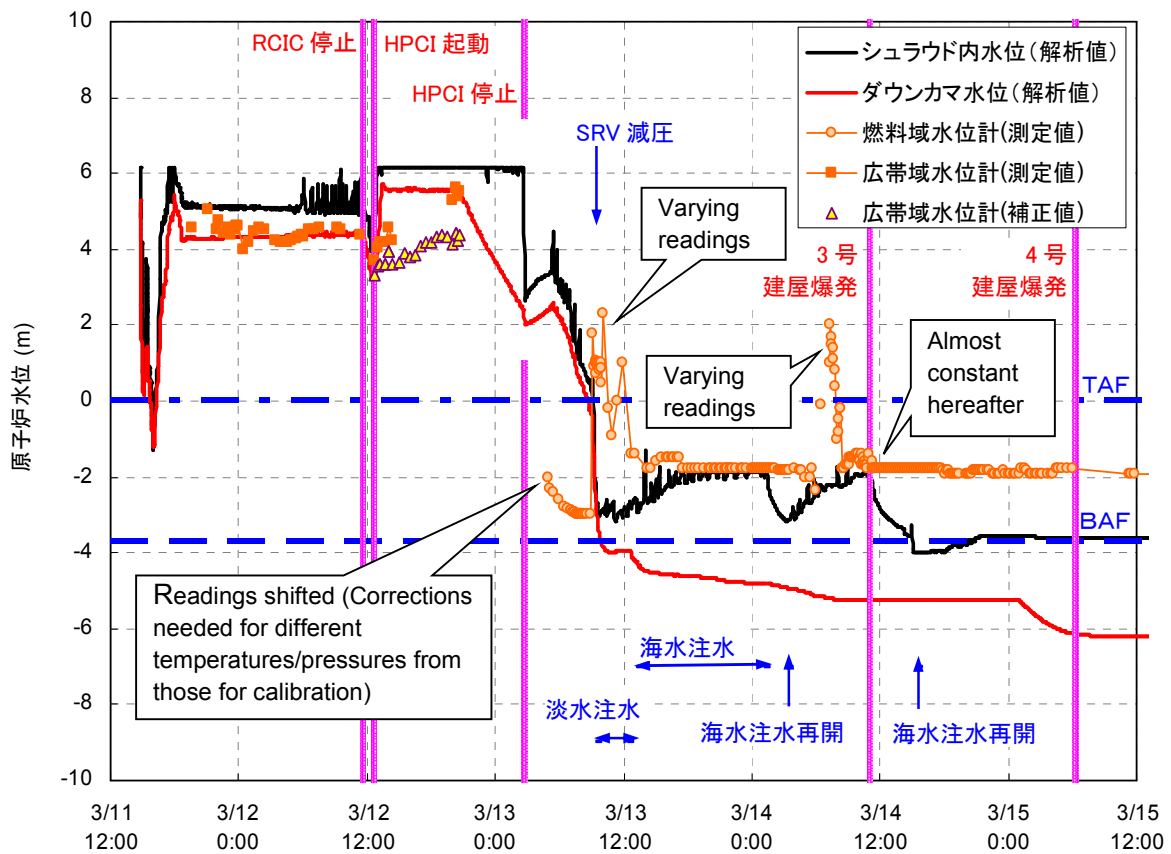
Figure Reactor water level changes at Unit-3

Unit-3/Issue-2	Unit-3	Category A⑤	Class (2)	Safety measures in [1]: -
RPV water level indicator readings at Unit-3 after loss of true value indications				Results: -
<p>The reactor water level indicators of Unit-3 showed roughly constant values after about 12:00 on March 13th, irrespective of the water injection conditions. It can be considered that the water level indicators were out of order, like those of Unit-1, because of the water level decrease both in their reference leg and variable leg.</p> <p>The condensing chamber type water level indicators installed in the Fukushima Daiichi NPS reactors lose their water in their internal piping (reference leg and variable leg) by evaporation, causing them to show wrong values, when the PCV temperatures increase or the reactor pressures decrease.</p> <p>But, the water level indicator readings represent the pressure difference between the reference leg and the variable leg. This may provide some relevant information concerning the timing of reactor pressure decrease and/or reactor water level</p>

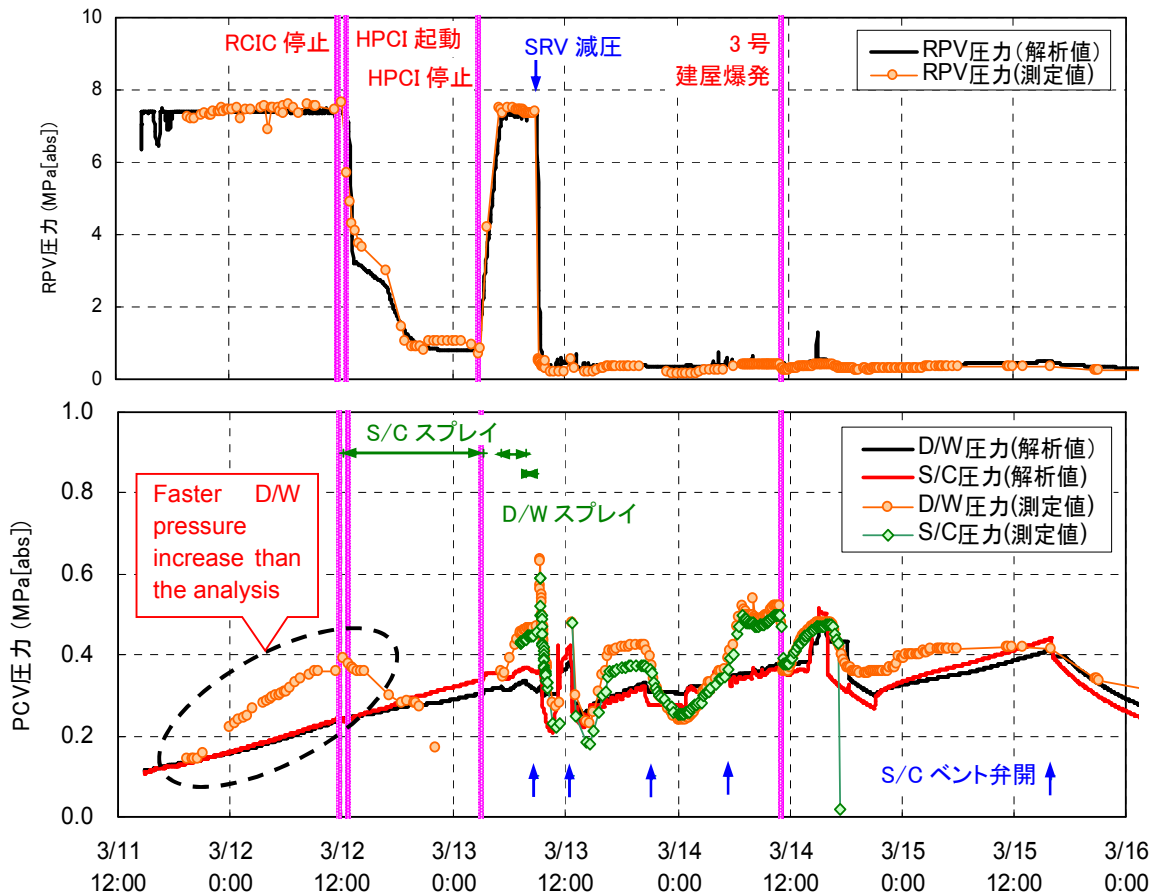
Figure Pressure changes of RPV and D/W of Unit-3

Unit-3/Issue-3	Unit-3	Category B①	Class (1)	Safety measures in [1]: pp. 17, 18, 39, 40
Thermal stratification in the S/C of Unit-3				Results: Attachment 3-7
<p>The D/W pressure of Unit-3 was in an increasing trend due to the exhaust steam from the RCIC and SRV(s), while the RCIC was in operation after the tsunami arrival.</p> <p>When compared with the MAAP analysis results with the use of design conditions, the observed pressures until about 22:00 of March 12th showed a larger and faster increase. The MAAP analysis could not simulate this pressure behavior (the D/W pressures increases were much larger as compared with the MAAP results until about 12:00 when the HPCI started operation, and the analysis pressures by MAAP continued to increase afterward while the observed pressures decreased rapidly).</p> <p>JNES suggested a possibility (*) of thermal stratification in the upper part of the S/C pool water causing a local temperature rise which led to the larger D/W pressure increase as compared with the uniform temperature rise of the S/C pool water. The thermal stratification would have been generated by the high temperature exhaust steam from the RCIC turbine only heating the S/C pool surface water.</p> <p>Further examination is due into the D/W pressure changes until about 22:00 on March 12th.</p> <p>(*) “Examinations into the impacts of thermal stratification in the suppression chamber water on the containment vessel pressures, and other parameters”, issued Feb. 1st, 2012, by the Japan Nuclear Energy Safety Organization (in Japanese)</p>

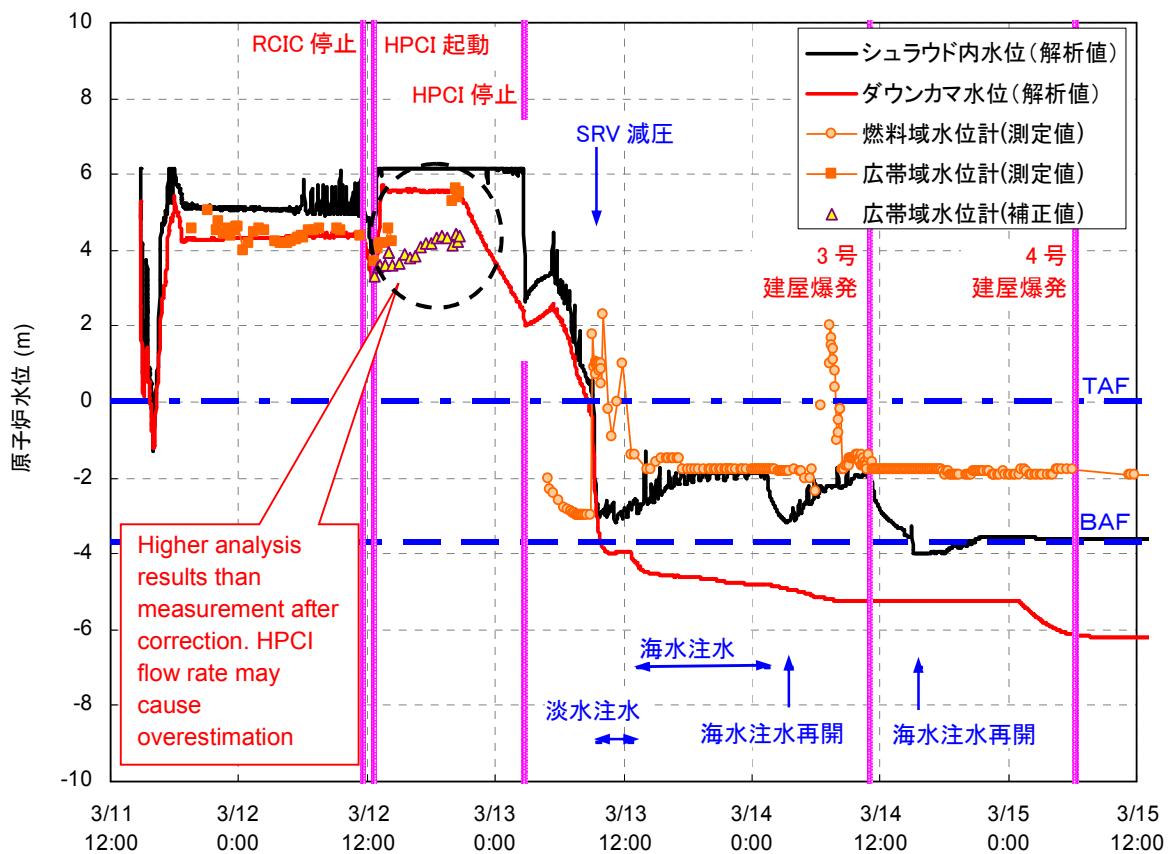
Figure Reactor water level changes at Unit-3

Unit-3/Issue-4	Unit-3	Category B①	Class (2)	Safety measures in [1]: p. 26 (for strengthened monitoring)
Reactor water level behavior during HPCI operation at Unit-3				Results: Attachment 3-3
<p>At Unit-3, the HPCI was adjusting the amount of water injection into the reactor by both using its return line to the CST water source and adjusting the set points of the flow controller while confirming the water level indicator to prevent the HPCI from being shut down by the high reactor water level signal (L-8). At 20:36 on March 12th, while the HPCI was in operation, the power supply to the reactor water level indicators was lost preventing the reactor water level from being monitored. The HPCI water injection flow rate of the flow controller was reset at a slightly increased level, and the reactor pressures, the HPCI discharge pressures, etc. were used to monitor the HPCI operation status.</p> <p>In the earlier MAAP analysis results, which TEPCO had disclosed in March 2012, the amount of water injection by the HPCI had been set to simulate the reactor water levels observed by the water level indicators (wide range). In the simulation, the reactor water levels measured until 20:36 on March 12th were used without corrections corresponding to the reactor pressures and PCV pressures. This caused the overestimation of the amount of water injected to the reactor in the MAAP analysis (The water level in the analysis is about 1m higher than that of measurement after such corrections). In consequence, it is likely that the amount of water actually injected by the HPCI was less than that assumed in the MAAP analysis.</p> <p>The amount of HPCI water injection will be reviewed and the real progression of the accident will be examined for estimating the core and PCV status.</p>

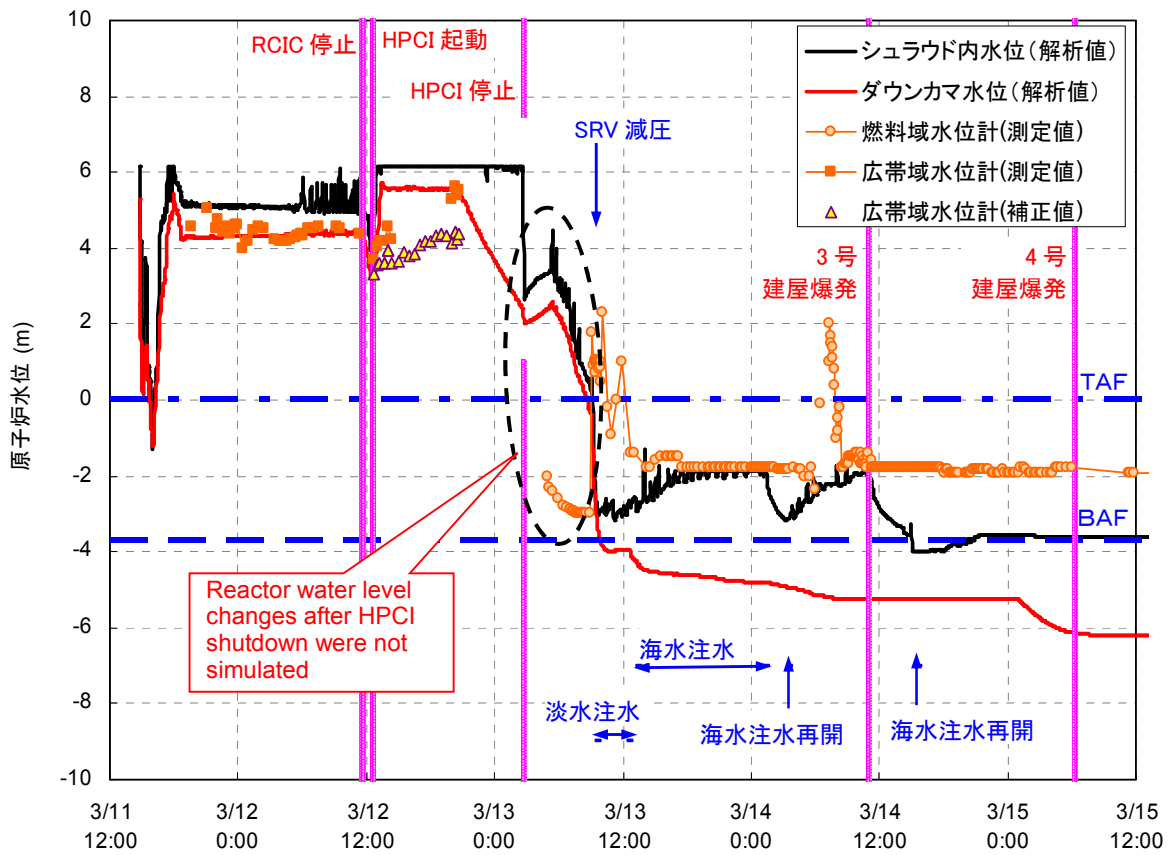
Figure 12 Reactor water level changes at Unit-3

Unit-3/Issue-5	Unit-3	Category B①	Class (2)	Safety measures in [1]: -
Reactor water level behavior after the loss of function of HPCI at Unit-3				Results: Attachment 3-3, 3-4
<p>At Unit-3, the HPCI was adjusting the amount of water injection into the reactor by both using its return line to the CST water source and adjusting the set points of the flow controller while confirming the water level indicator to prevent the HPCI from being shut down by the high reactor water level signal (L-8). At 20:36 on March 12th, while the HPCI was in operation, the power supply to the reactor water level indicators was lost preventing the reactor water level from being monitored. The HPCI water injection flow rate of the flow controller was reset at a slightly increased level, and the reactor pressures, the HPCI discharge pressures, etc. were used to monitor the HPCI operation status.</p> <p>From 20:36 on March 12th to about 04:00 on March 13th the reactor water levels were not measured. When the reactor water level indicators were restored, the fuel range water level indicator read about TAF-2m. But, the MAAP analysis maintained the water level higher than the TAF level until about 09:00 on March 13th when the Unit-3 was depressurized, overestimating the water level.</p> <p>This discrepancy indicates that the water actually injected by the HPCI after 20:36 on March 12th was less than that assumed in the MAAP analysis. It further indicates a possibility that the water injection by HPCI had actually ended before the HPCI was manually shut down at 02:42 on March 13th.</p> <p>In view of a high likelihood of a smaller amount of water actually being injected than that assumed in the analysis, the overestimated amount of HPCI water injection will be reviewed and the actual progression of the accident will be investigated for estimating the core and PCV status.</p>

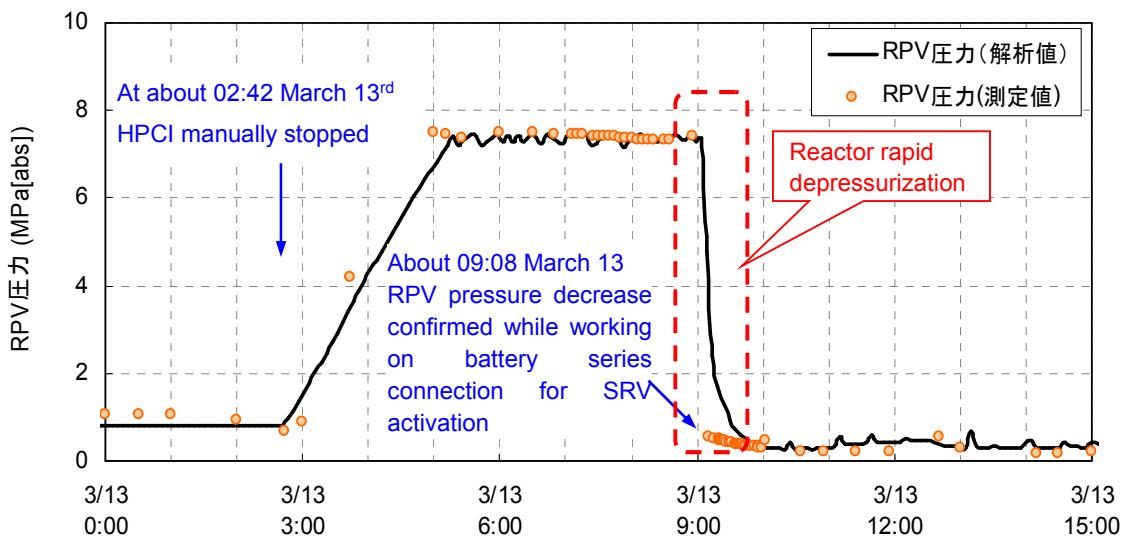
Figure Reactor pressure changes at Unit-3

This pressure decrease can be confirmed in two types of observed data: measured values recorded by the operators and the chart records. From the chart records, continuous transient behavior can be read, although the exact values are not known. The pressure decrease rate thus read is as large as about 7MPa[abs] down to about 1MPa[abs] in 2 to 3 minutes.

At this time, the battery connection work to the SRV control panel was not completed. The pressure decrease did not occur by the SRV manual actuation. It is necessary to investigate the depressurization mechanism.

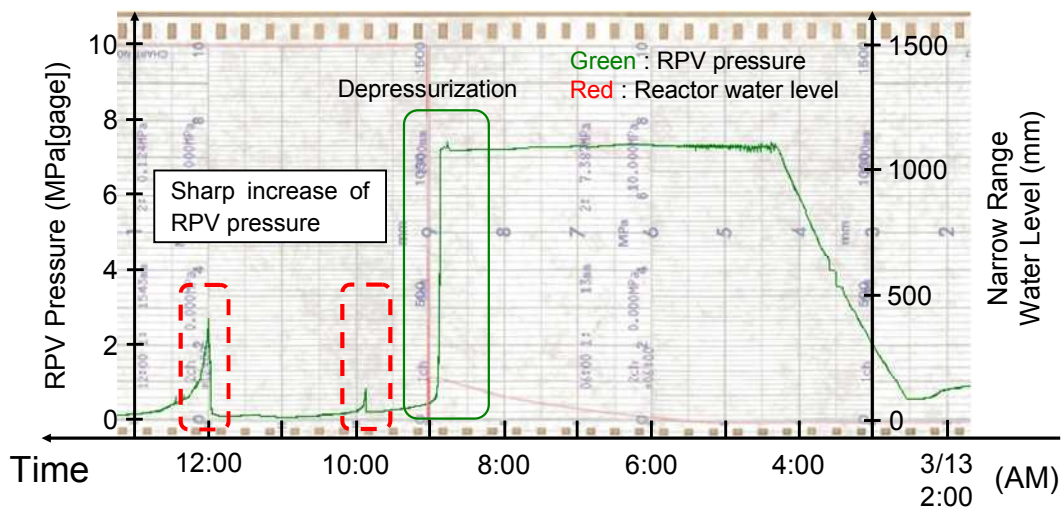
Figure Strip chart records (March 13th, 2011)

This pressure behavior, especially the pressure decrease, was considered and reported to be the responses to the SRV opening operations at 09:50 on March 13th upon the completion of battery connection and at about 12:00 upon the recovery from having found disconnected wiring. However, the pressure rise at these two times is very sharp as compared with the pressure increase at 02:42 on March 13th, when the HPCI had stopped operation.

The pressure behavior should be similar in the two cases, when the HPCI turbine steam regulator valve is closed upon the HPCI being shut down and when the SRV(s) are closed, because both cases are equivalent in having lost the steam discharge paths. But the observed pressure increase behavior is actually different. The sharp pressure increase might have been caused by the relocation of molten fuel down to the lower plenum or the generation of a large amount of hydrogen.

The pressure change mechanism and its relevance to the accident progression will be investigated.

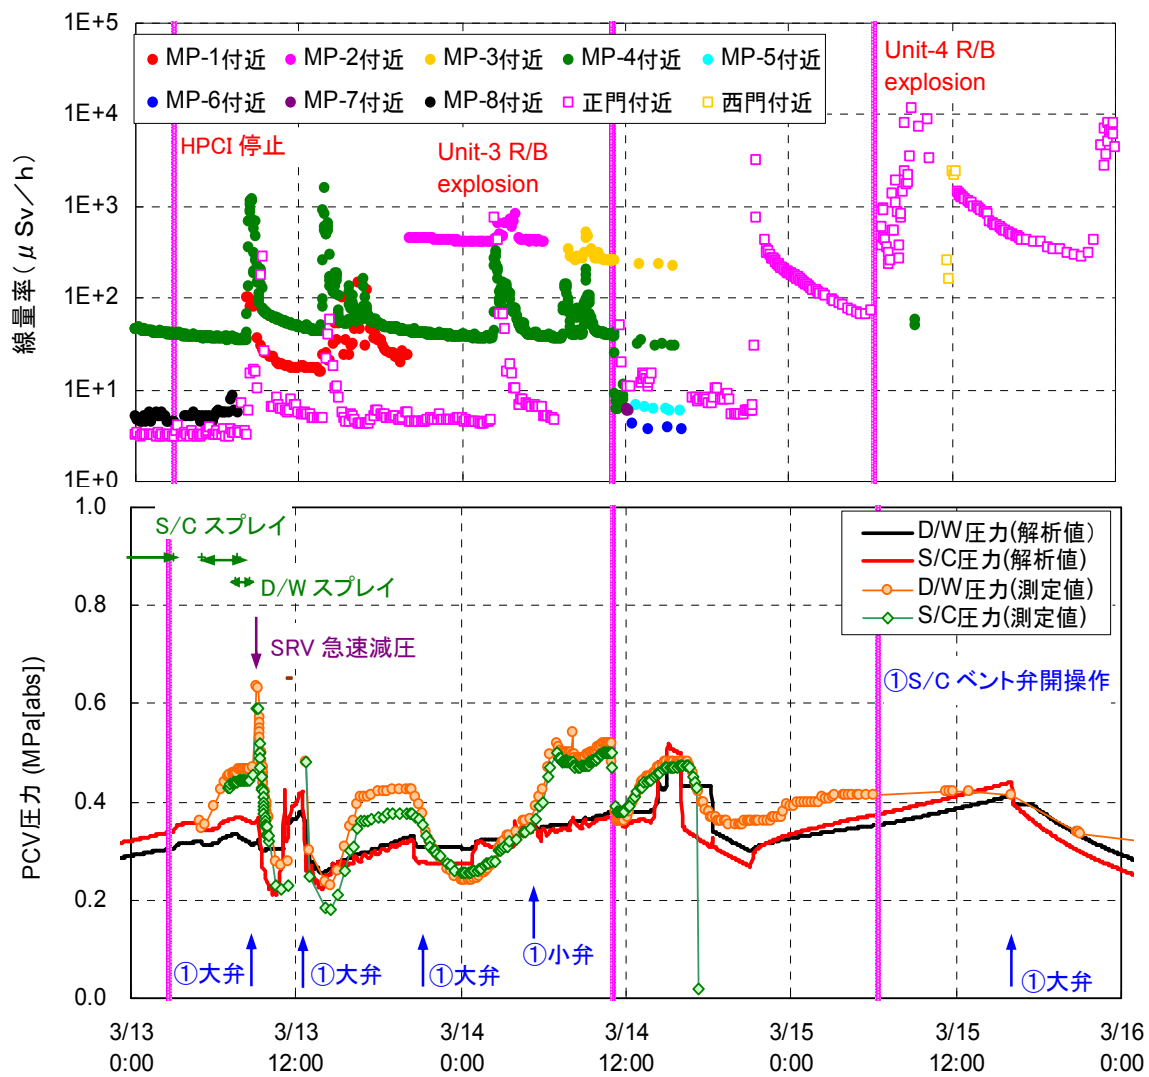
Figure Dose rate changes at the NPS (upper) and D/W pressure changes at Unit-3 (lower)

The Emergency Response Center at the Fukushima Daiichi NPS concluded that the PCV had been vented once at Unit-3 when the D/W pressure decrease had been observed at 09:24 on March 13th following the completion of S/C venting line configuration at 08:41 on March 13th. Thereafter, the large S/C vent valve (air-operated) was closed several times due to problems of driving air pressure or the actuation circuit using a temporary small generator. Each time it was attempted to open the large S/C vent valve by solving the problem causes.

The D/W pressures observed during this period repeatedly went up and down, but their timings were mostly not consistent with the timings of repeated opening operations of the large S/C vent valve. The flow rate changes anticipated by the small S/C vent valve opening operations seem too limited to explain the measured D/W pressure changes.

The causes of the D/W pressure changes during the series of venting operations will, therefore, be investigated.

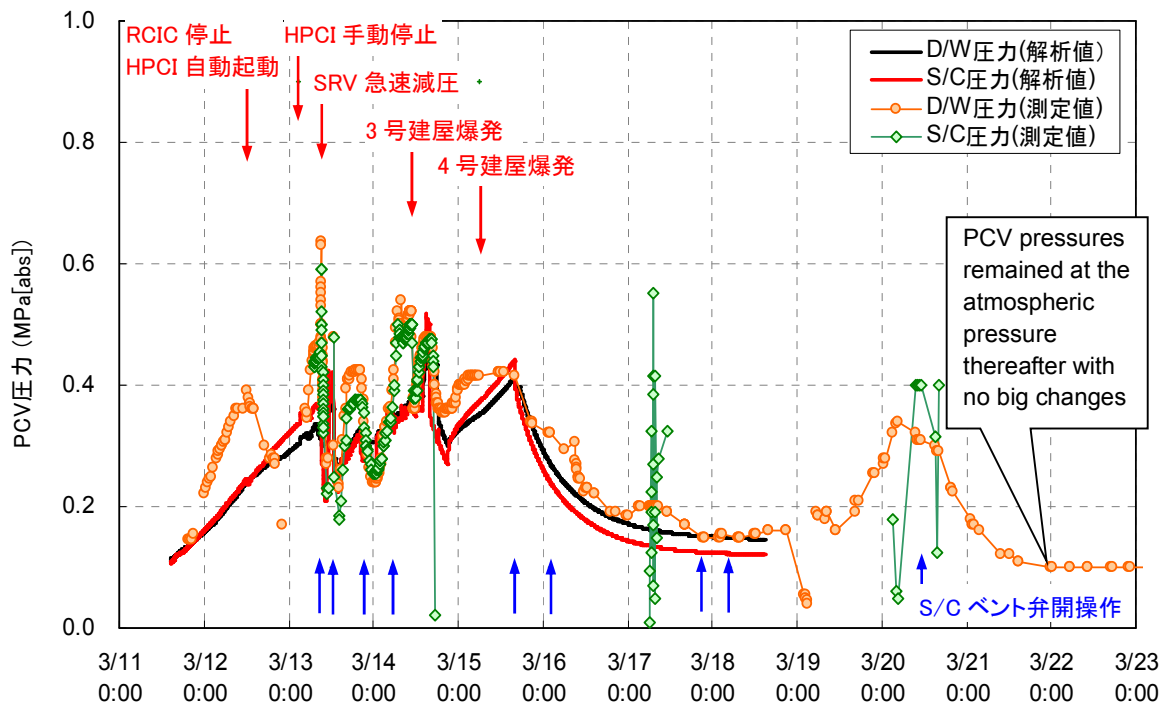
Figure PCV pressure changes at Unit-3

Unit-3/Issue-10	Unit-3	Category B③	Class (1)	Safety measures in [1]: pp.27-43
Leaks in gaseous phase from Unit-3 PCV				Results: Attachment 3-8
<p>At Unit-3, the D/W pressure increase due to the rapid reactor depressurization at about 09:00 on March 13th led to the S/C pressure increase big enough to exceed the rupture disk working pressures. Thereafter the D/W pressure decrease at 09:24 on March 13th was confirmed and the PCV venting was concluded to have been implemented.</p> <p>It was considered that the D/W pressure repeated thereafter ups and downs corresponding to the steam generation by water injection and to the venting operations. After it increased for a while on March 21st, it stayed at around atmospheric pressure, with no big changes.</p> <p>The MAAP analysis assumed no PCV leaks in Unit-3, but the steam leak from the PCV seems probable because the steam explosion occurred in the Unit-3 reactor building, steam release was observed near the reactor well in the reactor building, and the D/W pressure showed no big changes after March 21st at around atmospheric pressure.</p> <p>Adding to that, when nitrogen gas was injected into the PCV, Unit-3 showed no pressure changes in the PCV, while Unit-1 and -2 showed pressure increases in their PCVs. There is another relevant observation concerning the oxygen concentrations in the PCV air, when measured by the PCV gas control system, i.e., it was almost zero in Unit-1 and -2, while it was high in Unit-3, indicating the possibility of air inflow into the PCV.</p> <p>It is considered, therefore, Unit-3, for which the operators attempted to repeat venting operations, would have had the largest leaks in the gaseous phase. Further investigation is needed to clarify when and from where the leaks in the gaseous phase actually occurred.</p>

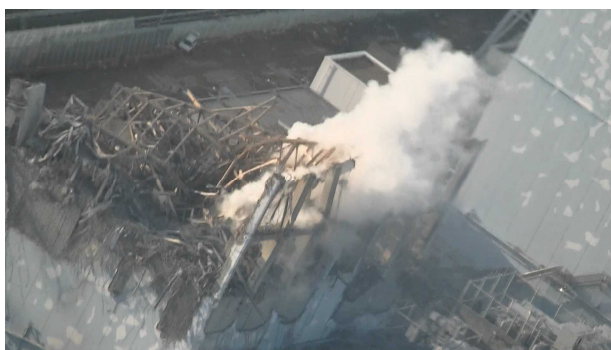
Photograph taken on March 16th, 2011

At Unit-3 a large amount of steam was observed to be blowing upward above the reactor building: dark smoke was observed on March 21st; and steam rising was observed on March 29th from the top and west side of the reactor building. Even after the spent fuel storage pool temperature was lowered sufficiently, steam release above the building was repeatedly observed.

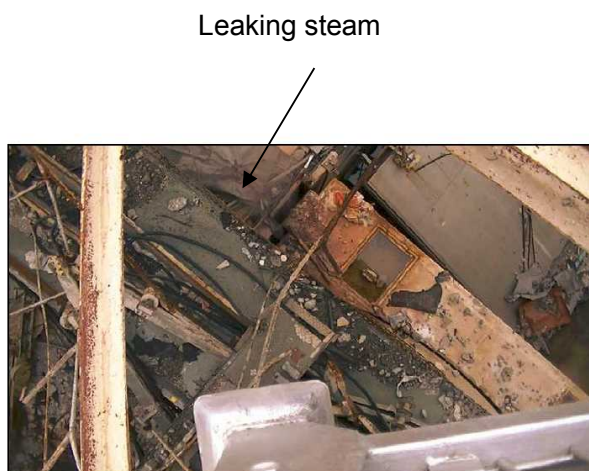
撮影者：東京電力株式会社
撮影日：平成23年8月24日

Movie sequences on August 24th, 2011, taken at the time of dust sampling above the reactor building, show steam leaking from the shield plug margin and the periphery of the deformed dryer separator (DS) pit gates.

Steam thus observed seems to be leaking from the PCV and it may provide some useful information to identify the leak locations.
