Dose increase around March 20th, 2011

1. Background

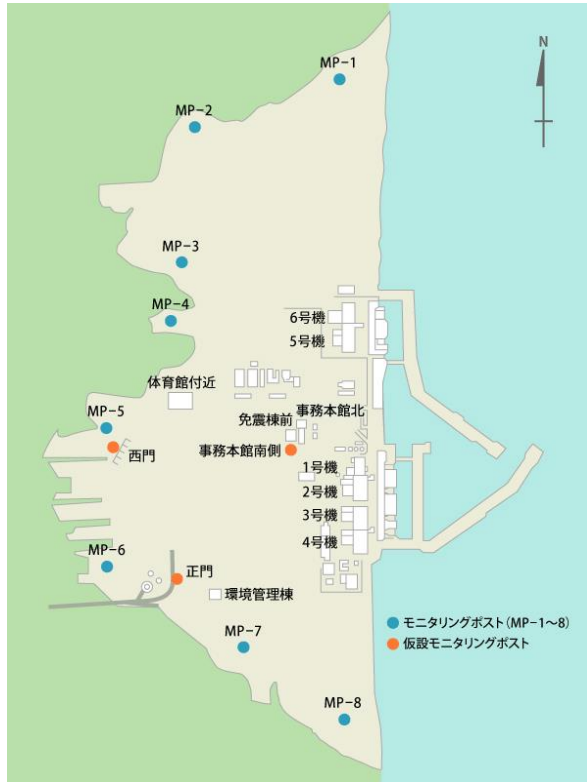
Figure 1 shows the dose level change observed during March 20th and 21st in the area surrounding the Fukushima Daiichi NPS. The dose increase in question is described by the data enclosed within the dotted red lines. On March 20th the dose rose about 800 μ Sv/h in two hours from 12:50 to 14:50 in the north area of the main administration building. The dose remained above 3000 μ Sv/h till about 16:00, then began to decrease. On March 21st the dose jumped to about 1400 μ Sv/h in 100 minutes from 16:50 to 18:30 near the main gate. The dose decreased thereafter and returned to the level before the dose increase.

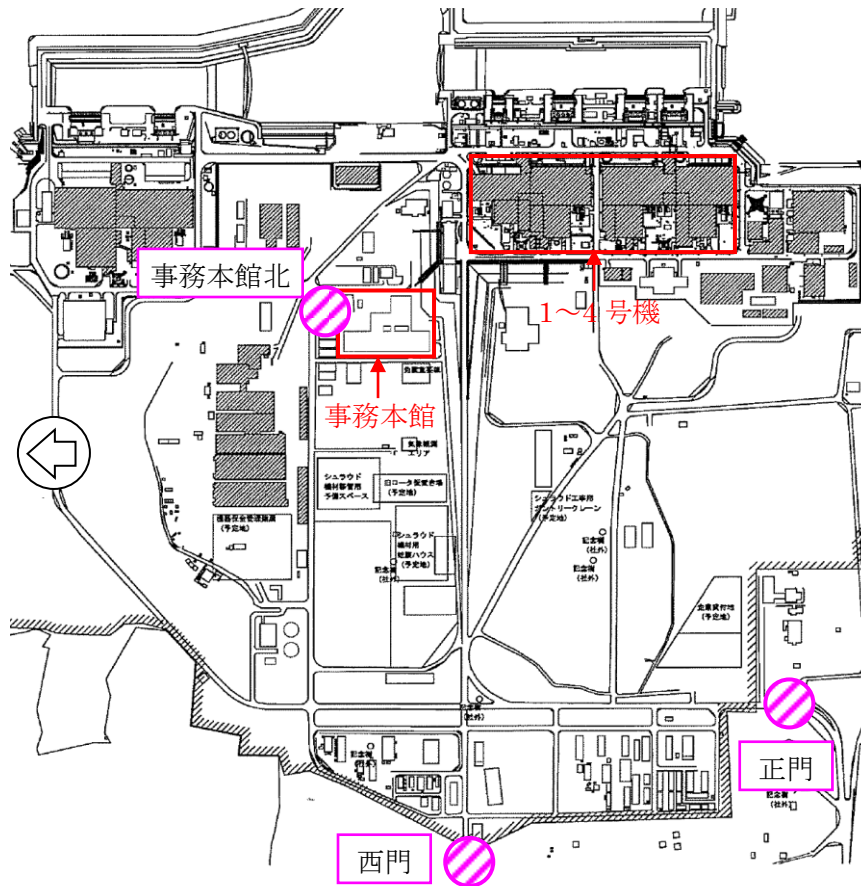
Figure 13 Air dose changes and wind direction

To assess this possibility, the car position at the time of the dose increase was checked as to whether it was downwind. Figure 13 shows the correlation between wind direction and air dose during the period of March 18th to 23rd [2]. The relation between the monitoring car position and wind direction was reviewed, especially at the time points ① to ④ in Figure 13, when the air dose increase had been observed. The monitoring car was positioned at these times at the north side of the main administration building, the west gate or the main gate.
