Status of investigation on estimating situation of cores and containment vessels

1. Introduction

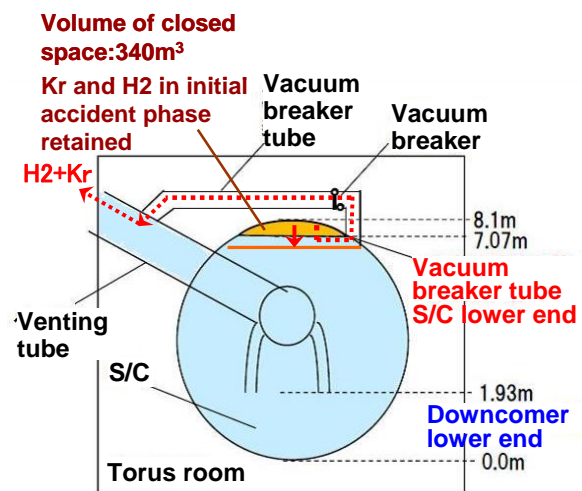
Figure 2-2 Closed space in gaseous phase inside S/C of Unit-1

In September 2012, a nitrogen gas injecting test was conducted into the suppression chamber (S/C), in which the theory was demonstrated that hydrogen gas and Kr-85 generated in the early stage of the accident and retained in the S/C upper space pushed down the S/C water level and were discharged to the D/W through the vacuum breakers. This helped to confirm that the S/C was currently almost filled with water (the level at around the lowest end of the vacuum breaker tube [2] (Figure 2-2).

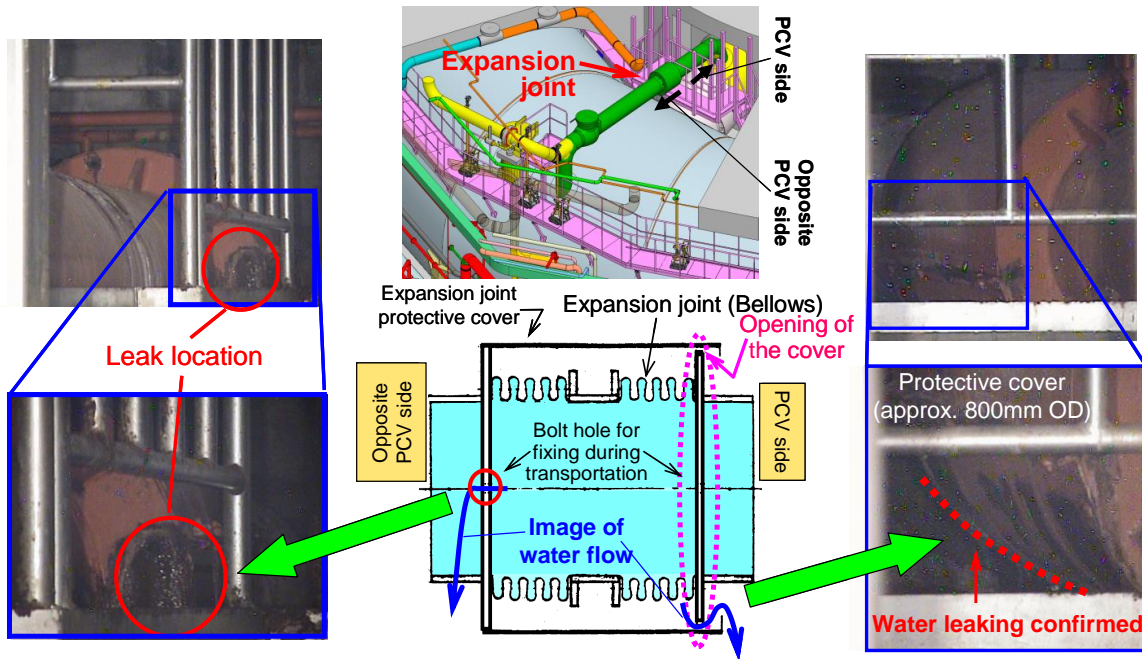
Meanwhile, the water leakage down to the S/C surface around both sides of the vent tube X-5E indicates the possibility of water leaks from the vacuum breaker tube (its bellows, for example) immediately above the vent tube. This elevation of the vacuum breaker tube is about the same level as that of the upper limit of PCV water level which was reached in an attempt to flood the PCV by increasing the amount of water injected in May 2011; where the PCV water level was calculated from the injected nitrogen gas pressure. The nitrogen gas pressure was stopped from changing at a specified level, which means the PCV water level was leveled off, i.e., an indication of leak hole existence at the level (Figure 2-5) [5].

**Illustration of Expansion joint (Bellows) for vacuum breaker tube**

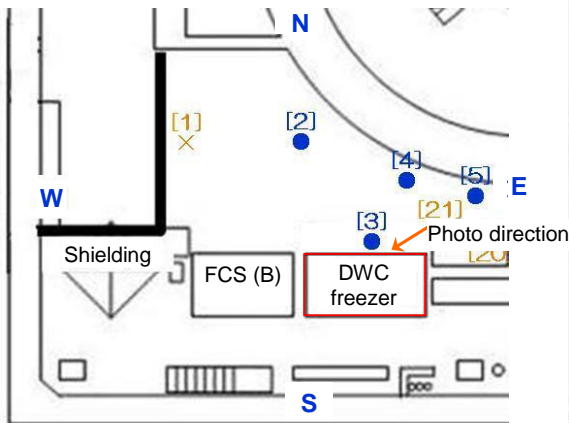
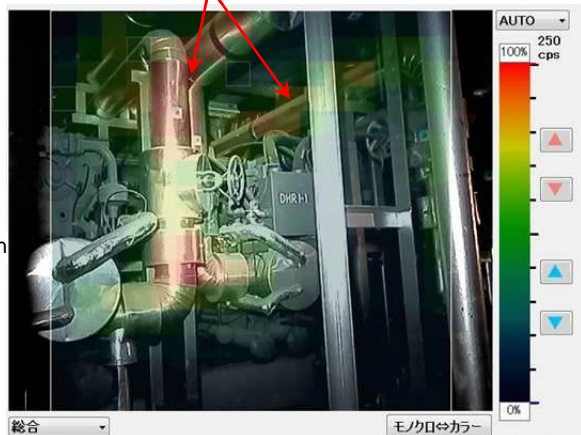
In December 2013, contamination was surveyed on the first floor of the Unit-1 reactor building by radiation dose measurements and gamma camera images taken using a robot. It was found that contamination was relatively high on the atmospheric control system (AC) piping and drywell humidity control system (DHC) piping (Figure 2-8) [8].

Hot spots confirmed along piping

Figure 10. Gamma camera image taken near the DWC freezer

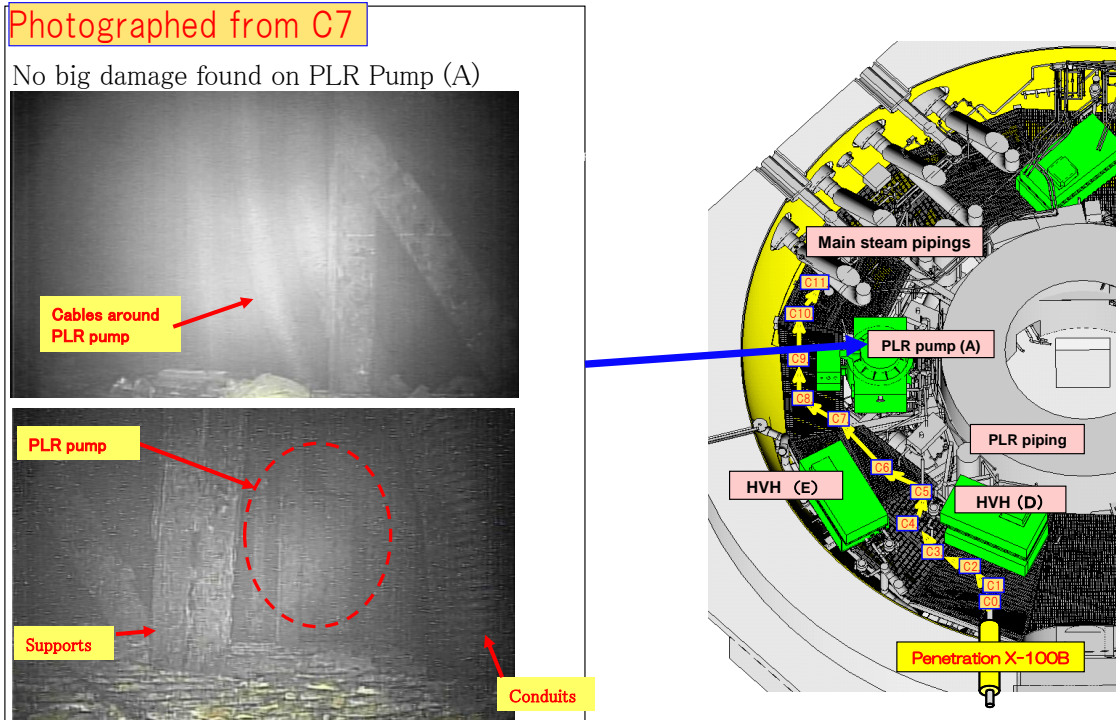
Figure 2-10 Photos taken during the clock-wise patrol [9]

The grating floor on the ground level outside the pedestal of Unit-1 was investigated from April 10 to 18, 2015. A running robot machine was sent through the PCV penetration X-100B. The robot patrolled clock-wise and anti-clock-wise by about 180 degrees for investigating damaged conditions of existing structures and presence of obstacles. Figure 2-9 and Figure 2-10 present a part of the photos taken during the anti-clock-wise and clock-wise patrols, respectively. As seen in Figure 2-9, no big damage was recognized on the HVH (heating ventilating handling unit), PLR piping, pedestal walls, PCV inner walls, etc., although fallen objects were noticed on the patrol path.

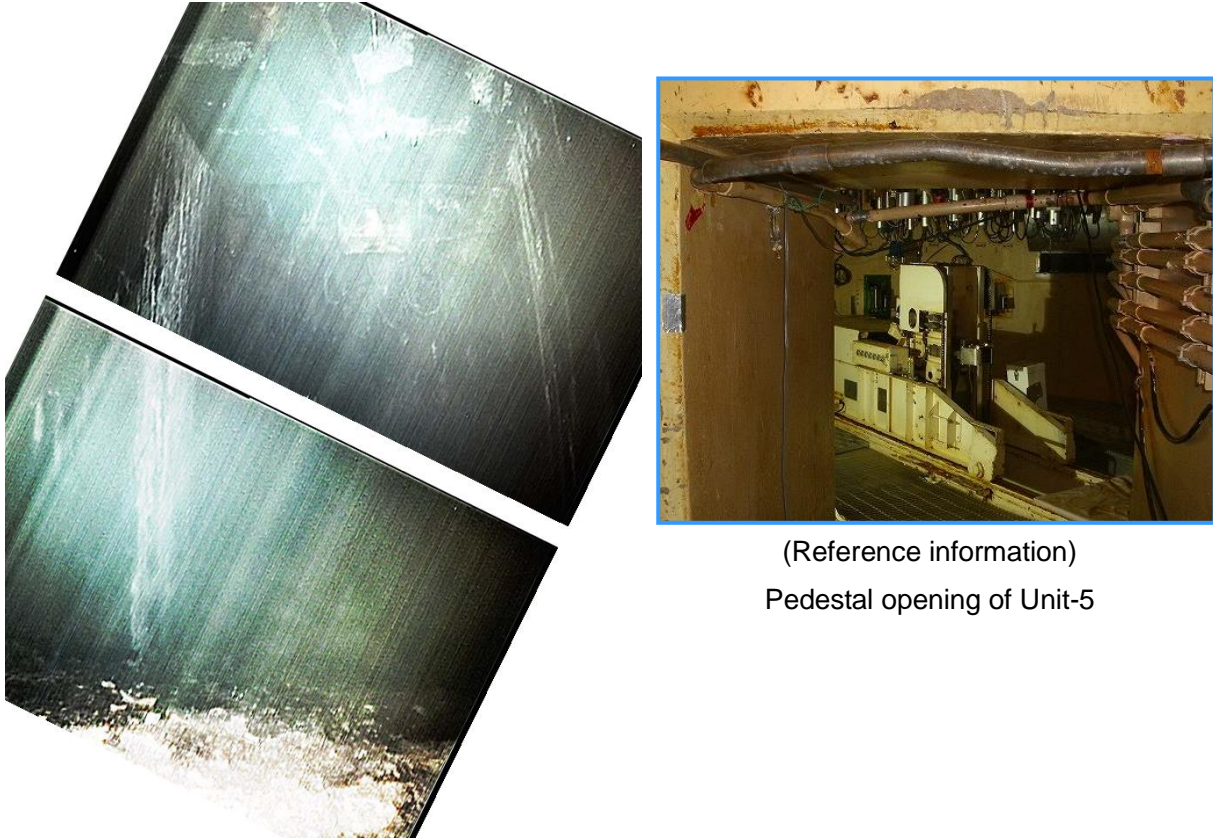
Figure 3-3 Photos taken inside the PCV pedestal at the pedestal opening (processed image)

photo processing for noise and contrast, they confirmed the position of the control rod position indicator probe (PIP) cables in the upper part of the pedestal opening, but no clear information was obtained regarding what was in the lower part inside the pedestal (Figure 3-3).

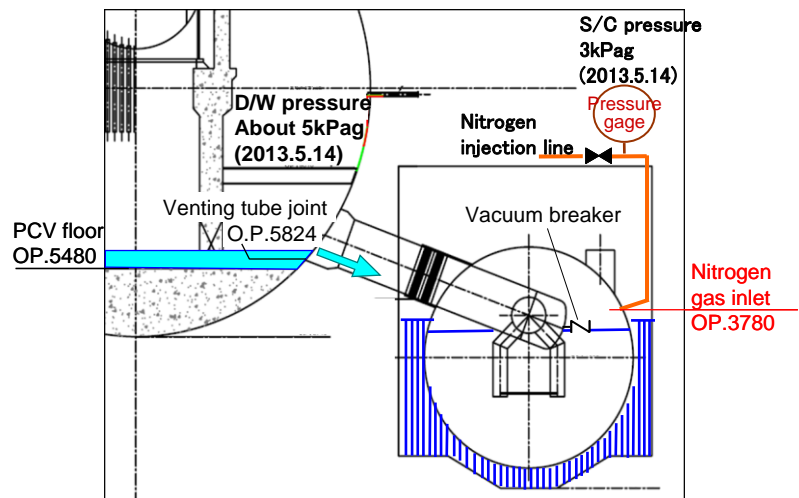
Figure 3-4 Closed space assumed in Unit-2 S/C

The S/C pressure was confirmed to be 3 kPag (as of May 14, 2013) in a nitrogen gas injecting test into the S/C done in May 2013. The absolute water level in the S/C was not accurately known, but it was confirmed to be approximately on the level of the nitrogen gas inlet (O.P. 3780), because some reasonable pressure due to the water head should exist at the inlet if the S/C were almost filled with water. If the low water level in the

D/W is considered in combination, the water injected into the reactor vessel is considered to have reached the S/C via the D/W and venting tubes. If this hypothesis is correct, the current S/C water level will be on the same level as that of water retained in the torus room [21] (Figure 3-4).

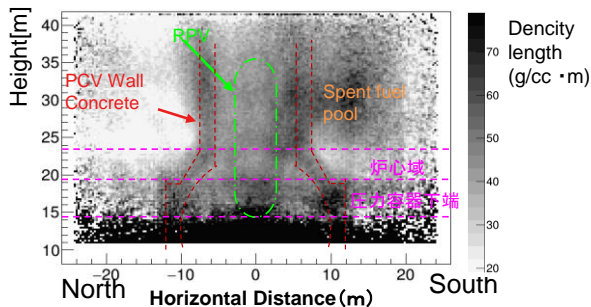
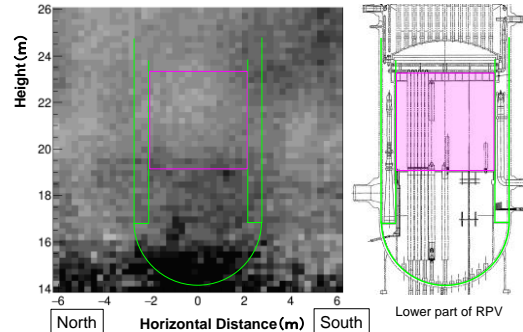
Figure 3-17 Distribution map of material quantities by muon measurements [29]

Figure 3-17 shows the analysis results of material quantities (density length) obtained from the muon measurements (left) and the enlarged portion of the RPV lower part (right). Besides the PCV and fuel in the SFP, dark tones were identifiable in the RPV lower part, too, indicating the presence of high density materials. Evaluation by muon technologies becomes difficult below about O.P. 15m due to reduced muon population detectable, but the dark tones at the RPV lower part can be believed to be significant, since those in the PCV at a similar elevation are identifiable.

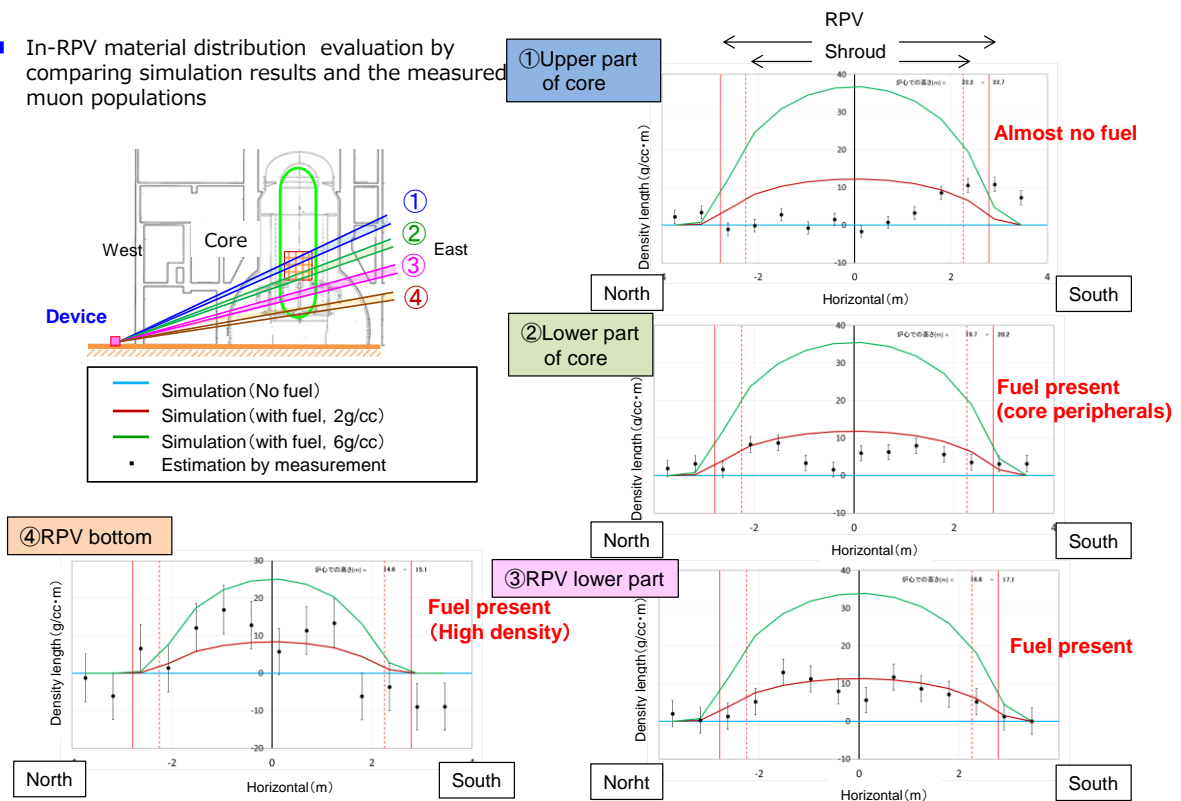
Figure 3-18 Material quantities distribution in RPV [29]

Figure 3-18 compares the results of measurements and simulation. In the simulation, two cases were assumed: one was the case in which high density materials (2 g/cc, 6 g/cc) simulating nuclear fuel were present in each evaluation region; and the other is the case in which they were not present. From the comparison, it was estimated that nuclear fuel had been present in the peripheral region of the core lower part and in the RPV bottom part, where the measured results had been closer to the results simulating the presence of high density materials there.

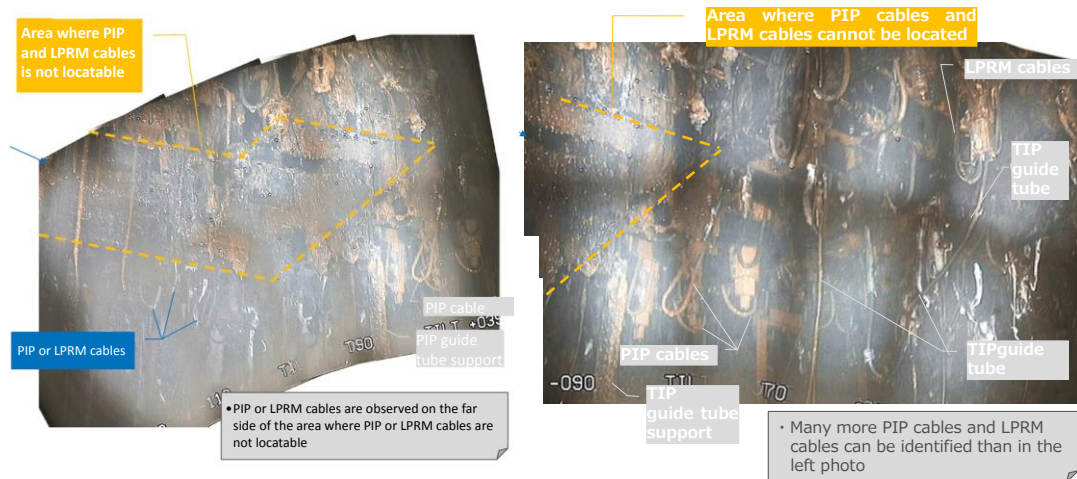
Figure 3-21 Conditions in the upper pedestal

Figure 3-21 is a photo of the upper part inside the pedestal. Damaged portions of the local power range monitoring system (LPRM) and control rod position indicator probe (PIP) cables can be identified. PIP cables and LPRM cables can be located at some places but cannot be located at other places. Figure 3-22 summarizes damage conditions in the pedestal, investigation results of cables in the upper part of inside the pedestal and other findings.

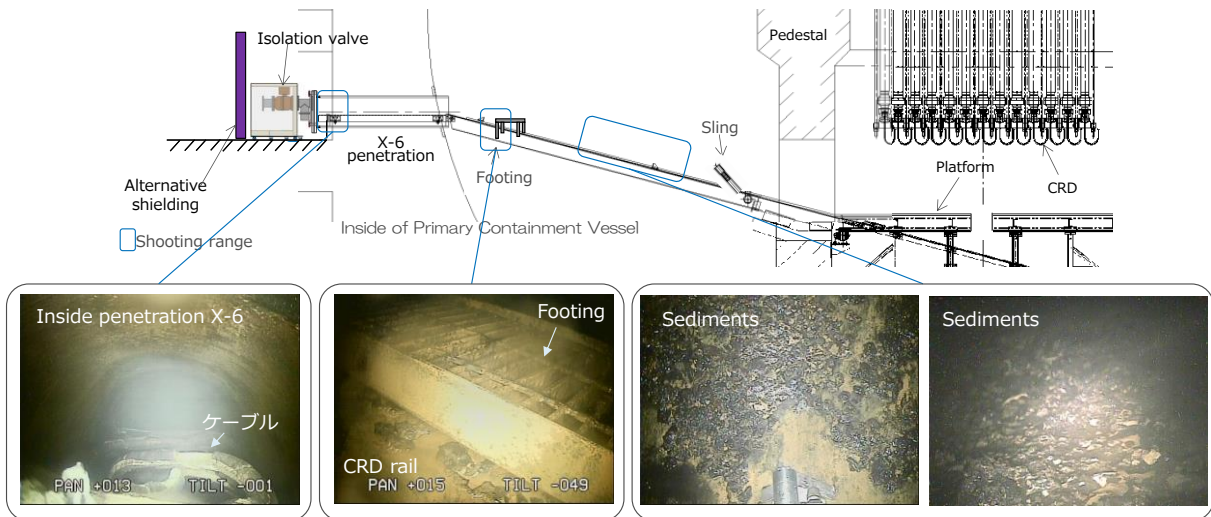
Figure 3-23 Images on the CRD rails starting from the X-6 penetration [31]

From February 7 to 9, 2017, attempts were made to remove sediments on the CRD replacement rail using the sediment removing equipment. Figure 3-23 is the photo taken by the camera mounted on the equipment. The sediments were mixtures of black paste-like materials, thin fragmented objects, and pebble-shaped objects. The sediments became more sticky and difficult to remove when the equipment approached the pedestal from the PCV penetration. On February 16, 2017, the self-propelled investigation device was sent in for investigation. The equipment failed to reach inside the pedestal, but could collect data on temperatures, dose rates and conditions of structures around it.

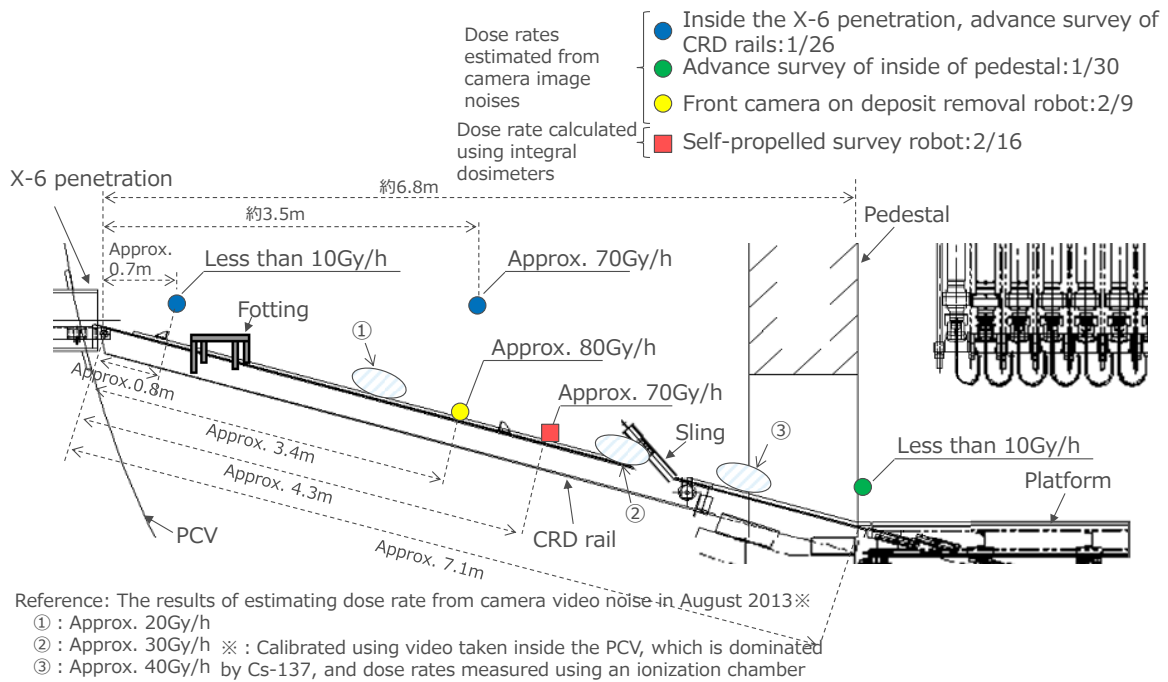
Figure 3-24 Dose rates measurement [32]

Figure 3-24 shows the dose rates at 4 points obtained in this investigation. Around the pedestal opening, the dose rates inside the pedestal were lower than outside.

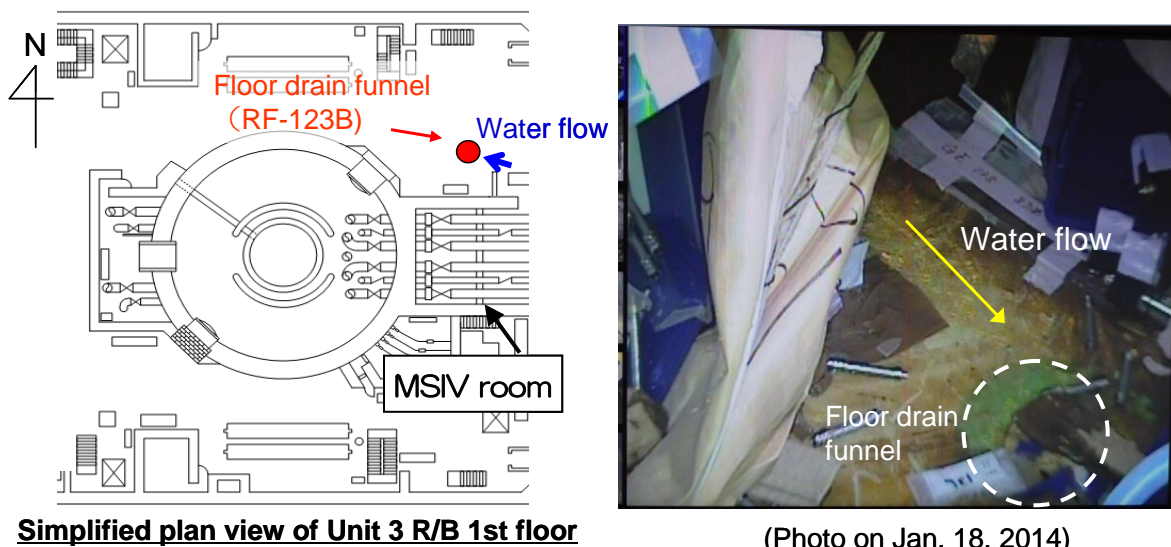
Figure 4-2 Water leak near the MSIV room door of Unit-3

In January 2014, while camera photos taken by the rubble and wreckage removal robot in the Unit-3 reactor building were being checked, water was seen to be flowing from near the main steam isolation valve (MSIV) room door in the northeast area of the reactor building first floor. The water was flowing towards a nearby floor drain funnel (Figure 4-2) [35].

The water level in the PCV is estimated as about OP.12 m (about 2 m above the reactor building first floor) by converting the S/C pressure obtained by the existing pressure indicators to water head. This elevation is on the level of PCV penetrations for main steam lines, thus indicating the possibility of water leaks from the PCV penetration in the MSIV room as the source of the water flow. In consideration of this possibility, instrumentation was inserted into the MSIV room from the HVAC system room on the floor above, in April and May 2014, and photos were taken and dose rates were measured in the room, in order to locate the water flows in the room. Water leaks were from near the expansion joint of main steam line D. It was concluded [36] that the leakage had occurred only from the main steam line D, based on: (1) confirmation of no leaks from the main steam lines A, B and C, and their main steam drain pipes; and (2) the flow directions of leaked water on the floor.

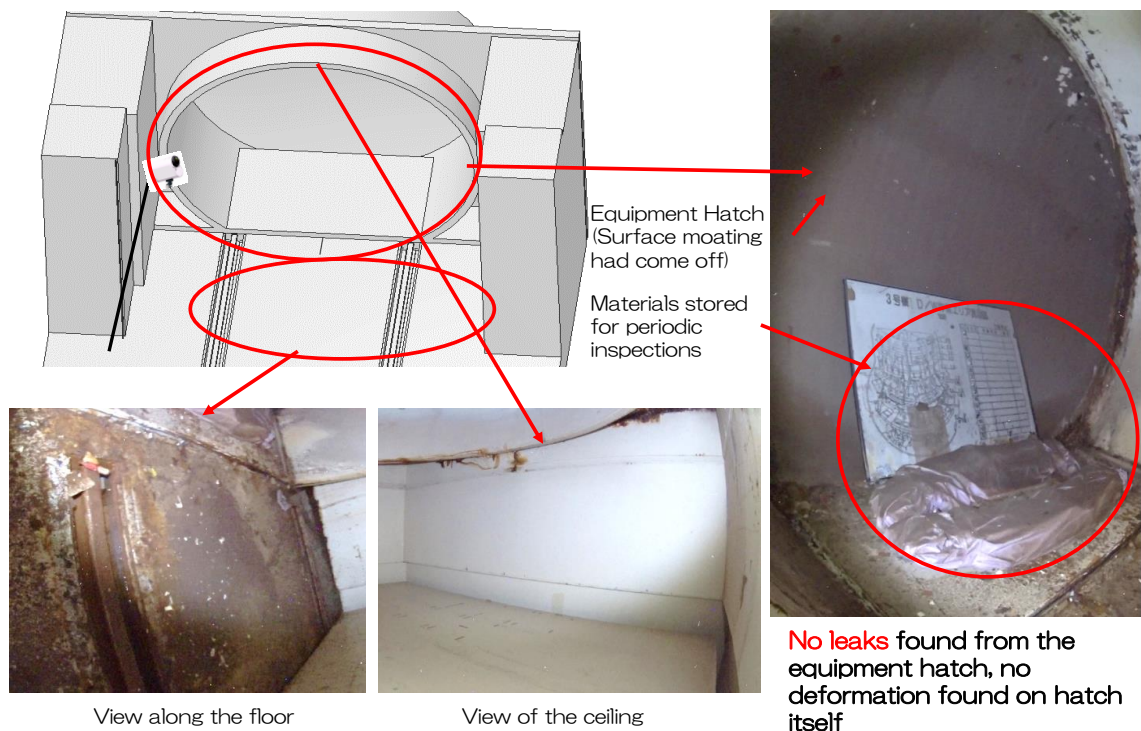
Figure 4-4 Photos of the equipment hatch [37]

In the current investigation, a small camera was inserted through the space between the shield plug and the wall originally surrounding the shield plug and the equipment hatch conditions were surveyed. Figure 4-4 presents photos taken of the hatch and around it. No water leaks from the hatch were recognized and no deformation of the hatch itself was recognized, either. Furthermore, no damage was found on the materials for periodic inspections that had been stored in front of the equipment hatch. Rather, it was noticed that the surface coating on the equipment hatch had come off and fragments of coating and other things had been accumulated on the floor in front of the equipment hatch.

At the original location for the shield plug, water (raindrops or condensed dew) was dripping from above and the floor seemed wet. Water puddles were recognized in the ditches for the shield plug travelling rails.

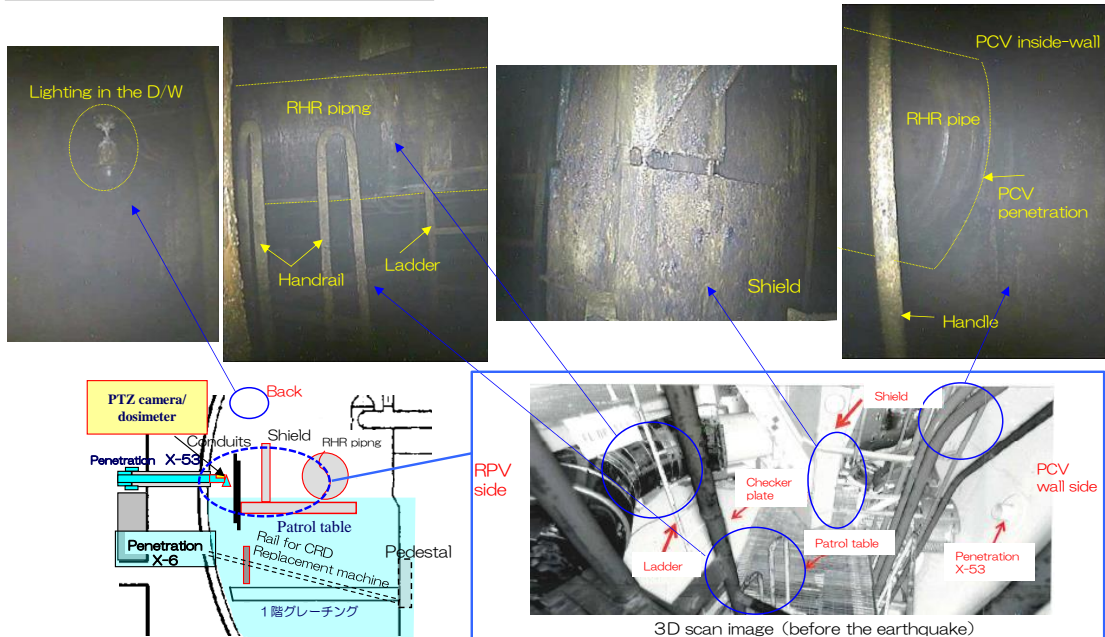
Figure 4-5 Photos of penetration X-53 taken from the front [38]

Figure 4-5 shows photos of the penetration X-53 taken from the front. Structures like piping, a

ladder and other things were visible, but no damage was recognized. Including the underwater photos, no damage was recognized in the PCV in the current investigation.

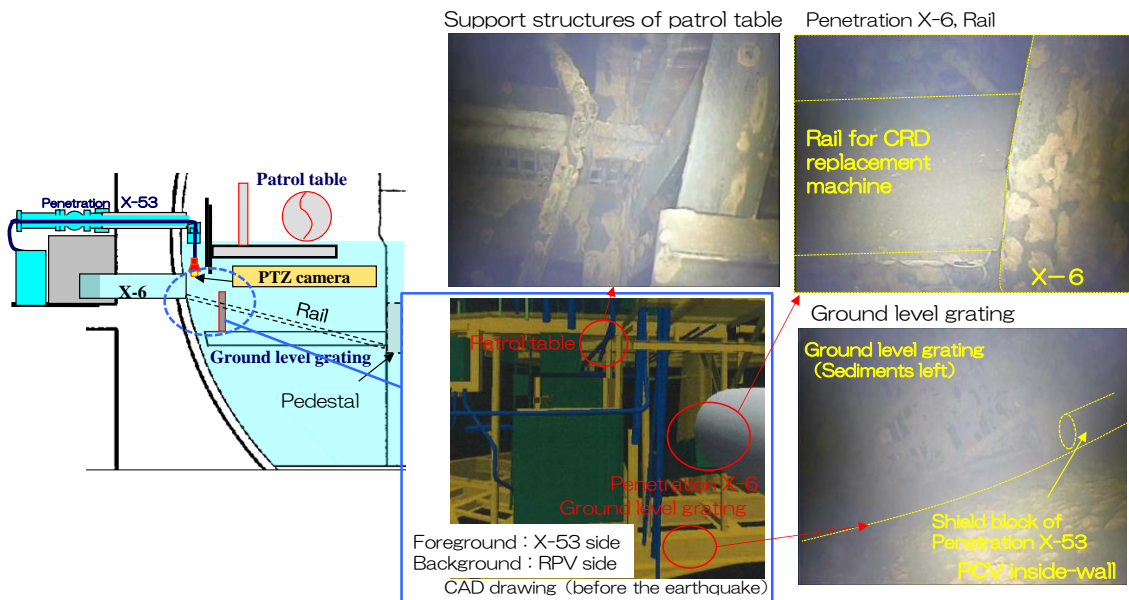
Figure 4-6 Photos in the water retained in the PCV [39]

Figure 4-6 shows photos taken underwater by a PTZ camera. The camera was inserted through penetration X-53. Sediments were recognized on the grating and the rails for the CRD replacement machine.

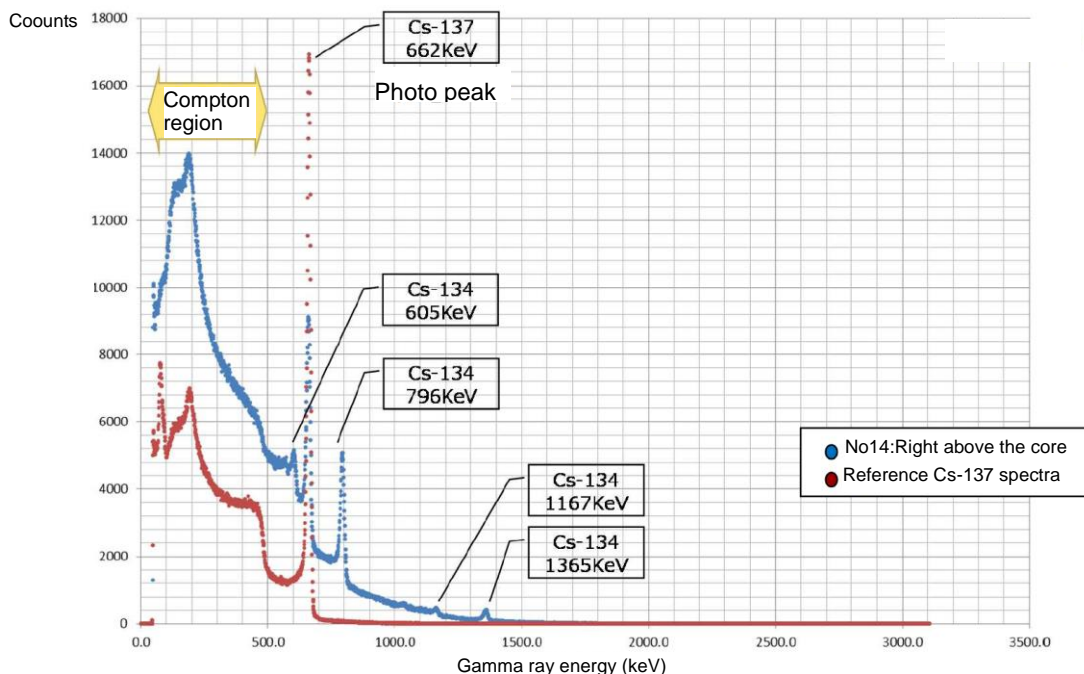
Figure 4-7 Gamma ray spectra measured (right above the core) [40]

Figure 4-7 compares, as a typical example, the gamma ray spectra measured (blue points) at Location ⑭ in Figure 4-8 and the gamma ray spectra of a reference Cs-137 source (red points) obtained at the calibration facility. Relatively higher counting rates are observed in the Compton region in addition to the photo peaks due to Cs-134 and Cs-137 in the measured spectra for the operating floor. When the heights of photo peaks and Compton peaks are compared, the contribution of Compton effects is relatively higher in the measured spectra for the operating floor than in the spectra measured at the calibration facility using reference sources. Similar trends have been confirmed at the measurement locations of the operating floor other than ⑭. Higher contributions of Compton effect mean higher contributions of scattered gamma rays. Therefore, it is possible that higher contributions to the dose rates for the operating floor came from scattered gamma rays from the source deep under the floor surface.

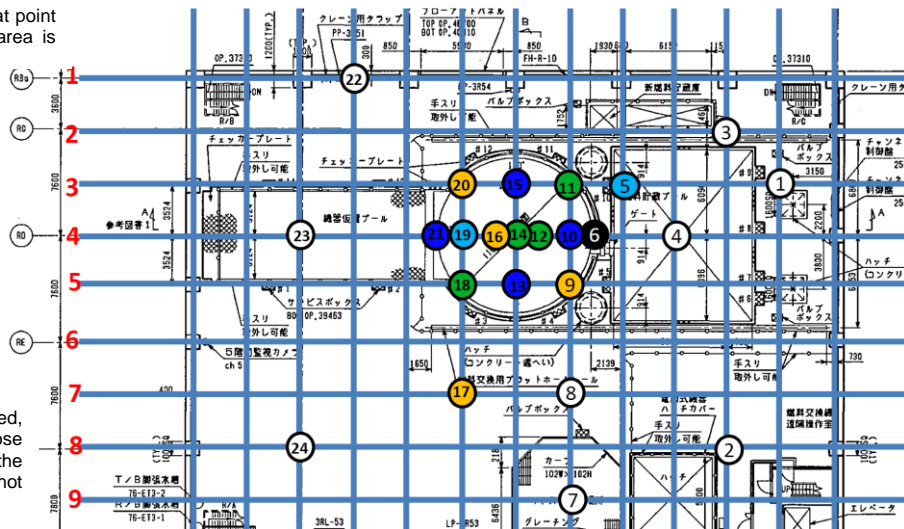
Figure 4-8 Dose rate distribution (relative)  
(Normalized to 1.0 at Location ⑳) [40]

Figure 4-8 shows the distribution of dose rates (relative) evaluated from the measured gamma spectra. Higher dose rates were observed at the periphery of the reactor well-cover (⑥, ⑨, ⑪, ⑱, ⑳) and at the slab interfaces (⑫, ⑯).

\* Data at ㉞ ignored, because the measured dose rates were outside the measurement limit and not correctly measured

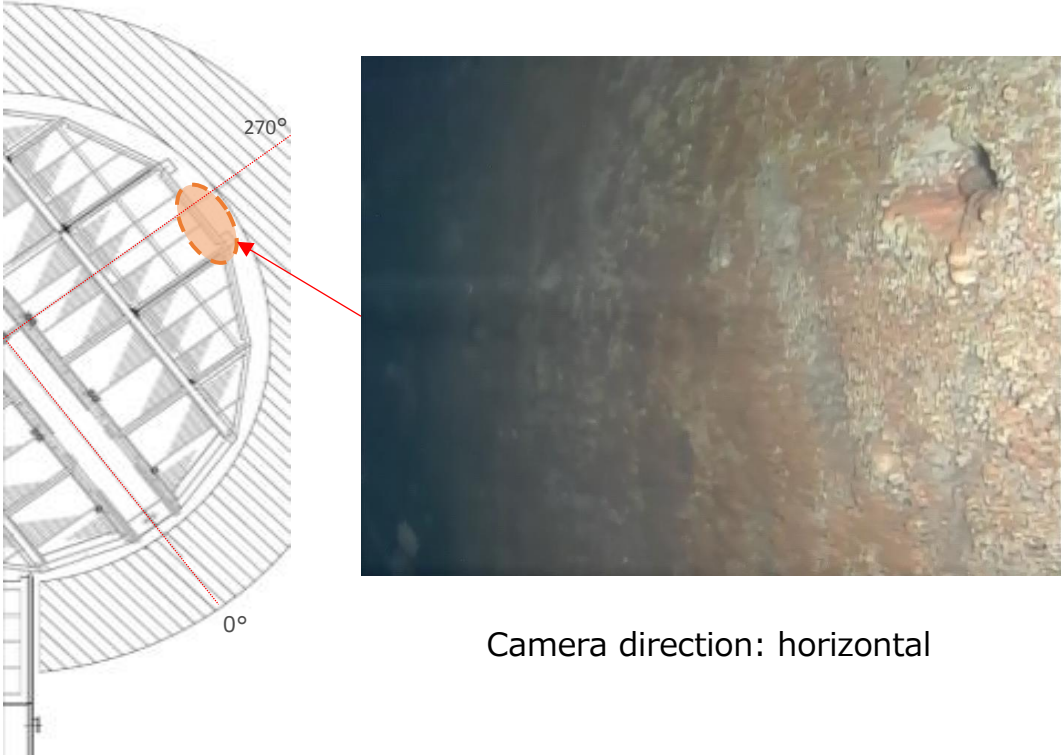
Figure 4-13 Camera photo (pedestal inner wall) [42]

Figure 4-13 and Figure 4-14 are photos of the pedestal inner wall. On part of the inner wall, the epoxy-based coating was stripped off and the wall surface was rough, but no big pedestal damage or deformation was confirmed as a whole (Figure 4-13). Part of the cables for the RPV bottom thermometers laid on the pedestal inner wall was found to be missing (Figure 4-14). It is estimated that high temperature molten debris deposited on the cables when falling down.

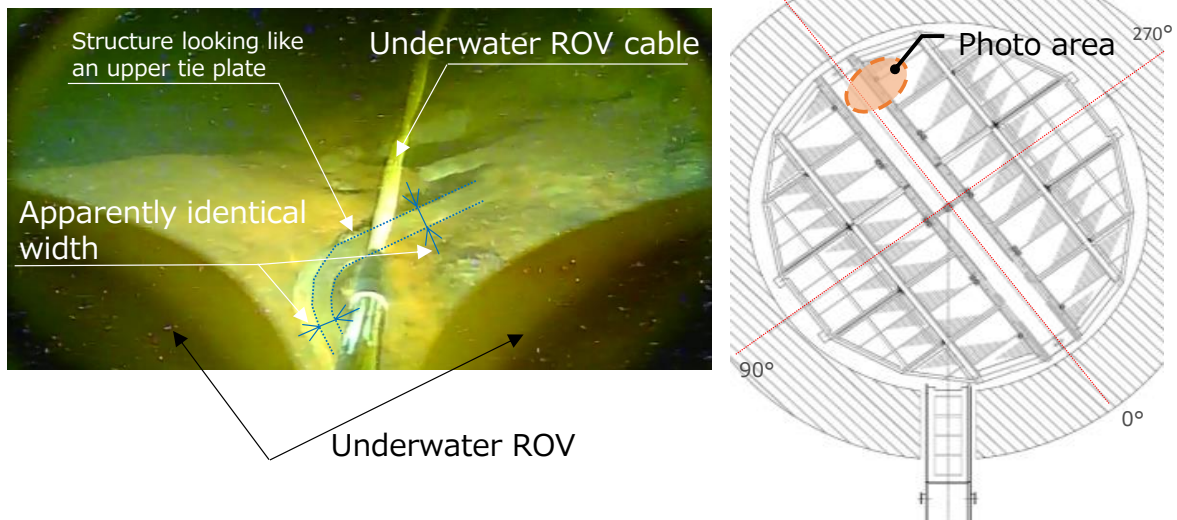
Figure 4-15 Camera photo

Figure 4-15 and Figure 4-16 are photos taken at a lower part inside the pedestal. Although not clearly identifiable, fallen objects looking like upper tie-plates of fuel assemblies or fuel support fitting plugs (Figure 4-15), or a control rod falling speed limiter (Figure 4-16) were found. In the pedestal lower part, pebble-like or lump sediments were confirmed besides sand-like sediments (Figure 4-16). The opening in the pedestal basement for human access was not checked visually, but sediments were confirmed to be present in the vicinity.

(A structure, possibly an upper tie-plate observed inside the lower pedestal) [42]

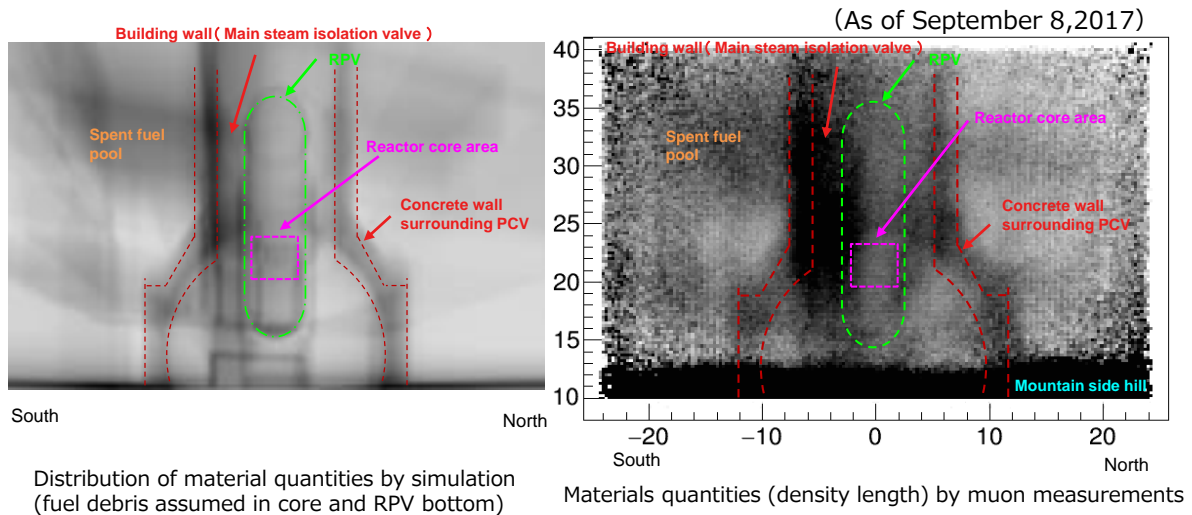
Figure 4-18 Distribution of material quantities from simulation (left) and muon measurement (right) [43]

Investigations with the muon device were conducted for Unit-3 in May to September 2017 following the investigations for Unit-1 and Unit-2. Figure 4-17 shows the location where the muon device was set up. Figure 4-18 compares the distribution of material quantities (density length) obtained from a simulation based on design and those obtained from muon measurements. Concrete in the PCV peripherals, spent fuel pool and reactor building walls could be identified in the distribution of material quantities from the muon measurements.

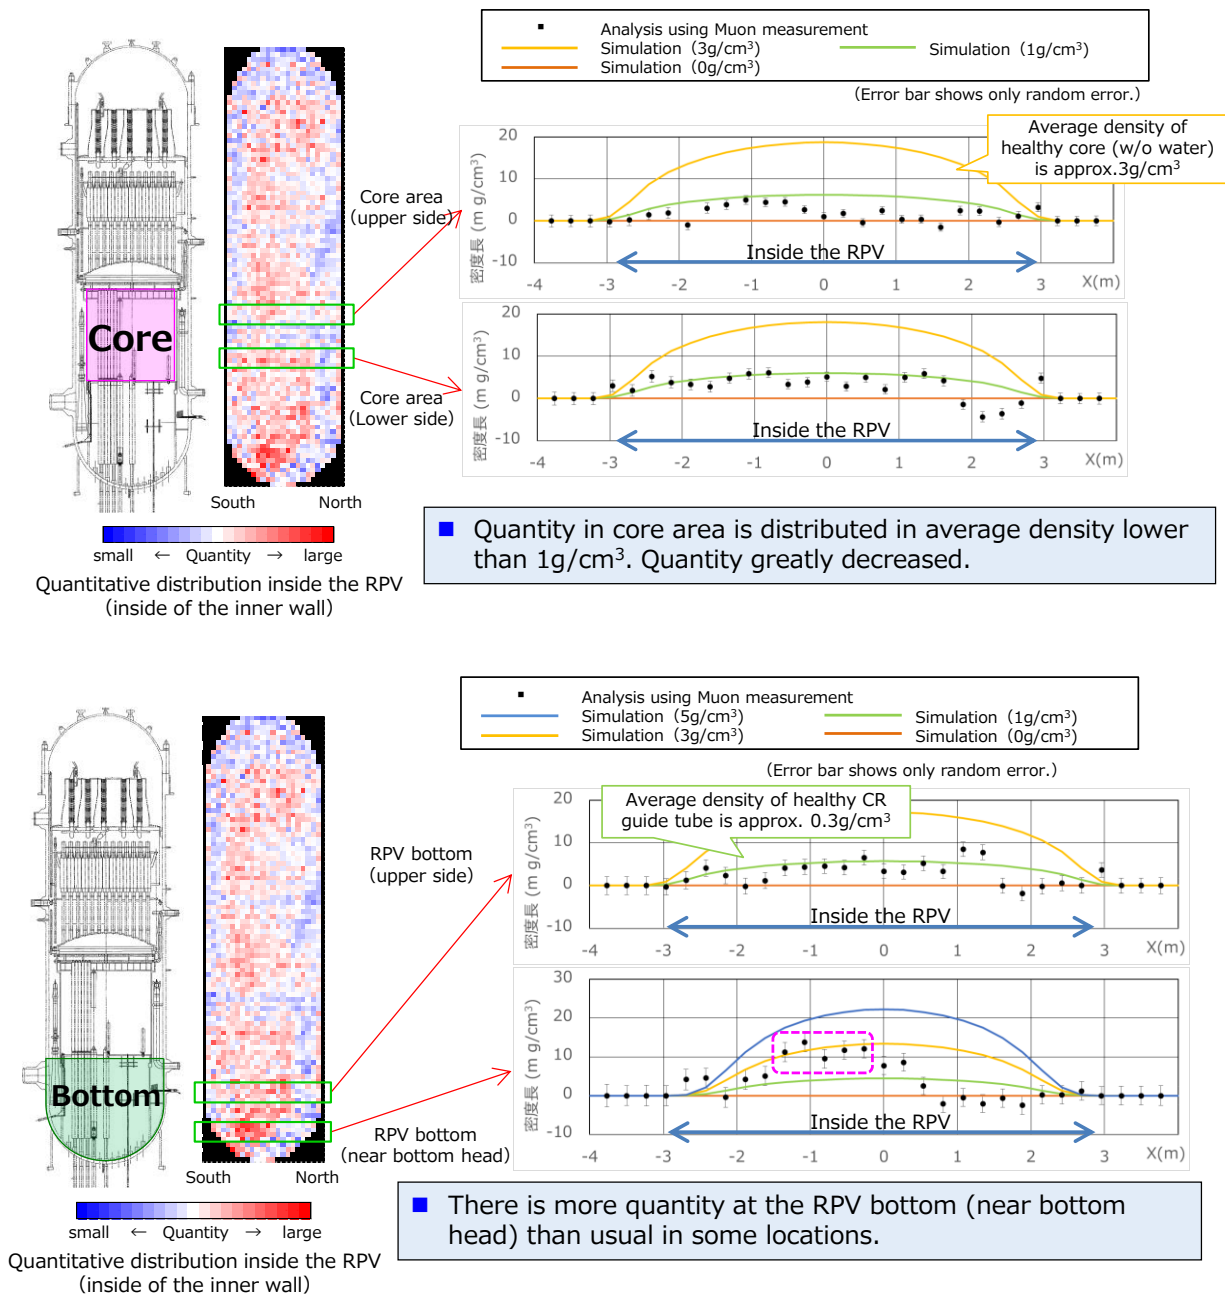
Figure 4-19 Distribution of material quantities in the RPV (Top: core region, Bottom: RPV bottom) [43]

The distribution of material quantities in the RPV was derived from the measured results by eliminating the influences from structures like R/B walls and the PCV based on the simulation model. The results are given in Figure 4-19 (left). These were compared with the simulation results, in which high density materials ( $3 \text{ g/cm}^3$ ,  $1 \text{ g/cm}^3$ , and in addition  $5 \text{ g/cm}^3$  at the PCV bottom) were assumed to be present in the RPV or not present. The comparison led to the estimation of the presence of fuel materials at different RPV elevations (Figure 4-19 (right)). Materials of about  $1 \text{ g/cm}^3$  or below were present at the core region, far lower than the normal average densities in the core (about  $3 \text{ g/cm}^3$ ). On the other hand, more material quantities were identified than normal in

some part of the bottom of the RPV. Quantitative evaluation results of material quantities are given in Figure 4-20 for respective positions in the RPV. By considering the big reduction of material quantities in the core region as compared with those before the accident, most of the fuel can be estimated to have been relocated downward together with structural materials. No big fuel debris is considered to be left in the core region. To the contrary, the material quantities at the RPV bottom increased from the quantities before the accident. This is an indication, with some uncertainties being admitted, that part of the fuel debris remains at the RPV bottom.
