## Relocation behavior of molten fuel to below the core

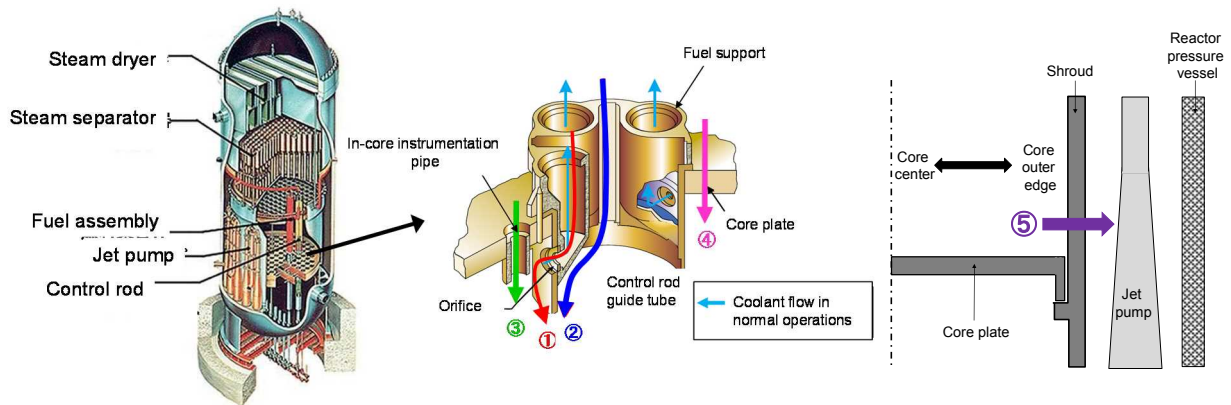
Figure 2.1 BWR lower core structures and molten fuel relocation paths considered in relevant previous tests [5, 6] and the latest research

To sum up, the following five relocation paths to below the core are considered from the relevant previous tests and the latest research.

- ① Inlet orifices of fuel supports (red)
- ② Control rod drive guide tube (CRGT) (blue)
- ③ Broken piping for core instrumentation lines (green)
- ④ Broken core plate (pink)
- ⑤ Broken shroud (violet)
