Analysis of the hydrogen explosion at the Unit-1 Reactor Building

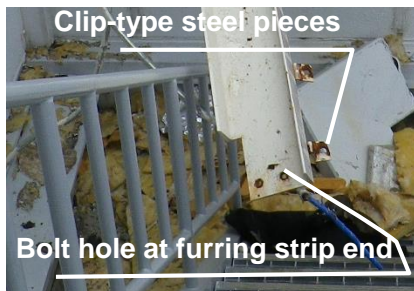
Figure 5 Joints between Floor 5 side wall and R/B structures

Figures 5 (A) to (C) show joints of the Floor 5 side wall and the R/B. The side wall of Floor 5 was made of steel panel and fixed to furring strips by dedicated clip-type steel pieces (A). The end of furring strips was fixed to brackets by two M-16 bolts (B) (C). After the hydrogen explosion, almost all furring strips were found to have been pulled off. This indicates that the bolts fixing the furring strips and brackets were damaged by the increased internal pressure (pressures of Floor 5) due to the hydrogen explosion.

As the bolt breakdown criteria, the internal pressure of 16 kPa was set. This value was derived by converting the bolt shear capacity obtained from tensile strengths of bolt material. In the analysis, the Floor 5 side wall was assumed to be damaged as soon as the Floor 5 internal pressure exceeded the criterion.

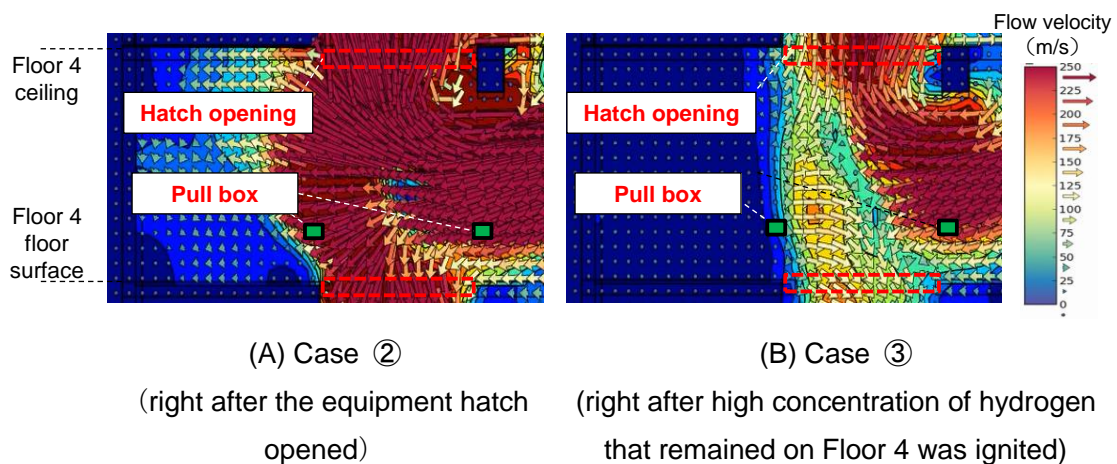
Figure 18 Maximum blast velocity at the pull box location

Figure 18 shows the blast analysis results in Case ② and Case ③, indicating that, in these cases, strong horizontal blasts collided against the pull box, after the high concentration hydrogen on Floor 4 had been ignited. The damage condition of the pull box shown in Figure 16 (B) indicates no marks of horizontal blasts.

From these comparisons, it is concluded that: the deformed shape of the pull box near the equipment hatch on Floor 4 is consistent with the blast directions in Case ① and Case ④ when hydrogen leaks on Floor 5 were assumed; whereas, it is inconsistent with the blast directions in Case ② and Case ③ when hydrogen leaks on Floor 5 and Floor 4 were assumed.

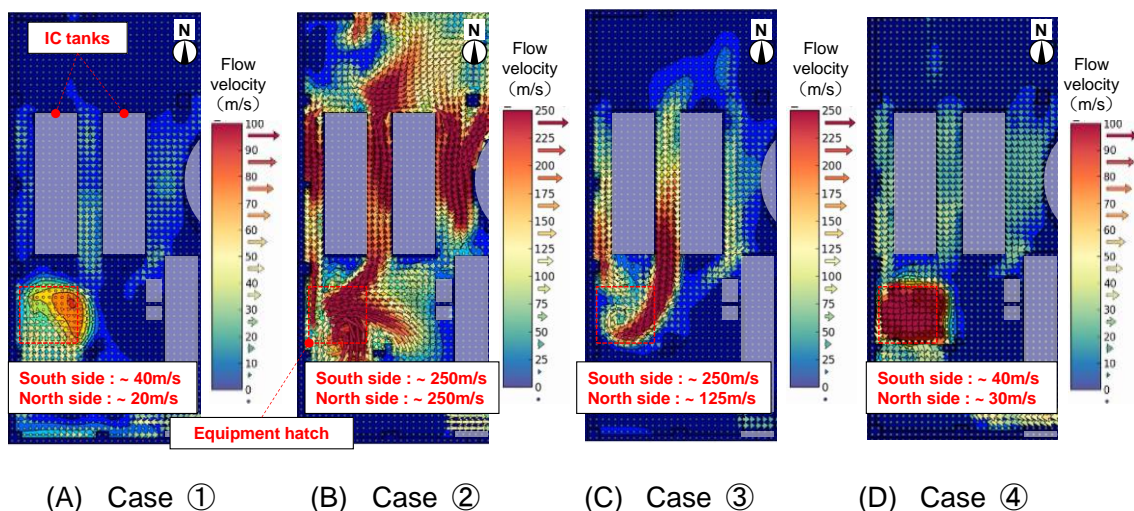
(A) Case ① (B) Case ② (C) Case ③ (D) Case ④
Figure 20 Maximum blast velocities on the horizontal cross section at the IC tank central elevation

Figure 20 shows the analysis results of the maximum blast velocities in the vicinity of the IC tank, presenting velocity vectors on the horizontal cross section at the IC tank central elevation. In Case ② and Case ③, the maximum blast velocities on the IC tank south side and north side are as high as about 125 m/s to 250 m/s, while in Case ① and Case ④ they are about 40 m/s on the IC tank south side and about 30 m/s on the north side. It is not certain whether the blast velocity on the IC tank south side is strong enough to strip the insulator covers off, but the velocity on the IC tank north side is comparatively lower

From these comparisons, it can be understood that: the damaged conditions of insulators and their covers seem to be consistent with Case ① and Case ④, when hydrogen leaks were assumed on Floor 5; while blast velocities may be too big in Case ② and Case ③, when hydrogen leaks were assumed on Floor 5 + Floor 4.

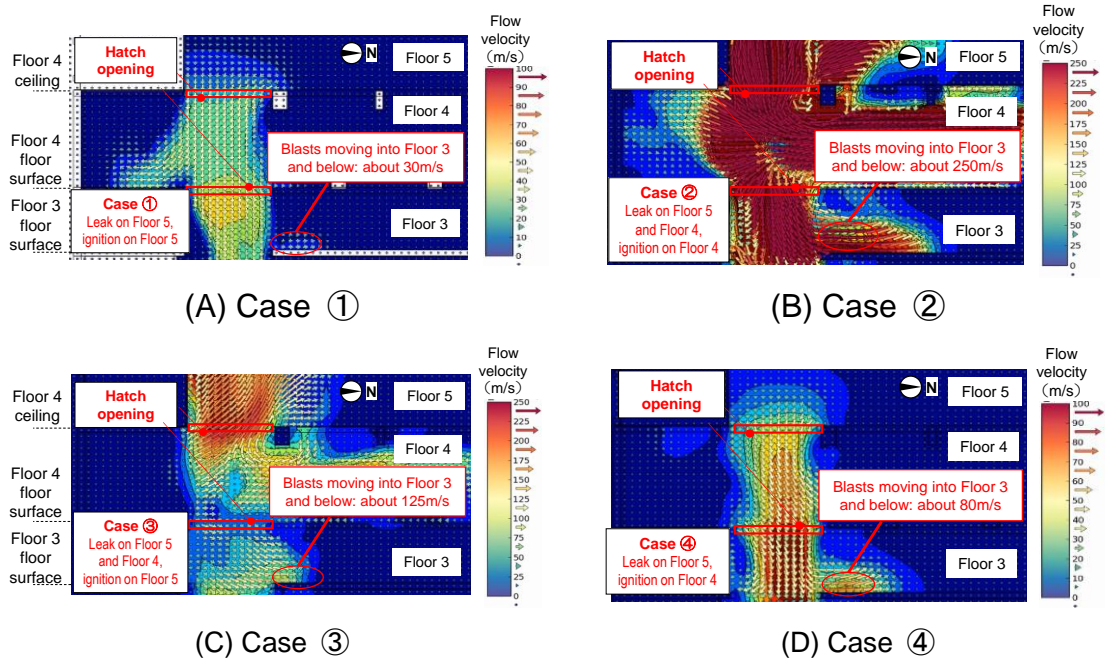
Figure 25 Maximum velocities of blasts moving to Floor 3 and below

Figure 25 presents the analysis results of maximum velocity of blasts moving down to Floor 3 and below. Velocity vectors on the vertical planes around the equipment hatch are shown in the figure. The direction in which the camera was pointed is the same as that in Figure 16 (A). The maximum velocities in the analysis of blasts moving into Floor 3 and below in Case ② and in Case ③ are much higher than in Case ① and Case ④. Blasts in Case ② and Case ③ could be too strong from the viewpoint of the blast velocities moving in.
