**The 5th Progress Report**  
on the Investigation and Examination of  
Unconfirmed and Unresolved Issues  
on the Development Mechanism  
of the Fukushima Daiichi Nuclear Accident

December 25, 2017

Tokyo Electric Power Company Holdings, Inc.

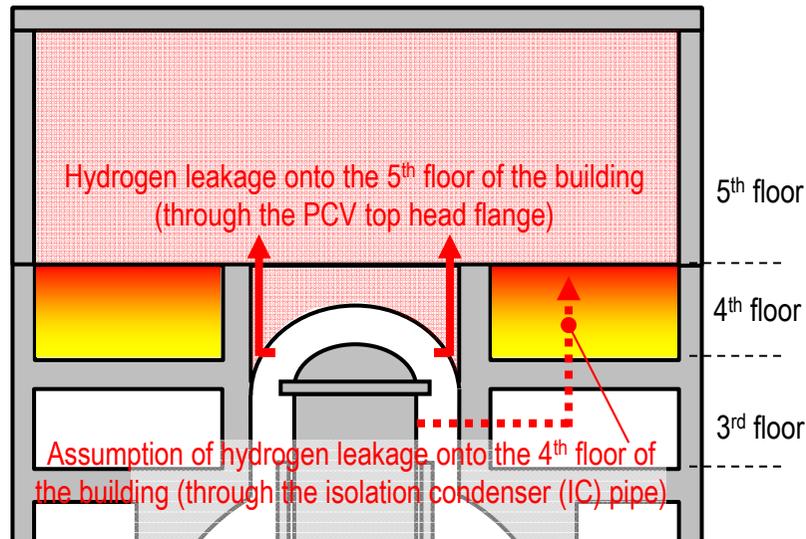
Figure: Image of hydrogen leakage route to the Reactor Building

On March 12, 2011, a hydrogen explosion occurred at the Unit 1 Reactor Building. Based on the record indicating a relatively high dose rate on the 5<sup>th</sup> floor of the building, the explosion was considered attributable to hydrogen generated inside the reactor, which leaked onto the 5<sup>th</sup> floor through the PCV top head flange and eventually triggered the explosion. To confirm this assumption, additional examination was conducted regarding the hydrogen explosion.

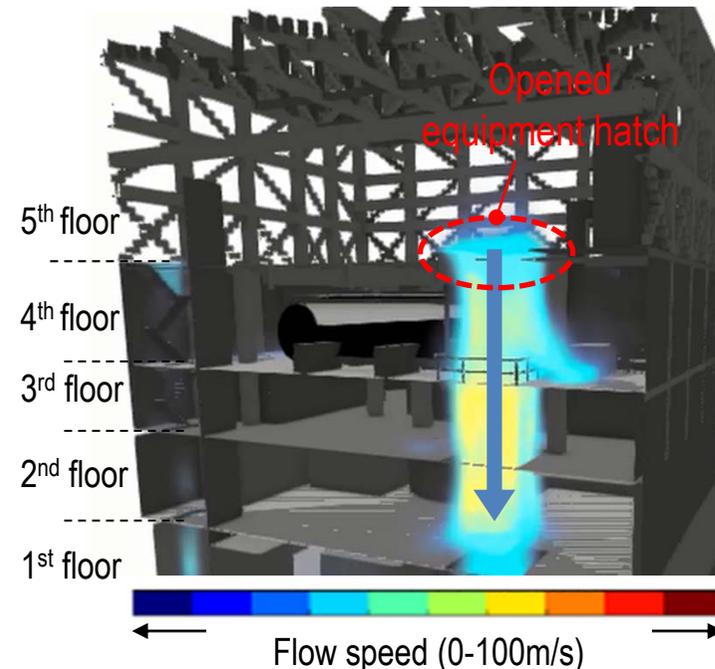
Figure 2: Distribution of blast speed (after the equipment hatch lid was opened)

- Hydrogen was distributed mainly on the 5<sup>th</sup> floor. Part of the hydrogen went from the 5<sup>th</sup> floor to the 4<sup>th</sup> floor via stairs, etc., though the concentration was low (Figure 1).
- The fire developed on the 5<sup>th</sup> floor and increased pressure on the 5<sup>th</sup> floor forced the equipment hatch\* lid open.
- Through the opened equipment hatch, a downward blast was generated on the 4<sup>th</sup> floor and below due to pressure difference. The horizontal blast inflow from the equipment hatch was small on the 3<sup>rd</sup> floor and below (Figure 2).

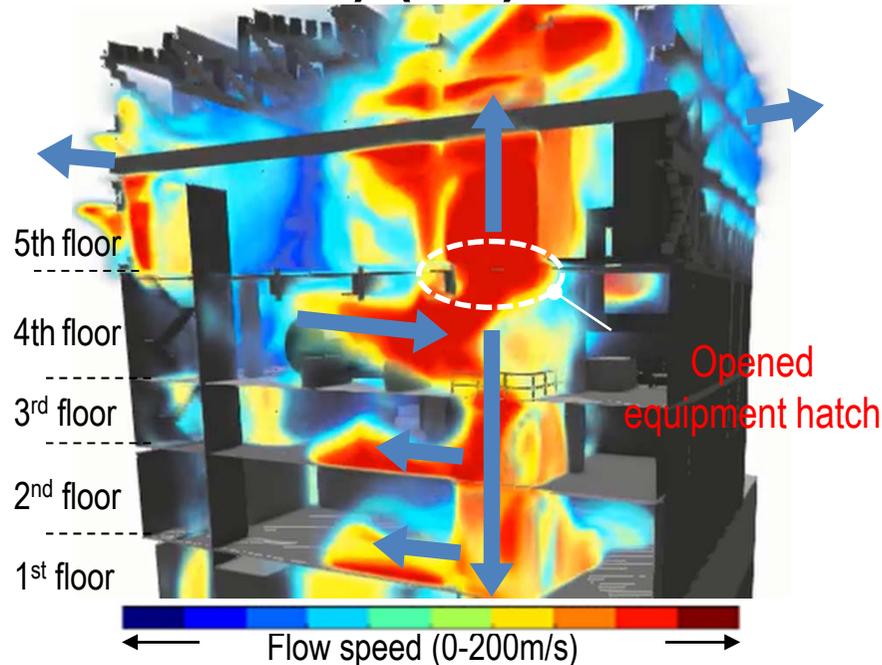
Figure: Distribution of the blast speed (when the 5<sup>th</sup> floor side wall was damaged)

- On the 5<sup>th</sup> floor, the equipment hatch lid and the side wall broke simultaneously, creating simultaneous horizontal and upward flows.
- On the 4<sup>th</sup> floor, where an ignition point was located, following an increase in pressure, a strong blast was generated toward the equipment hatch, which provided an escape route for the air.
- On the 3<sup>rd</sup> floor and below, a strong horizontal inflow blast was generated from the equipment hatch.

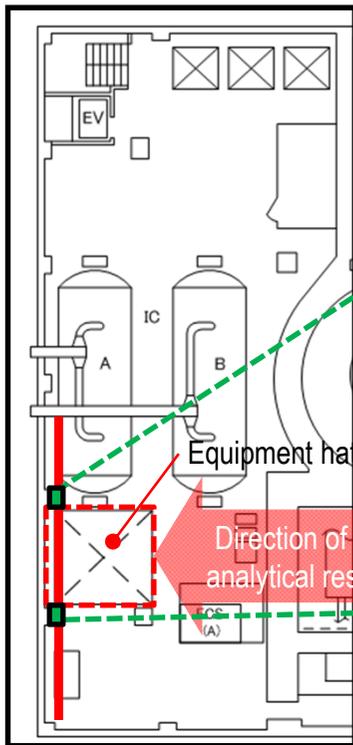
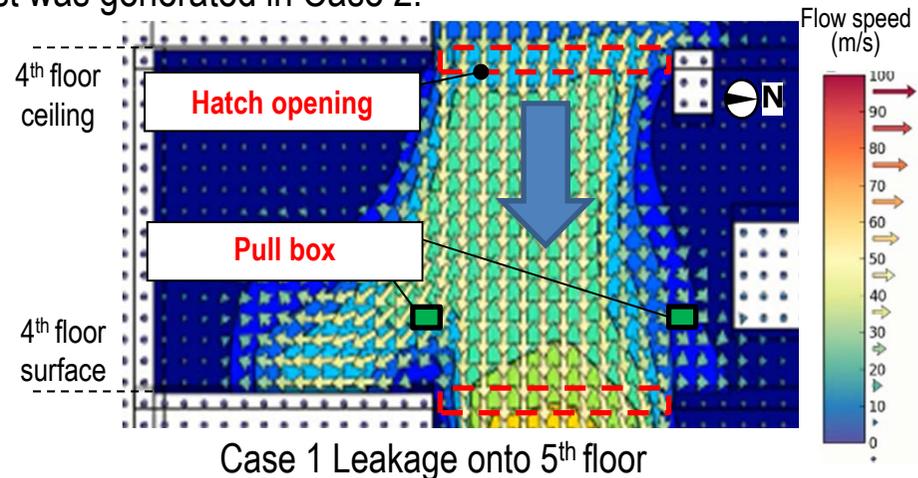
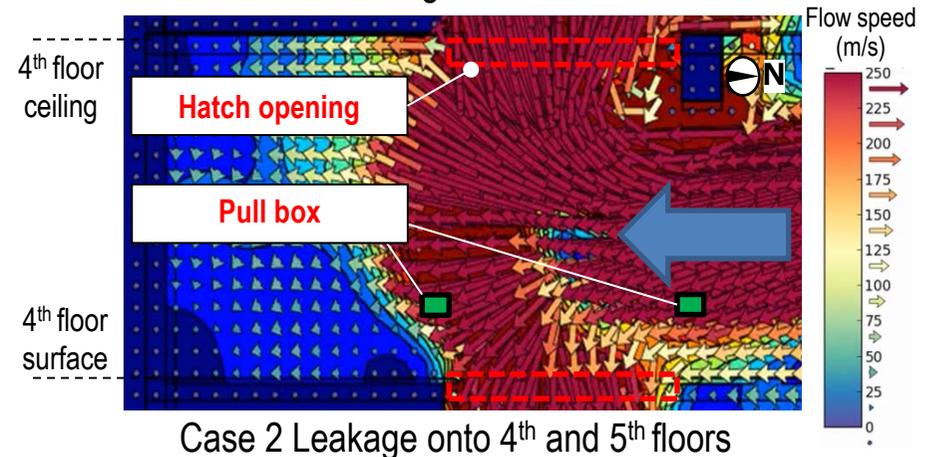
Plan view on the west side of the 4<sup>th</sup> floor

- An inspection of pull boxes (metal boxes that integrate and split cables) around the equipment hatch on the west side of the 4<sup>th</sup> floor identified distortion which was likely due to downward crushing.
- The analytical results concluded that a downward blast was generated at the above point in Case 1 (correlating with the damage status) while a strong horizontal blast was generated in Case 2.

The distortion direction of the pull boxes around the 4<sup>th</sup> floor equipment hatch was consistent with the direction of the blast in the case of leakage onto the 5<sup>th</sup> floor. The blast direction in the case of leakage onto the 4<sup>th</sup> and 5<sup>th</sup> floors differed from the distortion direction of the pull boxes.

- Potential leakage from PCV top head flange was again suggested.  
⇒ Measures to prevent leakage from PCV need to be implemented.
- In addition, measures to keep the hydrogen concentration inside the reactor building, including local hydrogen accumulation, appropriately low in the event of leakage need to be implemented to prevent hydrogen explosion.

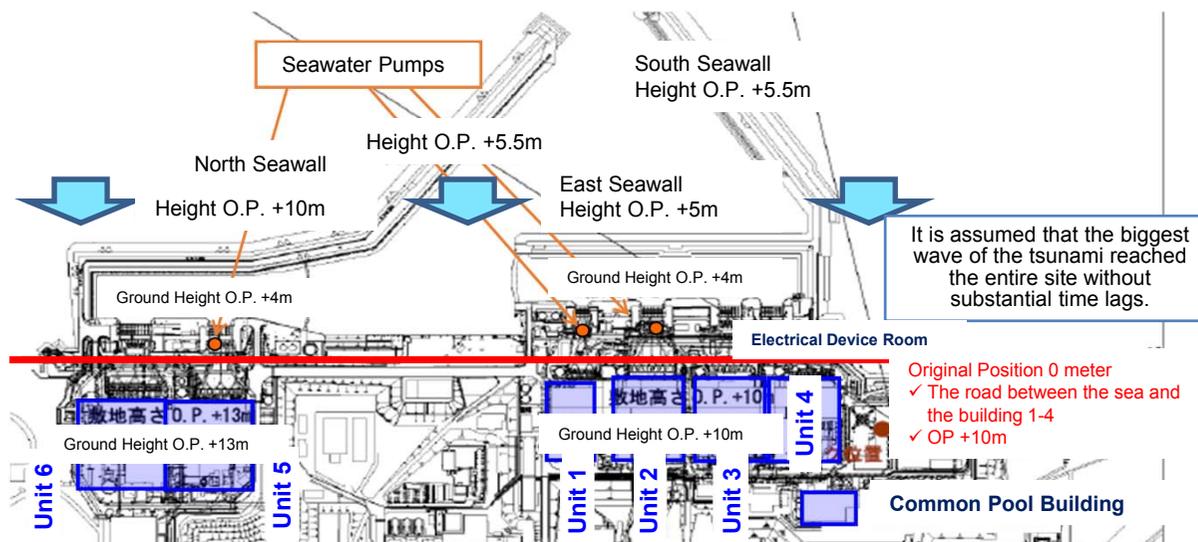
Figure Assumption of Each Reactor Building, the Location of the Seawater Pump, and Tsunami Runup

The investigation to date suggests that the loss of emergency AC power supplies was caused by the tsunami. Conversely, some point out the possibility that it was caused by the earthquake because the relationship between the intrusion of the tsunami and the loss of emergency AC power supplies remains unclear. Therefore, for further consideration and to enhance the plausibility of our deduction, we investigated the relationship between the intrusion process of the tsunami and the loss of emergency AC power supplies.

Assuming that the tsunami caused the loss of power supplies, the time of the water ingress to the power supply equipment of each reactor correlates to the time of its loss of function.  
→ As the time of water ingress is considered to correlate with the path length of the tsunami ingress to each power supply system, we investigated the relationship between the location of each system (path length) and the time of its function loss.

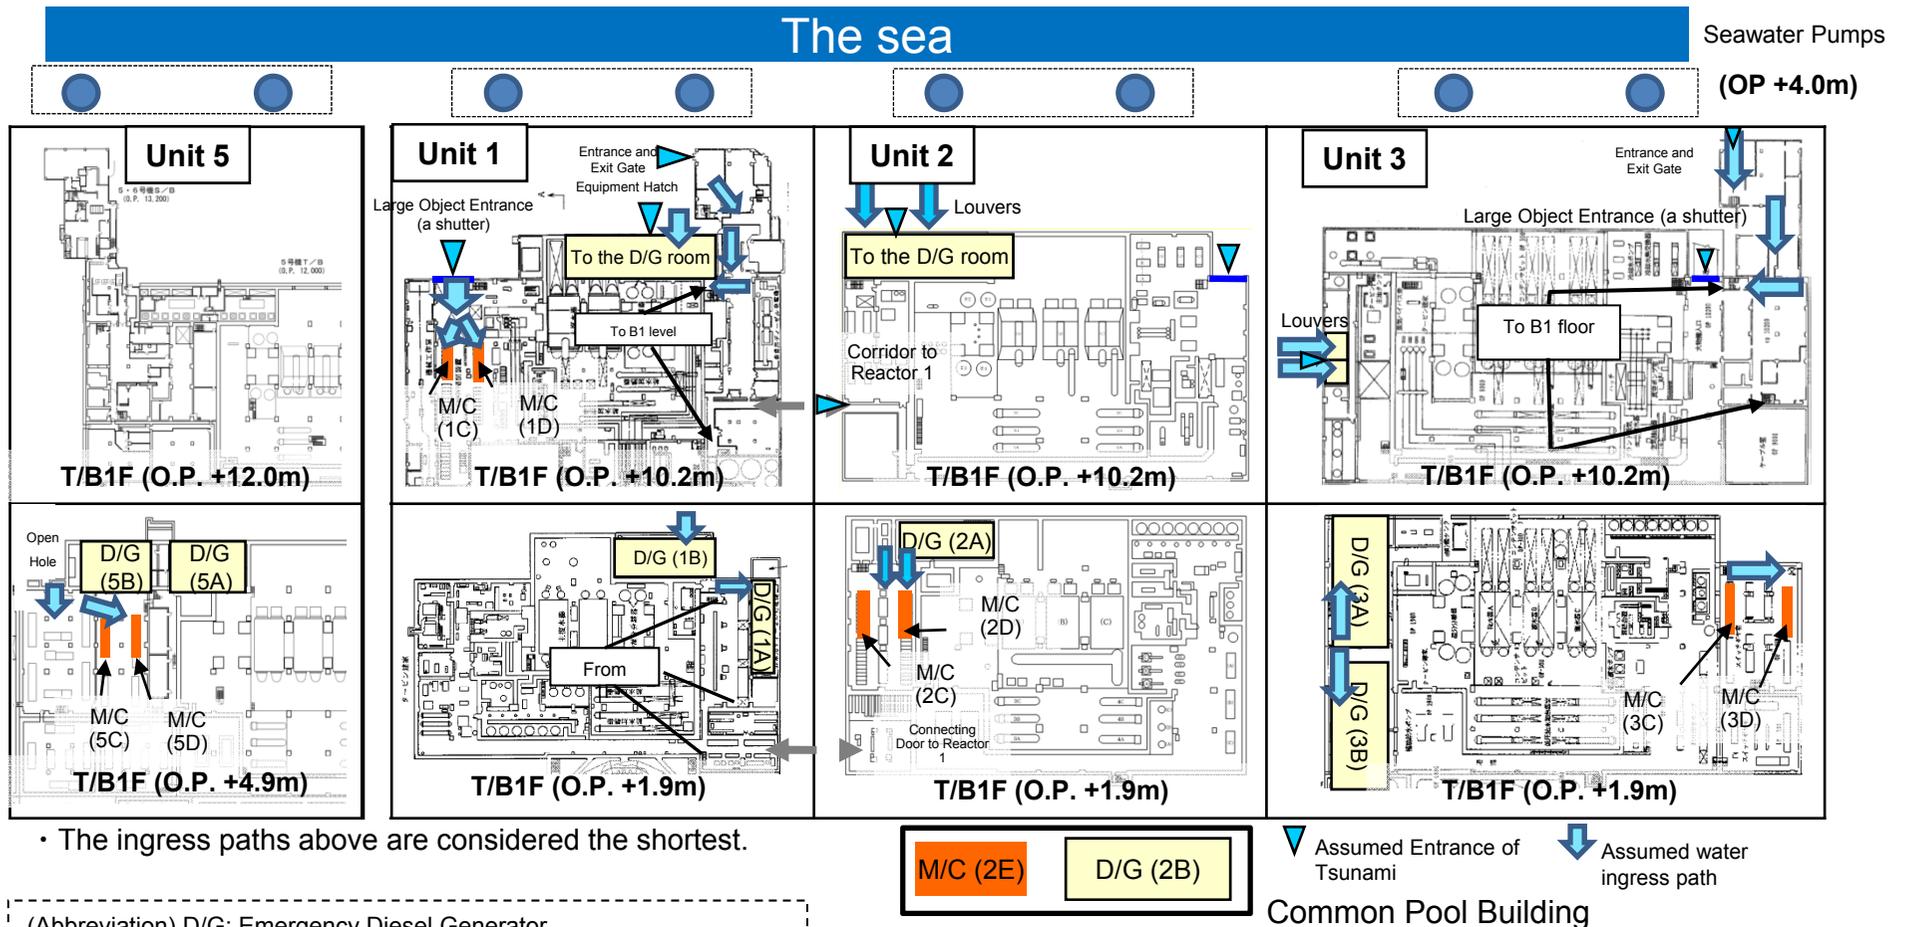
Figure Main Intrusion Path to Each Unit

✓ To consider the tsunami ingress into the buildings, the path lengths are calculated from the assumed length of the tsunami ingress, rather than straight lines from the standard.

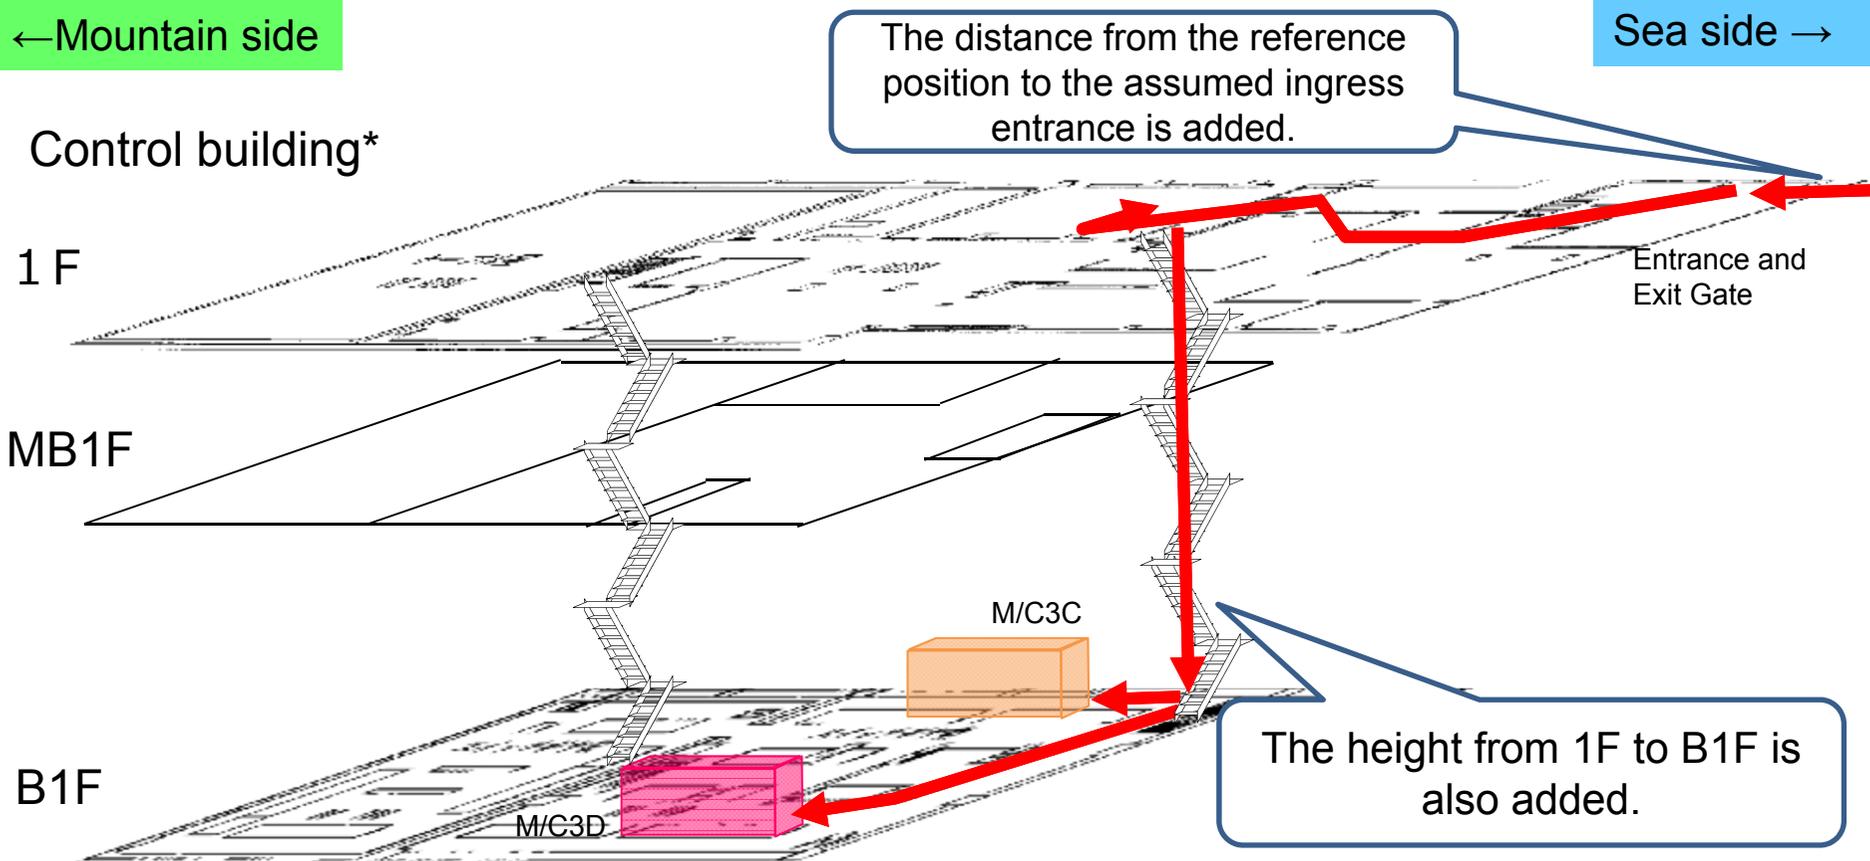
Figure Assumed Main Tsunami Intrusion Paths to M/C3C and 3D of Unit 3.

\* The figure shows only the control building because tsunami intrusion path to the M/C3C and 3D of Unit 3 was only in this building. The control building is located next to the turbine building.

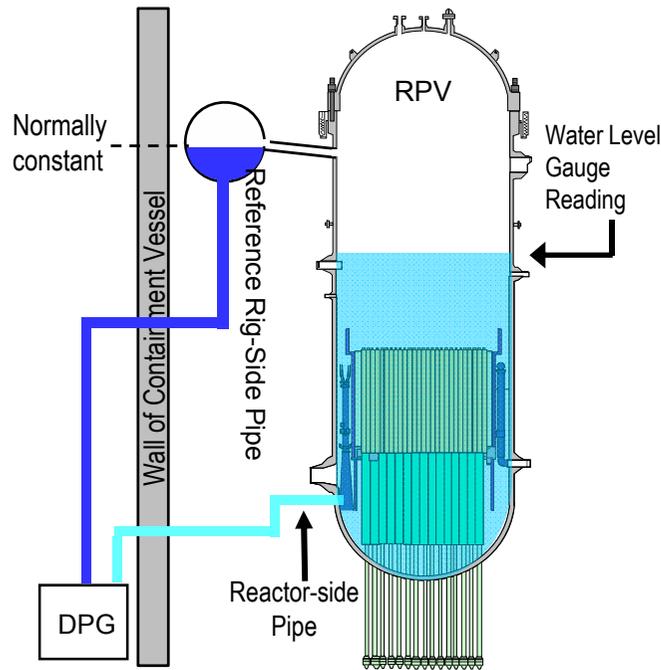
Figure 1 Structures of the Water Level Gauge

- Reactor water level is calculated from the difference in water head pressure between the reference rig-side pipe and the reactor side-pipe (Figure 1).
- Normally, the water level in a reference rig is always kept constant. The change in the reactor water level change is detected by the water head pressure change of the reactor-side pipe (Figure 1).
- Under grueling conditions, with progressive core damage and meltdown and soaring temperatures in the reactor and containment vessel, as occurred in the Fukushima Daiichi Nuclear Disaster, the water in the reference rig-side pipe evaporates and the water level in the pipe, which is normally constant, decreases (Figure 2).
- Consequently, an accurate reactor water level cannot be obtained. (When the water in the reference rig evaporates, the reactor water level is estimated to be higher than the actual water level (Figure 3)).

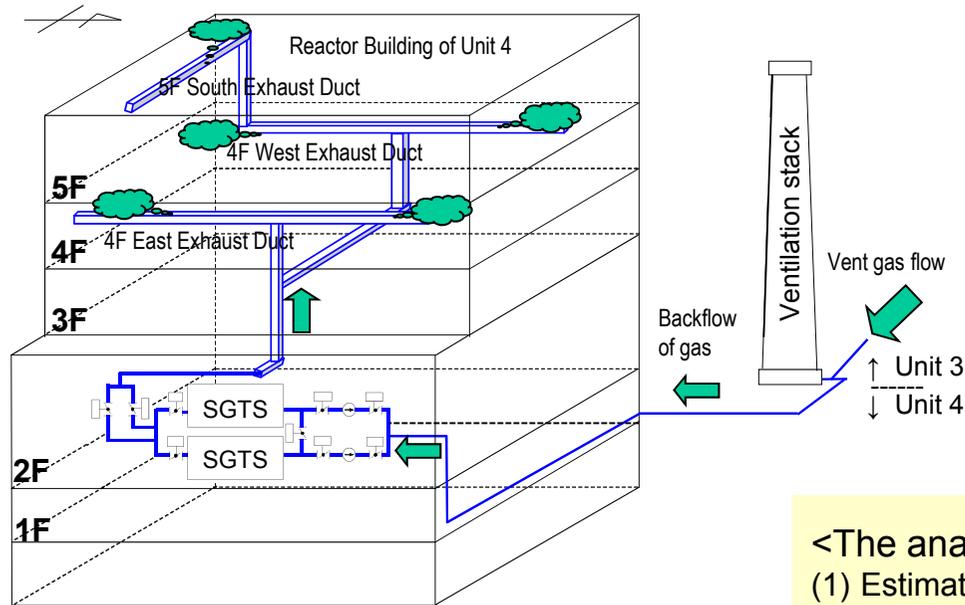
Figure Inflow route of vent gas to Unit 4

- We deduced that the hydrogen explosion in the reactor building of Unit 4 occurred because some vent gas, including hydrogen, flowed through the pipes of the Standby Gas Treatment System (SGTS) of Unit 4 into the reactor building of Unit 4 in the venting of the containment vessel of Unit 3. (It was already reported in our accident investigation report).
- To understand the hydrogen explosion in Unit 4, we estimated the percentage of vent gas having flown into the reactor building of Unit 4 with an analysis based on the design information, including the vent lines of the Units.

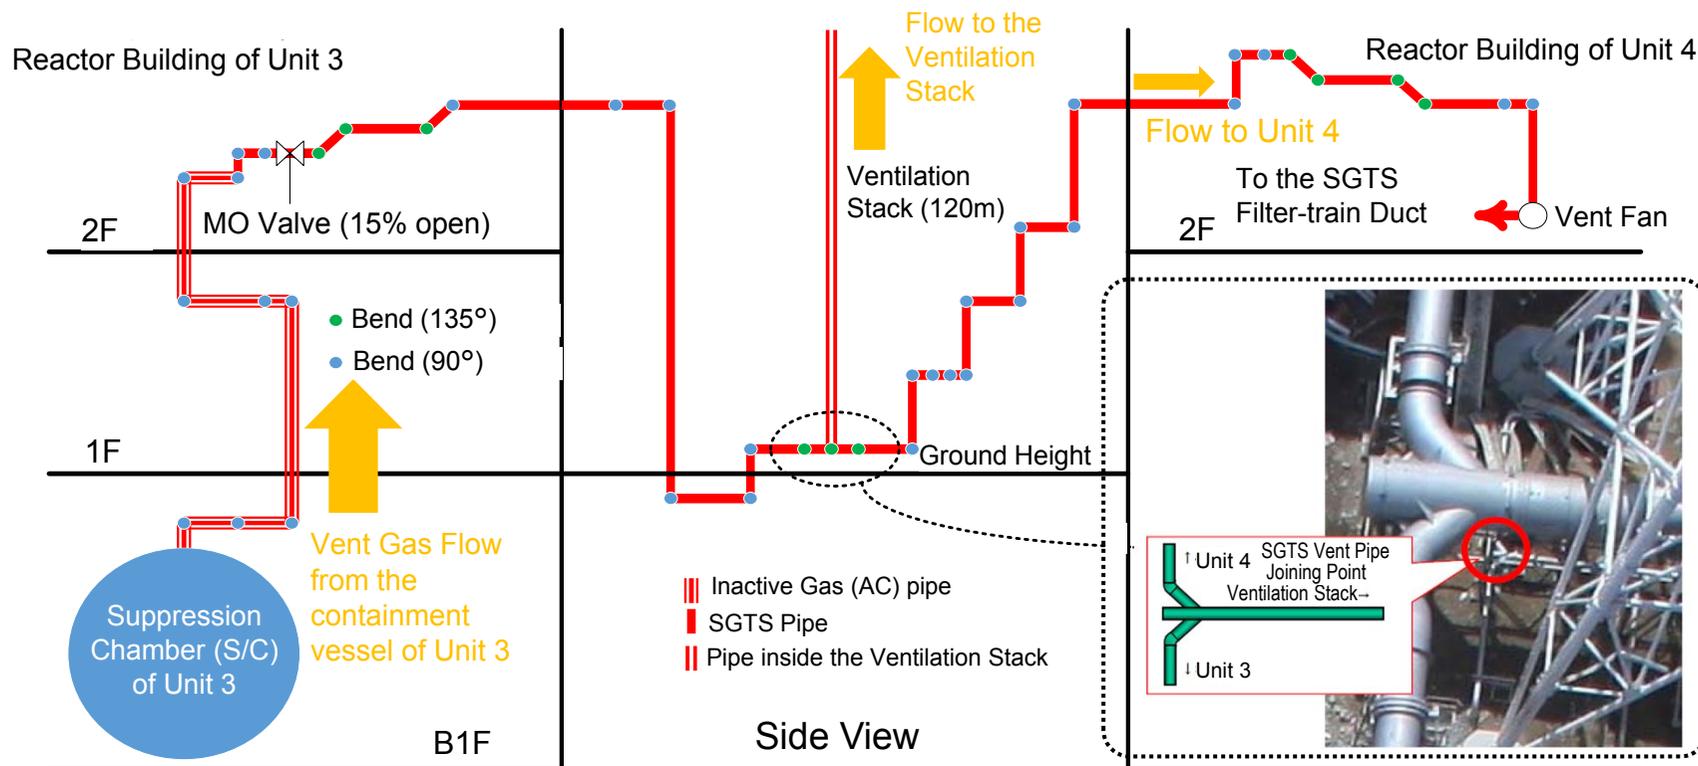
Figure Diagram of Vent Pipes and SGTS Pipes

## Causes of vent gas inflow from Unit 3 to the reactor building of Unit 4

- ① As accident management measures, vent lines were installed in the construction by using a large portion of existing SGTS pipes, which were connected to the duct on the building side and had an opening inside the building.
- ② SGTS pipes of Units 3 and 4 were connected to the shared ventilation stack.
- ③ All the valves of the SGTS pipes of Unit 4 were open because all AC power supplies were lost. (Fail-open design)

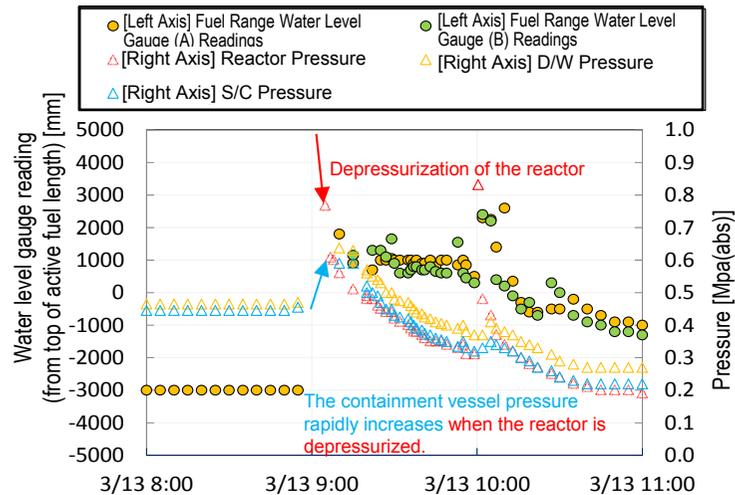
Figure 1 Parameters at the Start of Containment Vessel Vending

- Settings of the initial state in the containment vessel of Unit 3
  - We evaluated the conditions (temperature and gas composition) in the containment vessel of Unit 3 at the start of venting based on the plant parameters before and after containment vessel venting (Figure 1: reactor pressures, containment vessel pressures and fuel range water level gauge readings)

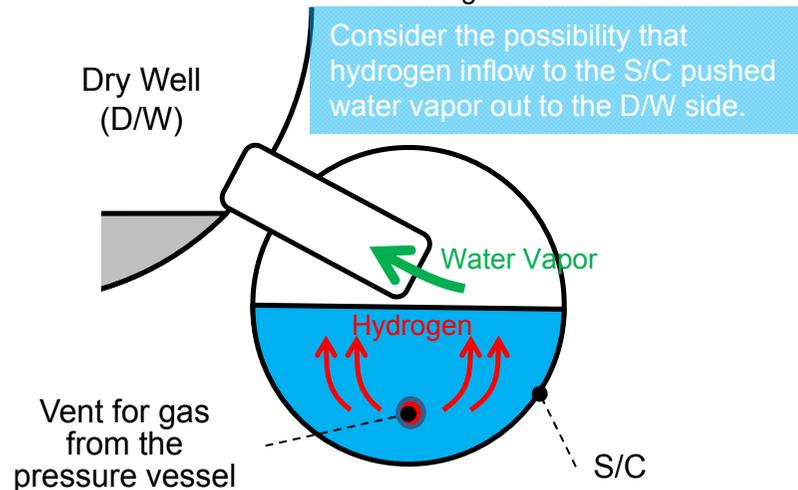
Figure 2 Vapor behavior in the S/C in hydrogen inflow

- Settings of the range of hydrogen in the containment vessel of Unit 3
  - Judging from the rapid pressure increase in the containment vessel during the reactor depressurization, it is likely that hydrogen was transferred from the RPV into the S/C, increasing the hydrogen concentration in the S/C (Figure 2).

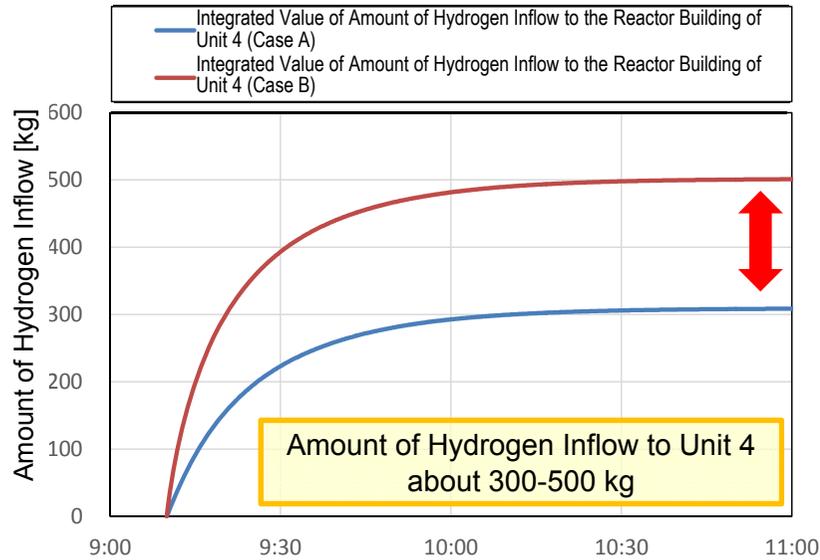
Figure 1 Amount of Hydrogen which Flowed into the Reactor Building of Unit 4

We deduced that a considerable amount of hydrogen flowed into the reactor building of Unit 4 and resulted in the hydrogen explosion in Unit 4.

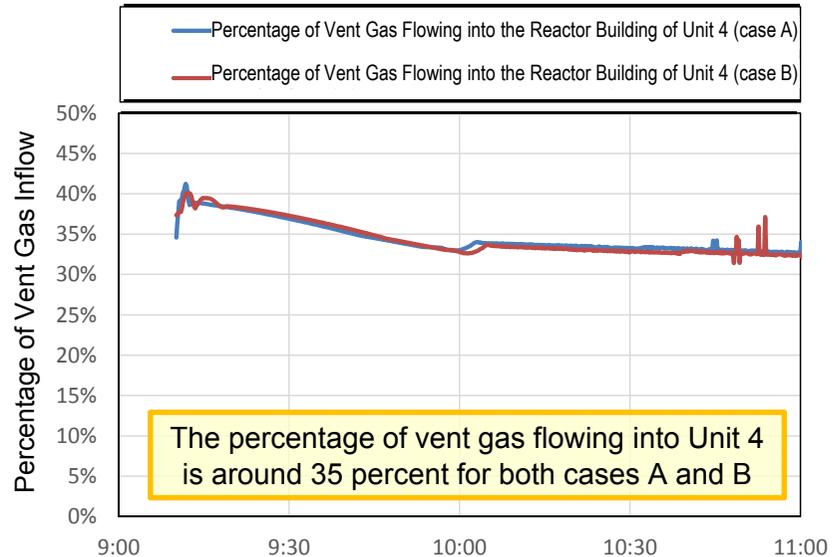
Figure 2 Percentage of vent gas flowing into the reactor building of Unit 4

Regardless of the partial pressure of gas in the containment vessel, the percentage of vent gas flowing into the reactor building of Unit 4 is almost the same (about 35 %).

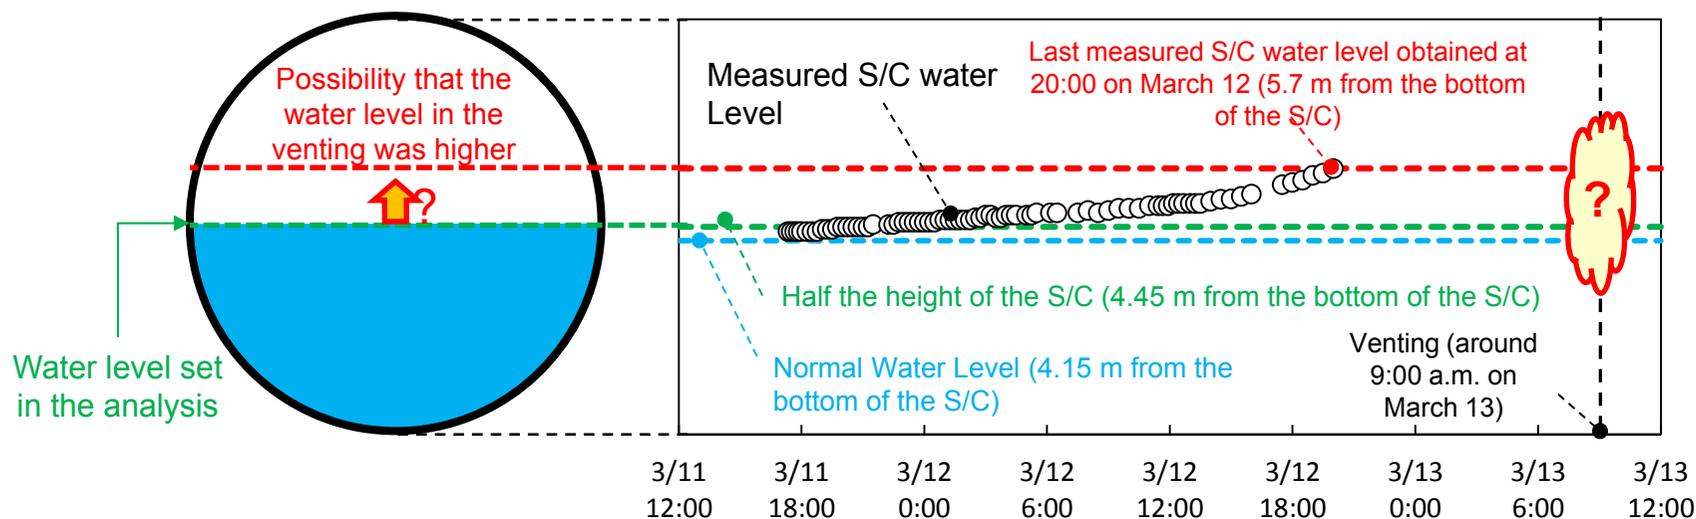
- In the analysis, we assumed that the S/C water level at the time of venting was half the S/C ( $\doteq$  normal water level). However, although the measured values don't exist, there is a possibility that the water level in the venting was higher because of the S/C spray and for other reasons (Figure above).
- If the S/C water level in the venting is as high as the last obtained measured value, the space in the S/C will be around 35 percent smaller than determined in the analysis, which means the hydrogen amount is estimated to be smaller correspondingly. Therefore, the analytical result, which shows a hydrogen inflow to Unit 4 of about 300-500 kg, is uncertain.
- We consider that if the plausibility of the S/C water level changes and the amount of hydrogen generation in the accident increases in future, this will help reduce uncertainty.

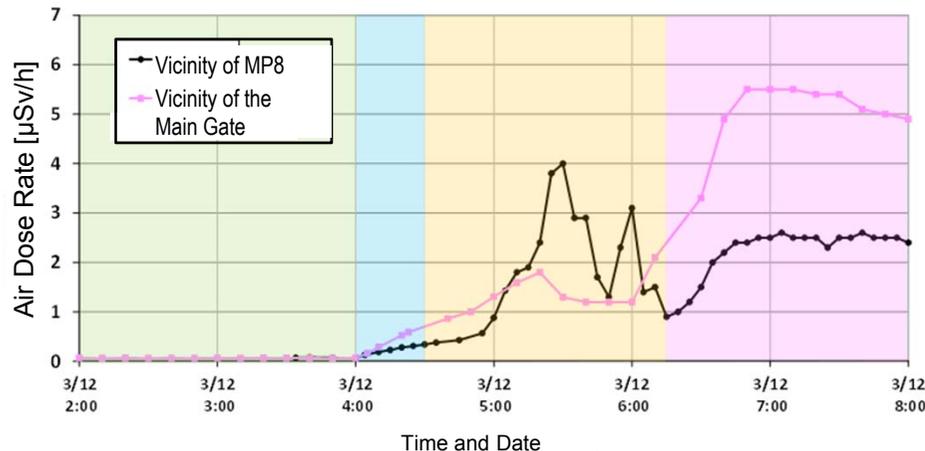
Air dose rate monitoring data in the Power Plant site

At around 4:00 a.m. on March 12

The air dose rate within and outside the power plant site shows no remarkable change.  
 <Deduction>  
 The transfer of radioactive materials from the containment vessel to the reactor building and to the environment was not significant enough to be observed outside the reactor building.

The air dose rate increases only in the power plant site. No peaks are visible. It is considered to reflect the features of pattern A (influence of direct and skyshine radiation).  
 <Deduction>  
 The transfer of radioactive materials from the containment vessel to the reactor building was significant enough to be observed outside the reactor building.

The peaks of the air dose rate, which are characteristic of pattern B (influence of the cloud of radioactive material), can be seen within and outside the power plant site. The influence of pattern A is also visible during the period.  
 <Deduction>  
 Radioactive material leaked from the reactor building into the environment.

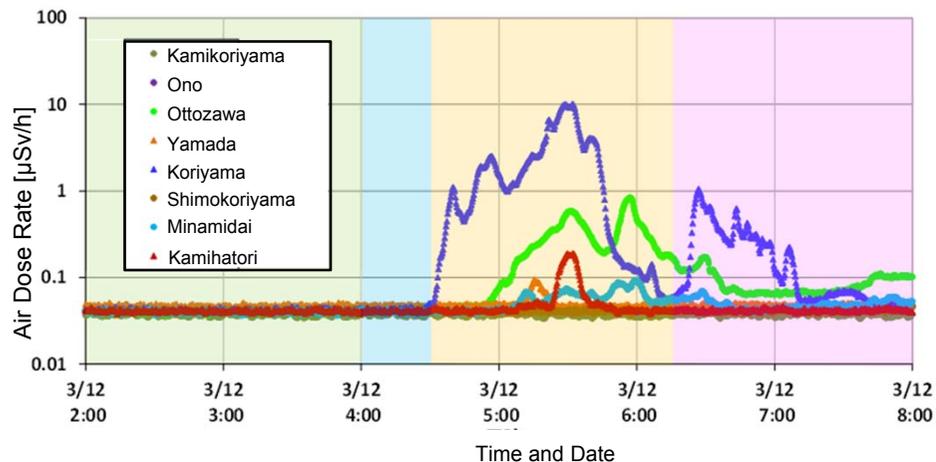
Air dose rate monitoring data outside the Power Plant site

From shortly after 6:00 a.m. to around 8:00 a.m. on March 12

The air dose rate in the power plant site increases and then remains flat. It is considered to reflect the features of pattern A. The air dose rate outside the power plant site has peaks, which are characteristic of pattern B.  
 <Deduction>  
 Judging from the high air dose rate in the site compared to the data before this period, more radioactive material transferred from the containment vessel to the reactor building.

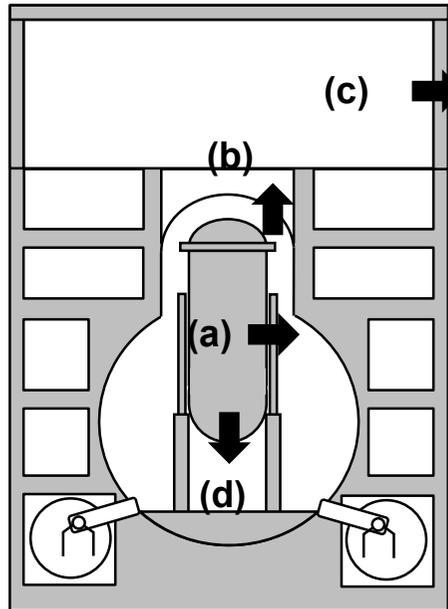
Example transfer path of the radioactive material

- (a) Pressure Vessel (Connecting pipes) → Containment Vessel
- (b) Containment Vessel → Reactor Building
- (c) Reactor Building → Environment
- (d) Pressure Vessel (Bottom Head) → Containment Vessel

Time and Date	Existing Accident Progression Scenario [1]	Accident Progression Scenario Based on the Air Dose Rate Behavior and Containment Vessel Pressure
Mar. 11	<ul style="list-style-type: none"> <li>• Fuel melted and radioactive material was transferred from the pressure vessel to the containment vessel. ((a) in the figure).</li> <li>• Molten fuel was transferred from the reactor core to the pressure vessel (bottom head).</li> </ul>	<p>&lt;Deduction (1)&gt;                      Until around 4:00 a.m. on March 12, the leakage of radioactive material from the containment vessel into the reactor building and the environment was not significant enough to be observed outside the reactor building.</p>
Mar. 12 around 4:00 a.m.		<p>&lt;Deduction (2)&gt;                      As of around 4:00 a.m., the transfer of radioactive material from the containment vessel to the reactor building was significant enough to be observed outside the reactor building ((b) in the figure).</p>

around 4:30 a.m.		<p>&lt;Deduction (3)&gt;                      The radioactive material leaked from the reactor building into the environment by 4:30 a.m. at the latest ((c) in the figure).</p>
around 6:00 a.m.	<ul style="list-style-type: none"> <li>• The pressure vessel (bottom head) was damaged ((b) in the figure)</li> </ul>	<p>&lt;Deduction (4)&gt;                      Some event which increased containment vessel pressure occurred at around 6:00 a.m. and caused an increase in radioactive material transfer to the reactor building ((d) in the figure).</p>

- The deduction that radioactive material transferred to the containment vessel as of March 11 in the existing accident progression scenario matches deductions (1) and (2) of the deduced scenario.
- The deduction that the pressure vessel (bottom head) was damaged at around 6:00 a.m. is also consistent with deduction (4).
