Welded Tank Internal Surface Inspection Results and Future Tank Plan in light of the Detection of Hydrogen Sulfide

April 25, 2019

Tokyo Electric Power Company Holdings, Inc.

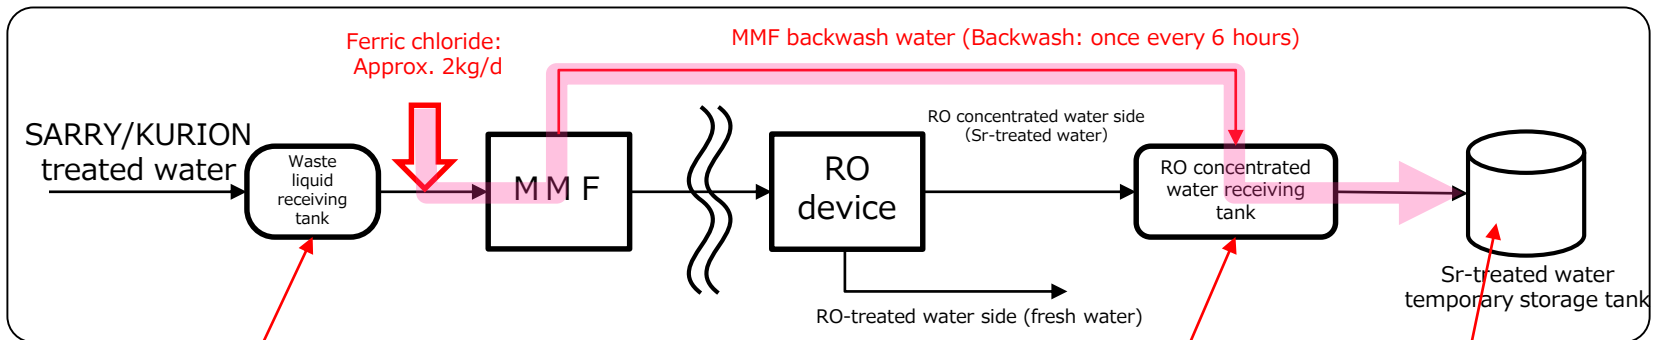
Ferric chloride infiltration route

- ① Ferric chloride injected into existing RO treatment equipment and removed by the multimedia filter (hereinafter referred to as, "MMF"), has coagulated and settled to form crud, and some of this crud was transferred to the Sr-treated water tanks via the RO condensed water side during backwashing to eliminate MMF clogs.
- ② Since Sr-treated water temporary storage tanks are repeatedly filled with and drained of Sr-water, ferric chloride coagulant (crud) has gradually accumulated at the bottom of the tanks thereby creating an anaerobic environment.
- ③ Sulfate-reducing bacteria (SRB) promotes organic decomposition during which sulfate is reduced to sulfide ions thereby generating hydrogen sulfide.

Crud and turbidity found at the bottom

Determined to be ferric chloride that has coagulated and settled (crud) inside the RO device
