Completion of the Internal Investigation of the Unit 2 Spent Fuel Pool (SFP) at the Fukushima Daiichi Nuclear Power Station

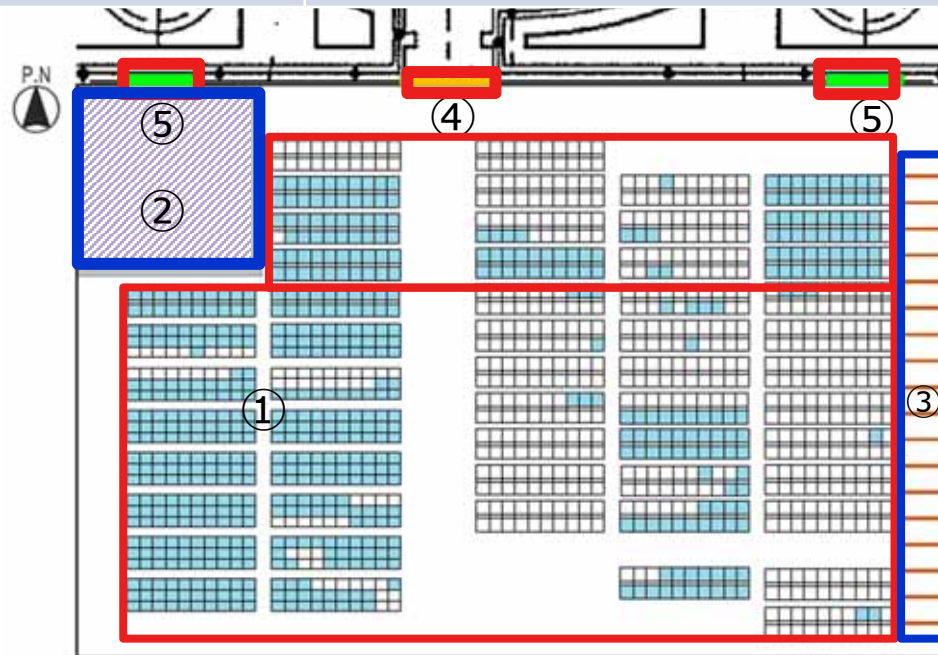
Location of investigation targets in the SFP

Investigation targets	Investigation focus
① Fuel, and area above the fuel rack	<ul style="list-style-type: none"> Check for fuel deformation and obstructions in the area above the fuel rack
② Cask pit	<ul style="list-style-type: none"> Check for obstructions at the bottom of the cask pit and the deformation of cask pit beams
③ Control rods	<ul style="list-style-type: none"> Check for fallen control rods and control rod hanger deformation
④ Pool gate	<ul style="list-style-type: none"> Check for deformation of the pool gate and the condition of the bolts that hold the pool gate
⑤ Skimmer surge tank inlet	<ul style="list-style-type: none"> Check for deformation of the movable weir inlet and confirm that locking bolts have not come off
