Seismic Data from the Unit 3 Reactor Building

February 25, 2021

Tokyo Electric Power Company Holdings Inc.

Background and steps to be taken going forward (1/2)

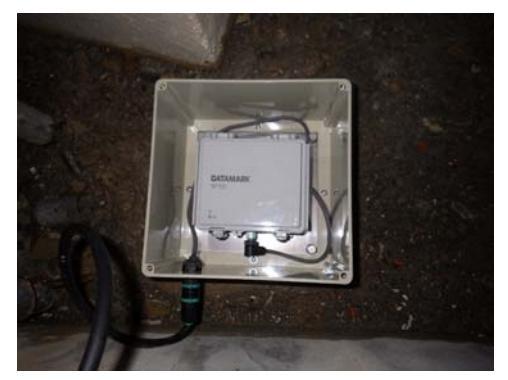
× Simple standalone seismometers that use solar panels for power and send data via wireless transmission were employed

A total of two seismometers were installed, one on the first floor level and one on the operating floor level of the Unit 3 reactor building

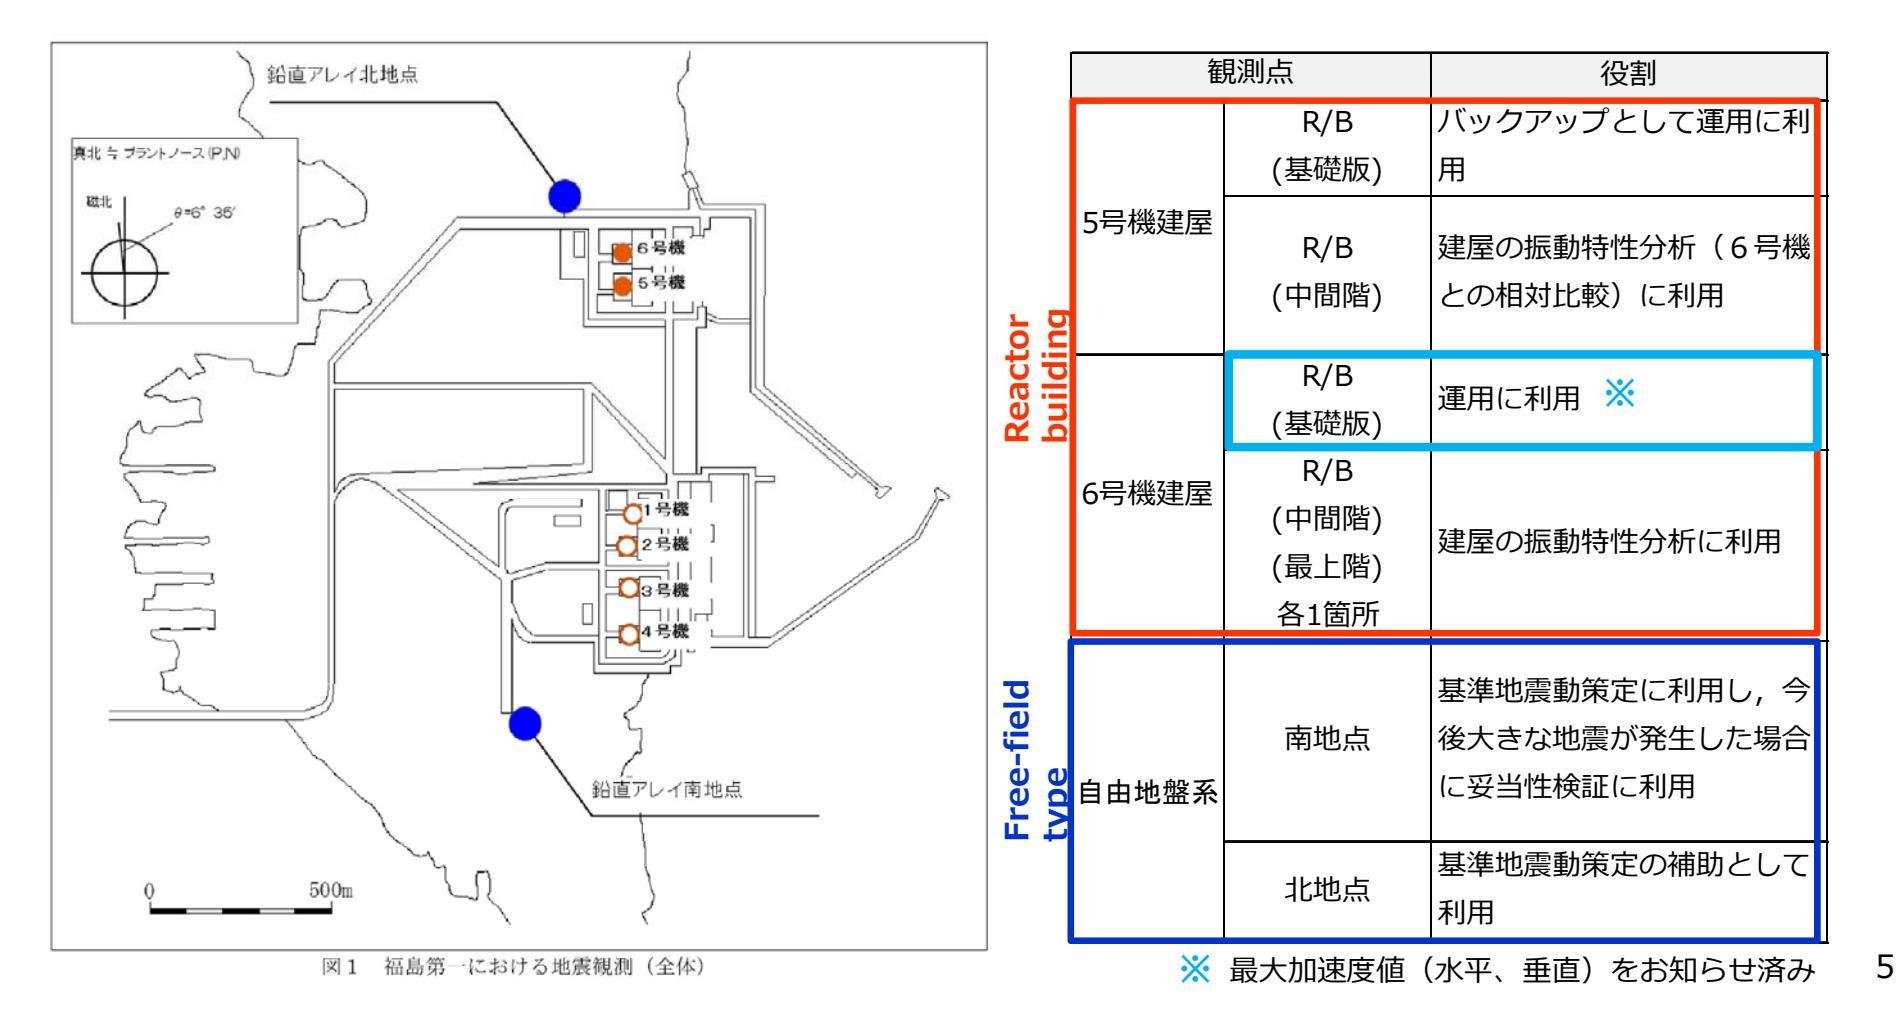
Location of observation seismometers at the Fukushima Daiichi Nuclear Power Station

- The seismometer installed on the foundation plate of Unit 6 is used during operation (for notifying other parties and publicly disclosing data, and conducting inspections in different zones following an earthquake), and used to quickly ascertain maximum acceleration.
- Other seismometers installed in Units 5 and 6 are backups and used for various types of analysis. When the seismometer installed on the Unit 6 foundation plate is being inspected, the seismometer on the Unit 5 foundation plate is used as a substitute to quickly obtain and announce measurement data.
- Free-field seismometers are used to take measurements used during the setting of standard seismic motion.
