Tank Displacement Caused by the Earthquake on February 13 and Countermeasures

February 25, 2021

Tokyo Electric Power Company Holdings, Inc.

March 1, 2021 Partially revised
(P2, P4 ,P5)

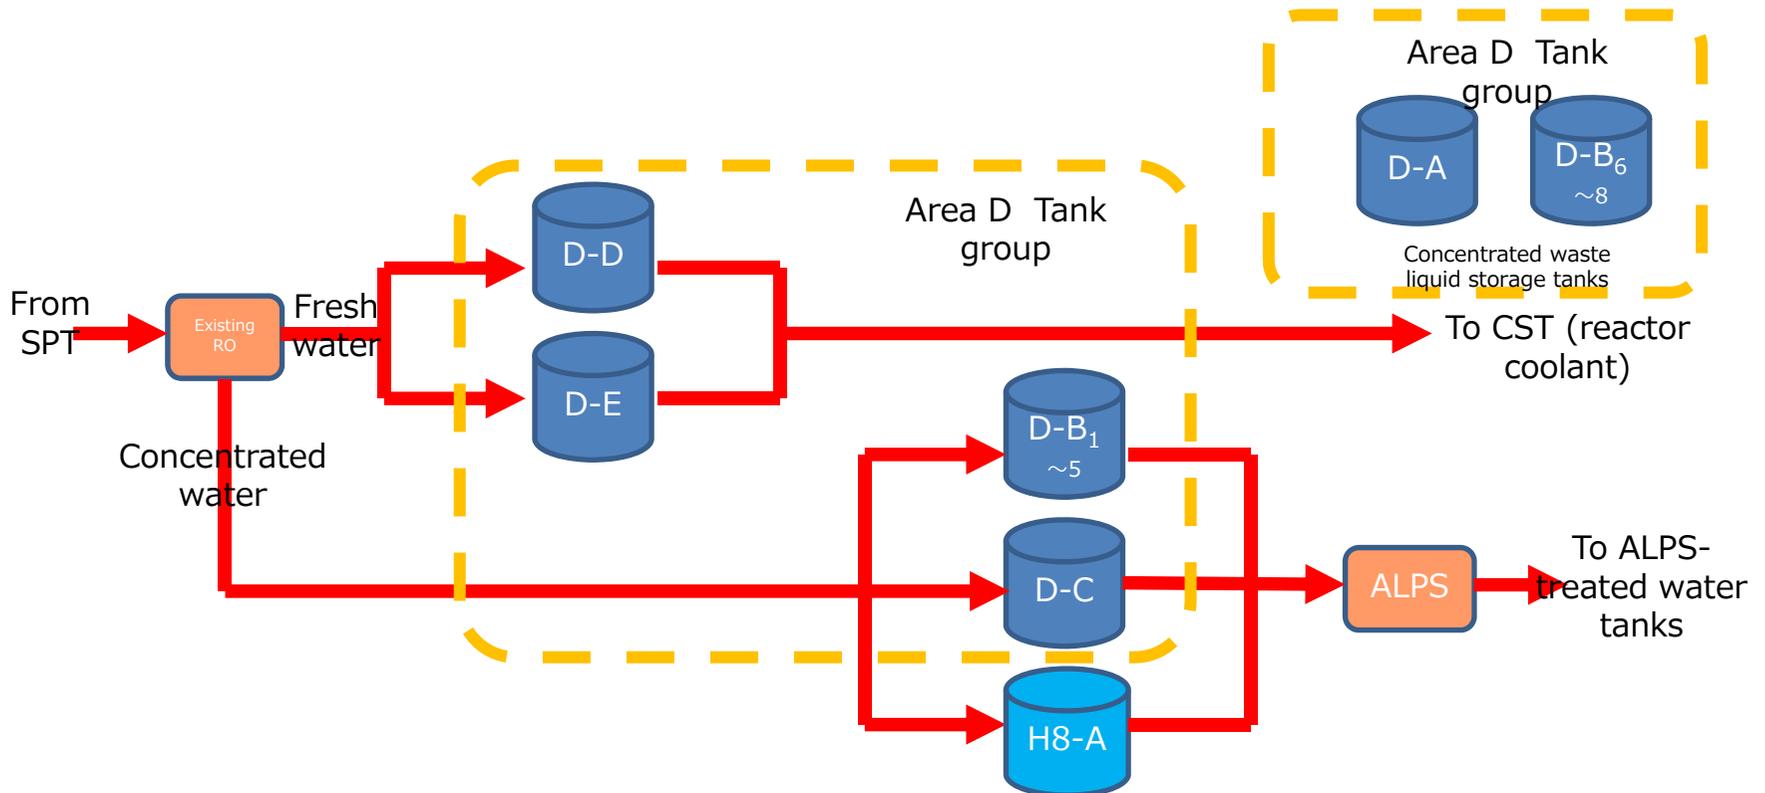
Concentrated waste water tanks **(Role)** Used to store concentrated waste liquid separated from concentrated salt water using evaporation condensation equipment immediately following the accident

Use of D-B and C group tanks will be suspended (substitute measures are being deliberated)
