Handling of the PCV Water Level Drops at Units 1 and 3

March 25, 2021

Tokyo Electric Power Company Holdings, Inc.

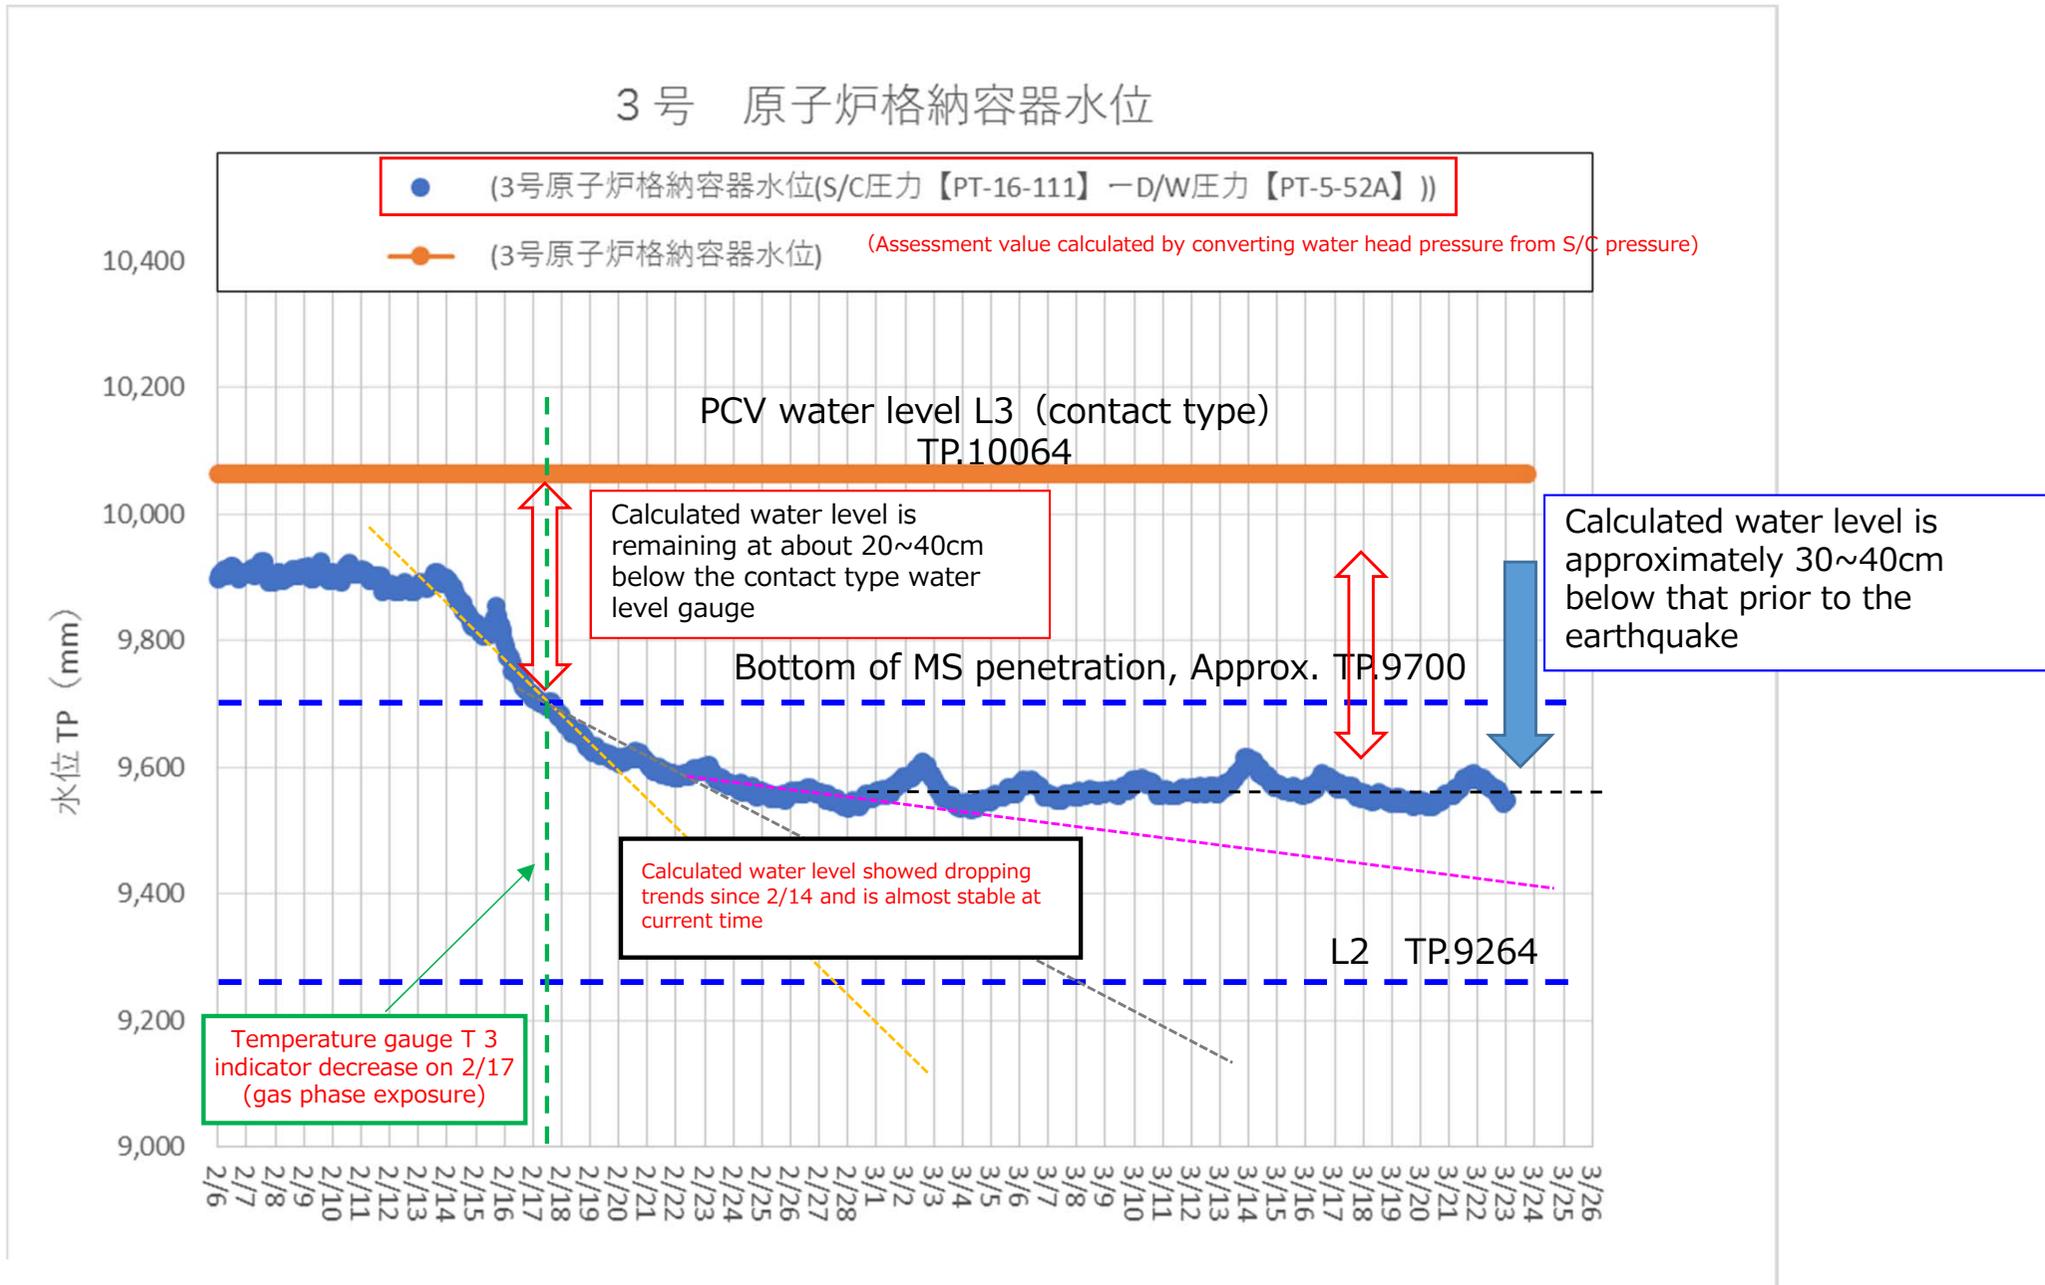
2-2. Trends in parameters related to the Unit 3 PCV water level drop

The Unit 3 PCV water level drop has stabilized around the main steam pipe expansion joints. At Unit 1, water level is slowly dropping around the vacuum rupture valve bellows, and the PCV water level drop continues.

Whereas we cannot deny the possibility that a new leak was caused below the PCV water level, it is more probable that the earthquake caused changes to the status of existing leaks.

- Going forward we aim to obtain more information by monitoring changes in parameters, such as water level, through cooling water injection shut off tests.

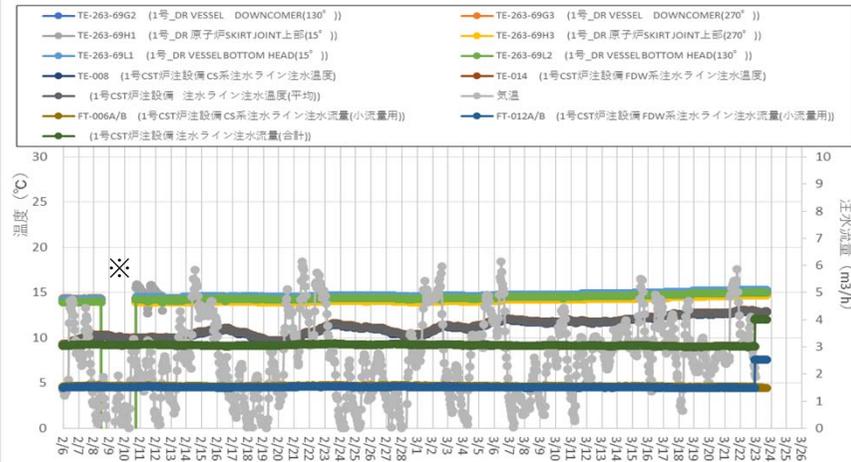
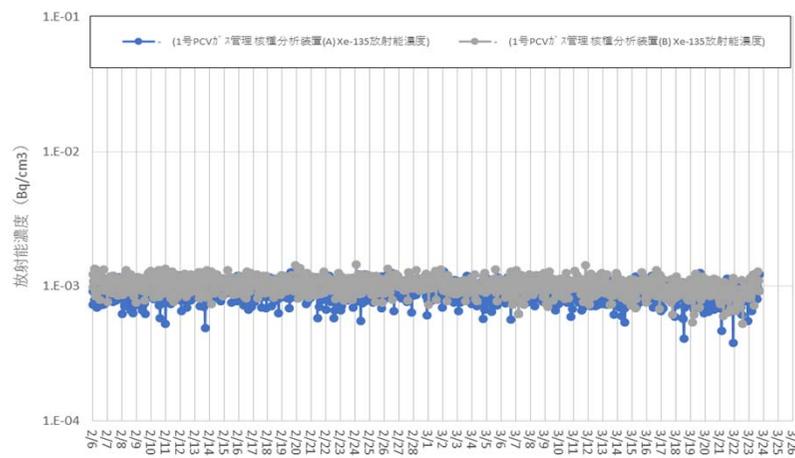
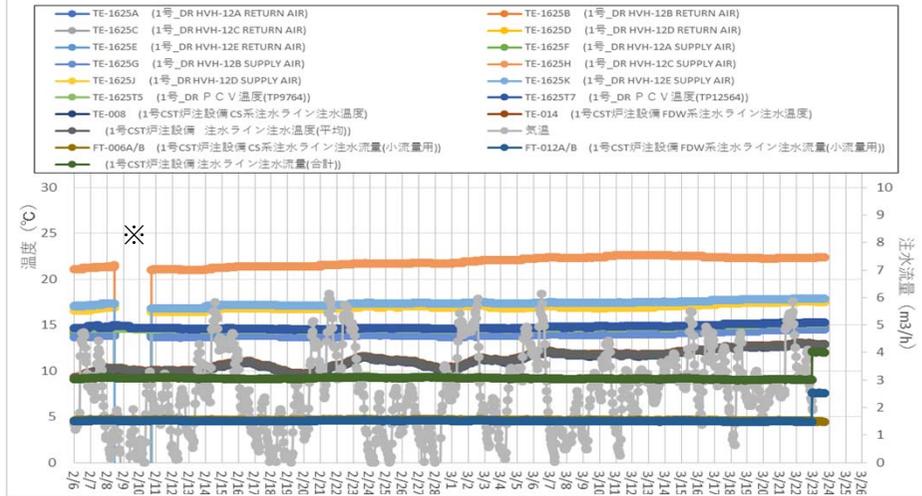
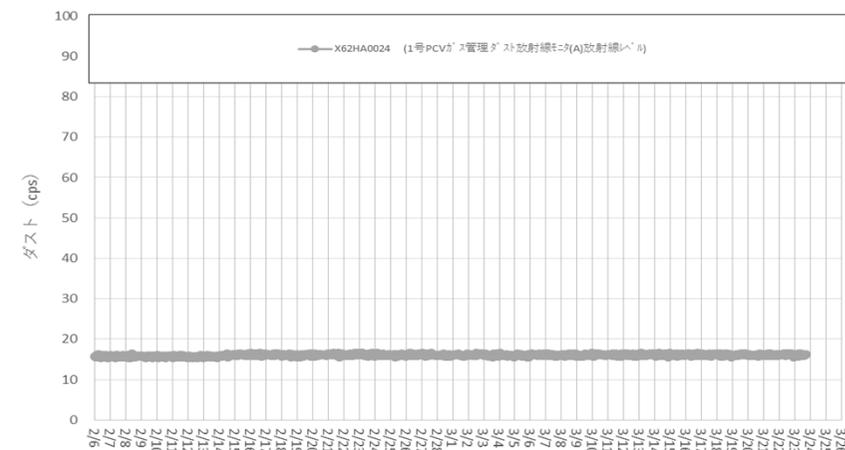
4-2. Unit 1 plant parameter trends

➤ A check of various parameters has shown no significant impact on anything other than the PCV water level drop

* No measurements due to ongoing work, temperature assessment implemented

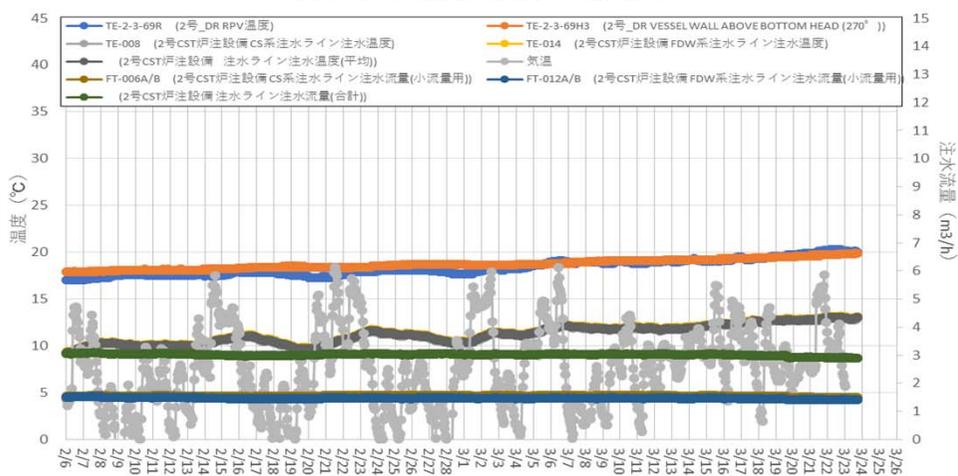
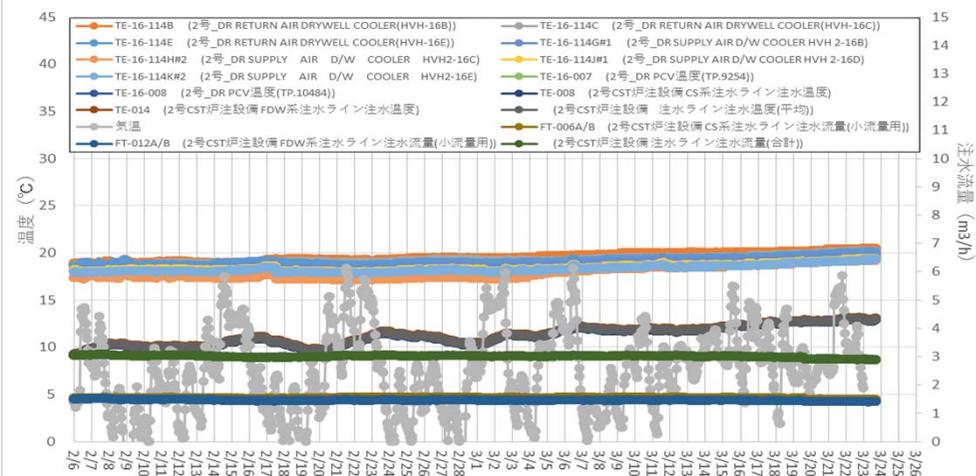
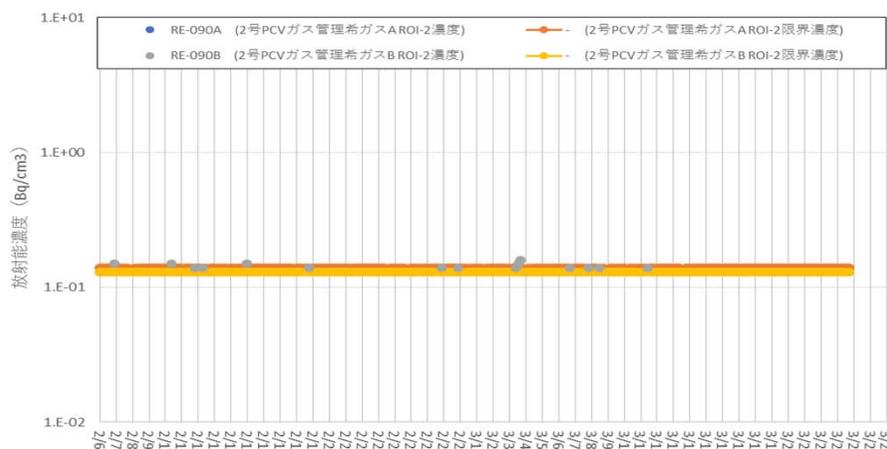
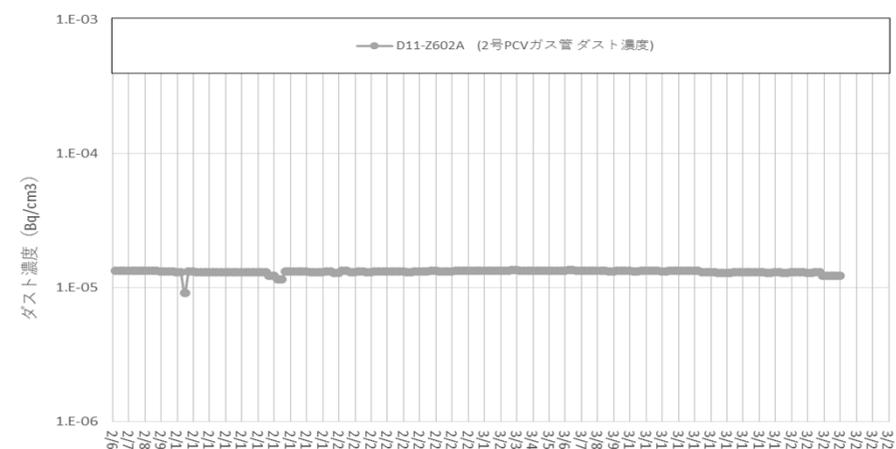
4-2. Unit 2 plant parameter trends

➤ A check of various parameters has shown no significant impact on anything other than the PCV water level drop

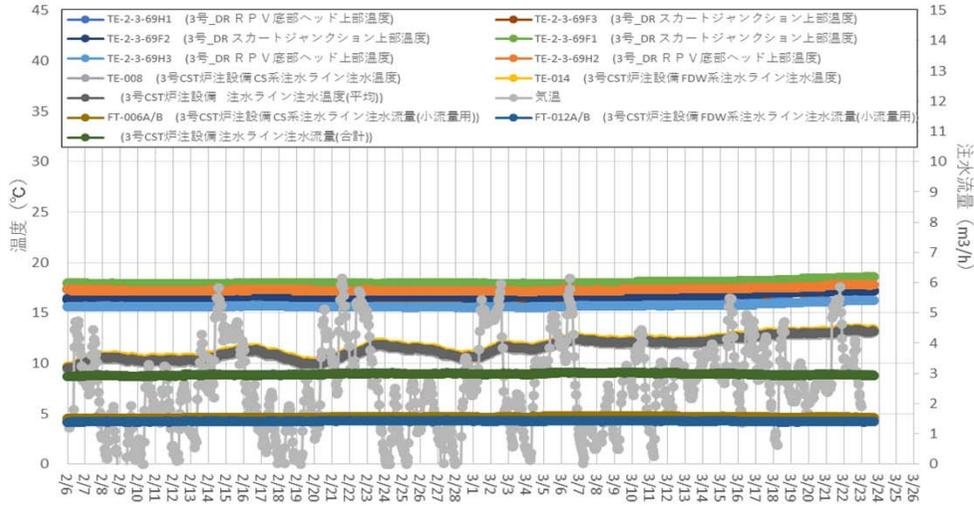
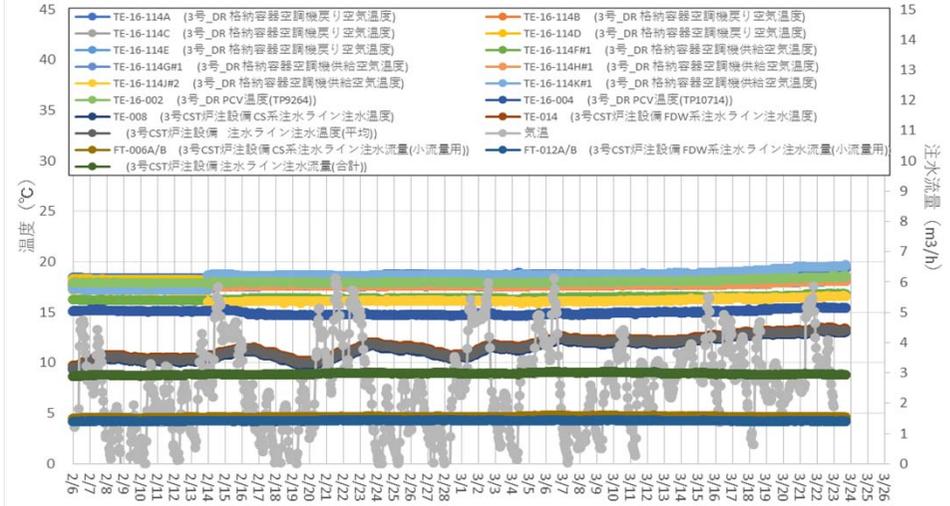
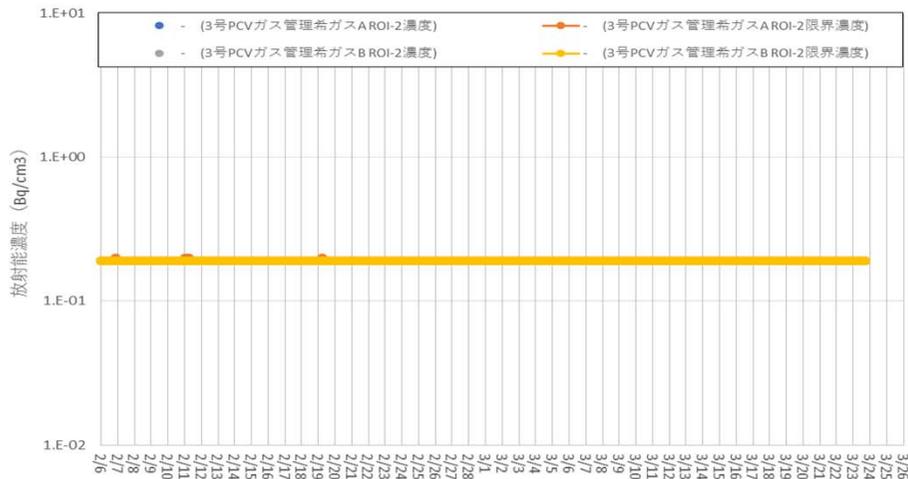
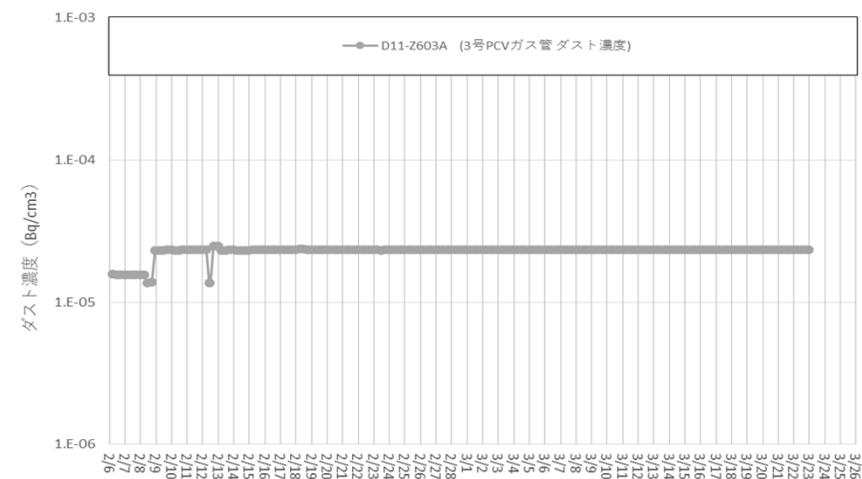
4-2. Unit 3 plant parameter trends

➤ A check of various parameters has shown no significant impact other than the PCV water level drop

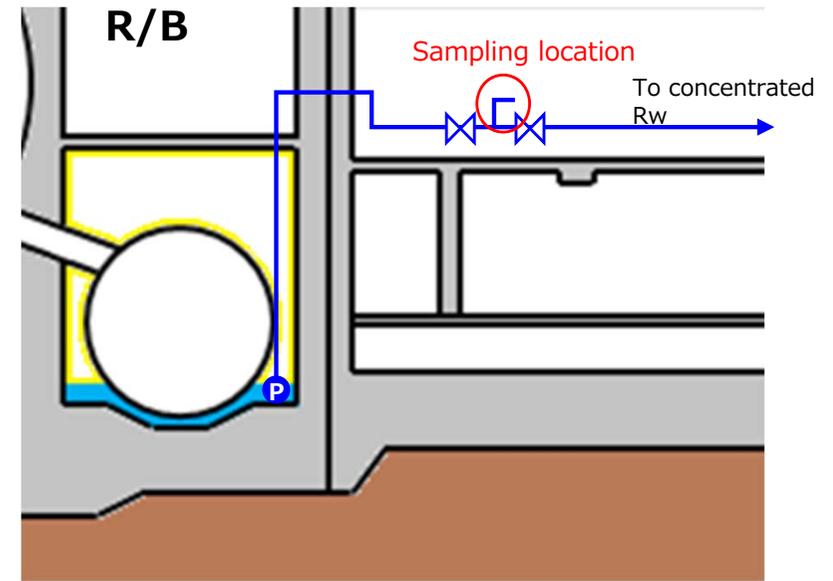
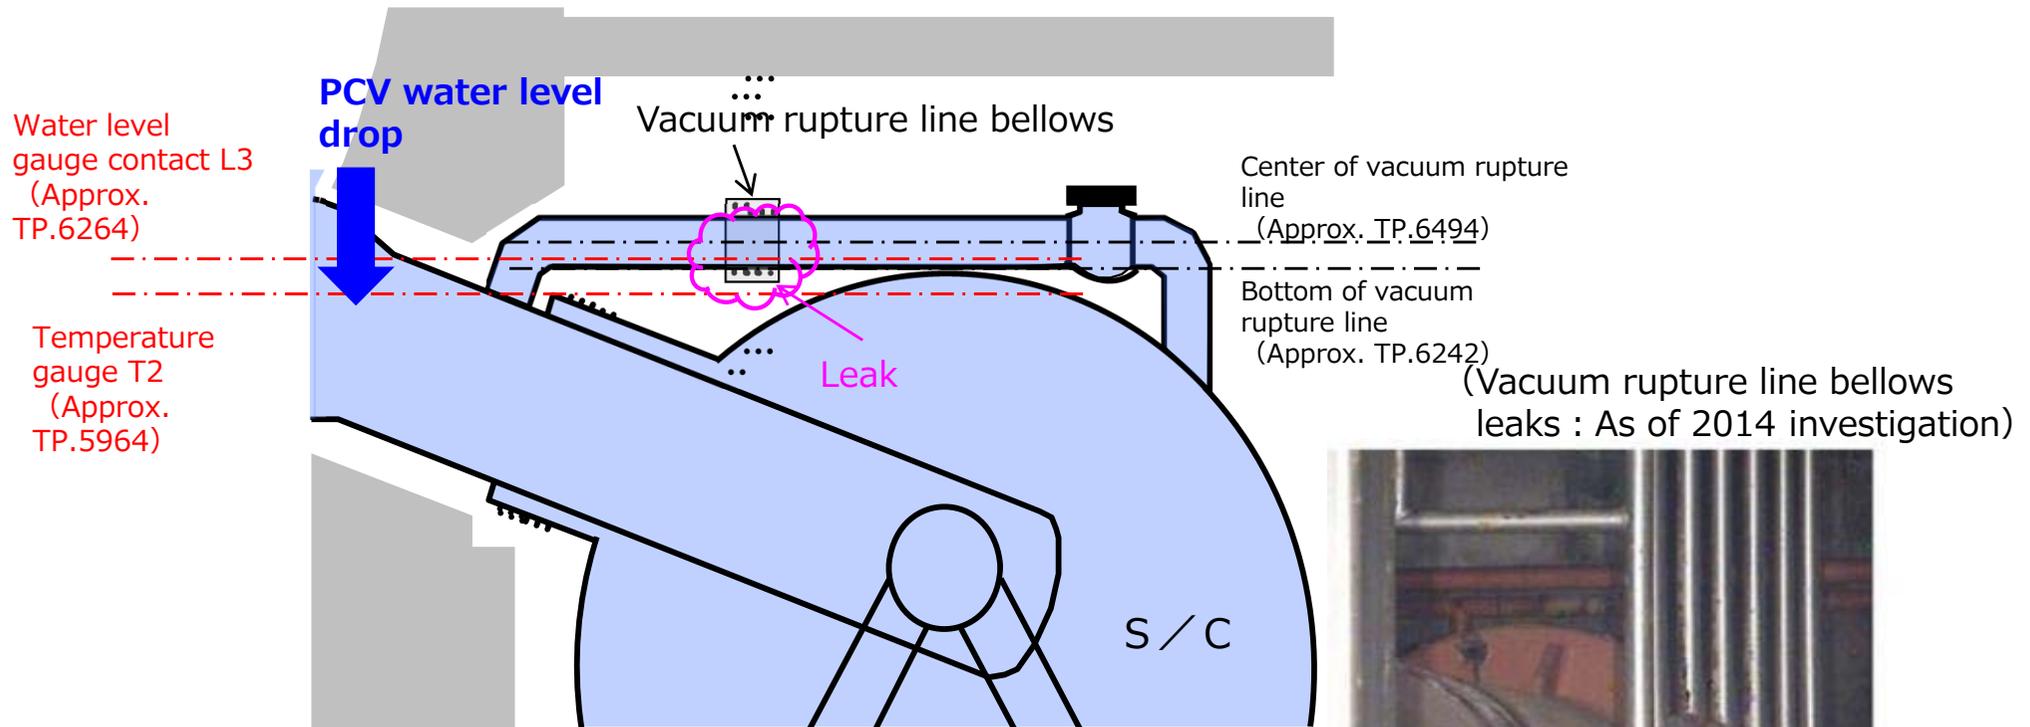
Radioactivity concentration of accumulated water in each R/B

- It is assumed that water leaking from the PCV flowed into the accumulated water in the R/B, so the radioactivity concentration^{※1} of accumulated water in the R/B prior to the earthquake shall be compared with that after the earthquake
- Fluctuations are within the scope of past fluctuations seen at each unit, and no significant fluctuations have been seen, however analysis results trends will be continuously monitored
