【Overview】

- On March 2, 2021, the simple radiation monitor (plastic scintillation fibers (PSF) monitor) in the unloading wharf drainage channel issued a "High" alarm. When the cause of the "High" alarm was investigated it was found that there was soil (deposit) that contained a gel-like substance with a high dose equivalent rate (Beta + Gamma) of 70 μ m on the surface of the ground in temporary storage area W2, which is upstream from the aforementioned drainage channel. The substance was subsequently collected.

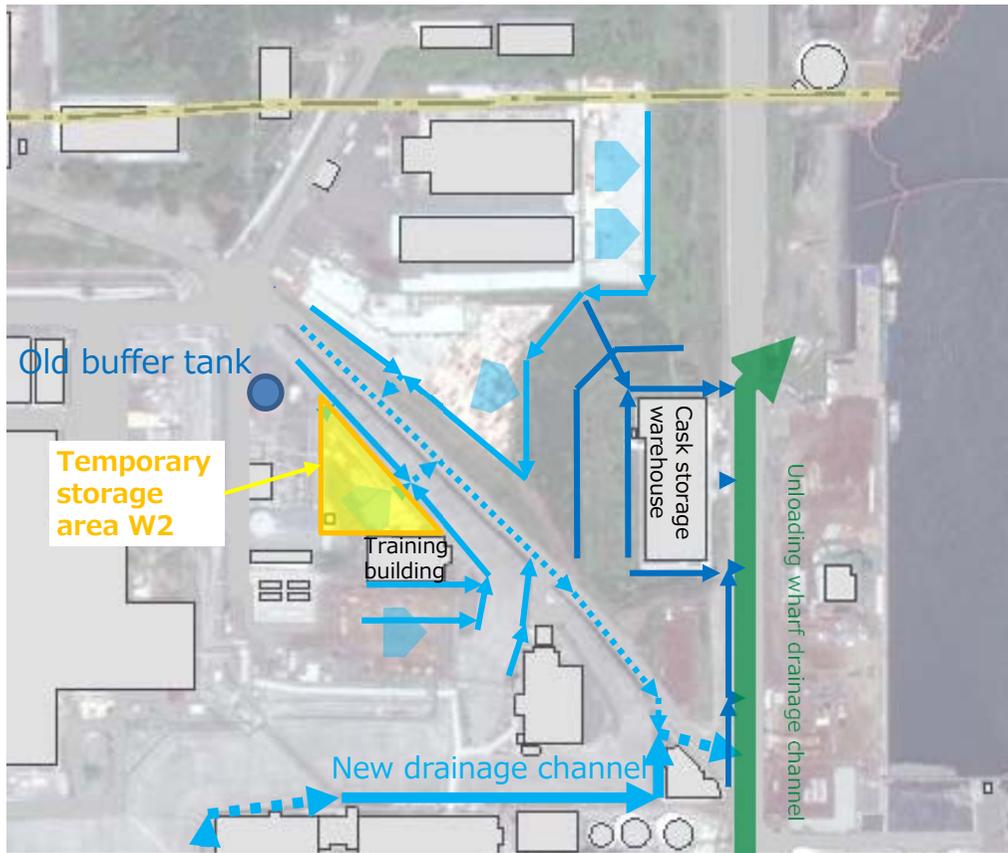
Figure 1. Locations of temporary storage area W2 and the unloading wharf drainage channel

Rubble, etc. from the disaster in temporary storage area W2 will be put into containers or covered with tarps. The area will be patrolled and air dose rate measurements (once a week) and measurements of the concentration of radioactive substances in the air (once every three months), taken.
