Implementation Status of the Fukushima Daiichi Nuclear Power Station  
Unit 1 Primary Containment Vessel Internal Investigation (ROV-A2)  
(work conducted on May 17 and 18)

< Reference Material >  
May 19, 2022  
Tokyo Electric Power Company Holdings, Inc.  
Fukushima Daiichi D&D Engineering Company

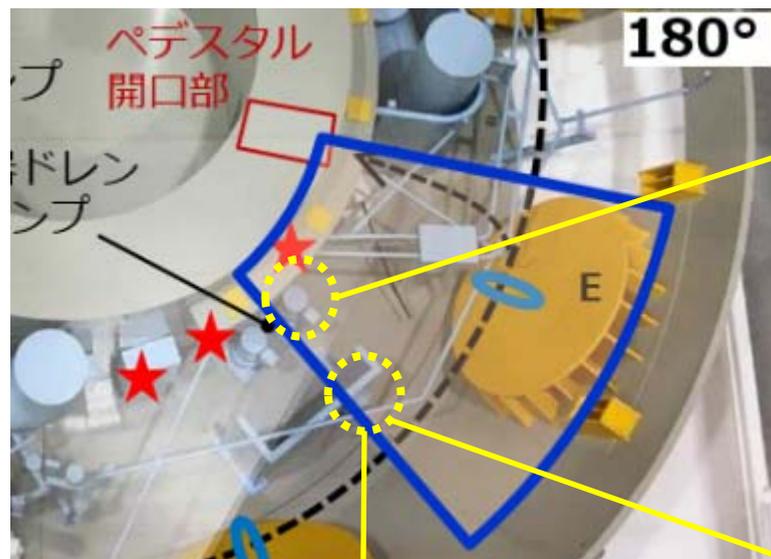
Photo 1. Conditions near the equipment drain sump pump

- ① No large damage to the pipes/valves of the reactor auxiliary cooling water system (hereinafter referred to as, "RCW") or the pipes (A) for the primary loop recirculation system (hereinafter referred to as, "PLR") was visible (Refer to photo 1 on slide 5, and photo 1 on slide 9).

- ② Deposits were found near the equipment drain sump pump (Refer to photo 1 on slide 5).
    - ③ Deposits form a top and bottom layer near the equipment drain sump pump shielding, and the inside is hollow (Refer to photos 2 and 3 on slide 5).

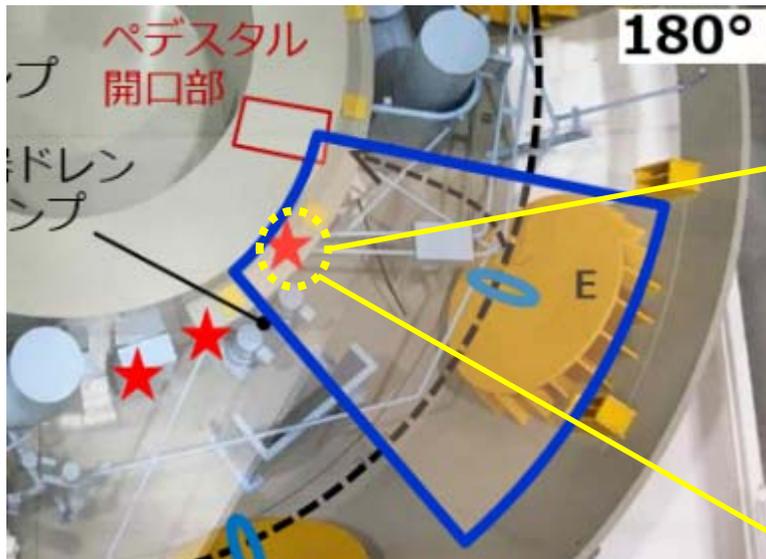
Photo 1. Conditions at top of pedestal foundation

- ④ No large damage was seen from the top of the deposits to the top of the pedestal foundation. Objects that are thought to be rebar were also found below the top layer of the deposits (Refer to photos 1 and 2 on slide 6, and photo 2 on slide 9).

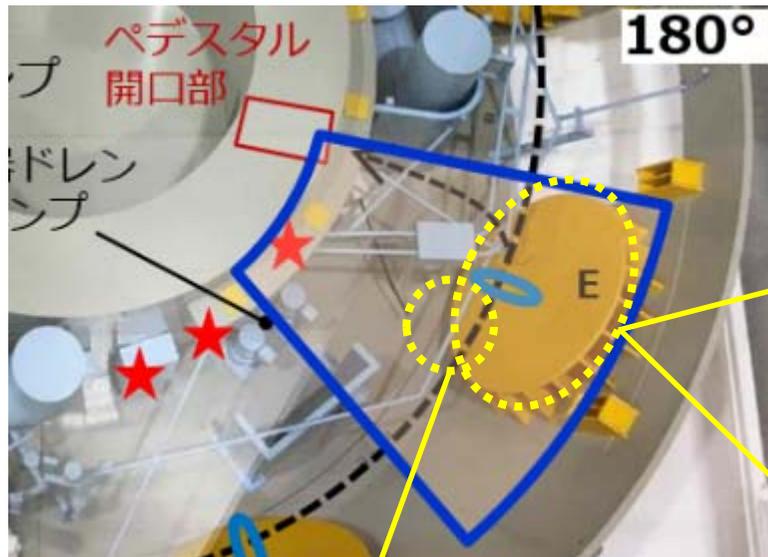
Photo 1. Looking down on jet deflector (E)

- ⑥ Clumped deposits were found on the bottom surface and at the back (pressure suppression chamber side) of jet deflector (E) (Refer to slide 8).

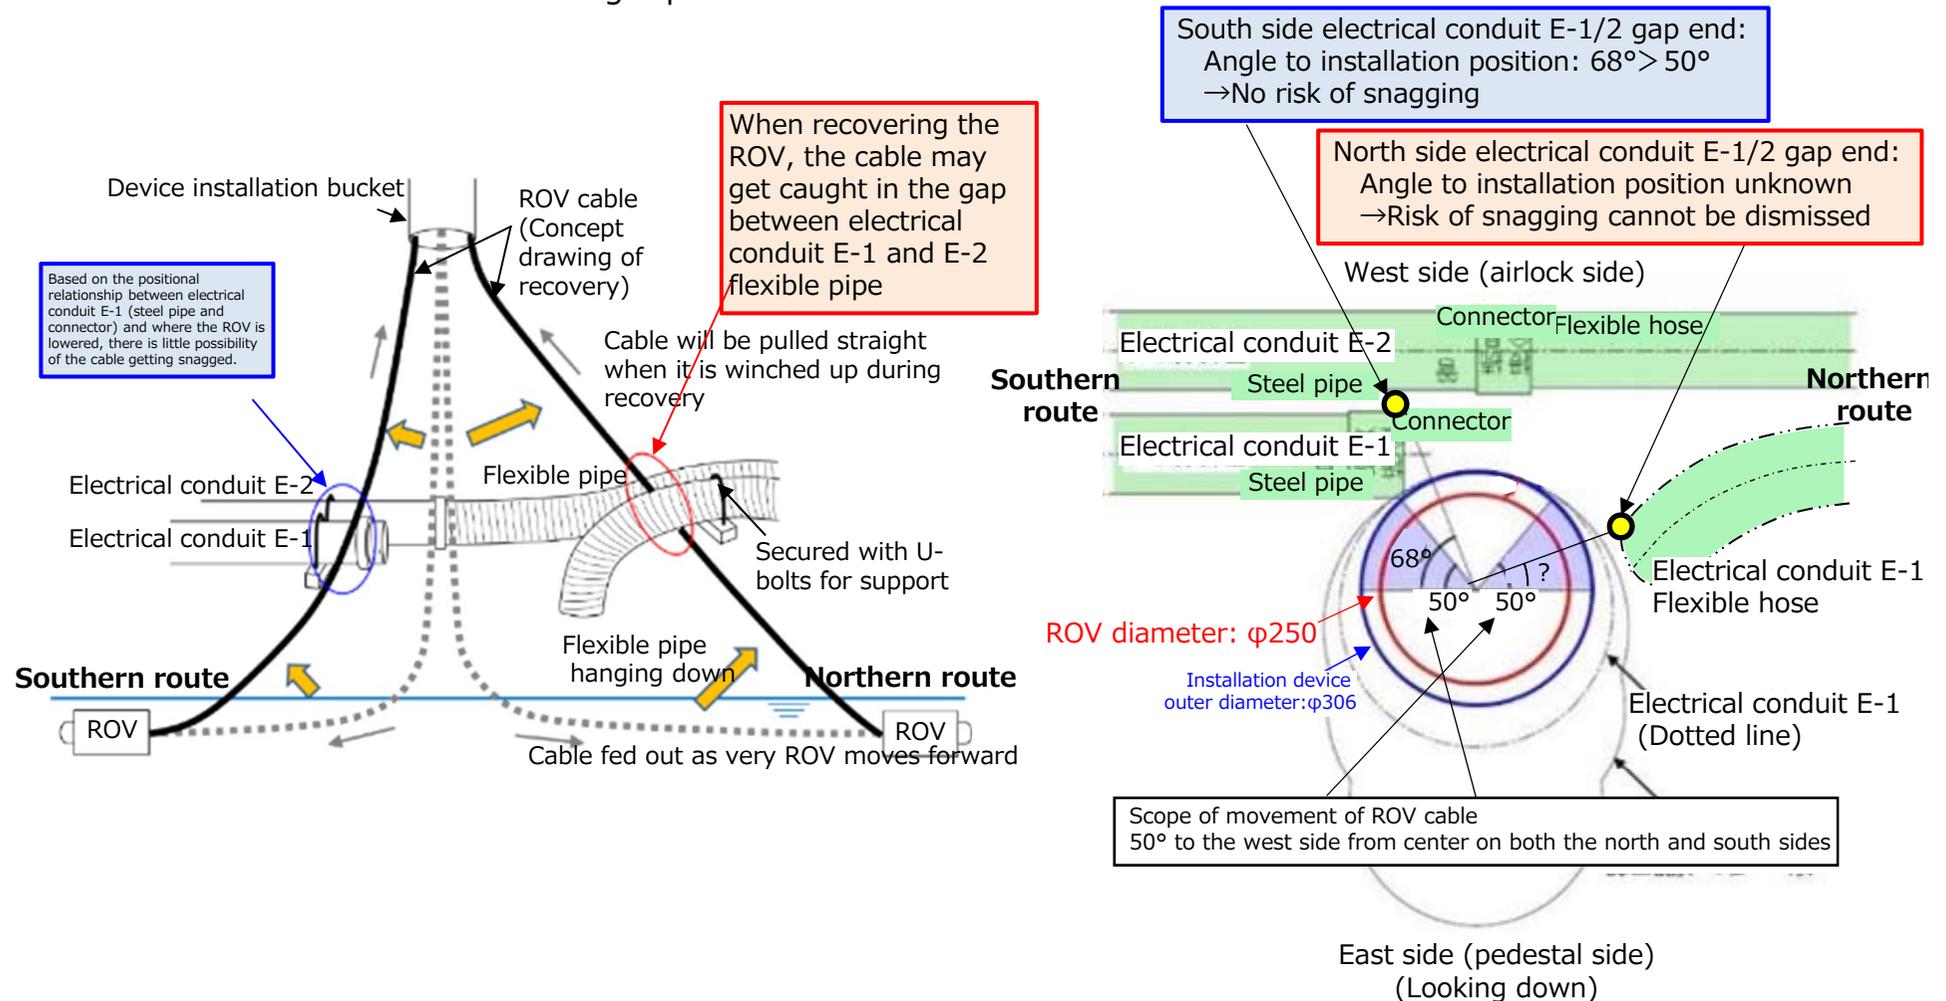
- During preparations to insert PCV internal investigation equipment, an electrical conduit that is obstructing the path was seen, and there is the risk that the submersible ROV cable will get snagged when investigating the northern route.
- If the ROV cable gets snagged, it will be impossible to recover the ROV and insert other ROV's, so investigation of the northern route is no longer possible.

- The investigation will be performed along the southern route in order to avoid the risk of getting the ROV cable snagged on the northern route.
- The scope of the southern route investigation will be approximately 0°~215°, so if all information can be obtained, it should be analogous to the northern route.
- If the pedestal cannot be accessed from the southern route, an investigation of the inside of the pedestal (ROV-A2) will be conducted from the northern route.
- The feasibility of an investigation from the northern route shall be quickly determined as the southern route investigation is performed.
