Fukushima Daiichi Nuclear Power Station Drone investigation of the inside of the Unit 1 and Unit 3 reactor buildings

November 27, 2025

Tokyo Electric Power Company Holdings, Inc.

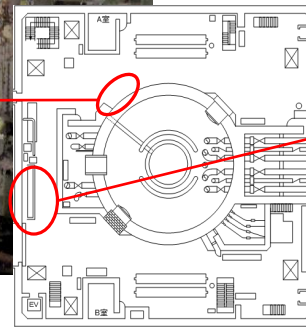
Unit 3 reactor building 1st floor

Jet pump instrument rack
(northwest area, 1st floor, reactor building)

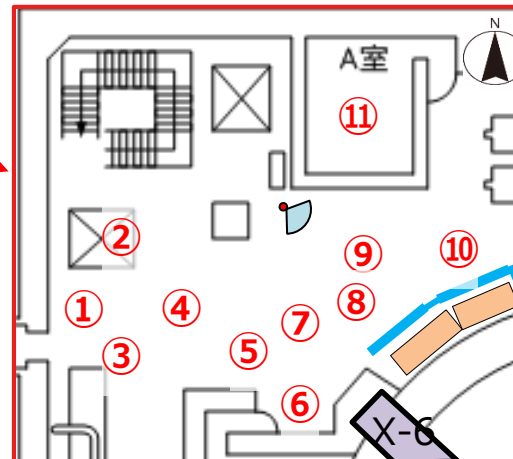
1st floor, Unit 3 R/B

Location	Measurement (mSv/h)
	Air dose (1.5m above the floor)
①	2.49
②	2.99
③	2.98
④	2.72
⑤	3.32
⑥	4.62
⑦	3.36
⑧	5.16
⑨	4.27
⑩	4.15
⑪	0.96

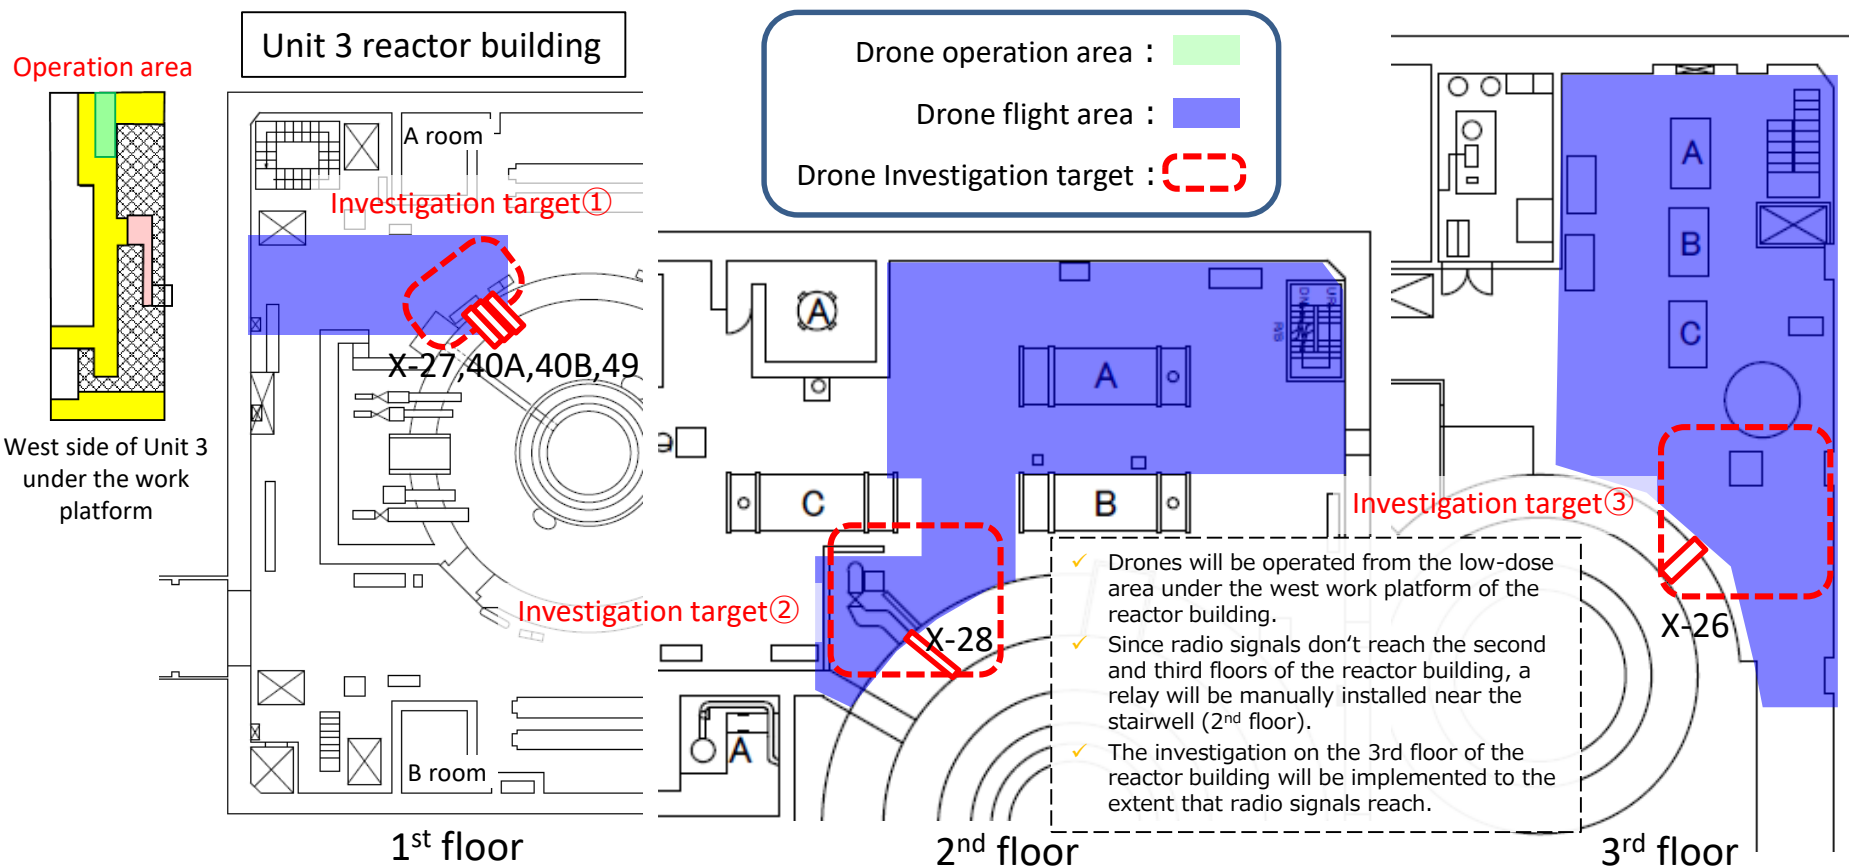
5. Unit 3 field investigation

Investigation target: Primary valves on lines connected to the instrument racks* on the northwest/west areas of the first floor of the reactor building

[1st fl. near X-27,40A/B,49, 2nd fl. near X-28, 3rd fl. near X-26]

- Since all of the investigation locations are high off the ground (near the ceiling), drones will be used to conduct the investigation
