Fukushima Daiichi Nuclear Power Station Unit 1

Results of Drone investigation of the inside the reactor buildings

January 29, 2026

Tokyo Electric Power Company Holdings, Inc.

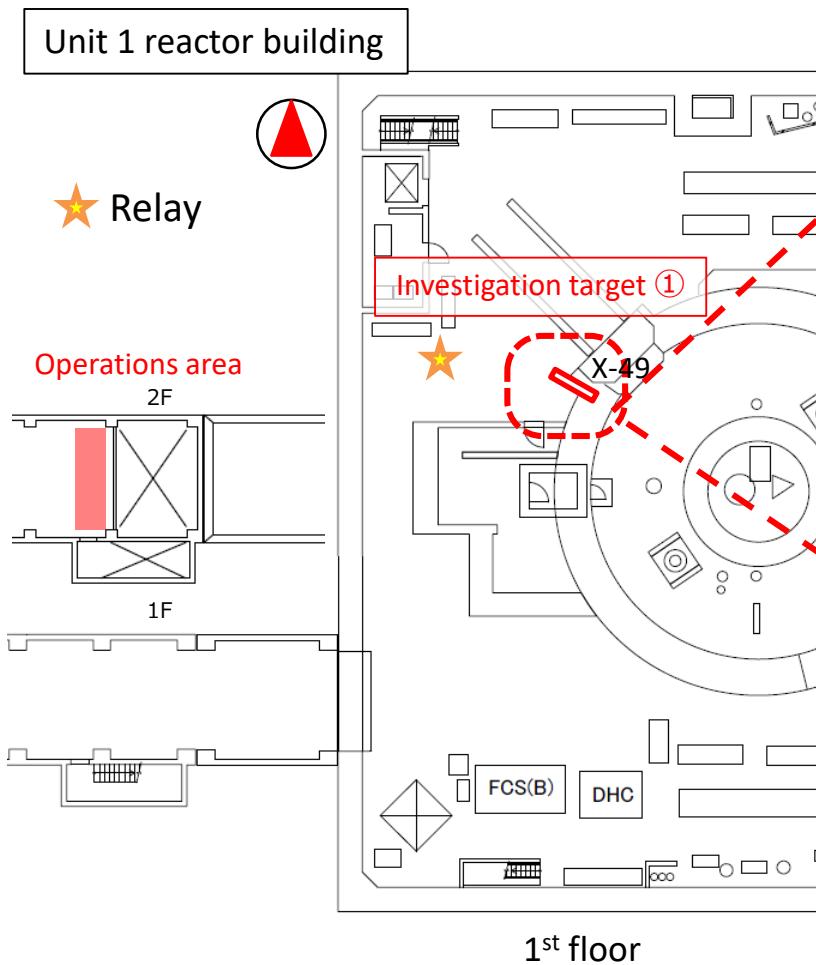
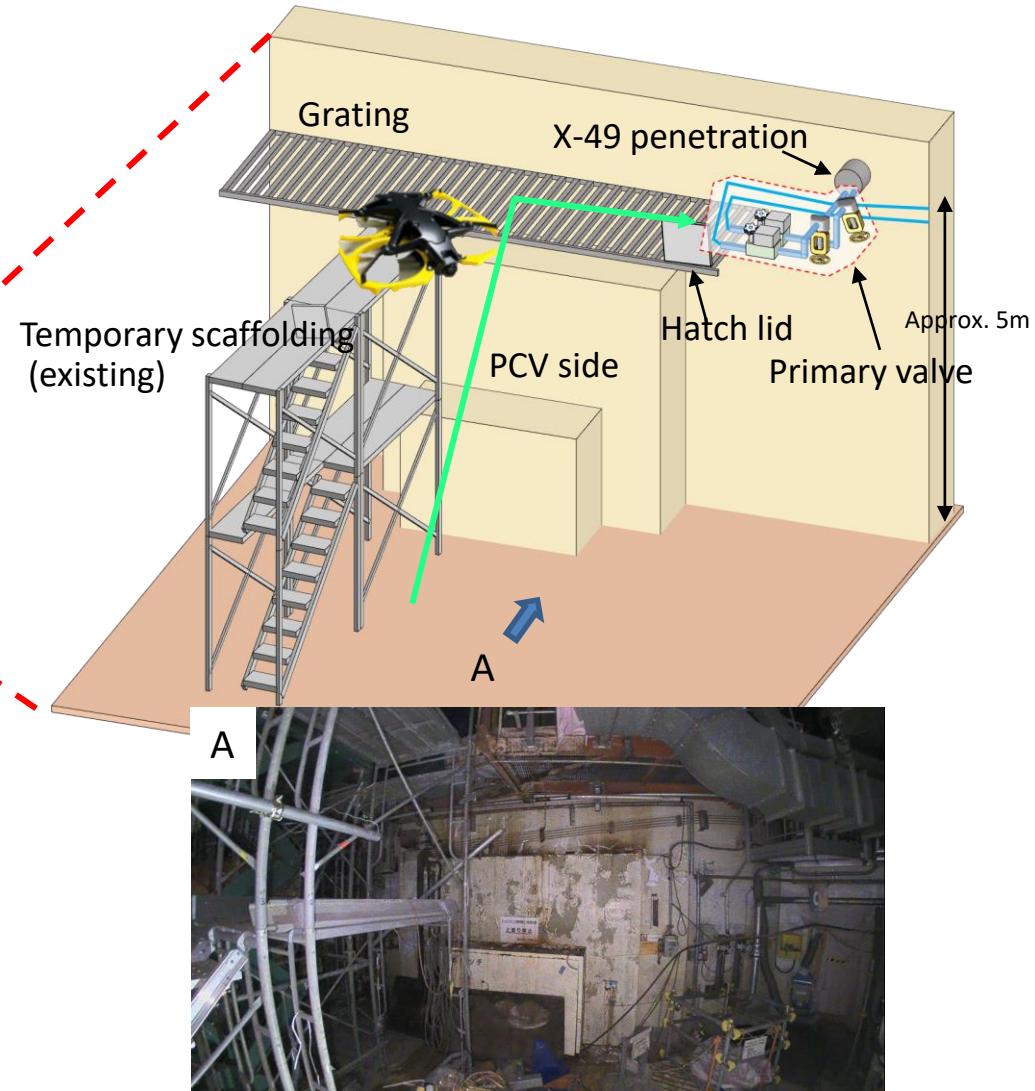
2. Targets of the Unit 1 reactor building internal investigation (1st floor)

- The objective of the investigation was to examine the condition of the instrument line primary valve.
- A micro-drone and relay were placed in the northwest area of the first floor of the reactor building and a flight was performed in the target area.

There are many obstructions at the top such as ducts, etc.

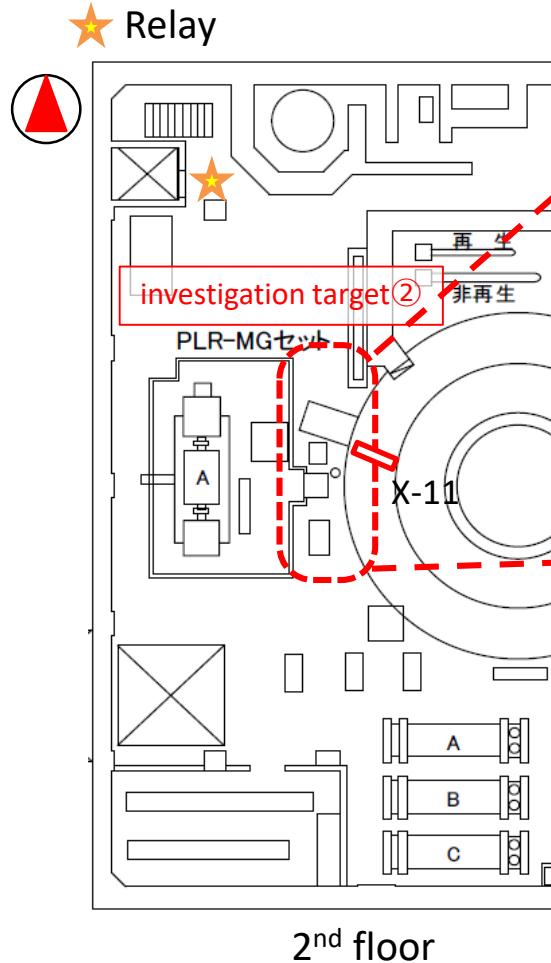
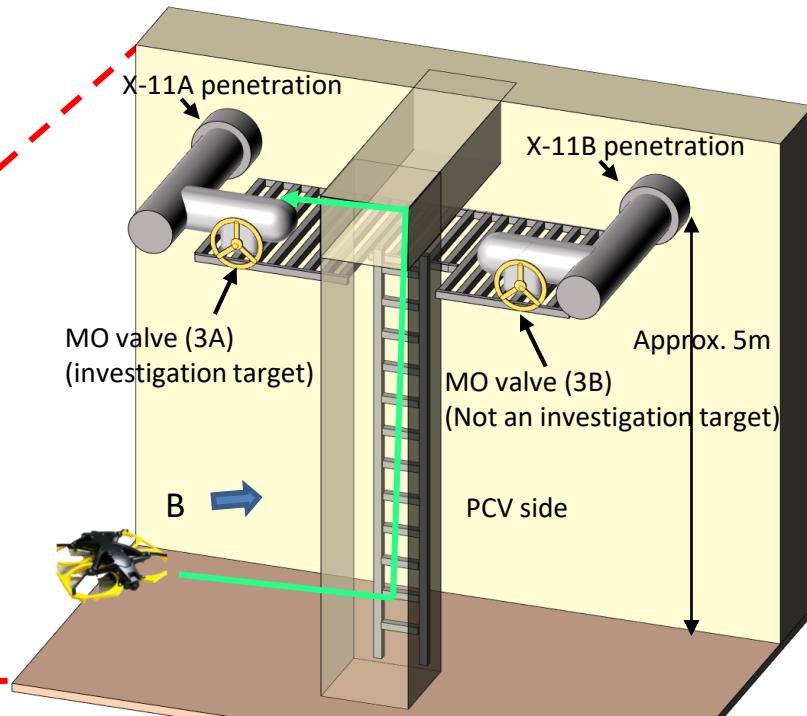
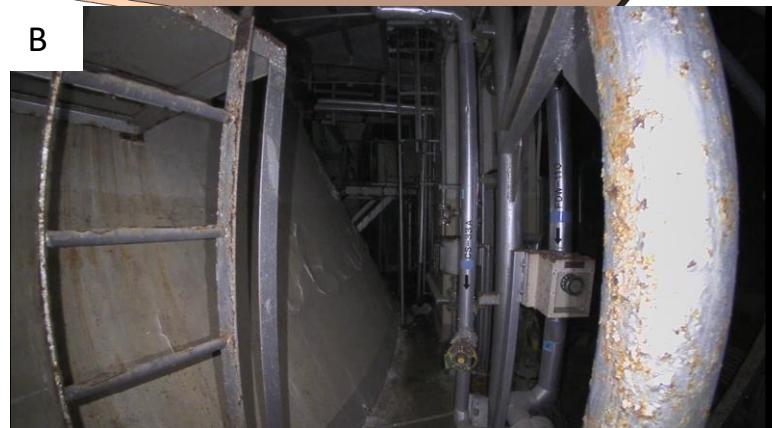
4. Targets of the Unit 1 reactor building internal investigation (2nd floor)

- The objective of the investigation was to examine the condition of the IC system line MO valves.
- A small drone and relay were placed in the northwest area of the second floor of the reactor building and a flight was performed in the target area.

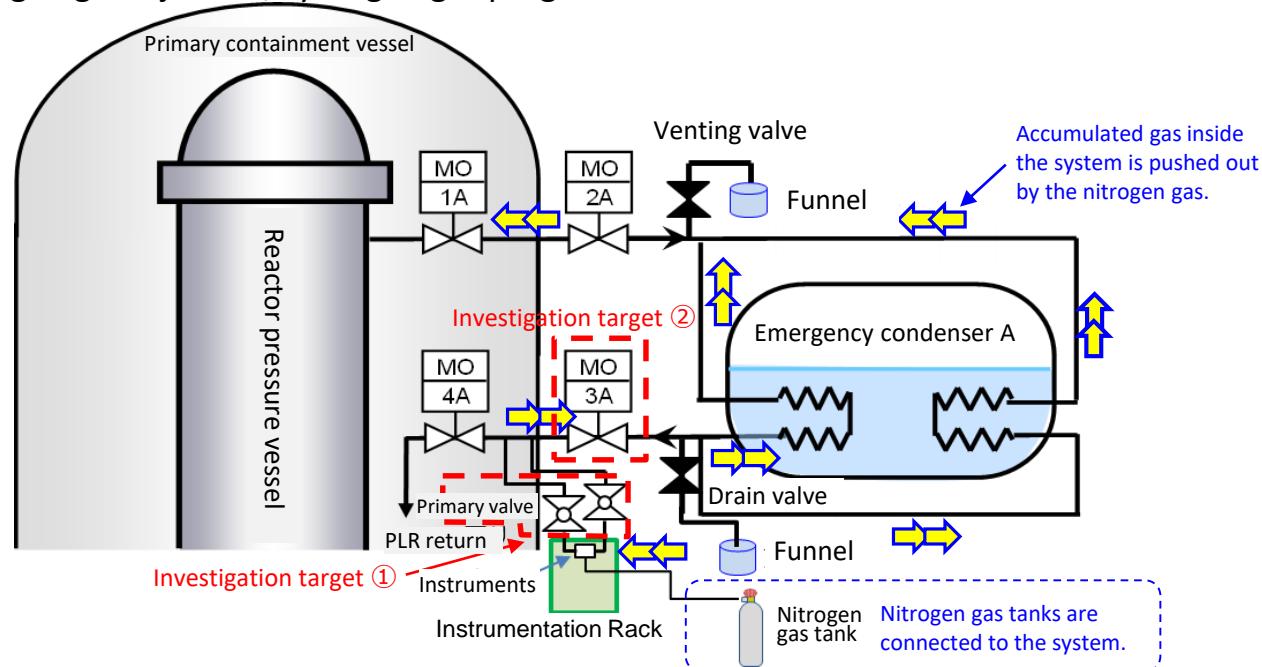
< Example of a nitrogen gas injection/hydrogen gas purge >

- Assessment of investigation result
 - Since no remarkable abnormalities were found with the valves or pipes, we may be able to inject nitrogen gas into the instrument line on the first floor of the R/B to purge the hydrogen gas.

- It may be possible to operate (open/close) MO-3A valve to configure a gas purge line.
- Steps to be taken going forward
 - Detailed deliberation of the nitrogen gas injection/hydrogen gas purge method.
The gas purge line must take into consideration workability, the impact assessment of nitrogen gas injection, and condition monitoring methods.
