# ALPS Treated Water Discharge Status Update

February 26, 2026

Tokyo Electric Power Company Holdings, Inc.

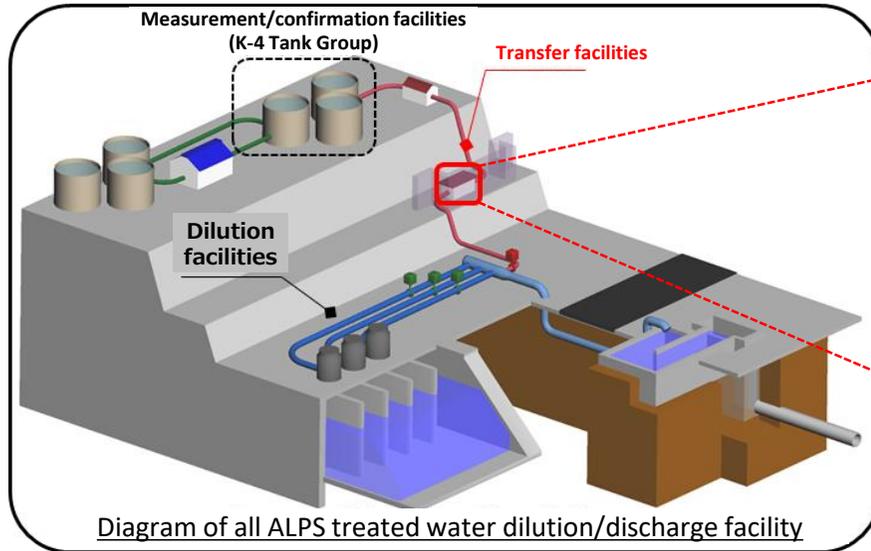
Emergency isolation valve-1 System A  
(after cleaning)

- A disassembly inspection of emergency isolation valve-1 Systems A and B was implemented and no abnormalities such as corrosion were found. Pictures of the disassembly inspection are shown below.

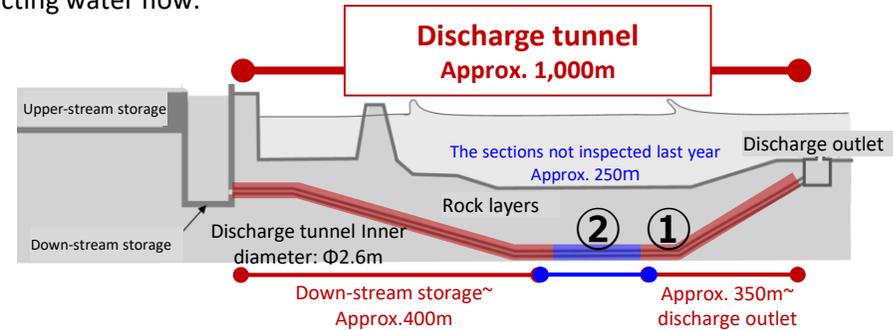
## ② Discharge tunnel conditions (sections not inspected last fiscal year\*) (Approx. 500m from down-stream storage)

- As with other sections no abnormalities were found
- Sediment is only a few centimeters thick
- Minimum marine organisms' adhesion

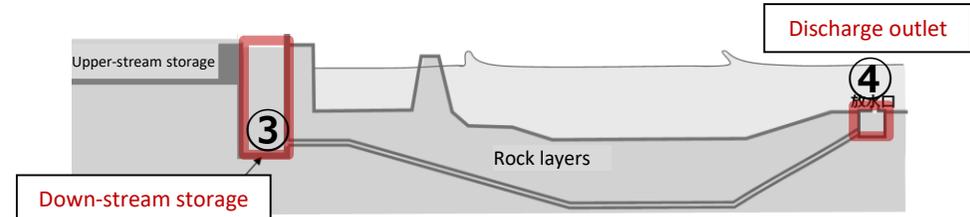
■ An inspection of the inside of the down-stream storage and discharge outlet was conducted and it was confirmed that there were no abnormalities.

- A submersible ROV and divers were used to check conditions inside the down-stream storage and the discharge outlet, and we confirmed that the concrete is intact and that sediment and marine organism adhesion is minimal and is not affecting water flow.

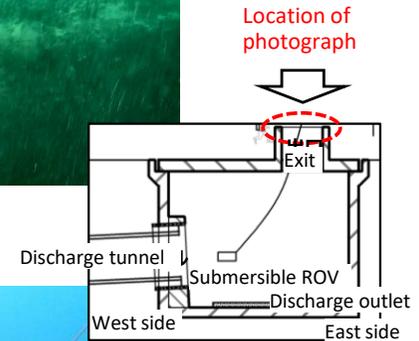
- No large changes were seen compared to last year
- Sediment is only a few centimeters thick
