Fukushima Daiichi Nuclear Power Station Unit 3 PCV Internal Investigation (non-submerged area) using Micro-drones

February 26, 2026

Tokyo Electric Power Company Holdings, Inc.

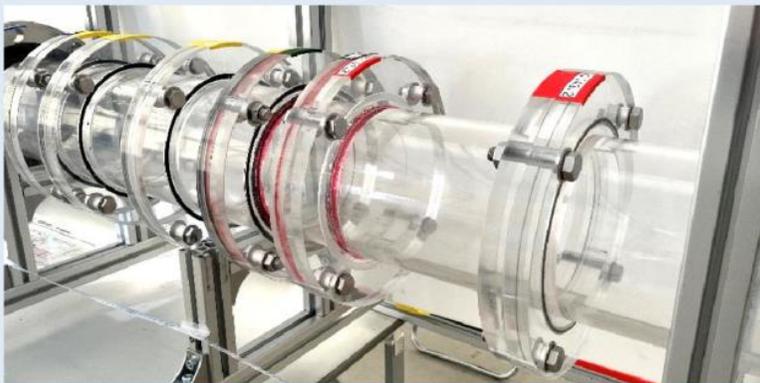
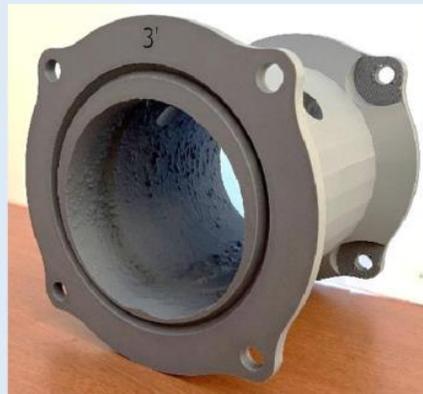
New insertion pipe models (Left: acrylic, Right: 3D-printed)

- Two types of insertion pipe models were made, one from acrylic and the other 3D-printed. (Capable of simulating steps, misalignment, etc.)
- Since the acrylic model is transparent piping, the condition of the insertion device during operation can be visually checked. It is primarily used to verify the overall posture of the device and the status of the crawlers.
- Since the 3D-printed model is produced directly from point cloud data of the insertion piping, it can closely replicate the actual internal geometry (including uneven surfaces) of the piping. It is used to examine whether or not the device is catching on anything inside the pipe.

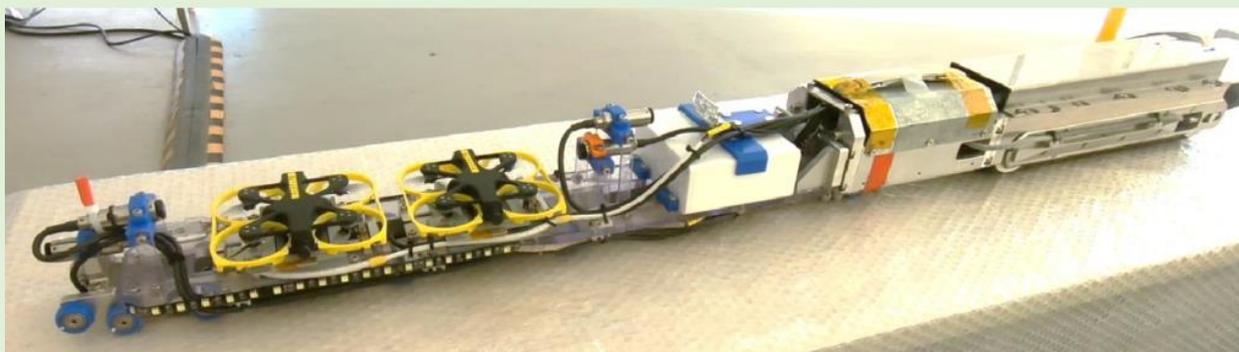
Insertion device model

- The weight, center of gravity, shape, material, size and motor source were replicated (Radio functions were not included since this was not needed for the running tests).
- The methods for wrapping and securing the cables and the location for securing the cables were also replicated to see if any of these were causing the device to snag.
- Since the camera on the front has the same field of view as the actual unit, it allows for comparison with the video footage from when the device was unable to move forward.

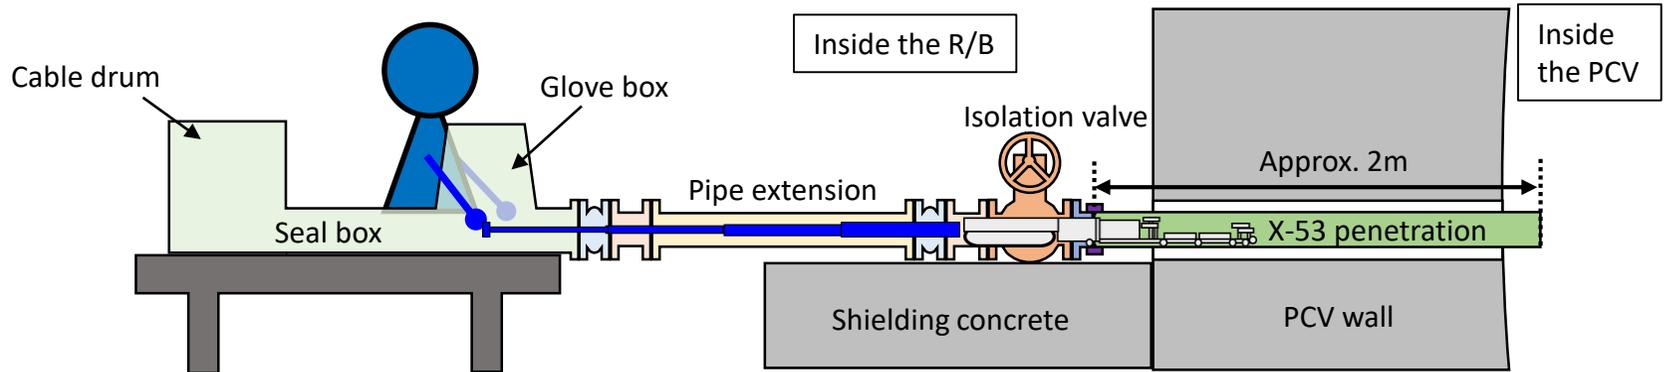
- If the crawler is unable to move on its own a rod housed in the glove box will be used to push the device from the back and alter its position. (done manually)
- The cable drum will be used to pull the device if it needs assistance moving backwards.

Concept diagram of manual insertion assistance using a push rod

■ Assisting with insertion using a push rod

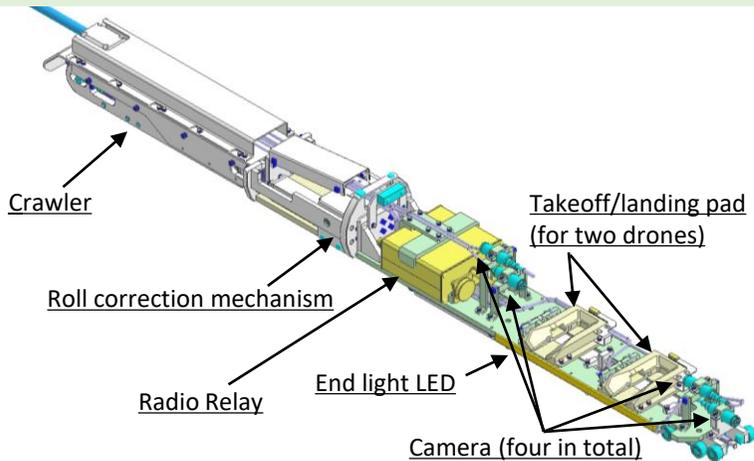
- When conducting function tests of the investigation device it suddenly became impossible to move the insertion device forward inside the X-53 penetration.
- Several attempts were made at insertion, but the device was unable to move forward past a certain point (approximately 50cm into the X-53 penetration).
- The device could be moved backwards, so normal procedures for withdrawal were conducted and the insertion device was returned to the seal box (Since the device was withdrawn to the seal box, the isolation valve, which is the PCV boundary, did not have to be opened or closed).

- Two drones can be loaded onto the takeoff and landing pad on the tip
- The device is moved backward and forward by driving the crawler mechanism at the rear
- Drones are carried into the PCV from the seal box
- Dimensions: Approx. 1.3m×Φ130mm
- Weight: Approx. 20kg

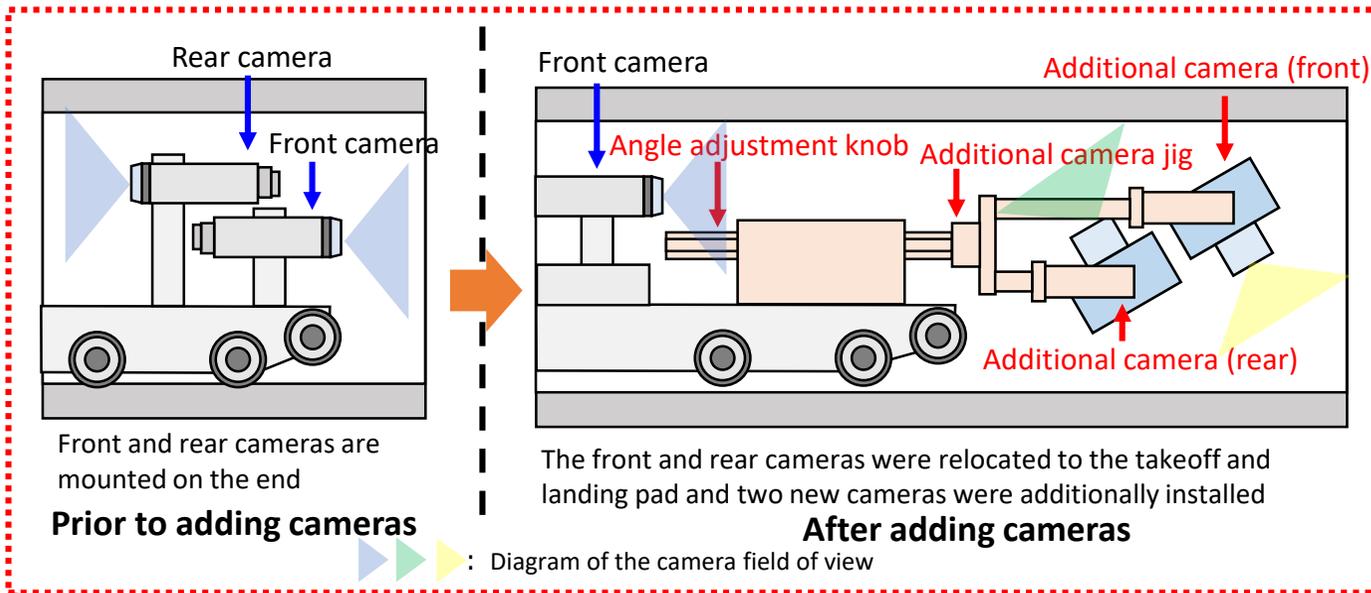
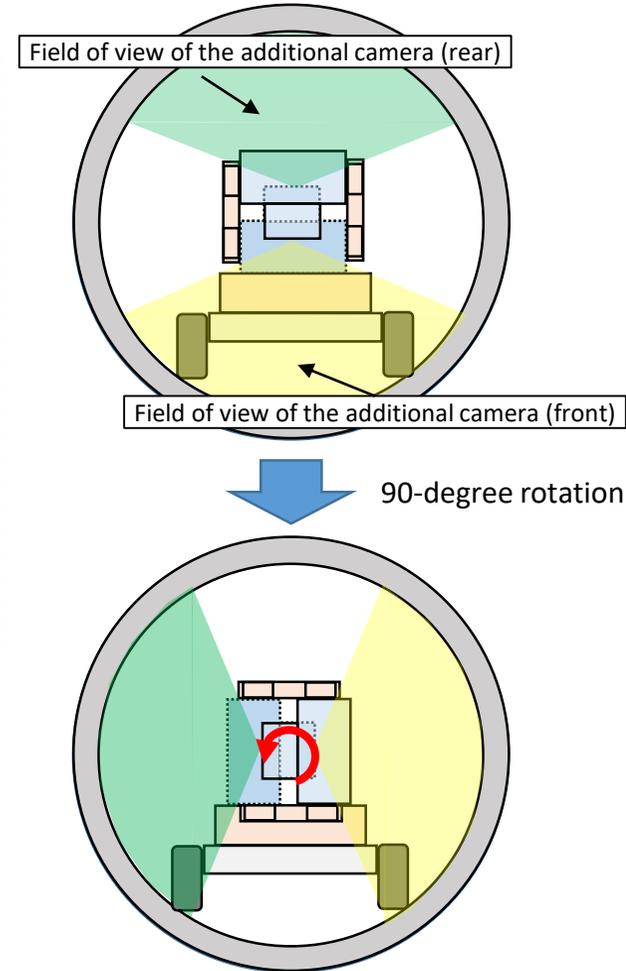
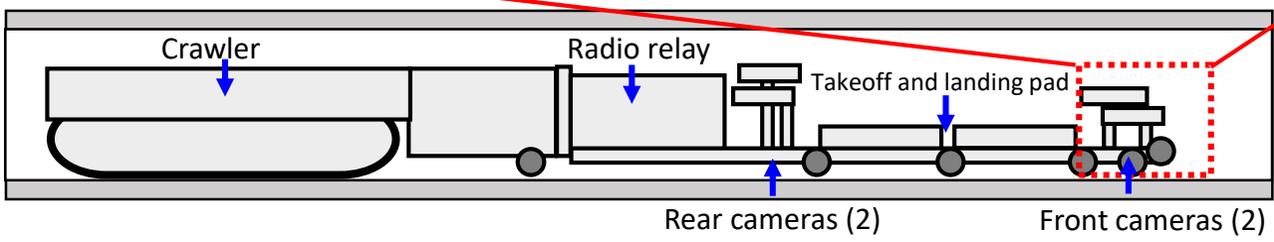
- Two cameras were added to the end of the insertion device in order to perform a detailed inspection of the inside of the insertion pipe.
- Both cameras are angled slightly forward and to the rear to take photos of the level difference inside the pipe and the shape of the inner walls of the pipe.
- The cameras can also rotate along the axis of the pipe, so turning each of them 90-degrees enables us to acquire footage of the entire inner circumference of the pipe.

Diagram showing the insertion device (side view)

Diagram of additional camera rotation (front view) 8
