# Fukushima Daiichi Nuclear Power Station Unit 3 PCV Internal Investigation (non-submerged area) using Micro-drones

August 27, 2026

Tokyo Electric Power Company Holdings, Inc.

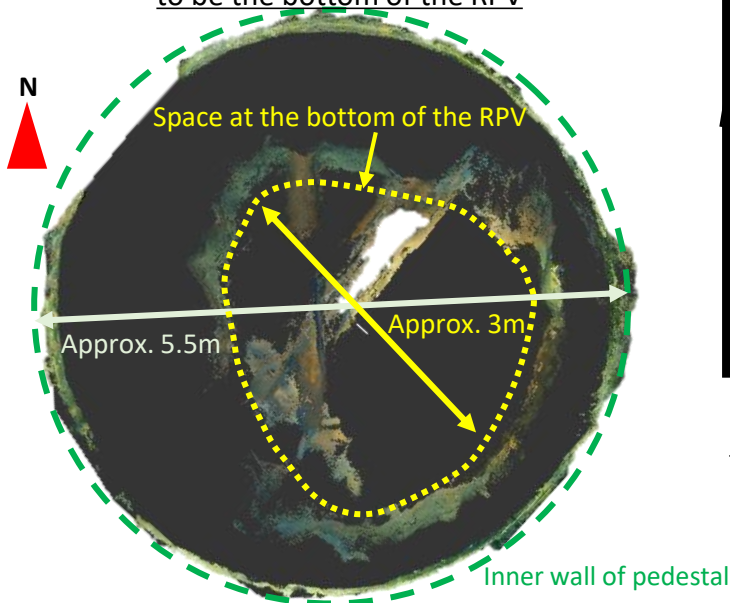
Shape of the space at the bottom of the RPV (Planar view)

- After using the generated point cloud data to assess the dimensions of the objects seen in the footage, we have confirmed that **the structure that appears to be the bottom of the RPV is consistent both in location and thickness with the dimensions of the bottom of the RPV as shown in schematics, and it is highly likely that they are the same structures.**
- **The space at the bottom of the RPV is oval in shape and we estimate that its maximum diameter is approximately 3m.**
- Since the maximum flight height of the drone was approximately 9.4 meters from the bottom of the pedestal, we estimate that the drone temporarily flew inside the RPV.

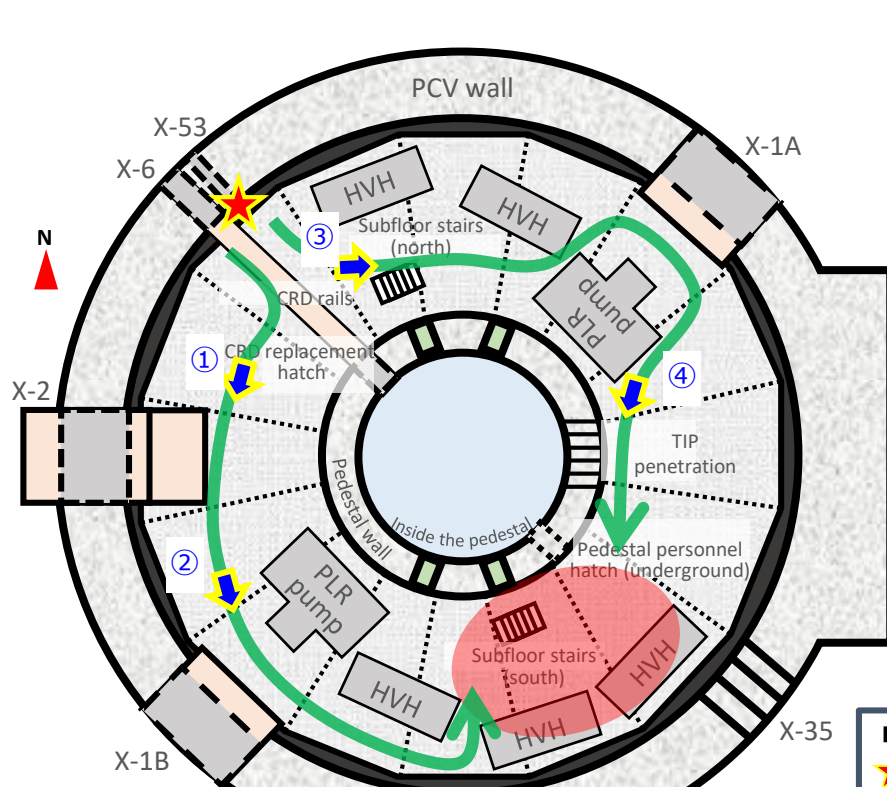
Unit 3 D/W1FL (planar schematic diagram)

- **Fog:** As with Unit 1, fog was found outside the Unit 3 pedestal (Visibility was approximately 3m)
- **Signal strength:** Signal strength in the southeast area, which is on the opposite side of the X-53 penetration where the radio was located, was poor.

- **Equipment/ obstructions:** No large scale damage or obstructions were seen (rust and fallen insulation was found)
- **Flight route:** With the exception of the southeast area where a signal strength was poor, flights were flown in the clockwise and counterclockwise directions on the first floor of D/W

- **Point cloud:** Footage from the landscape and portrait cameras were taken in order to create a point cloud. Point cloud processing is planned.
- **Dose rates:** Dose rates in the vicinity of the X-53 penetration were approx. 0.6Gy/h( $\gamma$  rays). General dose rates outside the pedestal will be estimated from the radiation noise in the footage

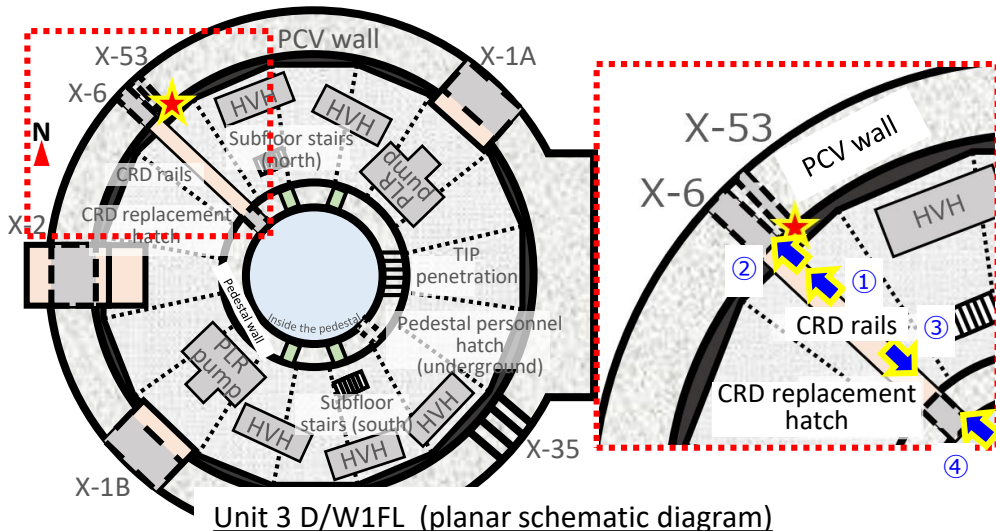
① : External view of the X-6 penetration

- **X-6 penetration:** No obstructions were seen around the penetration. There are cables around the inside of the entire penetration, but no deposits like those found at Unit 2 were seen in the scope of the footage.
- **CRD rails:** No significant damage or obstructions were found but an uneven surface was seen
- **CRD replacement hatch:** No obstructions were found in the vicinity of the hatch

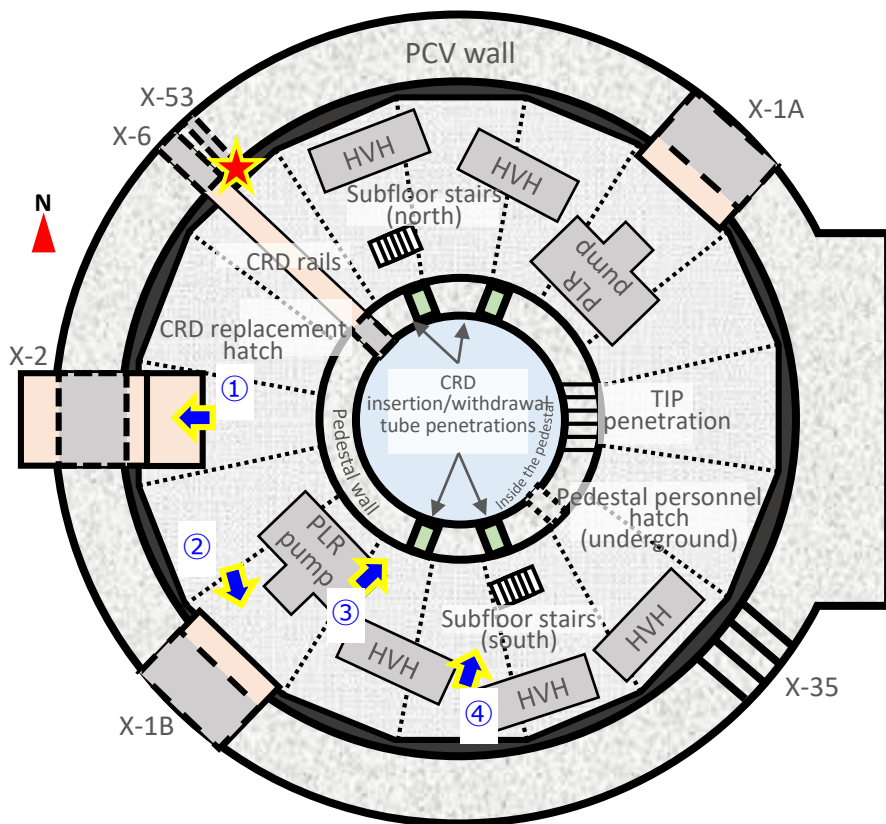
Unit 3 D/W1FL (planar schematic diagram)

- **X-2 penetration, X-1B penetration: No damage, deformation of the penetration or obstructions were found**
- **CRD insertion/withdrawal tube (south): No damage or deformation of the southwest side pipes were seen.** Signal strength on the southeast side is poor and flights could not be flown so this area was not investigated
- **Subfloor stairs (south): No damage or deformation of the stairs or obstructions was seen**
- **X-35 penetration:** Signal strength in the southeast area outside the pedestal was poor thereby preventing any flights from being flown.

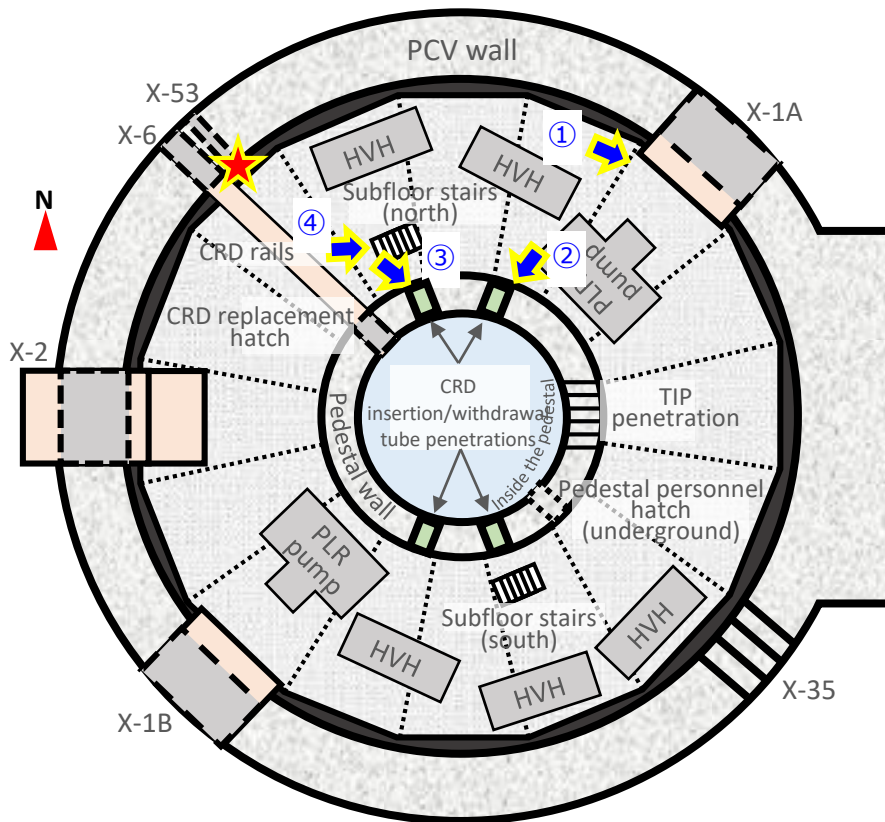
① : X-1A penetration (Flange)

- **X-1A penetration: No damage, deformation of the penetration or obstructions were found**
- **CRD insertion/withdrawal tube (north): No damage or deformation of the pipes on the northwest or northeast sides**
- **Subfloor stairs (north): No damage or deformation of the stairs or obstructions was seen**

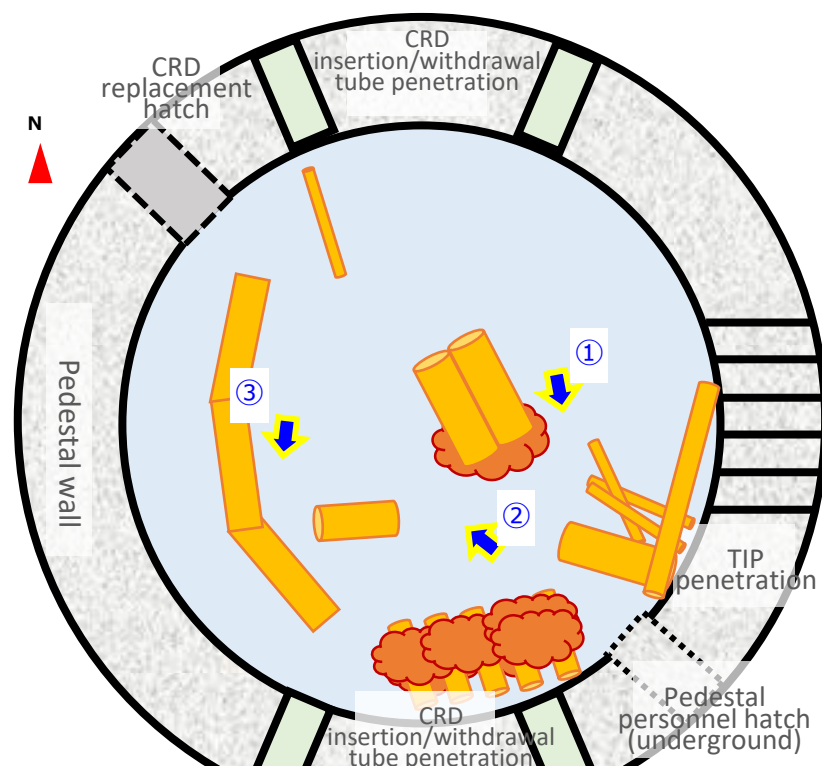
① : Deposits

- **Deposits:** Deposits were found at the bottom of the CRD guide tubes in the center. It is assumed that some exist underwater.
- **Fallen structures:** CRD guide tube, which are RPV internal structures, were found
- **CRD replacement machine ancillary equipment:** The platform was found to be tilted. The footage is currently being reviewed to look for other pieces of equipment
- **PCV water levels:** By comparing the height of the water surface with the height of structures we confirmed that water level is approximately the same as the water level in the PCV calculated from the S/C pressure gauge. (The water level outside the pedestal is also approximately the same)

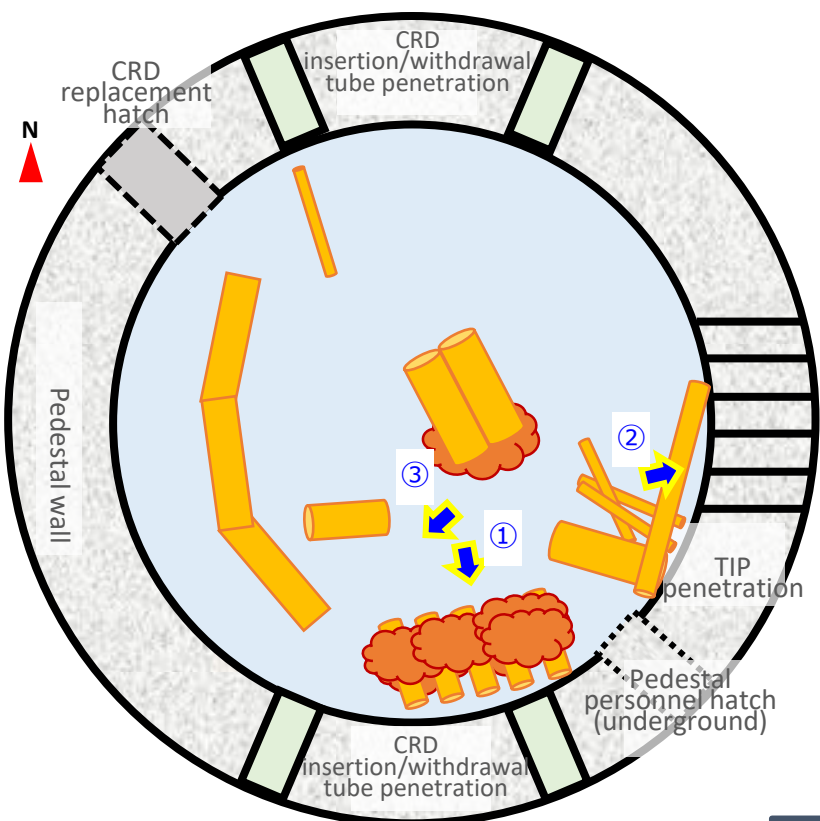
Unit 3 Inside the pedestal (planar schematic diagram)

- **Adhesions:** Clump-like adhesions were seen on the south side of the CRD housing group
- **Pedestal wall surface:** No remarkable damage was seen within the scope of the footage
- **TIP penetration:** Damaged TIP guide tubes were found
- **Fallen structures:** Part of the CRD housing group, which is a structure at the bottom of the RPV, was found to be tilted, and slightly lower than its original position.

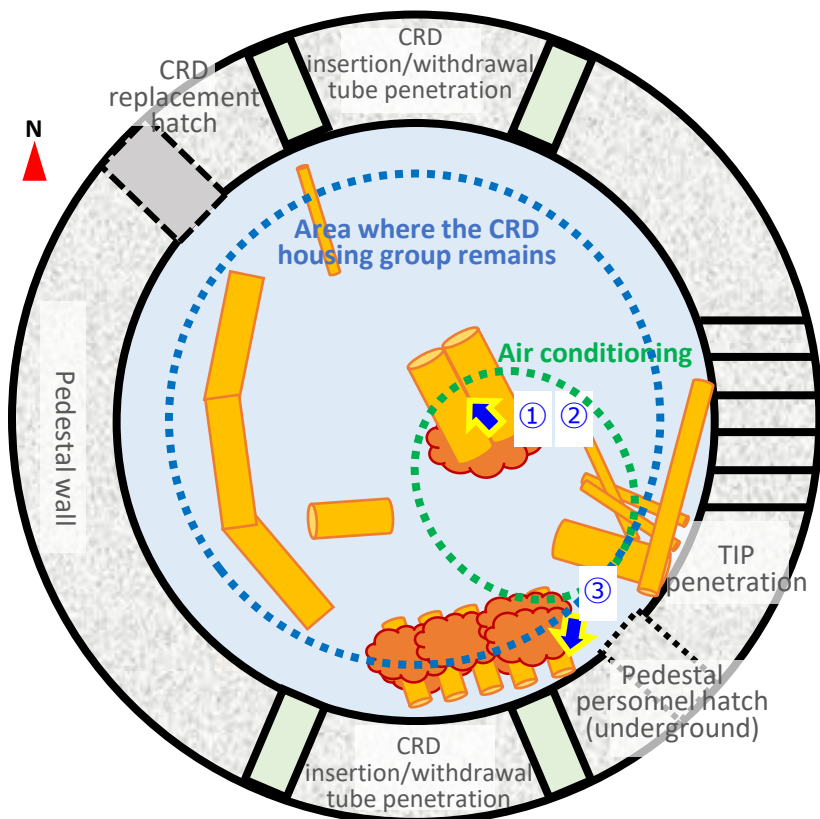
① : Bottom of arrow

- **Adhesions:** Clump-like adhesions were seen on the CRD housing group near the center and southeast side
- **CRD housing group:** Although the CRD housing group is tilted and deformed, most of it remains in its original position. **There is a space towards the top from the center to the southeast**
- **CRD insertion/withdrawal tube:** Only the southeast portion could be photographed and **damage to the pipes was seen**
