**<Status Report>**  
**Status of General Inspections Implemented  
after Discovering Partial Incompletion of Safety  
Measure Renovations at Kashiwazaki-Kariwa  
Nuclear Power Station Unit 7**

September 22, 2021  
Tokyo Electric Power Company Holdings, Inc.

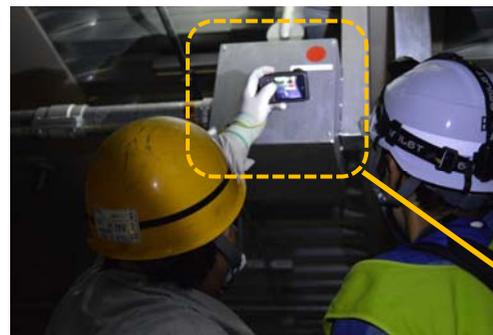
Recording of marking

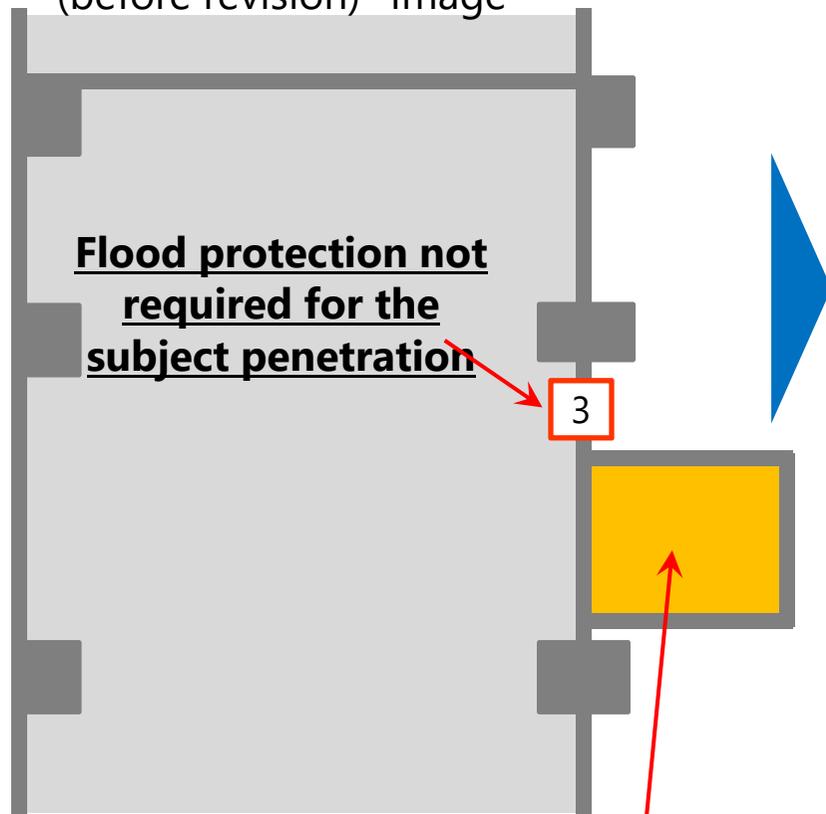
Flood protection demarcation map (before revision) \*Image

- The design management departments presented the materials on the revision of the flood protection demarcation map to the work management departments but they did not explain it in detail.
- The work management departments did not check the details of the revision with the design management departments, and incorrectly determined the penetration as not subject to flood protection measures.

Only orange areas subject to floor protection
