Impact of the Niigata Chuetsu-oki Earthquake on the Tokyo Electric Power Company (TEPCO) Kashiwazaki-Kariwa Nuclear Power Station and Countermeasures

September 2007

The Tokyo Electric Power Company, Inc.

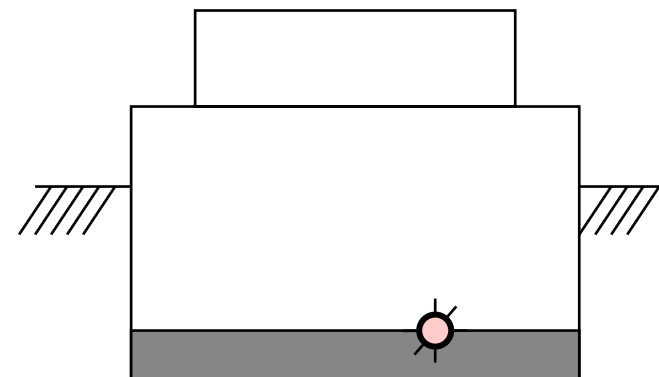
- Observed seismic motion largely surpassed the design-basis seismic motion.

Observed maximum acceleration at each unit / design-basis response acceleration in brackets.

Seismograph
 Measured by the base mat of each reactor building.
 Unit of Measurement: (Gal)
