# Results of the Fourth Soundness Inspection of Unit 4 Reactor Building at Fukushima Daiichi Nuclear Power Station

February 13, 2013

Tokyo Electric Power Company

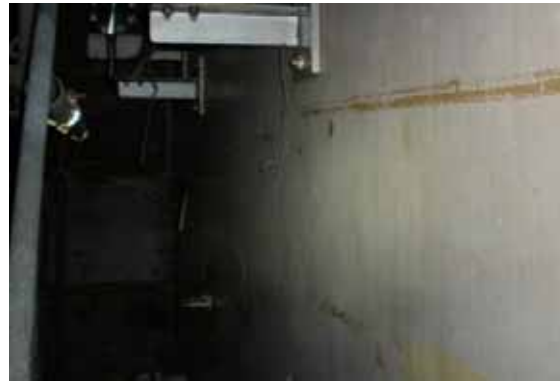
③ SFP side wall

Since no crack of a width of 1mm or more or with possible rebar corrosion was found as a result of visual inspection (similarly to the past results), it has been concluded that there is no hazardous deterioration of structural durability.

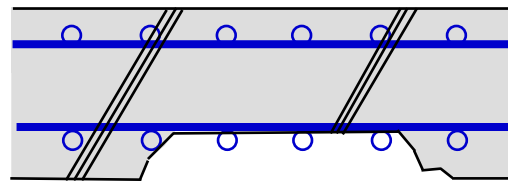
2. Rebar being exposed (Current)

Since the concrete surface of the posts and beams in Unit 4 Reactor Building came off and rebar is partially visible due to the hydrogen explosion, corrosion prevention measure (spraying mortar onto the exposed parts) will be implemented for the purpose of ensuring the durability of the members starting from around March 2013.
