Results of Investigation of the Lower Part of Unit 2 Vent Pipe at Fukushima Daiichi Nuclear Power Station

March 13, 2013

Tokyo Electric Power Company

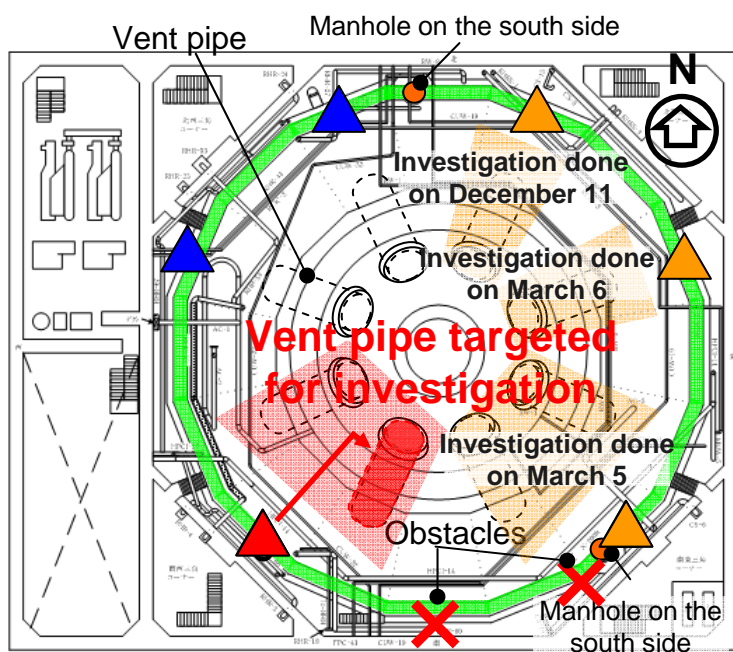
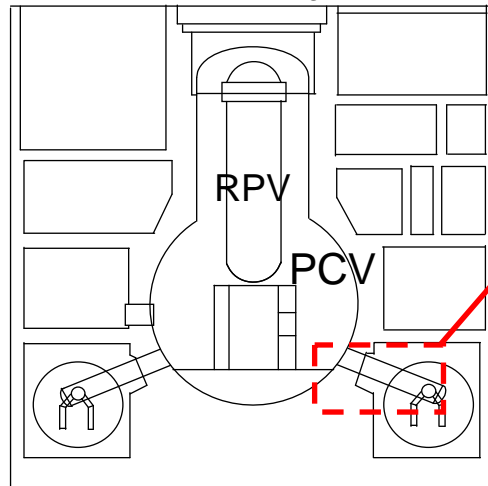
Investigation Locations and Current Conditions (South-southwest Vent Pipe)

Lower part of the vent pipe bellows cover: No water leakage found

No water leakage (water flowing) was found on the concrete stage (*) on the lower part though the condition was not directly checked.

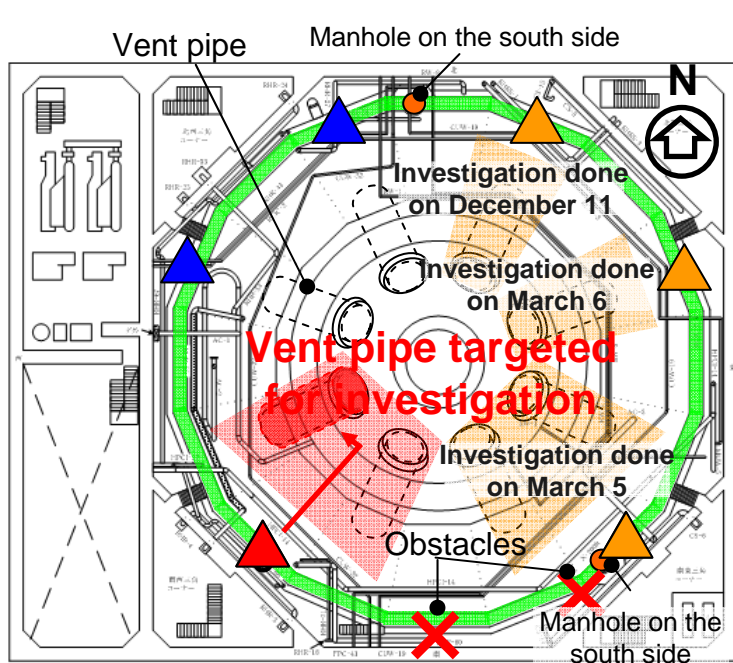
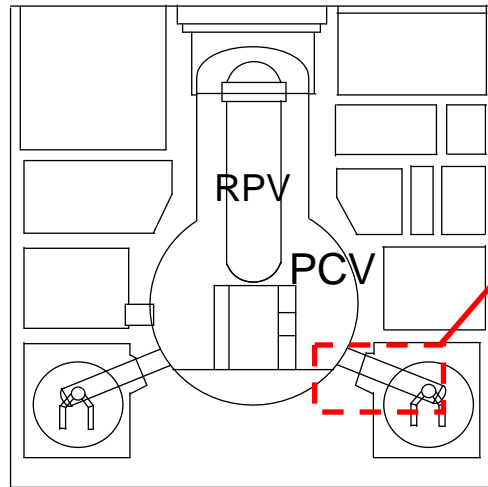
Investigation Locations and Current Conditions (West-southwest Vent Pipe)

Lower part of the vent pipe
bellows cover: No water leakage
found

No water leakage (water flowing) was found on the concrete stage (*) on the lower part though the condition was not directly checked.
