Results of Investigation of the Lower Part of Unit 2 Vent Pipe at Fukushima Daiichi Nuclear Power Station

March 15, 2013

Tokyo Electric Power Company

Investigation Locations and Current Conditions (North-northwest Vent Pipe)

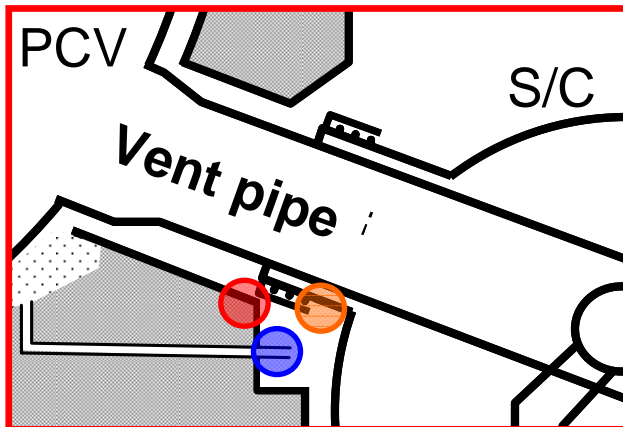
1. No water leakage was found at the edge of the vent pipe sleeve.
2. No water leakage was found at the edge of the sand cushion drain pipe.
3. No water leakage was found at the lower part of the vent pipe bellows cover.

Edge of the vent pipe sleeve

Edge of the sand cushion drain pipe

Lower part of the vent pipe bellows cover

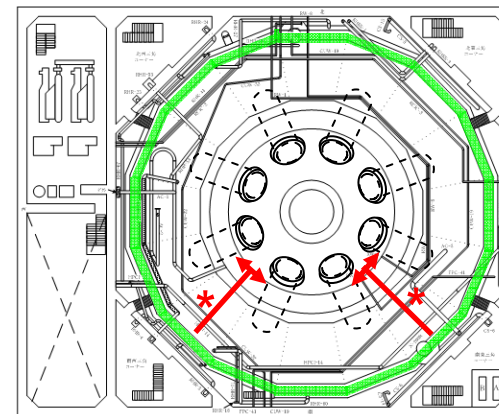
***2 locations were investigated by changing the camera direction.**
