Work Performed Today (April 12) in Response to the Leakage from the Underground Reservoirs

April 12, 2013

Tokyo Electric Power Company

Cause Investigation of the Leakage

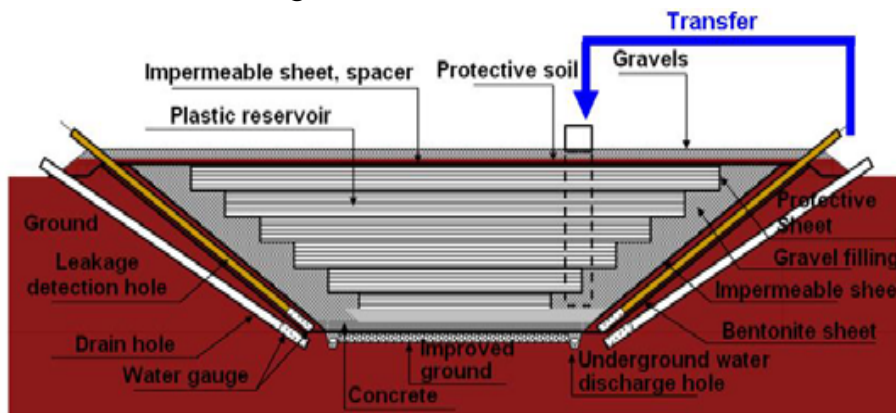
- In order to prevent the leaked water in the leakage detection holes from leaking into the ground in the surrounding area, the water in the leakage detection holes will be returned to the underground reservoirs.

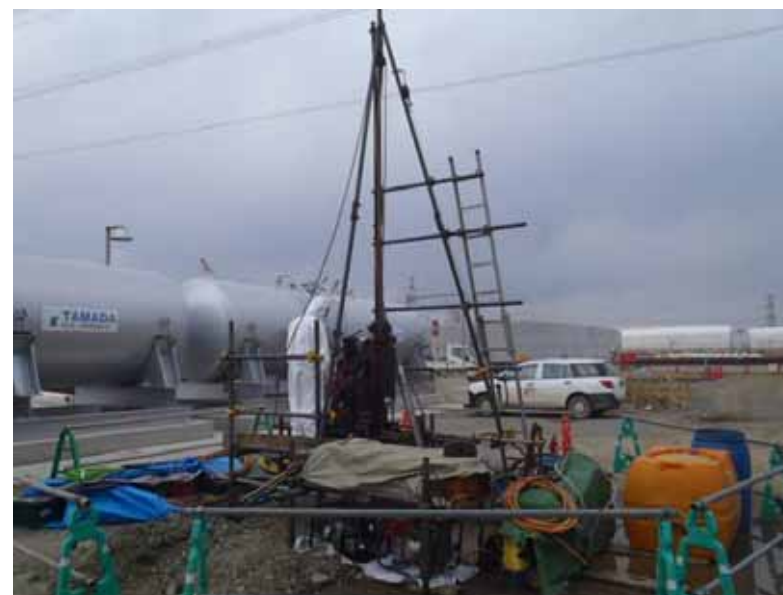
- Photo of the work performed today

Boring : 3m, cumulative 6m/approx. 30m
