Committee for monitoring and  
evaluating the specified  
nuclear facilities (provisional  
translation) (9th meeting)  
Reference 1-1

# Background of underground reservoir plan, current actions (cause analysis etc.), and future direction

April 19, 2013

Tokyo Electric Power Company

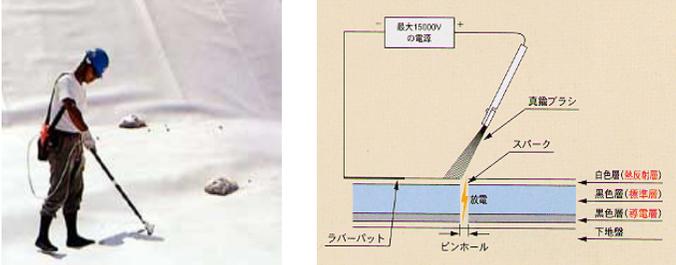
Part	Tests	Test standard/ subject	TEPCO monitoring
<p>Impenetrable sheet pinholes</p>	<p><b>Spark test</b></p>

<p>No sparks generated (voltage 15,000V or more)</p> <p><b>All surface test</b></p>	<p><b>Witness all work</b></p>
<p>Adhesion area defects (self adhesion)</p>	<p><b>Pressurized test</b></p>

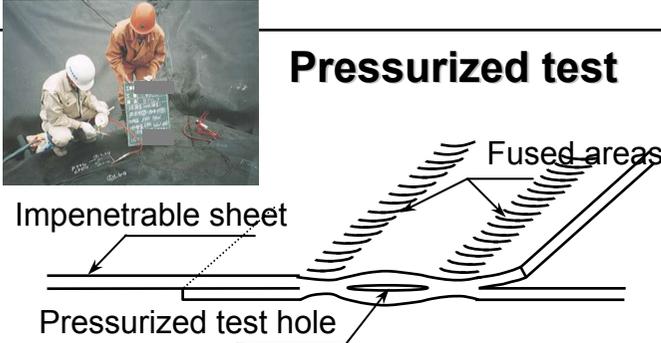
<p>No air leak, pressure loss rate is 20% or less ( Pressure 150kPa ) ( Maintained time 30s )</p> <p><b>Test all</b></p>	<p><b>Witness all</b></p>
<p>Adhesion area defects (manual adhesion)</p>	<p><b>Negative pressure test</b></p>

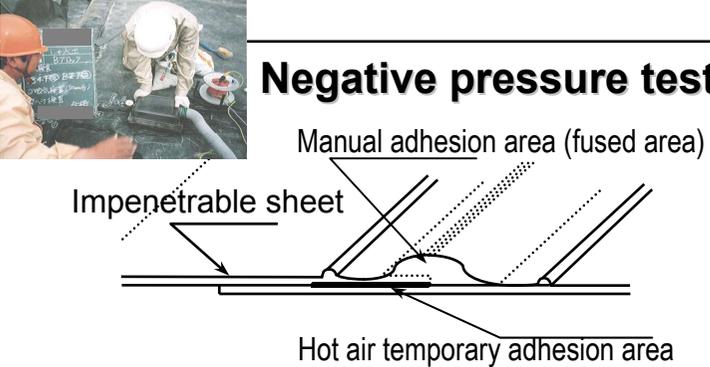
<p>No air bubbles ( Gage pressure-about 6.7kPa ) ( Maintained time 10s )</p> <p><b>Test all</b></p>	<p><b>Witness all</b></p>

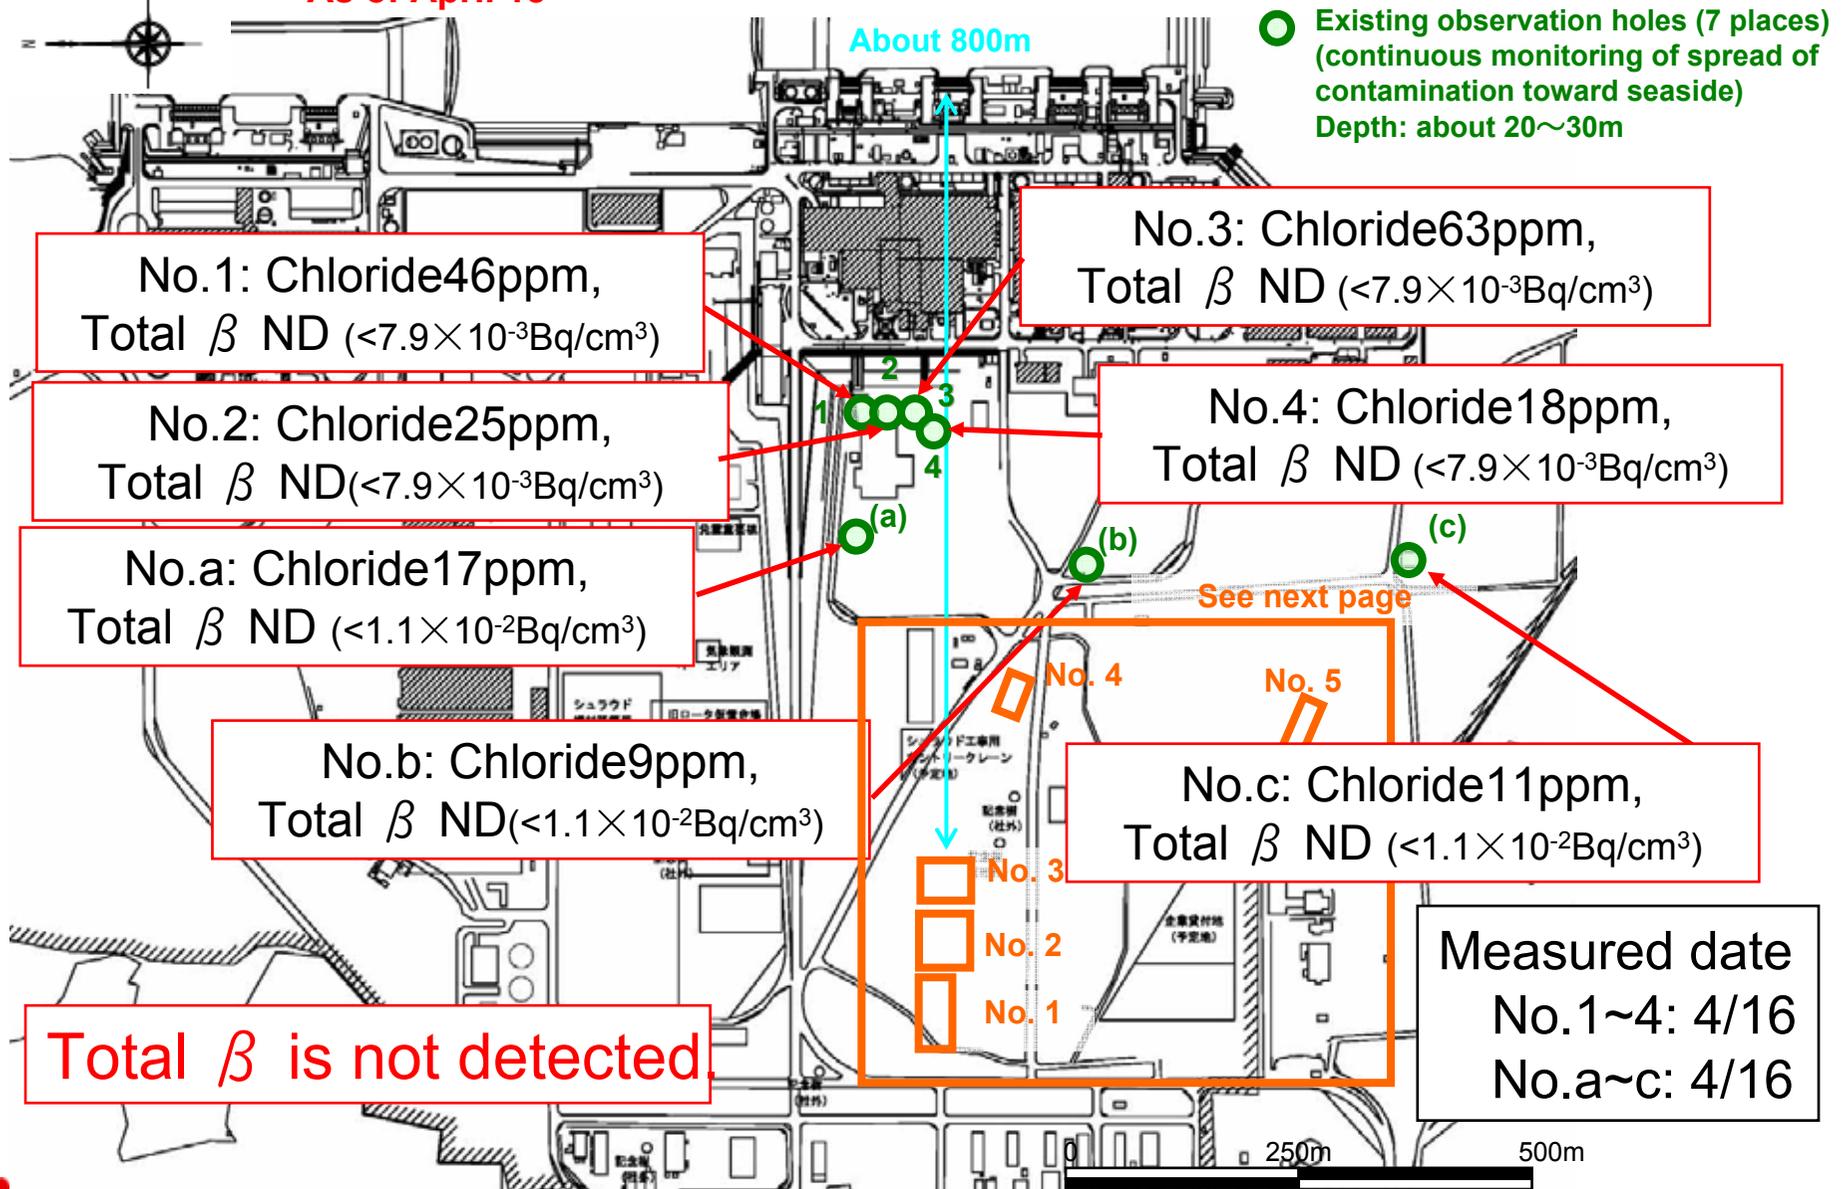
# 8. Current response (1) ~ Existing boring hole monitoring

As of April 18

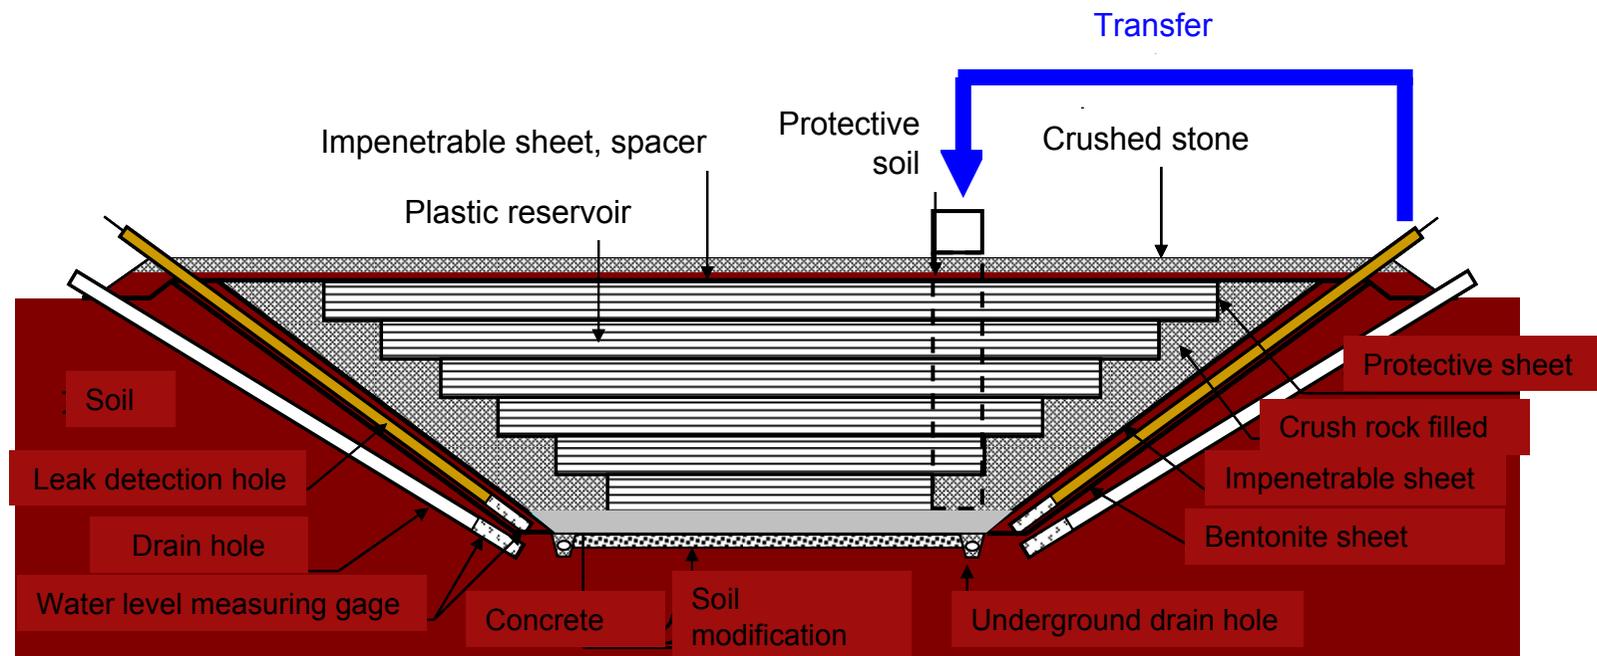
## 8. Current response (3) ~ Conduct draining & circulation of leak detection hole

- No1 Underground reservoir : Started on 4/10, conducted 22 times by 4/18 (pumped amount: about 1~17 liters/time)
- No2 Underground reservoir : Started on 4/11, conducted 17 times by 4/18 (pumped amount: about 3~19 liters/ time)
- No3 Underground reservoir : Stared on 4/13, conducted 20 times by 4/18 (pumped amount: about 2~35 liters/ time)

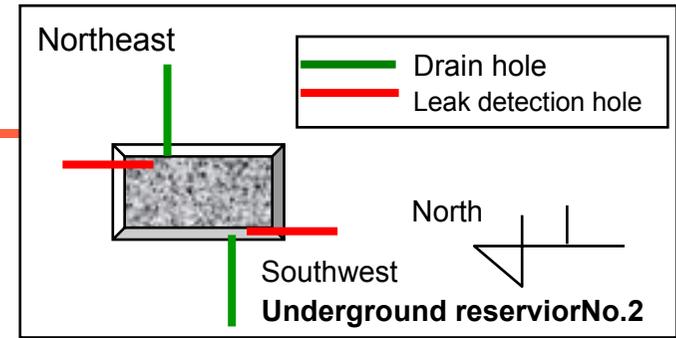
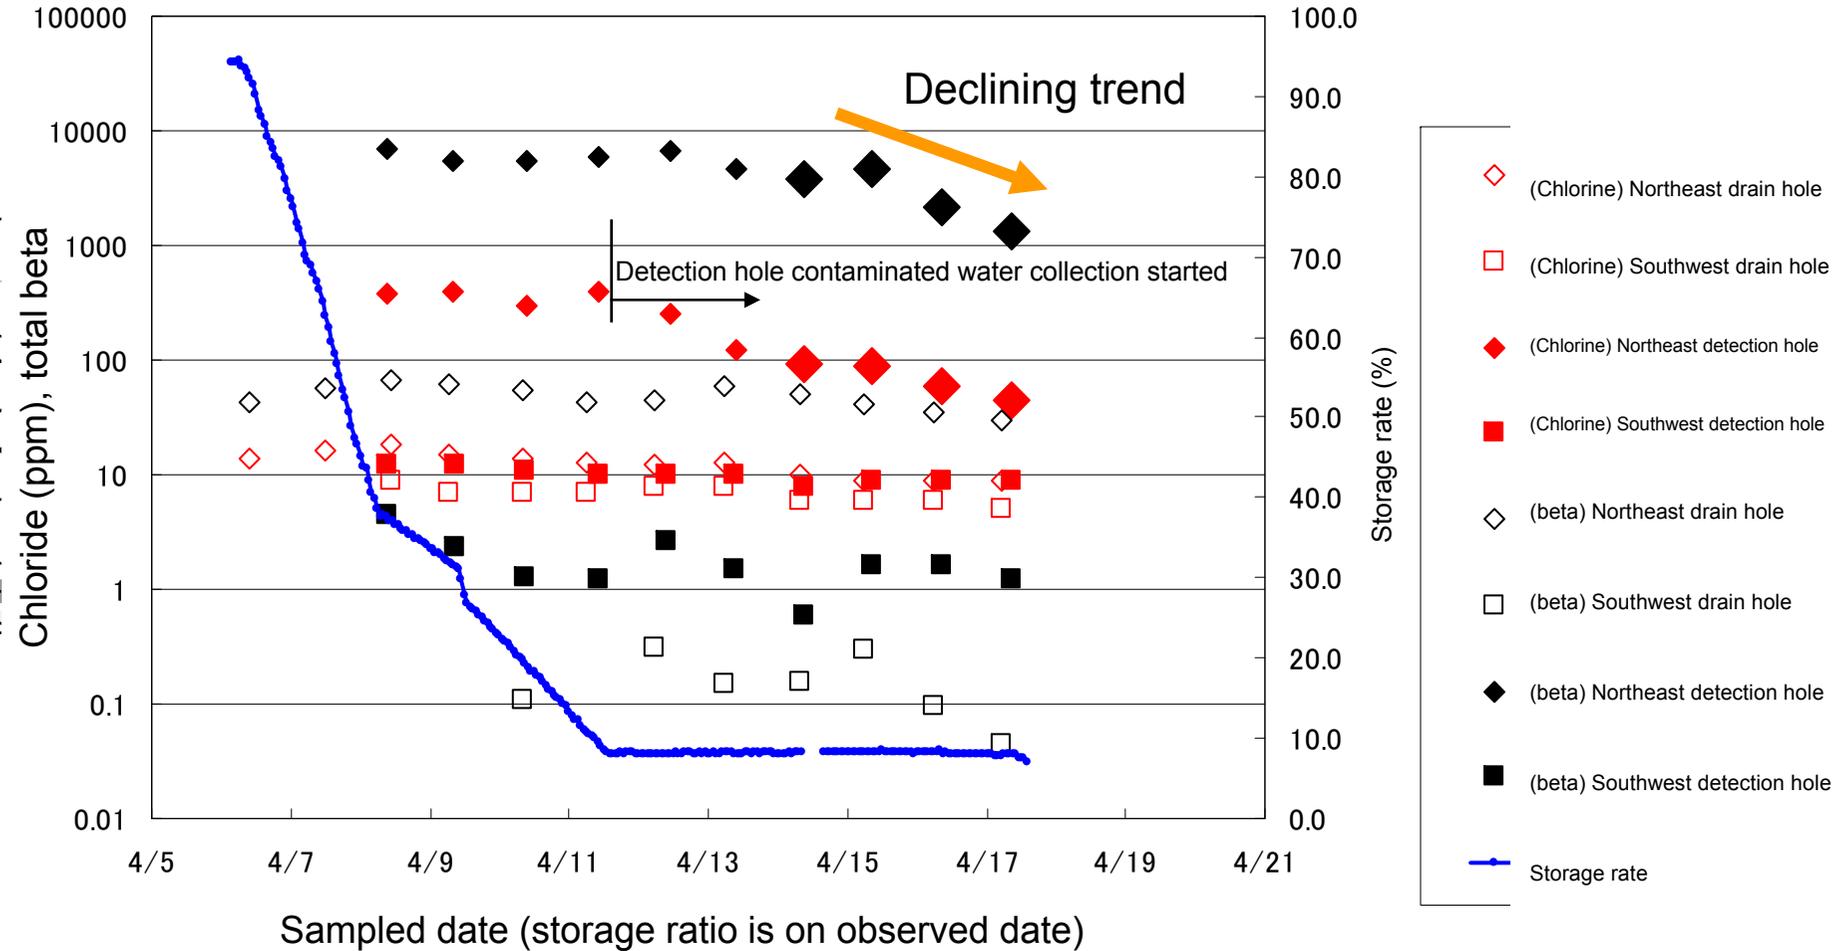
# [Reference 1-2] No2 monitoring data

As of April 18 No.2 reservoir

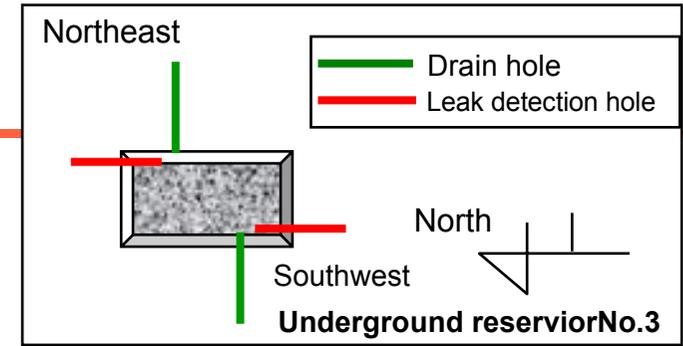
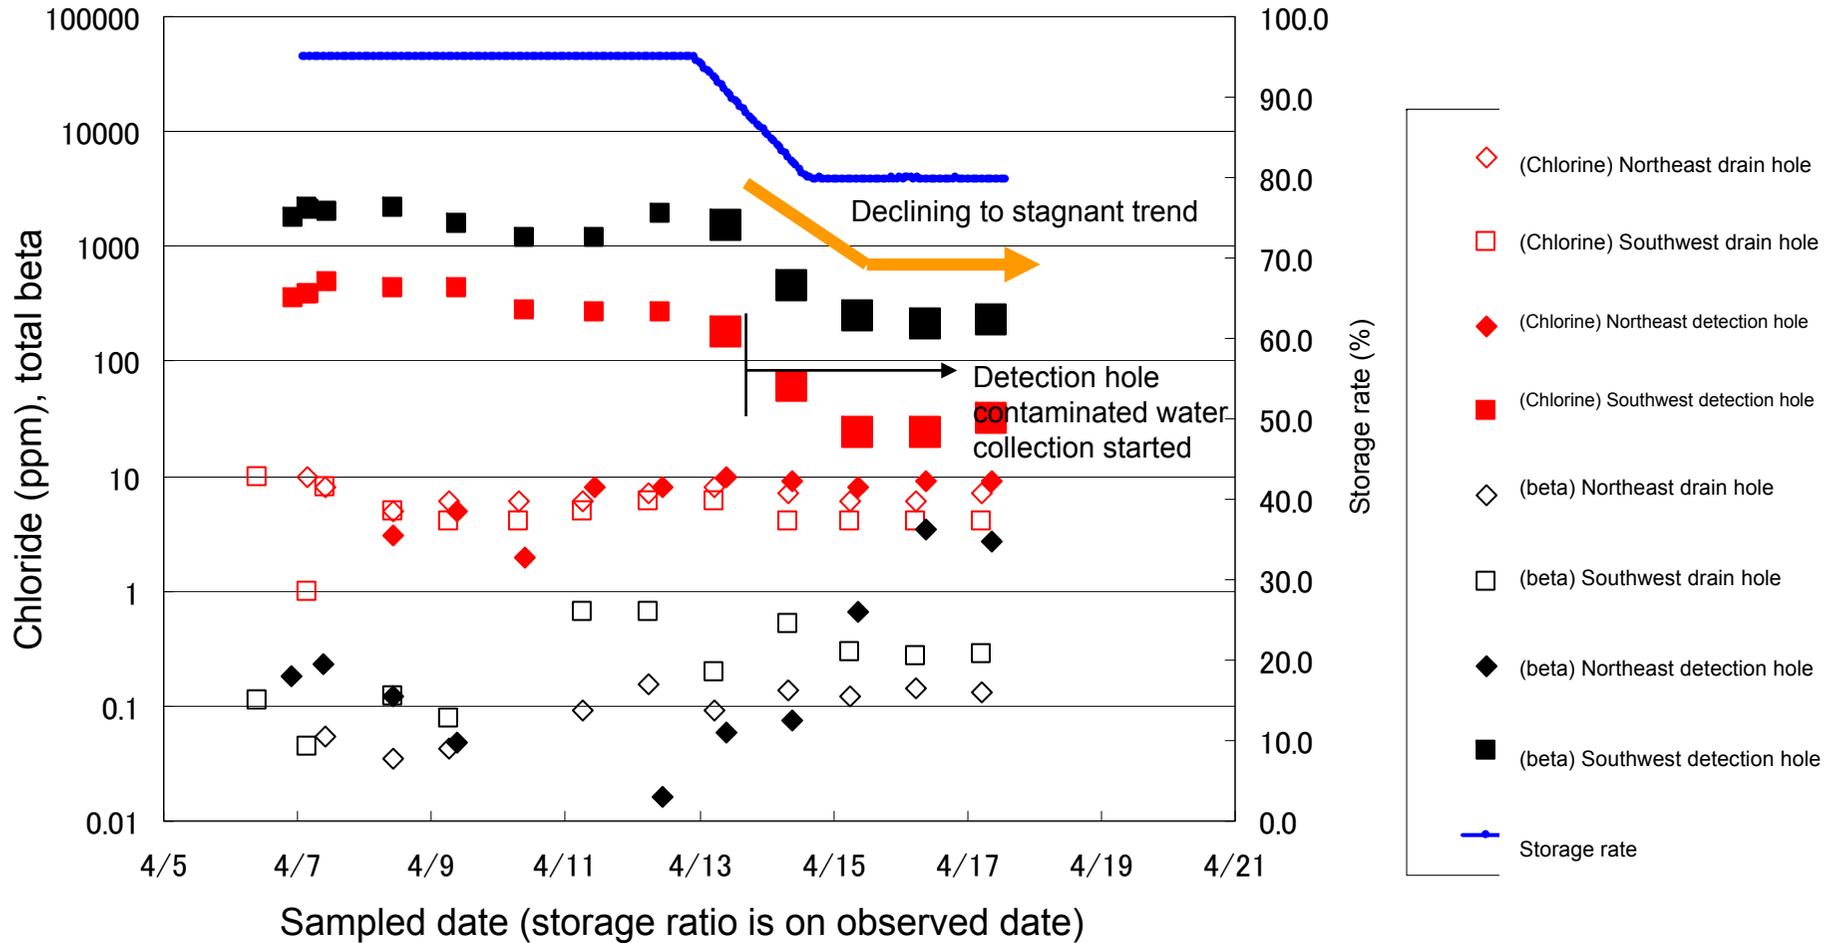
# [Reference 1-3] No3 monitoring data

As of April 18 No.3 reservoir
