# Small Animals (Mice) Found in the Low Voltage Transformer Box for Unit 2 Spent Fuel Pool Alternative Cooling System at Fukushima Daiichi Nuclear Power Station

< Reference >  
April 22, 2013  
Tokyo Electric Power Company

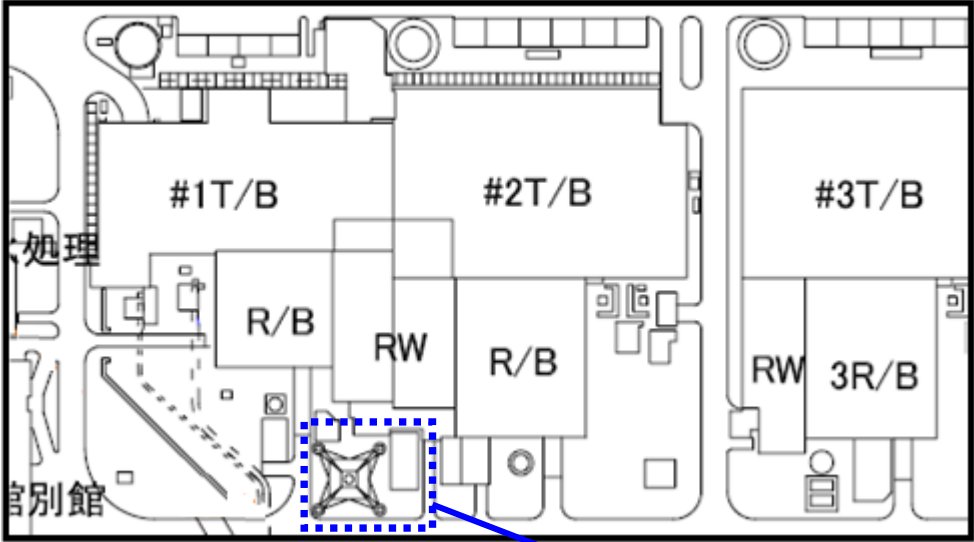
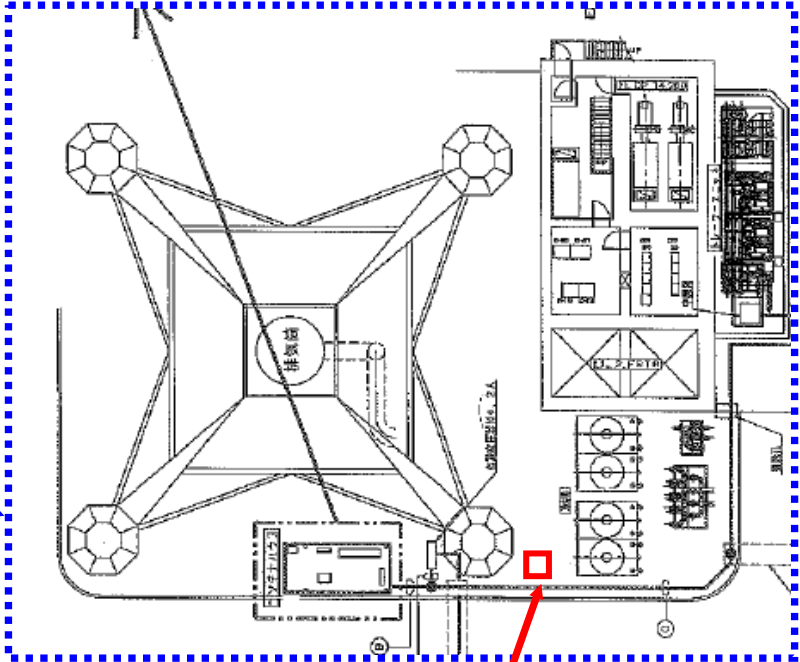
## (5) Layout of the low voltage transformer box

Small animals were found dead near the terminal on the primary side upon opening the door of the low voltage transformer box.

After the small animals were removed, appearance inspection was performed on the transformer. No damage (burn) was found on the terminal and no abnormality was found with the appearance of other areas. As a result of insulation resistance measurement, no problem was found in the primary side of the transformer, the interphase on the secondary side and the voltage to ground.
