# Results of the Fifth Soundness Inspection of Unit 4 Reactor Building at Fukushima Daiichi Nuclear Power Station

May 29, 2013

Tokyo Electric Power Company

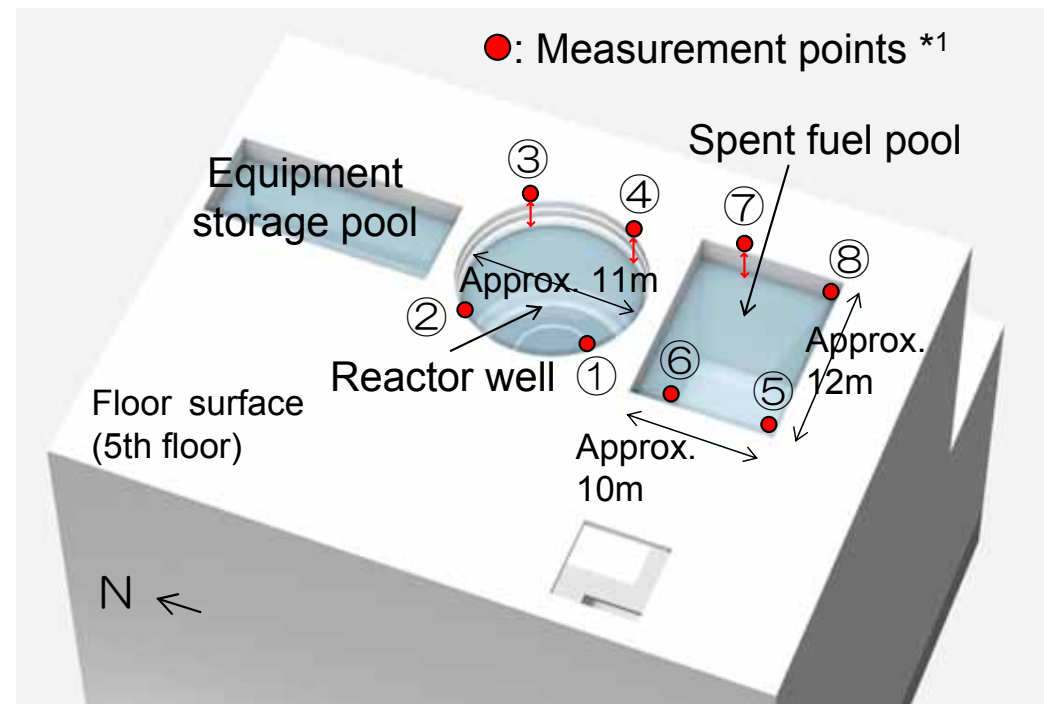
Measurement points (Floor surface of the 5th floor)

Considering that the water level measurement values on the four corners were about the same, it has been concluded that the 5th floor surface and the water surfaces of the spent fuel pool and the reactor well are parallel and the building is not tilted similarly to the past results.

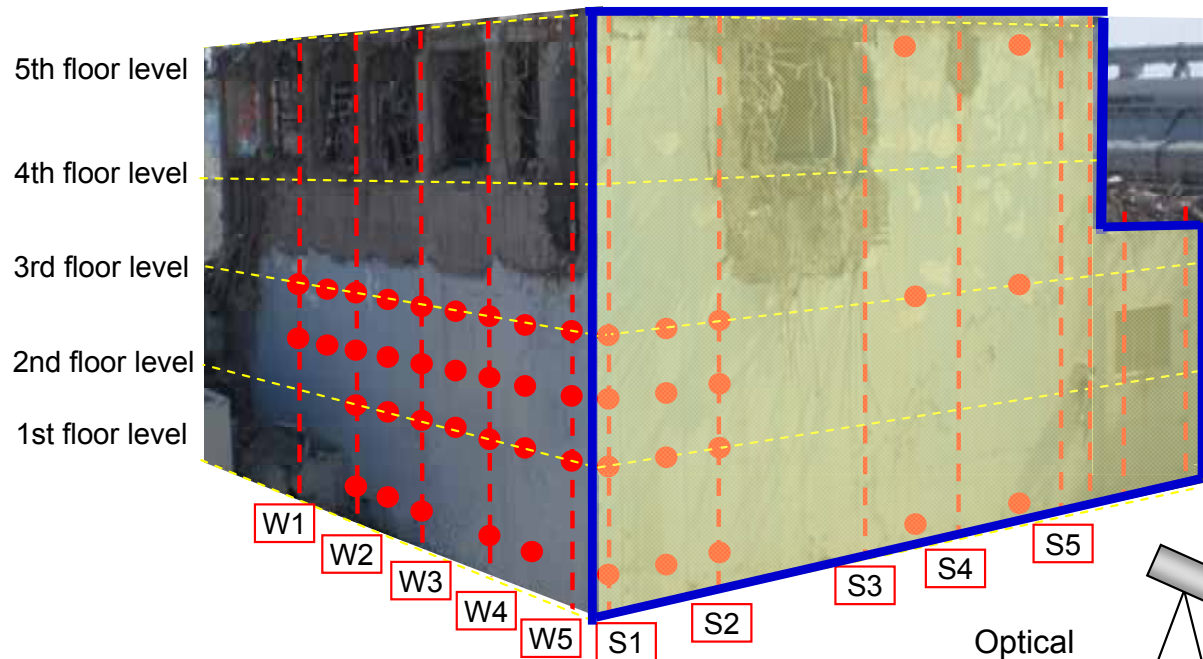
Measurement points

Though partial bulge was found on the outer walls, it has been confirmed that the building itself is not tilted based on the results of the first regular inspection (May 2012), detailed inspection of outer walls (June 2012), and second to fourth regular inspections (August and November 2012 and February 2013).

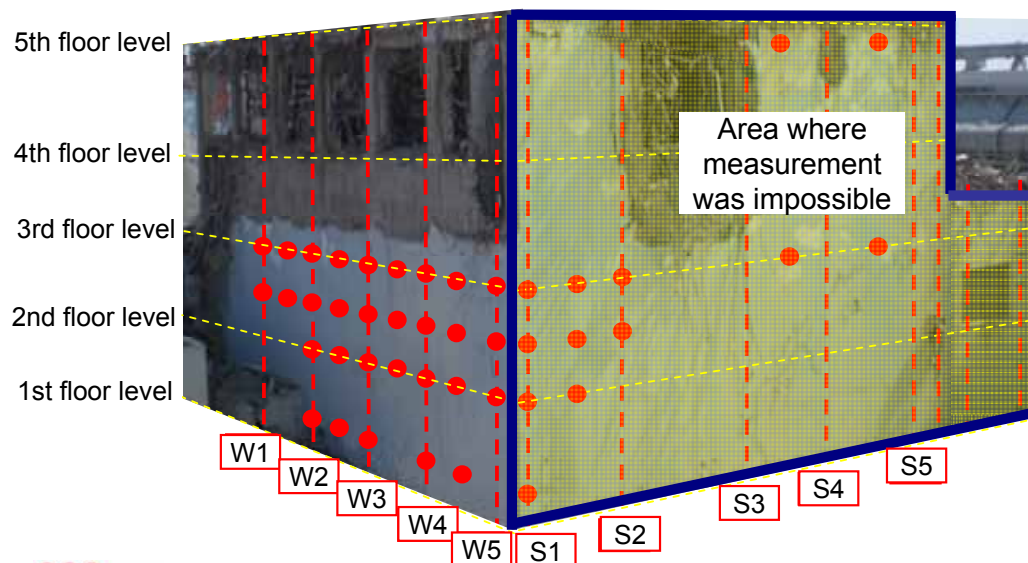
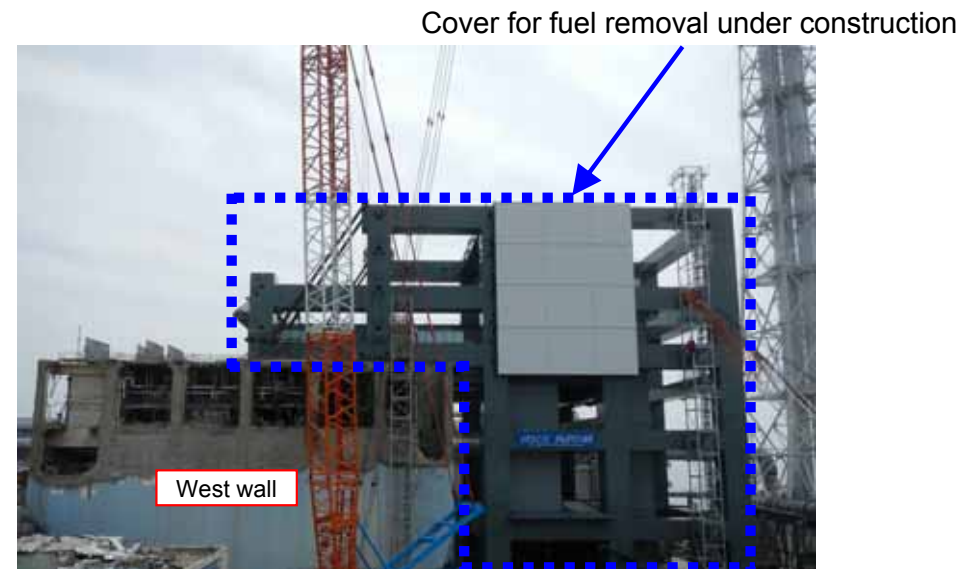
- The horizontal differences measured this time were about the same as those in the first to fourth inspections, and the deformation characteristics on the measurement points were also similar.

- The small difference from the previous measurement results may be due to factors such as error of the optical equipment (Measurement error of  $\pm 2\text{mm}$  may cause approx. 4mm (Max.) error in horizontal difference) and thermal expansion of concrete (thermal expansion coefficient: Approx.  $7\text{-}13 \times 10^{-6}/^{\circ}\text{C}$ ) which may cause approx. 3-6mm error because of the difference of average monthly temperatures between February and May.

- The south wall was excluded from the present and future measurements due to interference with the cover for fuel removal, which is under construction. However, we consider that no significant change would be found with the measurement on the outer surface of the south wall, since no significant change was found with measurement results on the west wall and the inspection results for the other three inspection items.

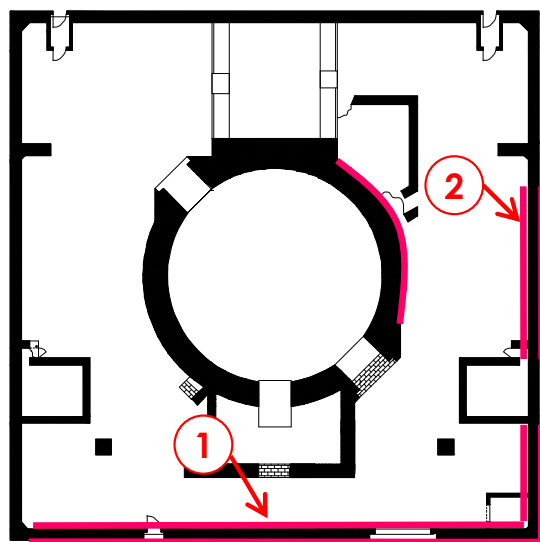
First floor

Since no crack of a width of 1mm or more or with possible rebar corrosion was found as a result of visual inspection (similarly to the past results), it has been concluded that there is no hazardous deterioration of structural durability.
