Results of Soundness Inspection of Unit 2 TIP Guide Pipe (4th Day)

July 11, 2013

Tokyo Electric Power Company

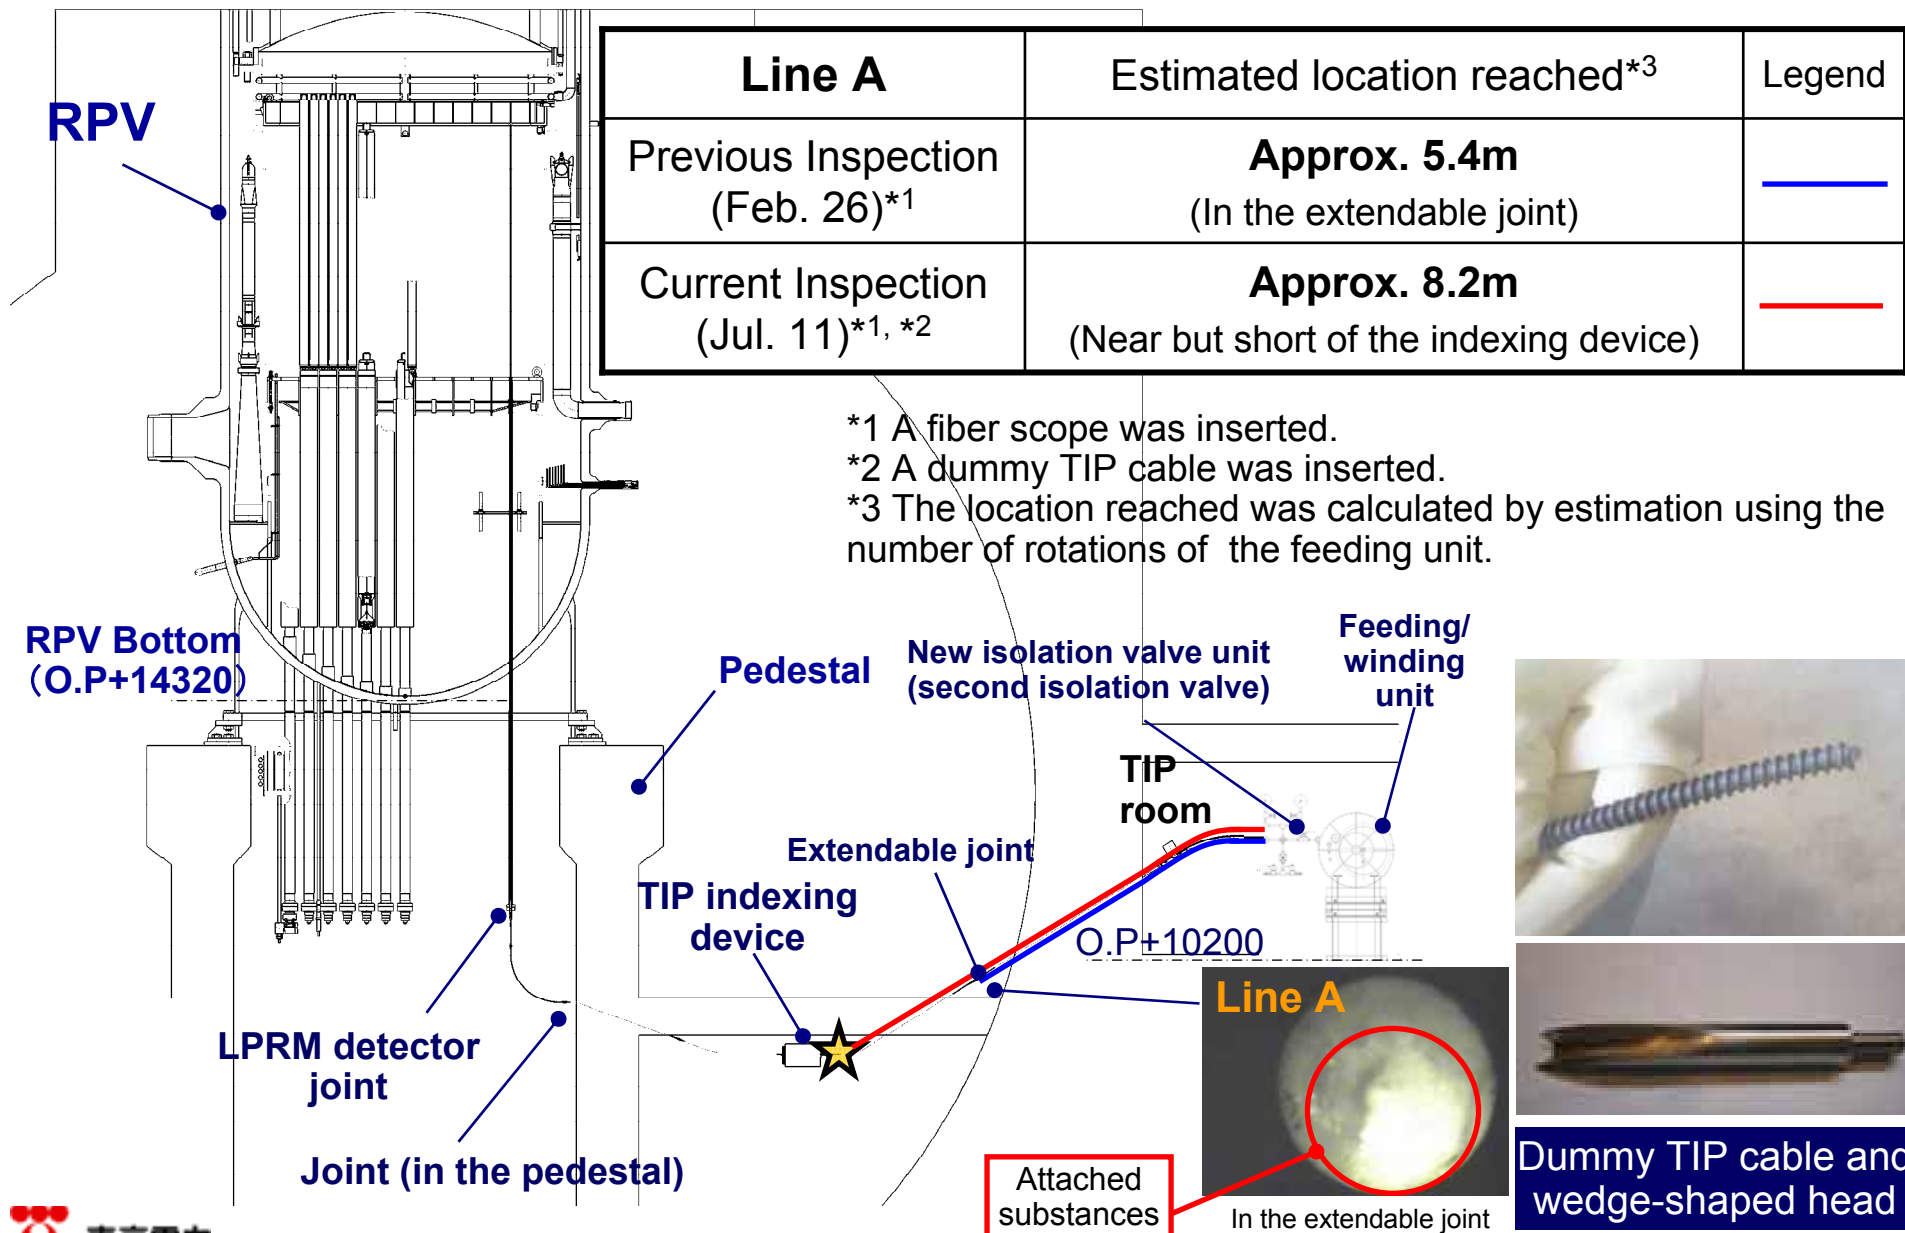
1-1. Contents of Work

- The dummy TIP cable was inserted and reached approx. 8.2m from the second isolation valve inlet flange of Line A. Further insertion of the cable became impossible at a location near but short of the indexing device.
- After the dummy TIP cable was pulled out, attached substances were found on the head.
(γ -ray: 17.0mSv/h, β - and γ -rays: 45.0mSv/h)
- Inspection of Line A was completed.

- We will study the inspection results of the respective lines and decide on our next course of actions.

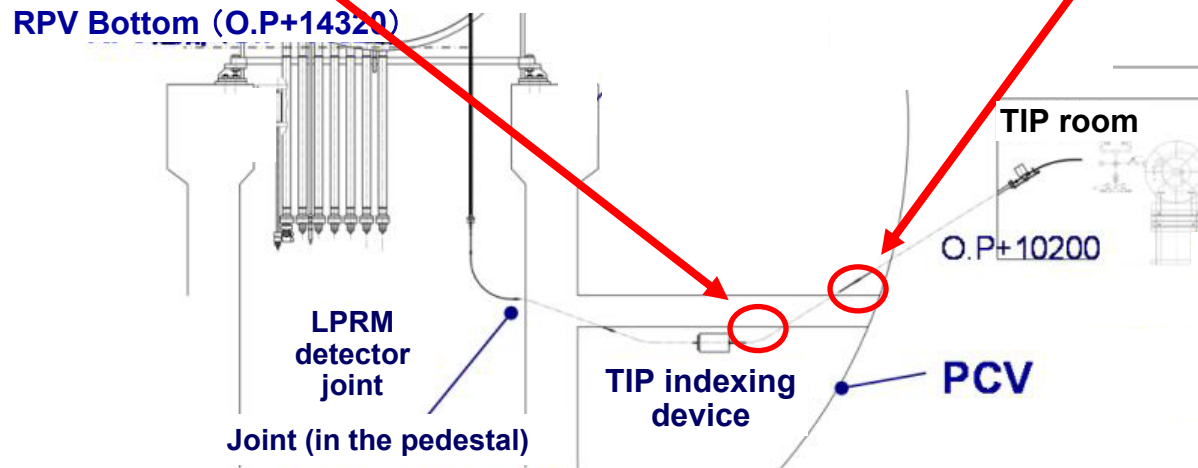
Near the location reached previously

Attached substances
