Tokyo Electric Power Company

**Results of Additional Investigation
Based on Leakage from
Batch Treatment Tank of the
Multi-nuclide Removal Equipment
(Follow-up Information)**

Additional Investigation of Multi-nuclide Removal Equipment

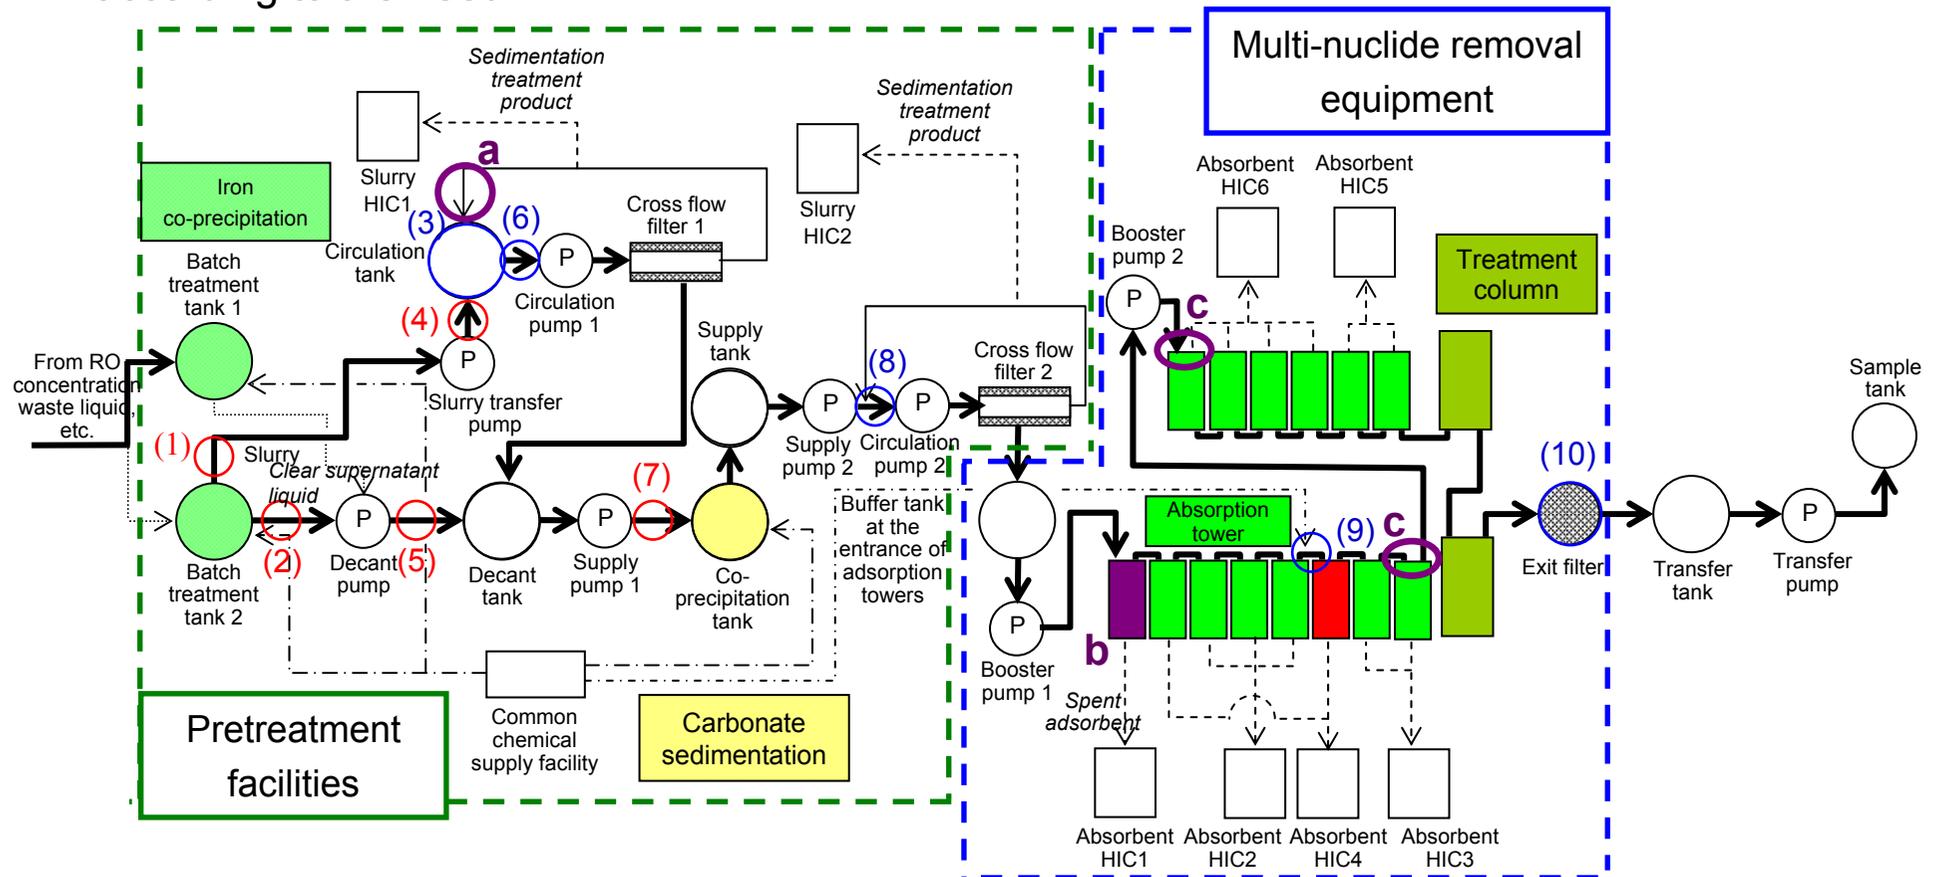
- Since corrosion was found inside the absorption tower 6A, horizontal development investigation is being implemented at the A system. (■○: Location where additional investigation was performed this time)
- Similar investigation is also being implemented at system B, which had been suspended, according to the need.

○ : Location where corrosion was found in the previous investigation
 ○ : Location where corrosion was not found in the previous investigation

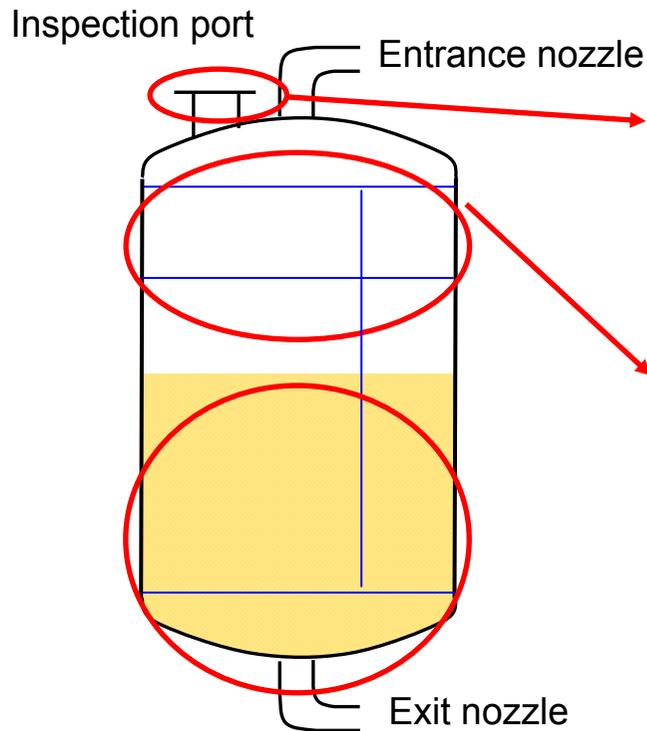
Flange surface (blank flange) of inspection port of the adsorption tower 1A

No crevice corrosion was found.

* Black part of the surface of flange sheet is remaining gasket.

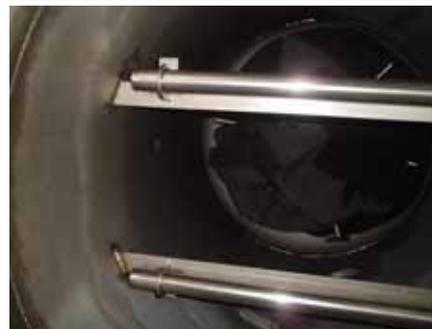
Inner surface of the adsorption tower 1A

No discoloration, etc. which is estimated to be corrosion was found at vicinity of welding line.

* Black part at the bottom is remaining adsorbent 1.

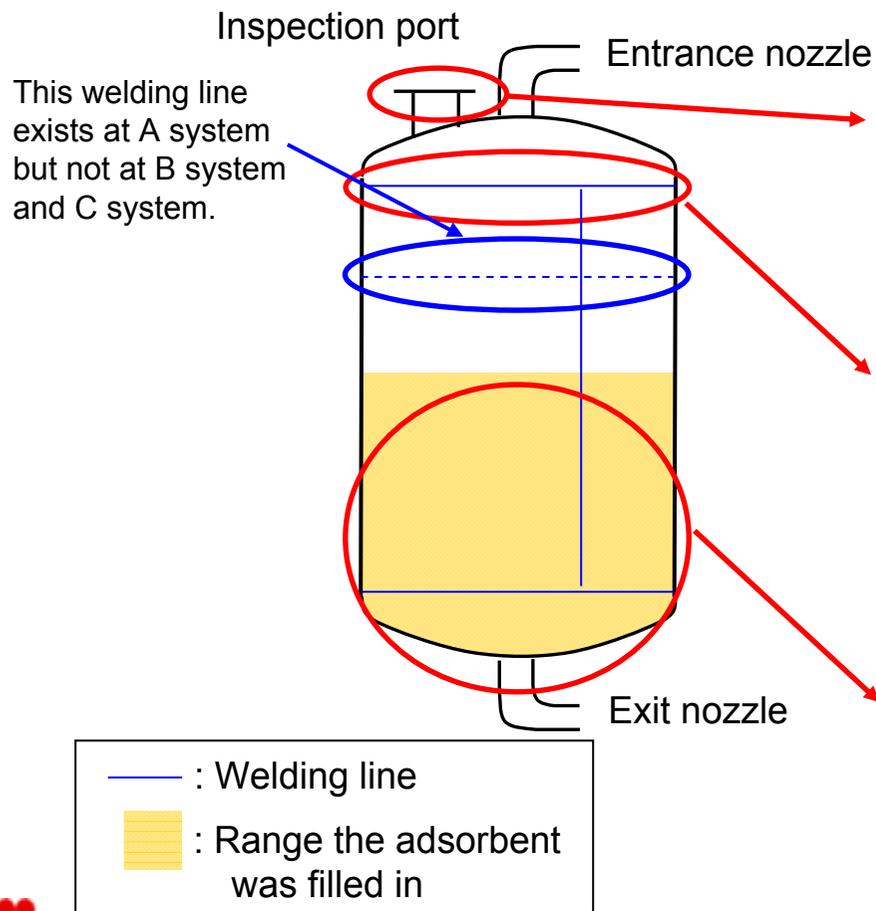
Flange surface (blank flange) of inspection port of the adsorption tower 6B

- Since crevice corrosion at the flange surface, and discoloration, which seems attributable to corrosion of the inner surface of the absorption tower, was found on the absorption tower (6A), we conducted an internal inspection on the absorption tower (6B) of system B with the adsorbent having been pulled out of the tower. As a result, crevice corrosion at the flange surface, and discoloration, which seems attributable to corrosion of the inner surface of the absorption tower, was found similarly to 6A.

Crevice corrosion was found at the flange surface.

- We will continue to investigate the equipment including B system in order to identify the extent of influence of the corrosion.
- We will consider causes of the corrosion and measures to prevent the recurrence of the corrosion, taking into account a difference such as environment, etc. between the location where the corrosion was found and the location where corrosion was not found.
- How to repair corrosion-damaged parts will be considered.
