# Results of Tank Patrol at Fukushima Daiichi Nuclear Power Station

<Reference>  
September 2, 2013  
Tokyo Electric Power Company

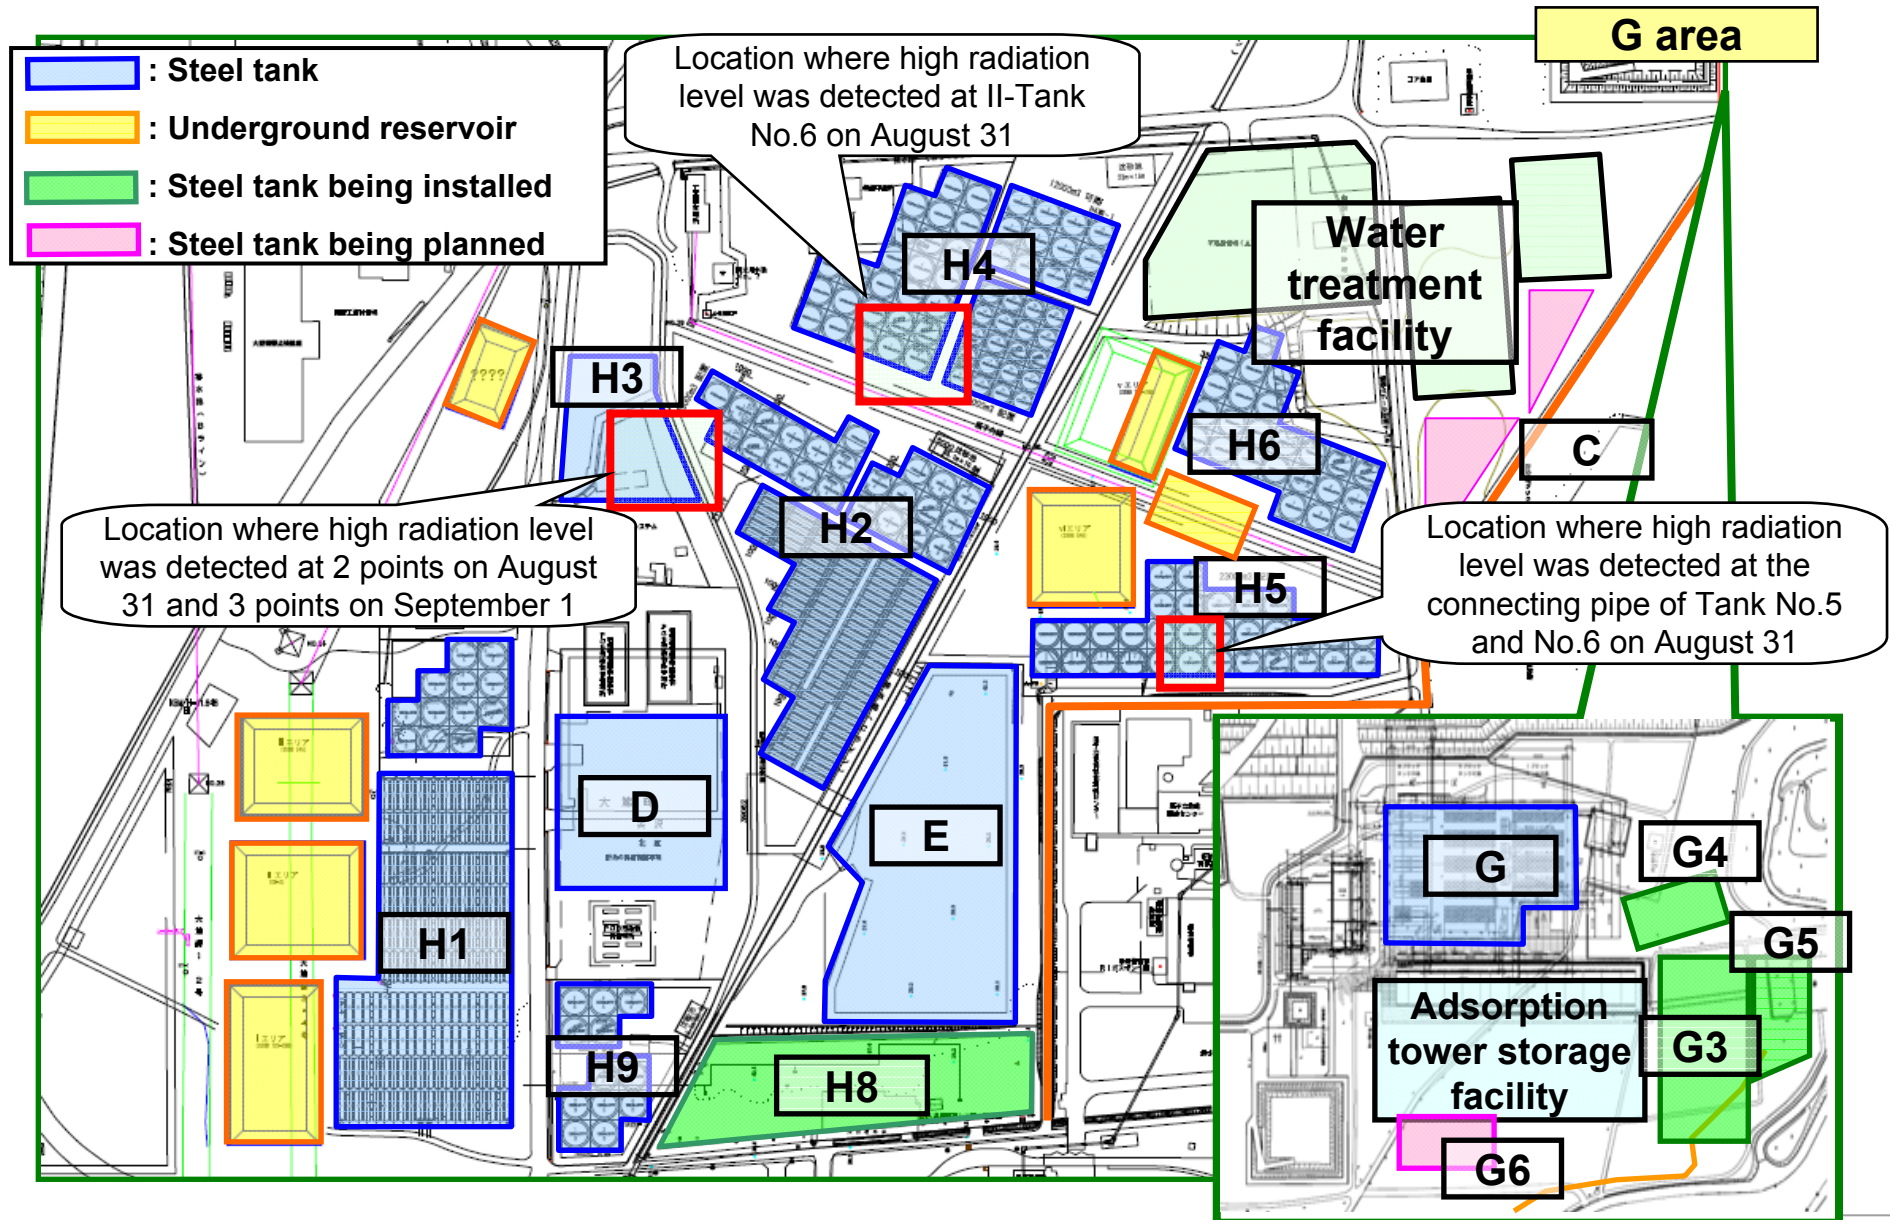
- H4-II-Tank No.6 where high radiation level (approx. 70mSv/h (70  $\mu$ m dose equivalent rate) from 5cm high)) was detected on August 31 during the patrol → Radiation level was below 10mSv/h from 50cm high on September 1, and no location with high radiation level was found.
- One location (point (2)-2) with high radiation level was additionally found at H3-B-Tank No.4 on September 1 → Approx. 60mSv/h from 50cmhigh, approx. 1700mSv/h from 5cm high

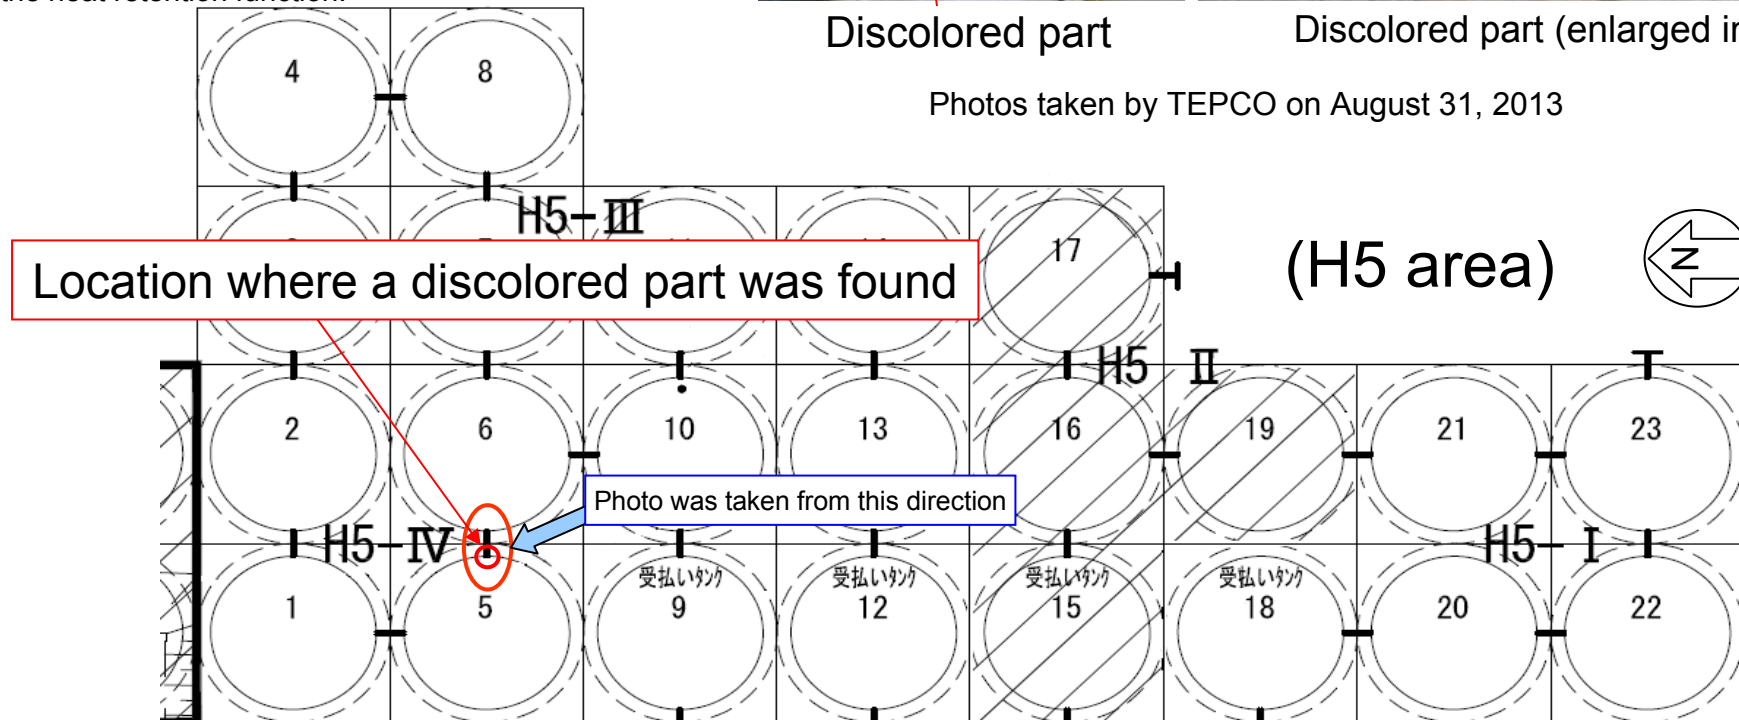
Photos taken by TEPCO on August 31, 2013

- Date of detection: August 31, 2013
- Location: Connecting pipe section between Tank No.5 and Tank No.6 in Group IV in the H5 area
- Situation: Discolored part was found above the floor surface under the outside flange of the entrance/exit valve of Tank No.5 in Group IV in the H5 area, and water was dripping one drop per approx. 90 seconds (dripping was found at around 11:10 PM on August 31).
- Countermeasures: After the bolts had been tightened up, the flange part was observed for 30 minutes, and we determined that no water leakage was occurring (at 2:20 PM on September 1). A drain receiving pan was installed under this valve, and monitoring will be continued for approx. 3 days. After that, we will reconfirm whether water leakage is occurring or not and will restore the heat retention function.
