High Radiation Locations Found at the H3 Area Tank

<Reference>
September 2, 2013
Tokyo Electric Power Company

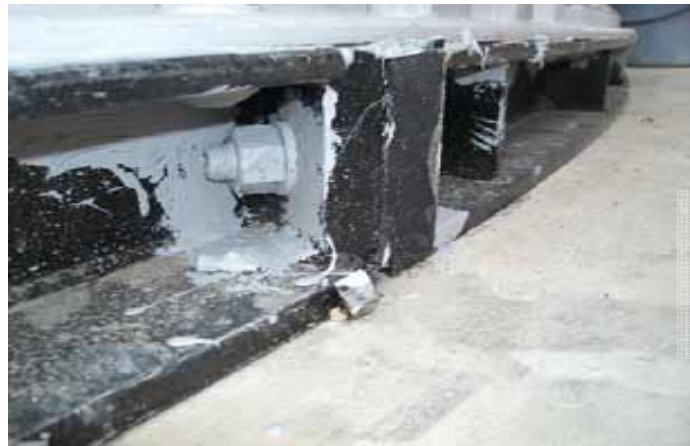
Photo of the joint part of flange at the bottom of the tank

- All 3 high radiation locations were the flange parts of the bottom of the tanks (edge of a packing with water expansible water stop function).
- Aside from these 3 locations, there was a record that someone measured the bottom of the tank where radiation level was higher than the surrounding area. (Since the level detected was below the record standard (10mSv/h in the measurement conducted within 1m from the outer surface of the tank, at the height of 50cm), this record was voluntarily made). There is a possibility that this was also the flange part of the bottom of the tank, so we will implement a detailed investigation.

- There are 8 similar flange parts per each tank, so we will investigate flange parts of the other tanks.
