Regarding the Incident Where a Jib Mast at the Tip of a Remote-control Large Crane Was Bent Down [Cause and Countermeasures]

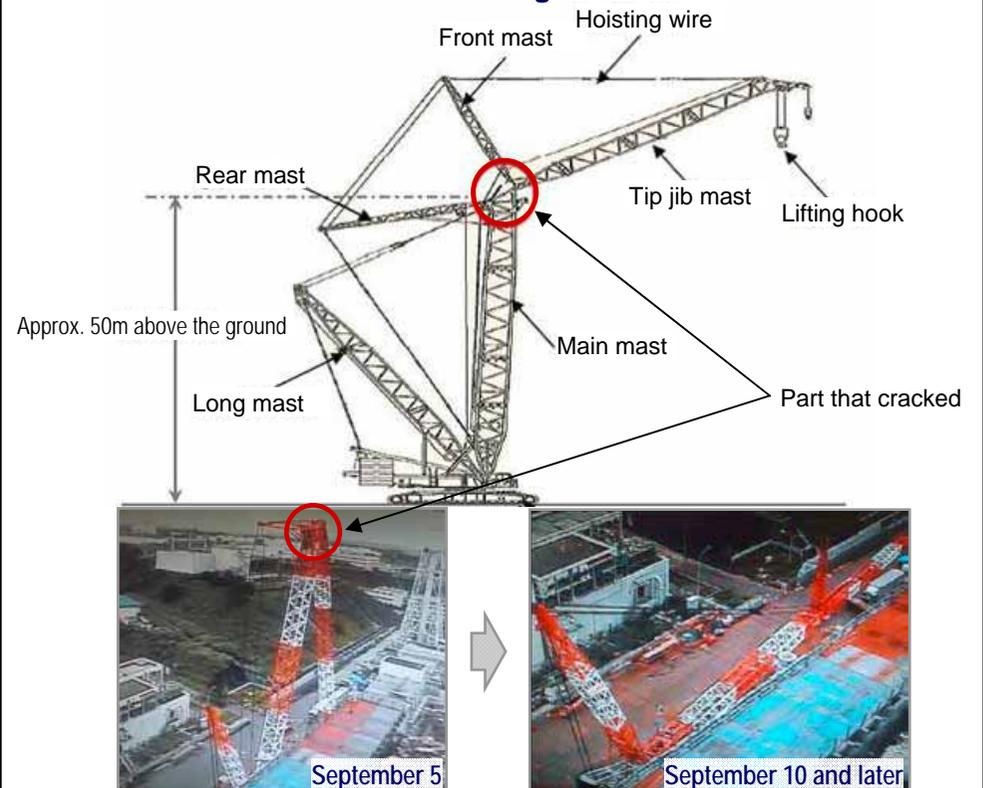
Overview of the remote-control large 600-ton crane

On September 5, 2013, a jib mast at the tip of a remote-control large 600-ton crane was accidentally bent down while being parked near Unit 3 Reactor Building. On September 10, we laid down the tip jib mast and the main mast on the ground, and conducted an inspection of the crane and an investigation of the cause of this incident.

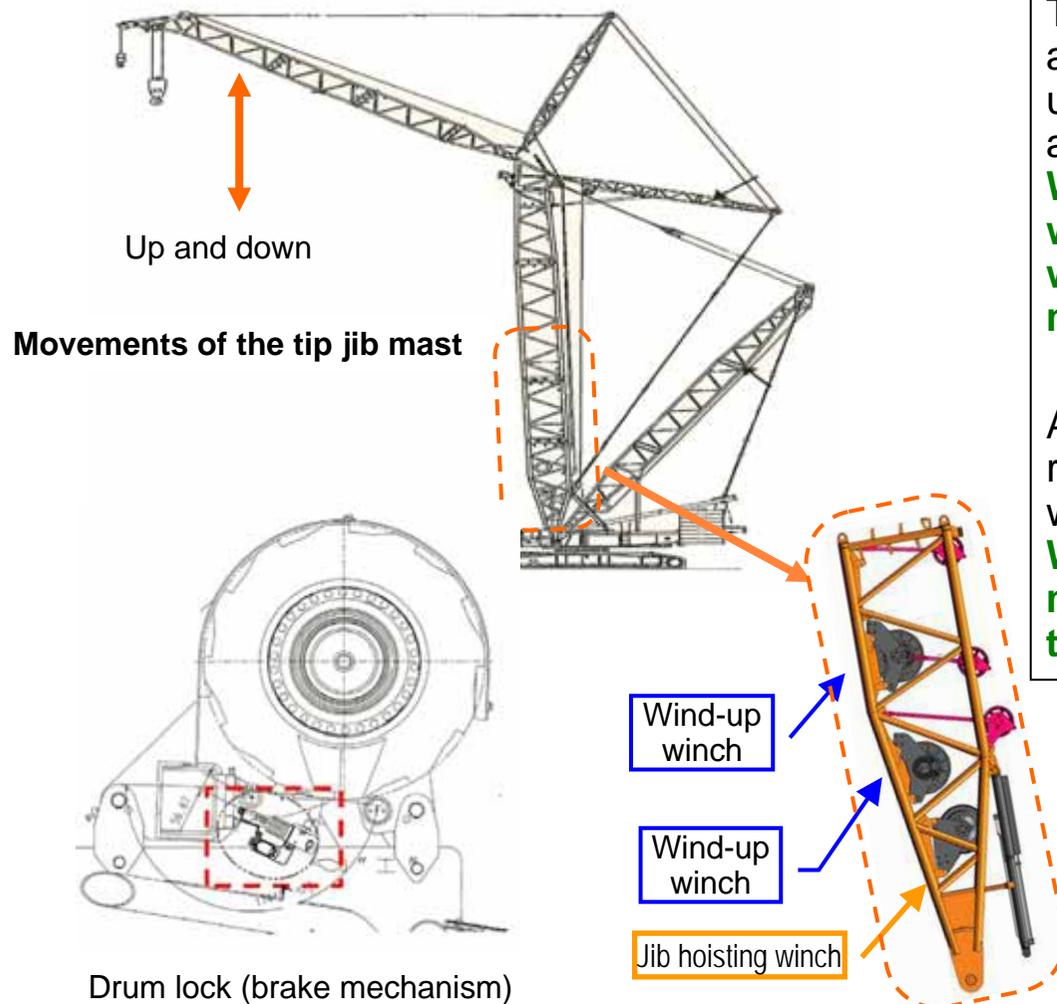
Overview of the failed crane (600-ton crane: 6000SLX)

The failed crane has a winch embedded in the boom for size reduction of equipment, and hence has a mechanism different from that of a typical crane.

The drum lock* of the jib hoisting winch was released, and this caused the hoisting wire to relax, so that the tip jib mast was gradually bent down. Then, a load larger than expected acted on and caused a crack to the main mast.

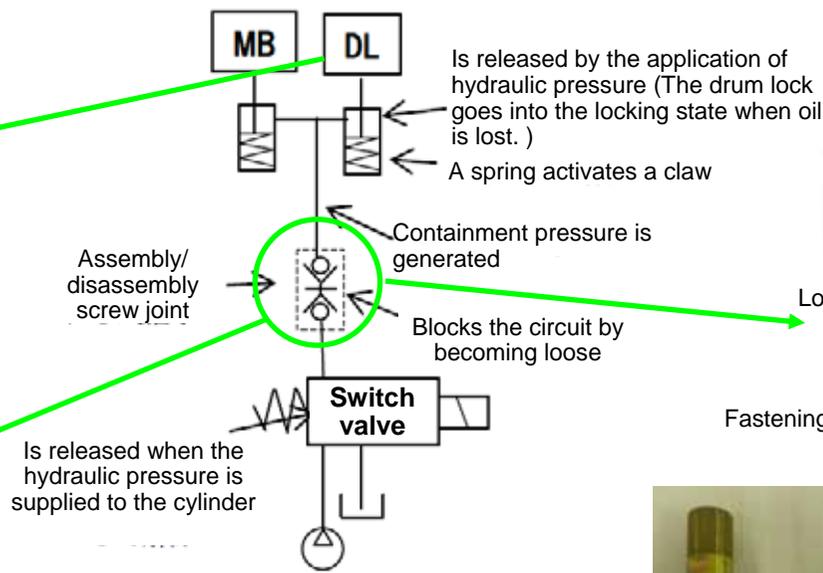
The assembly/disassembly screw joint

- The drum lock* was released as the loosened assembly/disassembly screw joint, which was in used for the hydraulic hose of the drum lock, prohibited decrease in hydraulic pressure.
- The drum lock normally functions to unlock the winch as a result of increase in hydraulic pressure while the crane is operated, and to lock the winch as a result of decrease in hydraulic pressure while the crane is not operated.

Oil was unable to go back blocked by the loosened screw

Measure (1)	Replacement of the failed screw joint used in the brake mechanism with a new one	[Factor (1)]
Measure (2)	Addition of a procedure that requires a worker to confirm, before and after operating the crane, that the screw joint is tight and that the drum lock is in the locking state, as a monthly and a daily inspection item.	[Factors (1), (2), and (3)]
Measure (3)	Installation of an indication light by which a worker can see the status of the drum lock from a remote room.	[Factors (1), (2), and (3)]
