Results of the Seventh Soundness Inspection for Unit 4 Reactor Building at Fukushima Daiichi Nuclear Power Station

December 18, 2013

Tokyo Electric Power Company

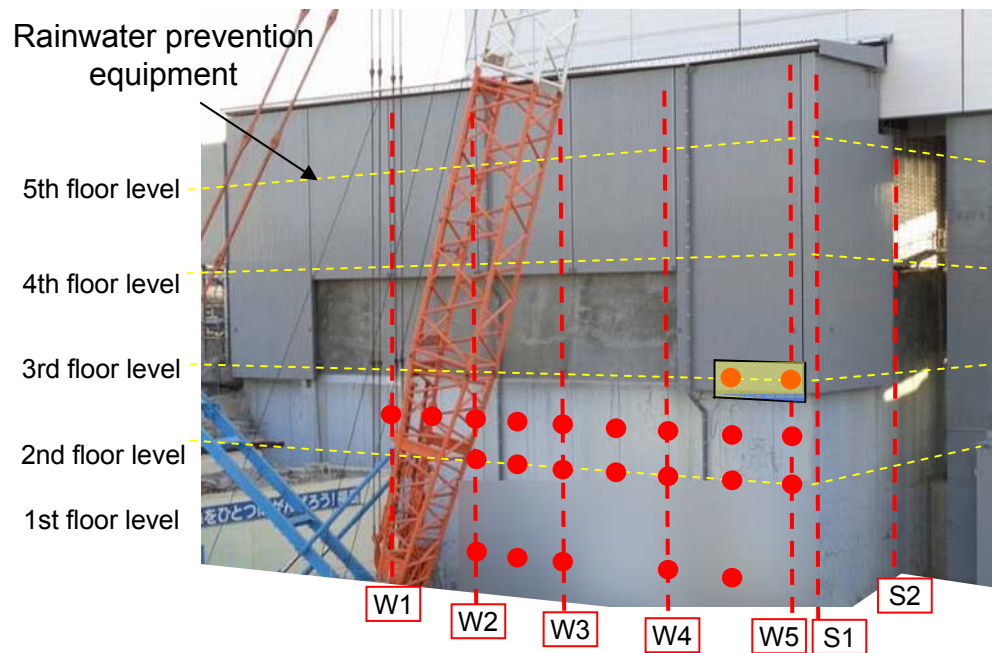
Measurement points

Though partial bulge was found on the outer walls, it has been confirmed that the building itself is not tilted based on the results of the first regular inspection (May 2012), detailed inspection of outer walls (June 2012), and second to sixth regular inspections (August and November 2012, February, May, and August 2013).

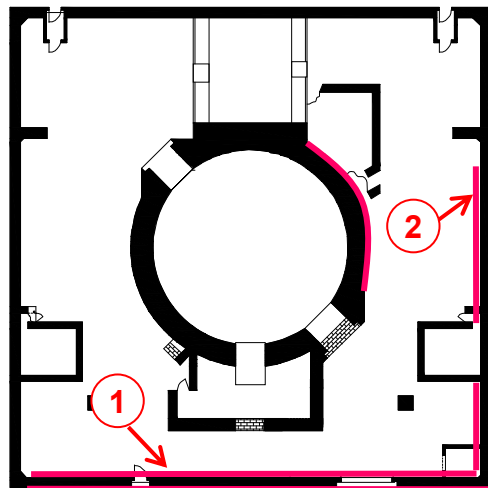
First floor

Since no crack of a width of 1mm or more or with possible rebar corrosion was found as a result of visual inspection (similarly to the past results).

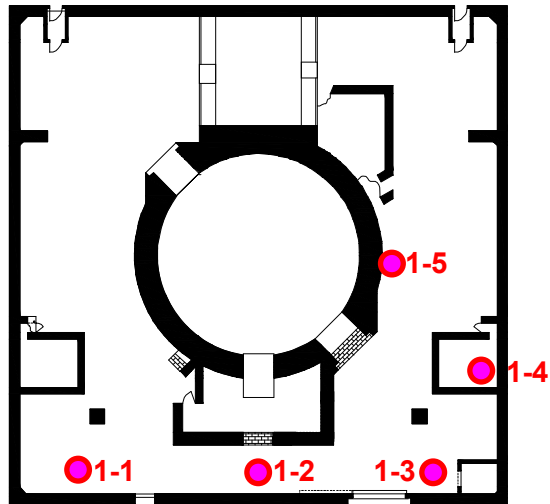
First floor

As a result of measurement, the concrete strengths on all the measurement points were above the design standard (22.1N/mm²) similarly to the past results. The concrete strength is considered to be about the same as the past results taking into considerations the error of Schmidt Hammer*¹ and that the measurement points were set at slightly different locations from the previous ones.
