# **Water Overflow from the flange of the top panel on the upper part of H6 tank area**

**Revised Version**

February 20, 2014

Tokyo Electric Power Company

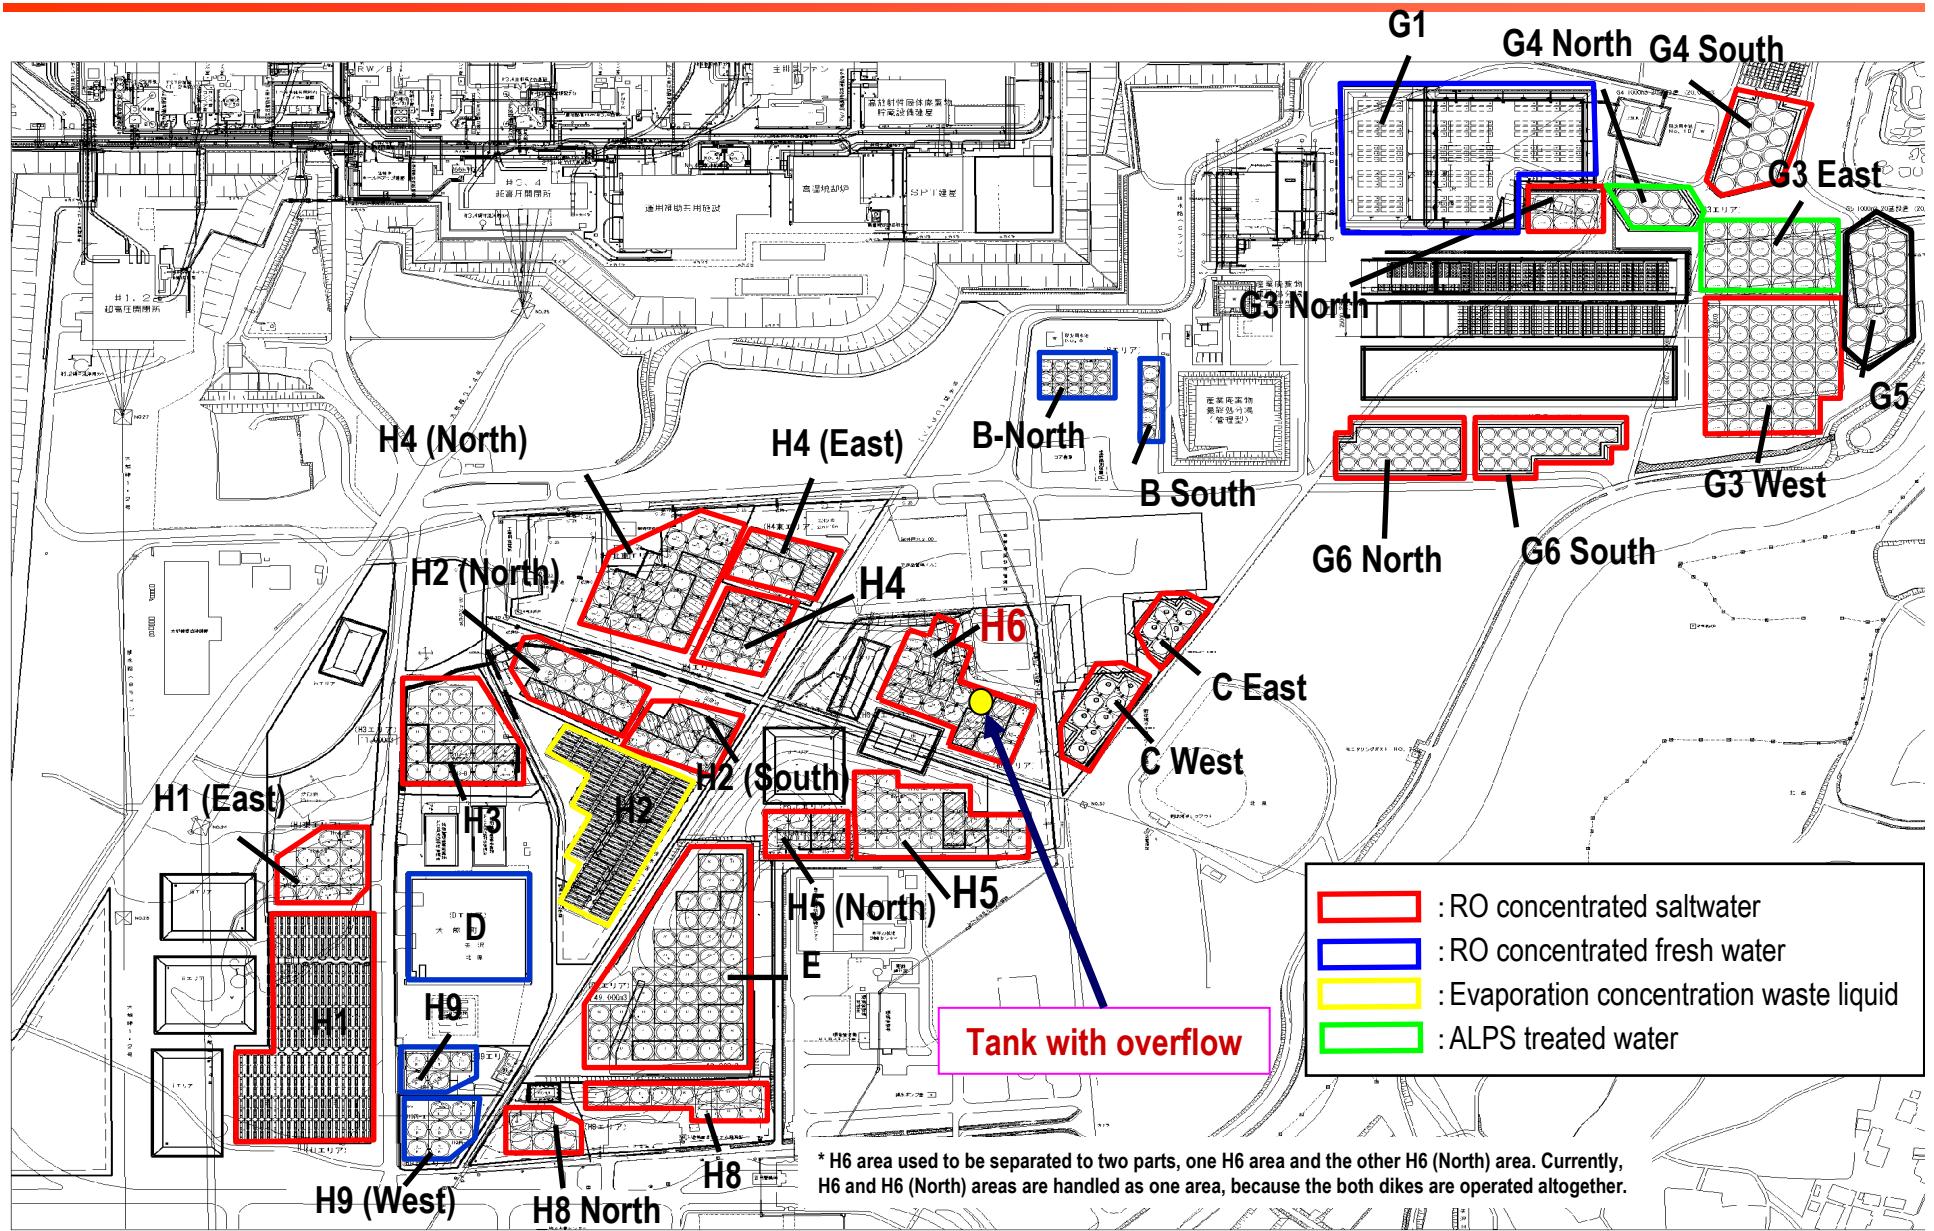
# Tank area layout

- Around 11:25PM February 19, a worker of a cooperative company found water was flowing out of the upper part of a tank in H6 area that contains RO concentrated salt\* water on his patrol in the tank area.

- As a result of inspecting the site, it is confirmed that water was escaping from the flange of the top panel on the upper tank, then downed though the rain gutter to the outside of the dike.

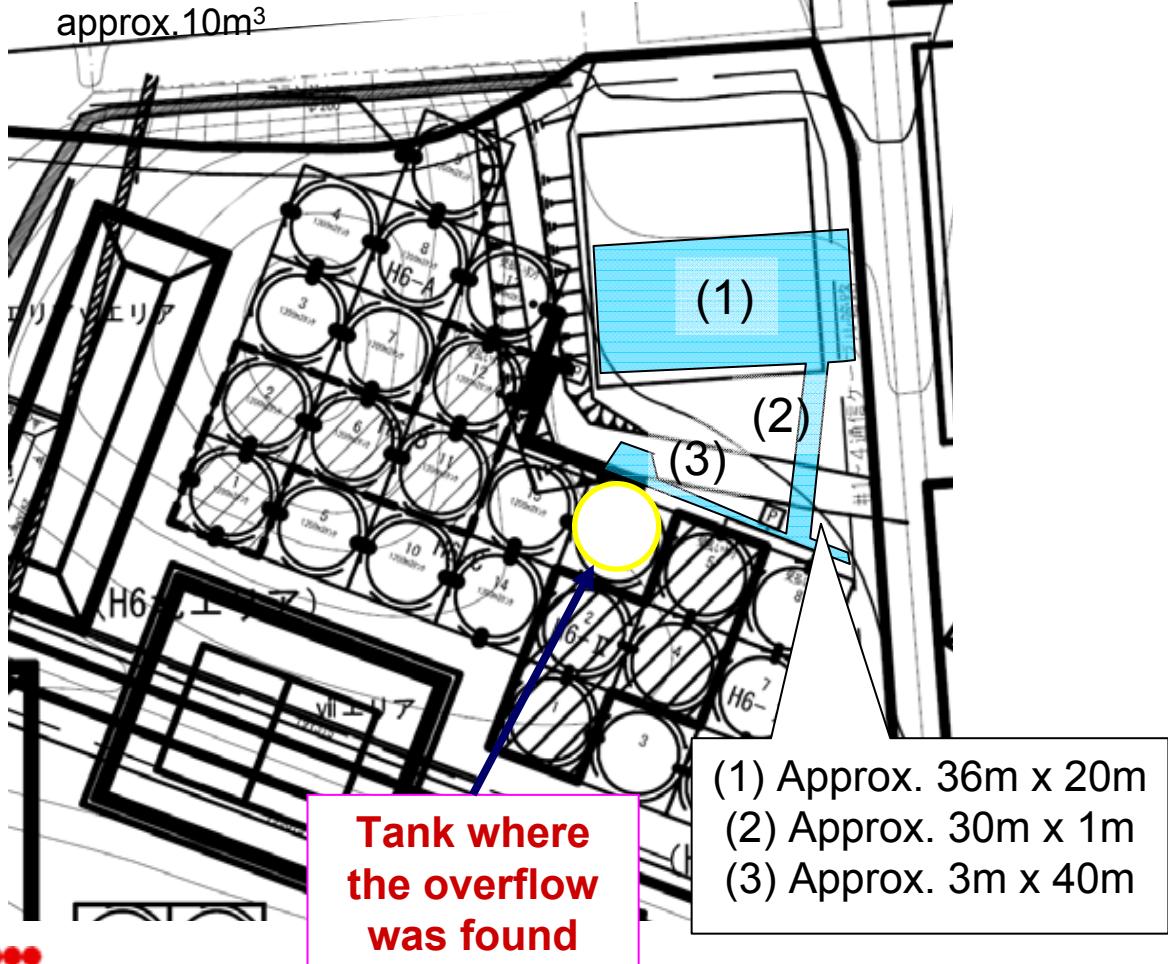
Condition of the overflow  
(Area (1))

- The area which where the overflowed water of approx.  $100\text{m}^3$  flowed to is the below three areas.
  - (1) Area where the desalination system (evaporative concentration) is installed
  - (2) U-shaped gutter where electric cable is accommodated
  - (3) Area near the H6 tank area dike
- Overflowed water which still remains inside of the dike is approx.  $10\text{m}^3$

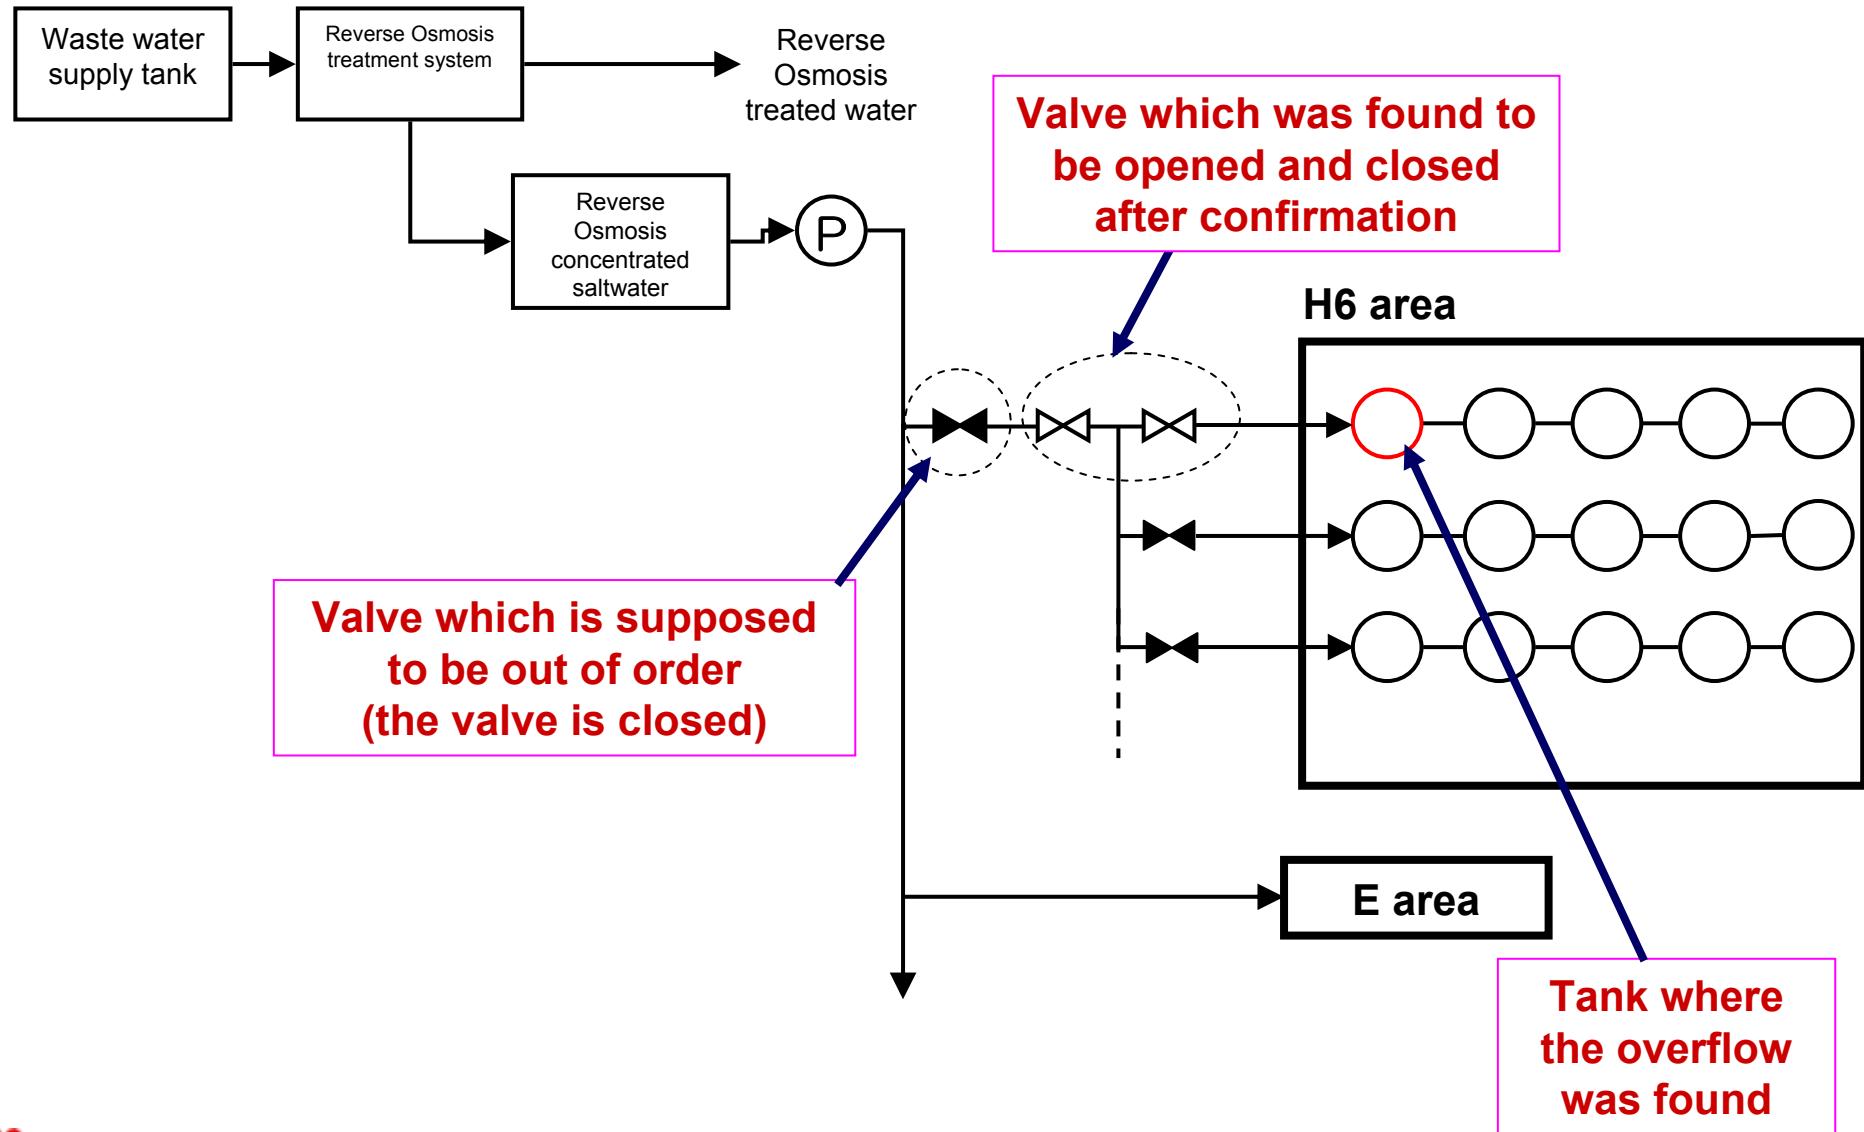
# Schematic Diagram of Pipes Transferring Water Treated by the Desalination System (Concentrated Saltwater)

- Finding that acceptable valves of the tank were being opened (two locations), the said valves were closed to decrease the amount of water overflowed. Later at 5:40PM February 20, it was confirmed that the overflow has stopped by lowering the water level in the tank.
