“Development of a technology to investigate inside the Reactor Primary Containment Vessel (PCV)”

- Results of site test “Investigation B1” on grating around the
pedestal inside Unit 1 PCV -**

April 30, 2015

Tokyo Electric Power Company

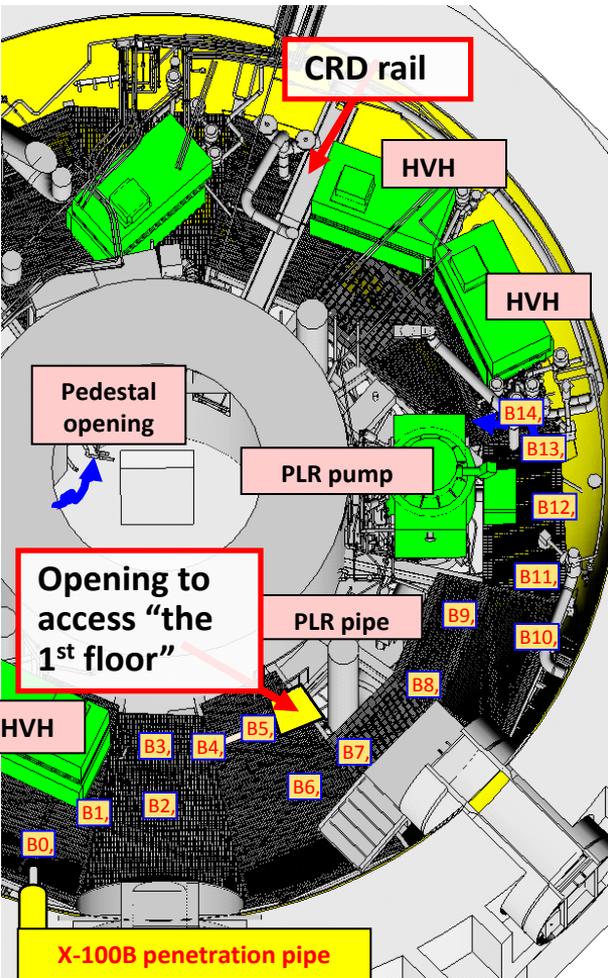
3-1 Investigation results (Counterclockwise: done on April 10)

The following data have been obtained through the investigation up to the point B14.

Investigation point	Investigation results
Opening to access the basement	<ul style="list-style-type: none"> For B2 investigation planned to be conducted (investigation on the basement around pedestal), it was confirmed that there is an accessible opening at the basement, and thus, there are no obstacle objects existed around it.
CRD rail	<ul style="list-style-type: none"> Yet to be reached at CRD rail. Images taken with a camera facing towards CRD rail at the end point where the robot reached at have been evaluated, to find that CRD rail can not be visually identified.
On access route	<ul style="list-style-type: none"> No significant damages are found on existing facilities (HVH, PLR pipe, and pedestal walls, etc.) Data on the temperature and radiation dose have been obtained at each investigation point.

* The first investigation device was stuck and ended up being disabled to be retrieved, therefore, it has been left inside the PCV after its corresponding cable was cut. (Apr. 13, 2015)

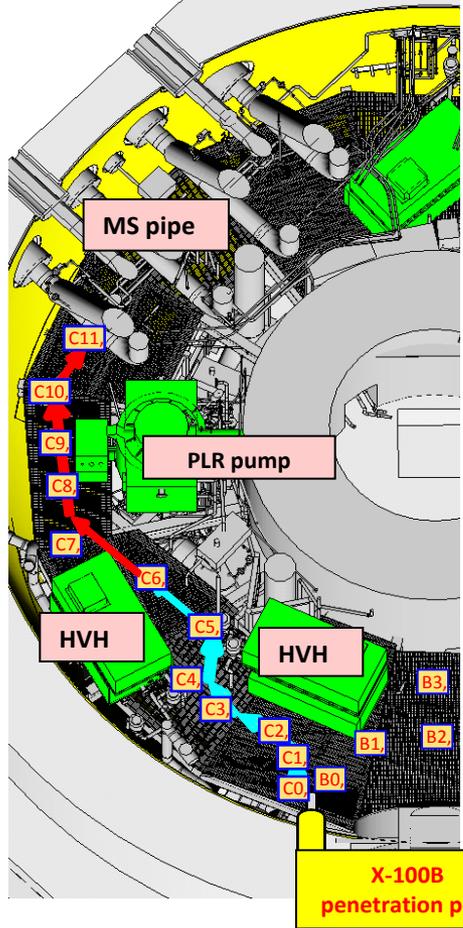
3-2 Investigation results (Clockwise: Done on April 15 and 16, 2015)

■ The following data have been obtained through the investigation up to the point C11.

Investigation point	Investigation results
On access route	<ul style="list-style-type: none"> • No significant damages have been found on existing facilities (PLR pipe, walls inside the PCV, and HVH, etc.) • Data on the temperature and radiation dose have been obtained at each investigation point.

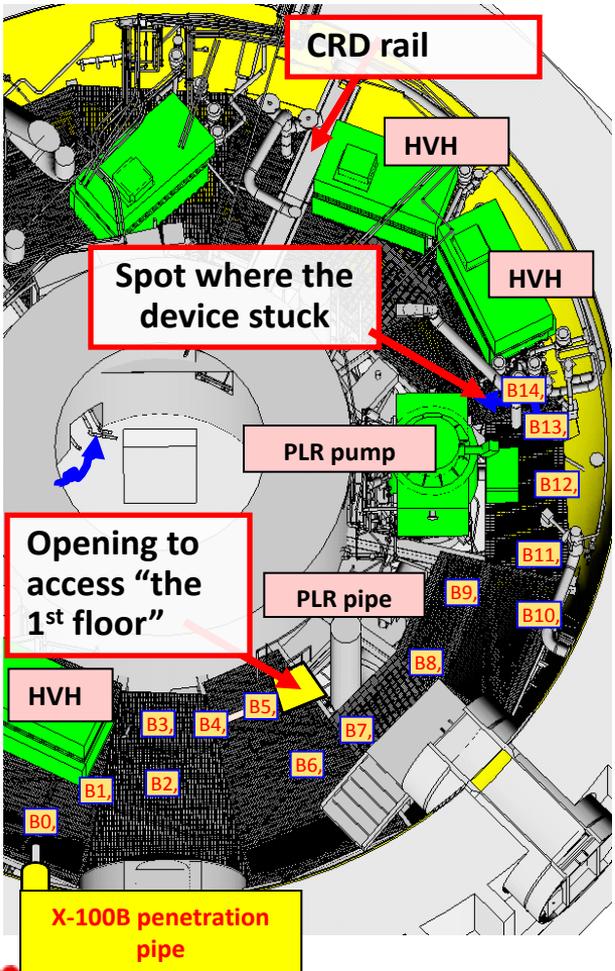
3-3 Investigation results (Clockwise: Done on April 18, 2015)

■ With the second investigation device, re-investigation on counterclockwise was conducted to obtain the following information.

Investigation point	Investigation results
Check the route of the cable remained	<ul style="list-style-type: none"> The cable being left around the opening to access the basement is confirmed of having no problem with B2 investigation.
Investigation device stuck	<ul style="list-style-type: none"> Checked on the condition of the crawler of the device stuck.
Check the access route up to CRD rail	<ul style="list-style-type: none"> The access route up to CRD rail goes through a narrow part between structures, which resulted in the investigation device having been disabled to pass through.

* A pan-tilt camera used for retrieving the device became dysfunctional due to, seemingly, the radiation effect, hence, it was determined to leave the second investigation device in the spot where will not interfere with future works inside the PCV (around C2 on the wall side of the PCV) . (dated Apr. 20, 2015)

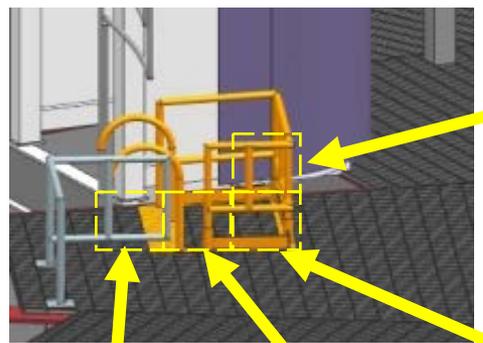
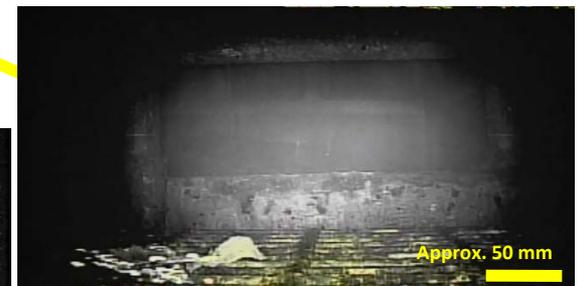
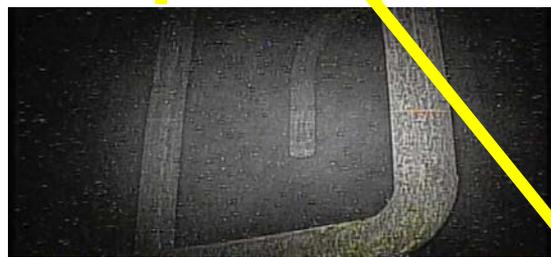
Taken from B4

- It was confirmed that there is an accessible opening at the basement for B2 investigation planned to be conducted, and thus, there are no obstacle objects existed around it.

Spot available for inserting the device

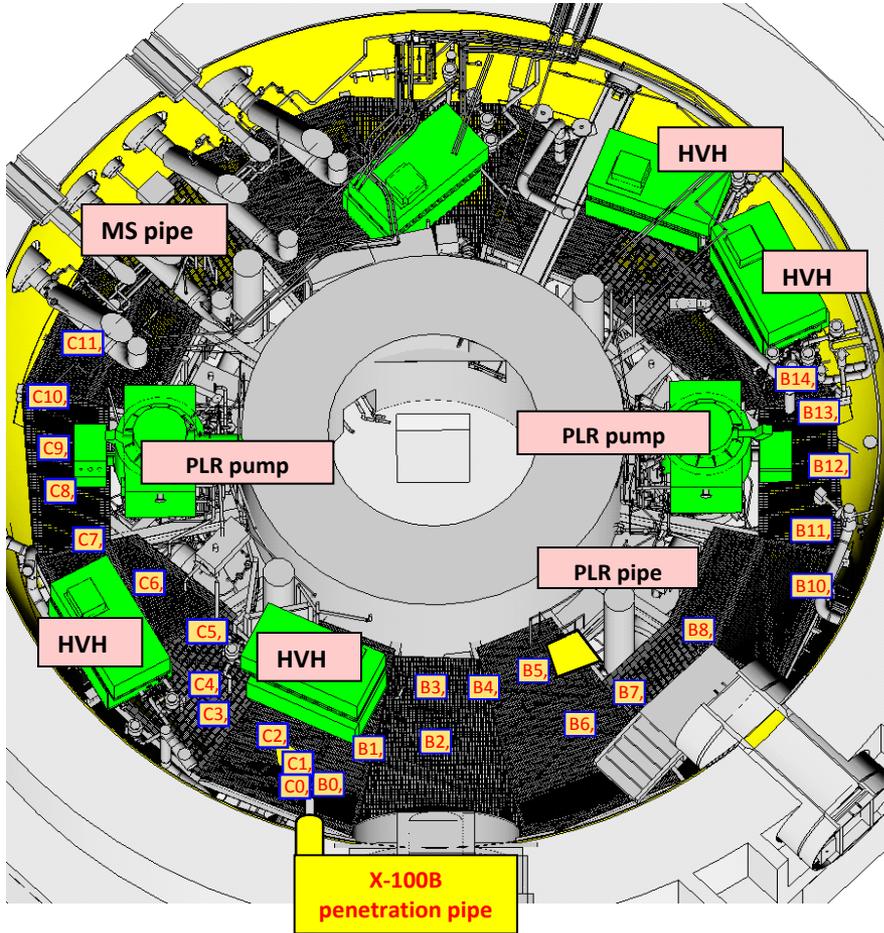
6. Measurement results for temperature and radiation dose rate

■ Temperature and dose rate were measured at the following points.

Dose rate (Sv/h)	Temperature (°C)
B3	7.4	17.8
B4	7.5	19.2
B5	8.7	19.4
B7	7.4	19.5
B11	9.7	19.2
B14	7.0	20.2
C2	6.7	19.6
C5	8.3	19.5
C6	7.7	19.4
C9	4.7	20.8
C10	5.3	21.1
C11	6.2	20.7

B3 to B14 (Measurement date: Apr. 10, 2015)
 C2 to C6 (Measurement date: Apr. 15, 2015)
 C9 to C11 (Measurement date: Apr. 16, 2015)

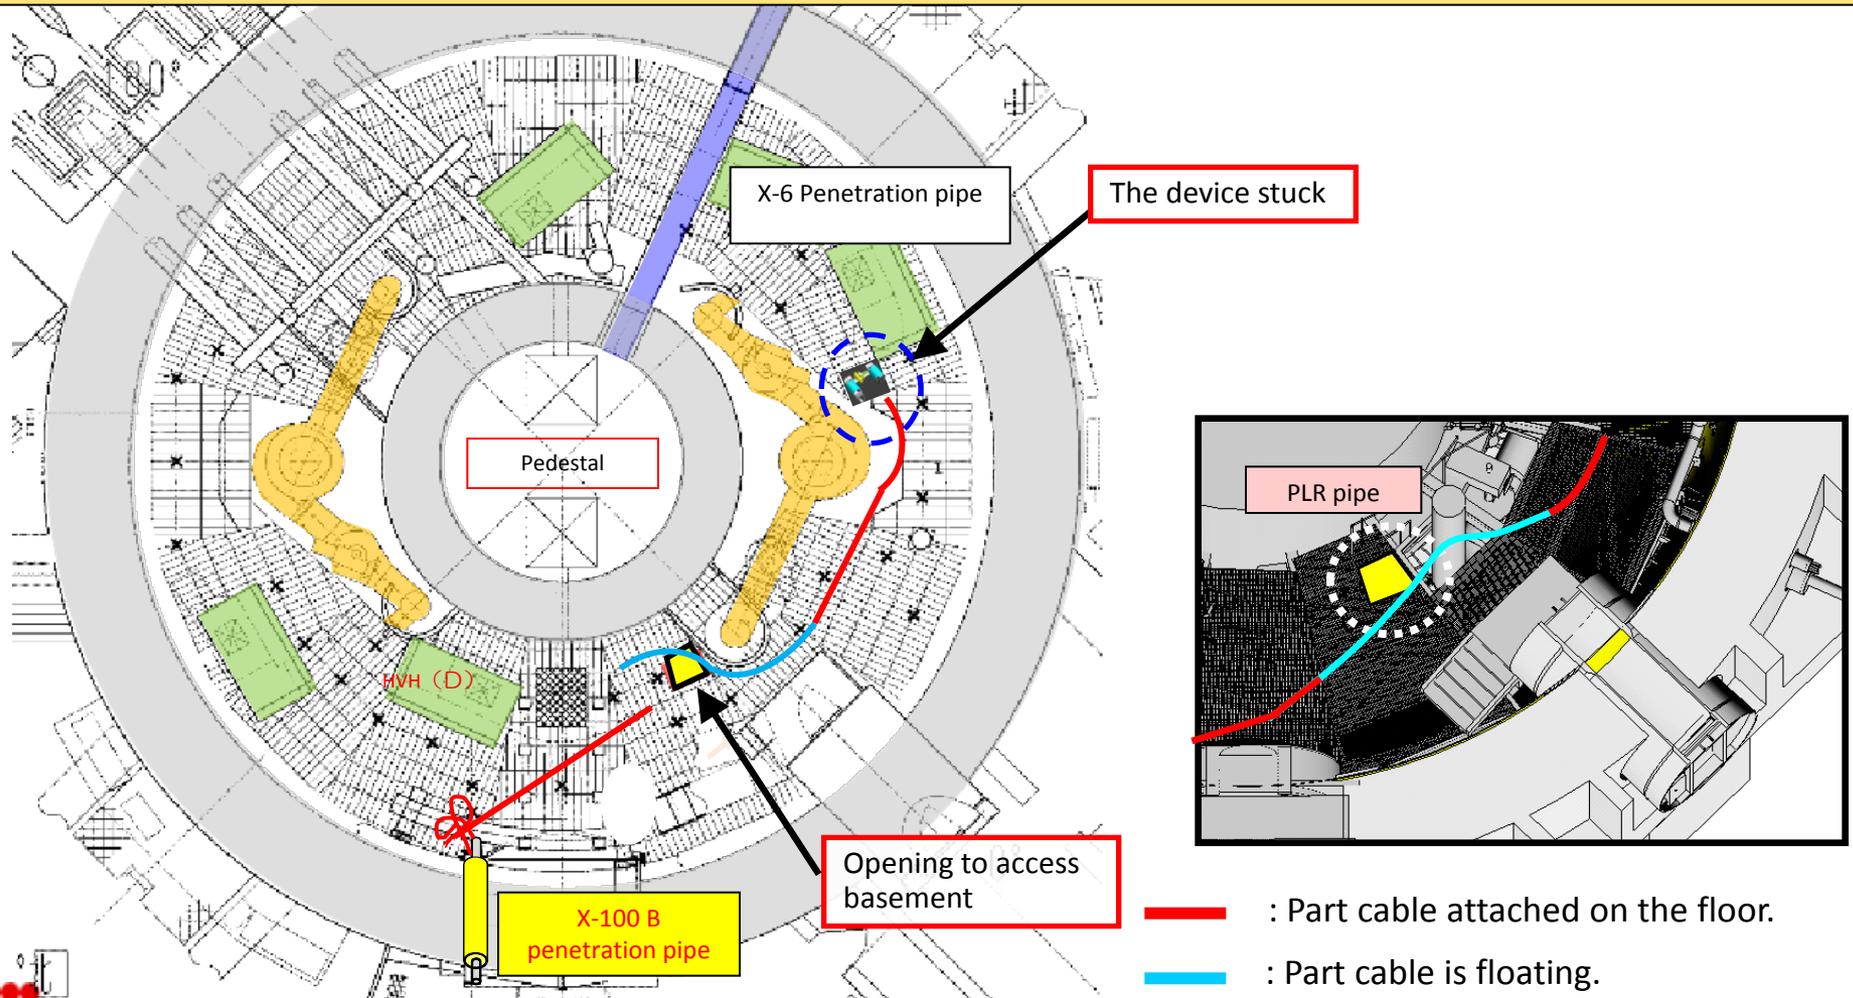
7. Conditions of cable remained

- The route of the cable remained is shown as below.
- It was confirmed that the cable remained around the opening to access the basement will not interfere with B2 investigation.

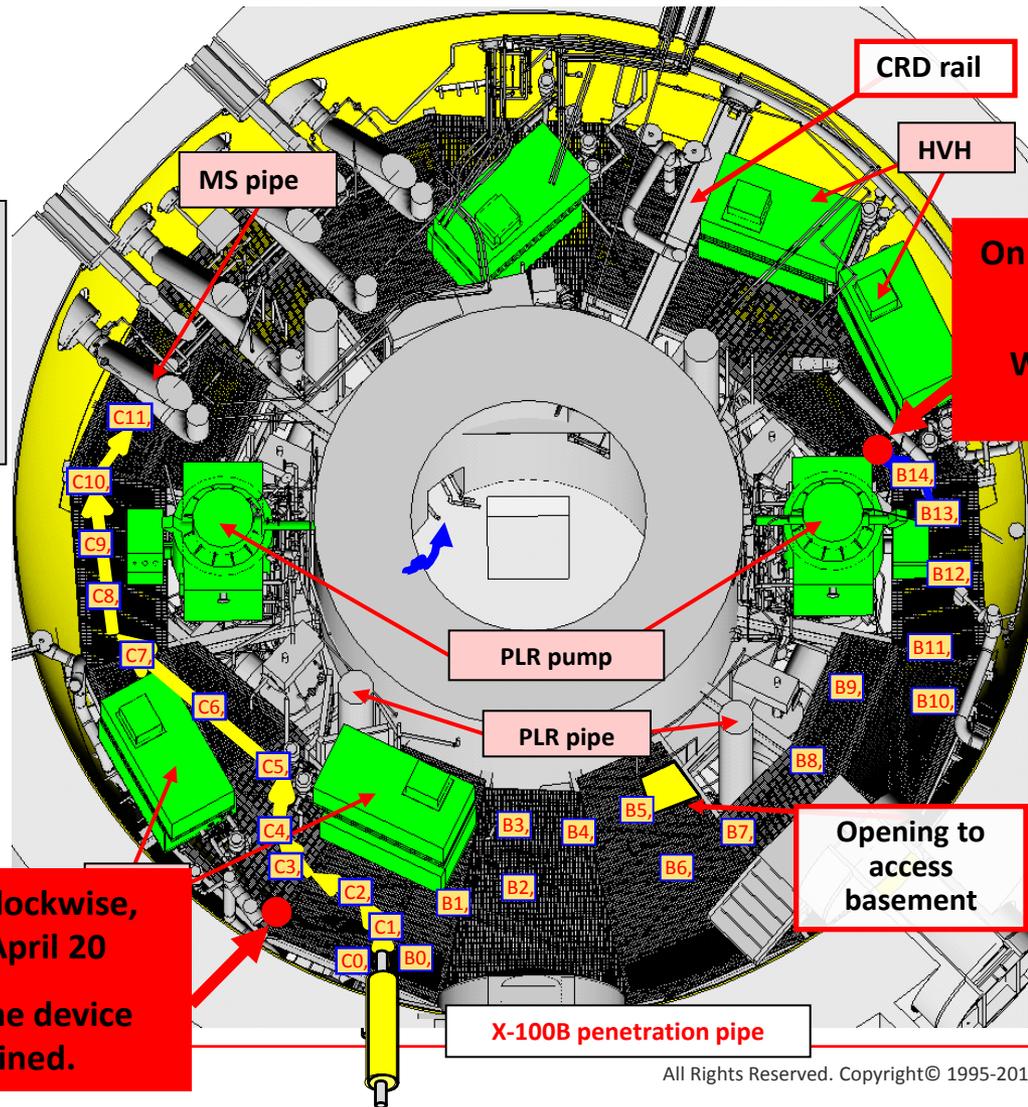
10. Investigation device remained

- Where the device remained is as shown in the figure below.
- The investigation device remained will not interfere with B2 investigation planned to be conducted.

**On counterclockwise,
 dated Apr. 13.
 Where the device
 remained.**

**Counterclockwise,
 dated April 20
 Where the device
 remained.**

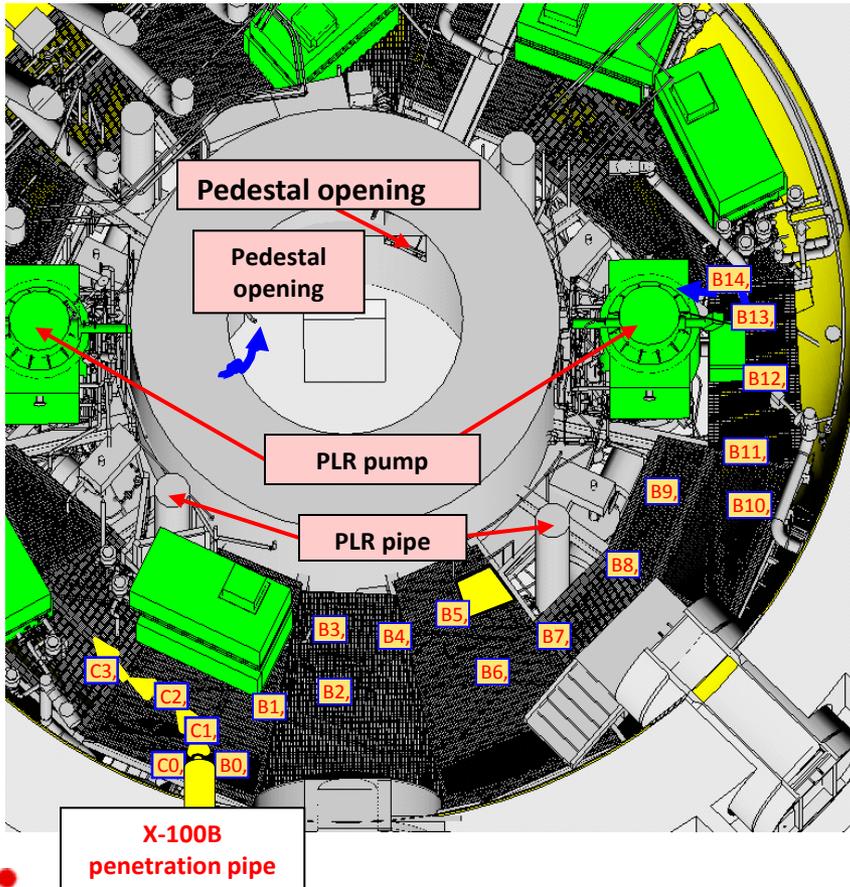
(Reference) Measurement of temperature and radiation dose rate

■ Temperature and dose rate were measured at the following points after conducting a review of the investigation on counterclockwise.

Measurement date: Apr. 19, 2015

Dose rate (Sv/h)	Temperature (°C)
Around B14	4.4	17.9
Around B11	5.7	18.7
Around B7	5.9	19.1
End point where the device remained. (Around C3)	4.1	20.4

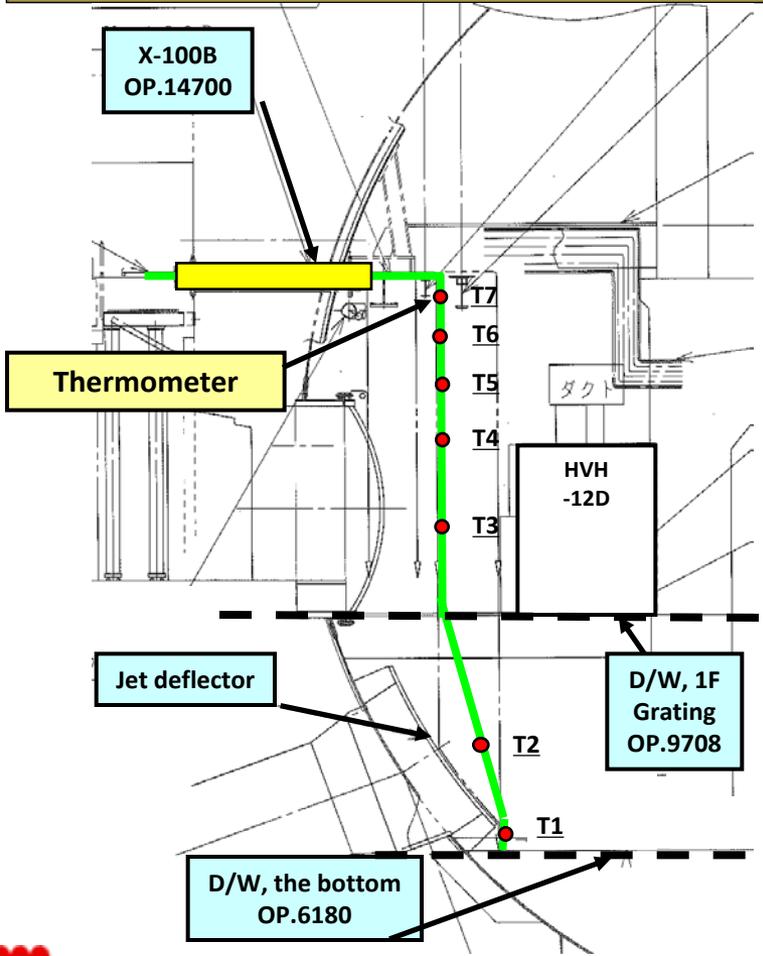
Overview of the re-installation of measuring instruments inside the PCV for surveillance monitoring

Measuring instruments installed inside Unit 1 PCV for surveillance monitoring were removed in order to conduct B1 investigation. Having completed the investigation, new measuring instruments equivalent to the existing ones are newly installed on the same position where the former ones were set.

Newly installed thermometers			[Data taken as of 12:00, 4/23]
No	Installation level (Under evaluation)	Indication value (°C)	DC resistance (Ω) (Measuring value/ Design value(±56))
T7	OP.14500	18.1	1830 / 1842
T6	OP.14000	18.1	1845 / 1858
T5	OP.13230	18.0	1875 / 1889
T4	OP.12500	17.8	1903 / 1917
T3	OP.11200	17.8	1950 / 1965
T2	OP.7500	18.9	2091 / 2102
T1	OP.6330	18.9	2135 / 2146

Existing thermometers		[Data taken on as of 12:00, 4/23]
OP.14000	TE-1625J	24.9°C
OP.11200	TE-1625D	17.4°C

Regarding the thermocouple reinstalled inside the PCV, with the fact that both DC and insulation resistance values after inserting are found to have no problem, plus the fact that value indicated before and after the replacement shows almost no difference in figure, it was verified that the reinstallation has been made without fail.

Regarding the thermometer having installed, for the next one month or around, it will be checked whether the device is working in accordance with the status of water injection into reactor and the condition of outdoor temperature fluctuation, etc. And when the device was judged as acceptable for monitoring the cooling status, it will be selected as a surveillance thermometer for monitoring the cold shutdown condition specified at Article 18, Chapter III of the implementation plan.

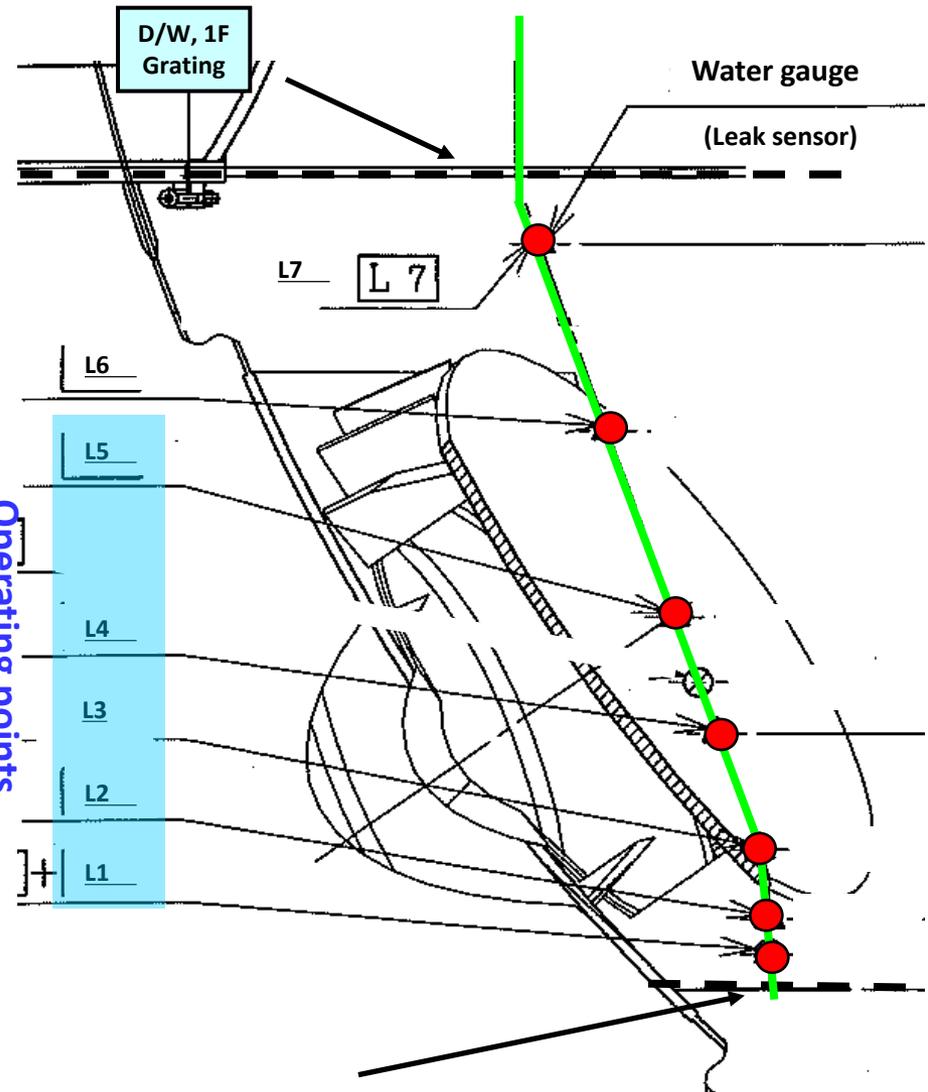
■ Check on the operating point of water gauge inside the PCV

■ Water gauge operating status

- In operation : L1~L5
- Non-operating : L6~L7
