Reference February 2, 2017 Tokyo Electric Power Company Holdings, Inc.

Pre-investigation results of the area inside the pedestal for the Unit 2 Primary Containment Vessel Investigation at Fukushima Daiichi Nuclear Power Station (examination results of digital images)

# 1. Current conditions of Unit 2 Primary Containment Vessel (PCV)

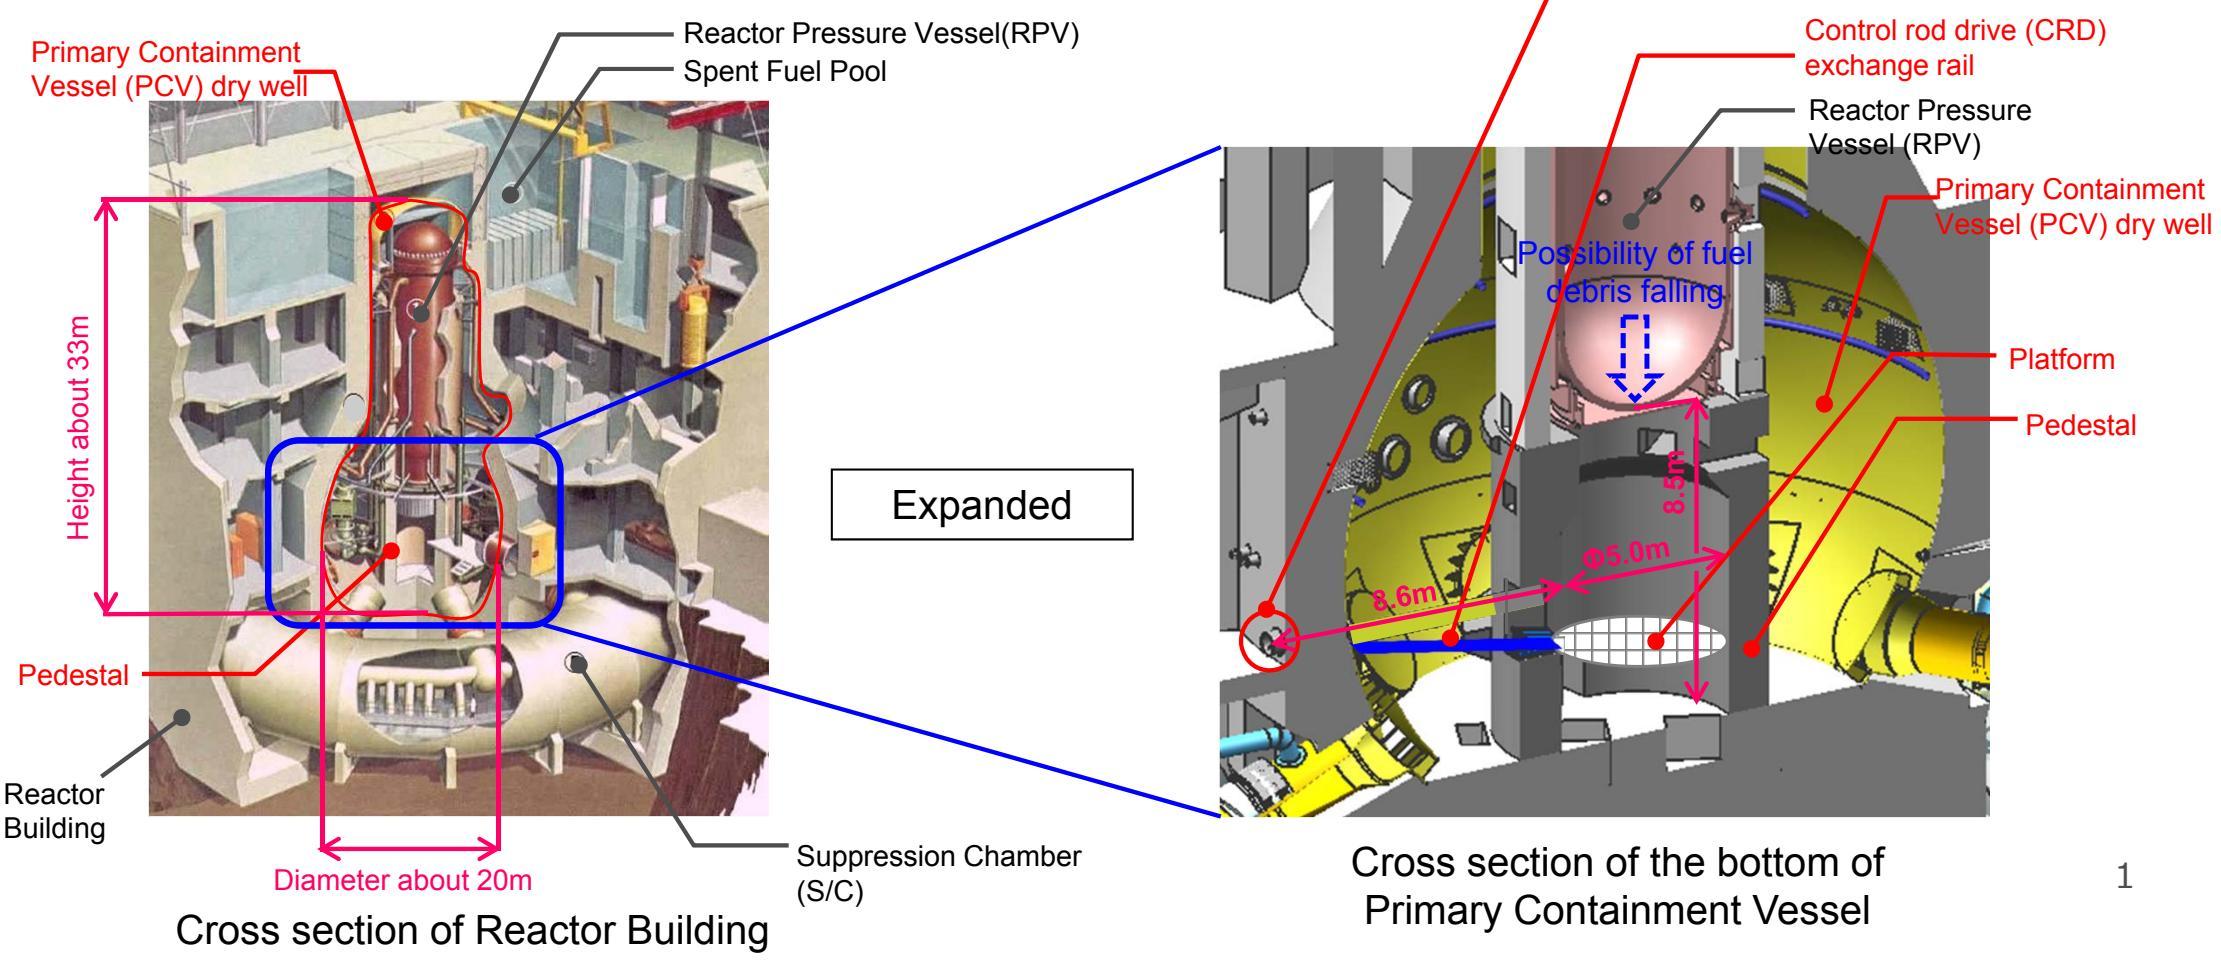
- Nuclear fuel in the Primary Containment vessel (PCV) was exposed to the air and melted from the impact of March 2011 Great Earthquake.
- As a result of the accident analysis, it was found that a portion of melted nuclear fuel might have been fallen inside the pedestal.
- To remove fuel debris, it is necessary to investigate the PCV and clarify the conditions of debris and surrounding structures.
  X-6 penetration

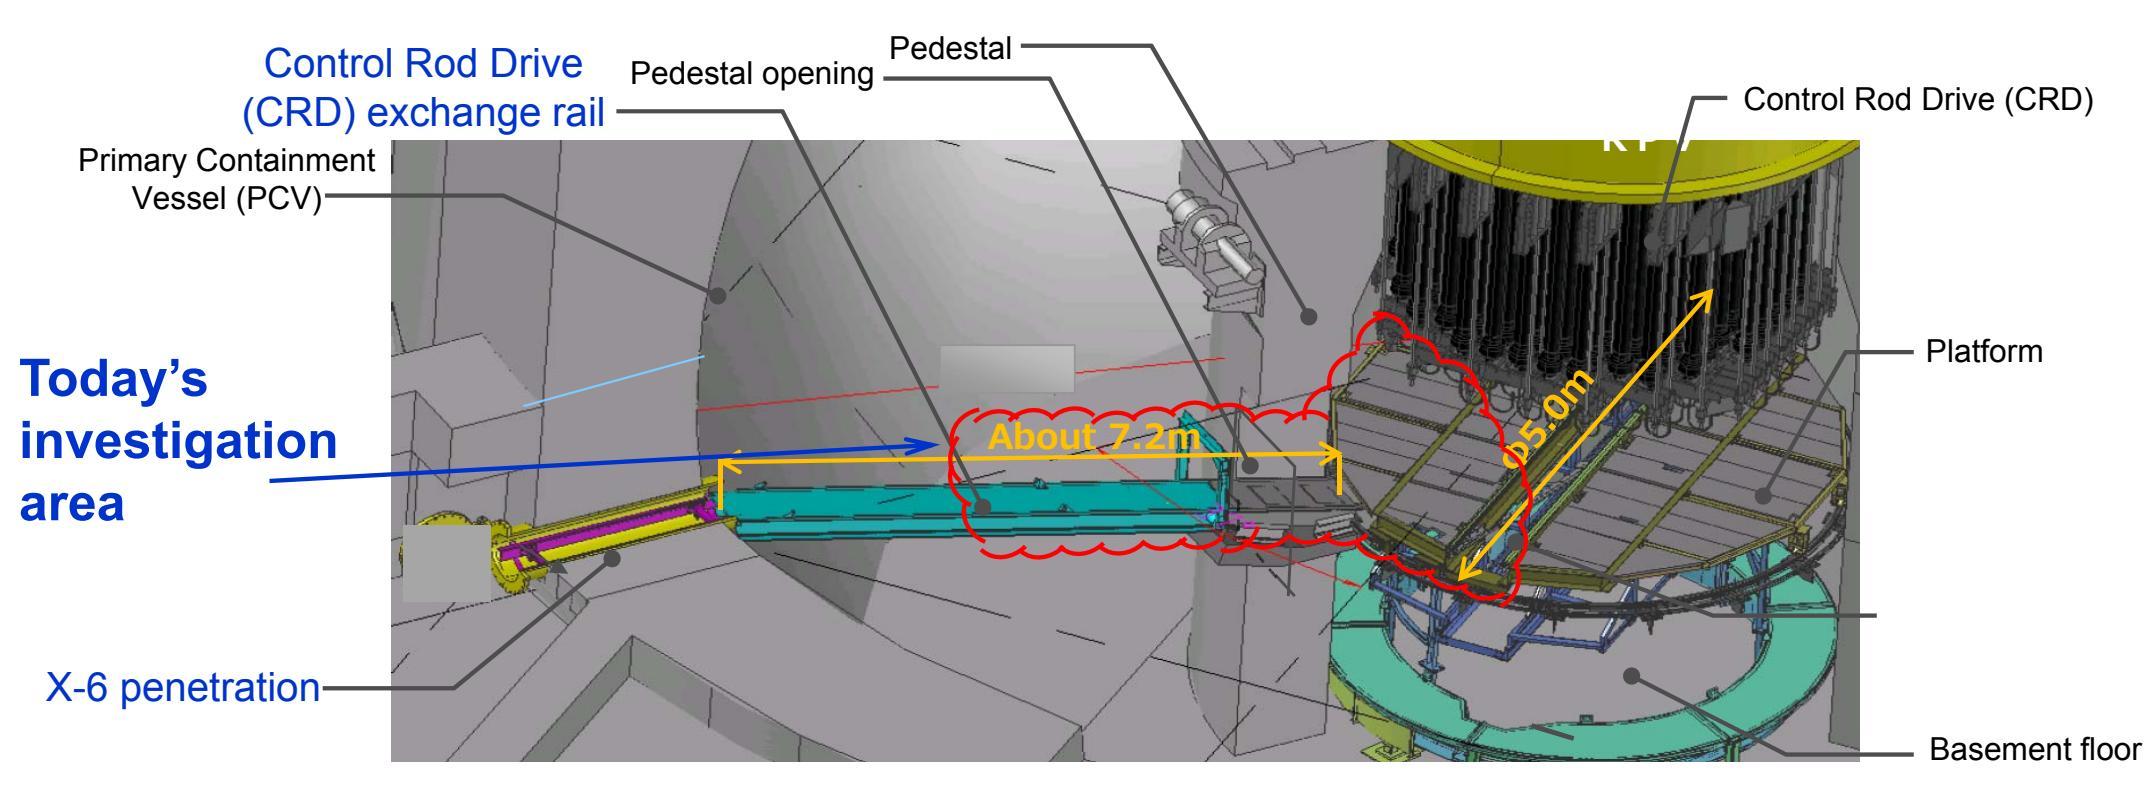
Investigation area inside the pedestal

Today, preparatory investigation was conducted for X-6 penetration and CRD exchange rail which the self-propelled Scorpion robot will take to the pedestal.
